**FLUID SYSTEMS DIVISION  
PARKER HANNIFIN CORPORATION**

**133A4 VACUUM REGULATOR  
EXAMINATION**

Model:	Piper PA-28-160
Serial No:	28-1215
Manufacture Date:	1963
Registration:	N5714W

Subject: June 10, 2013 Examination of a 133A4 Vacuum Regulator for the NTSB (ERA13FA088)

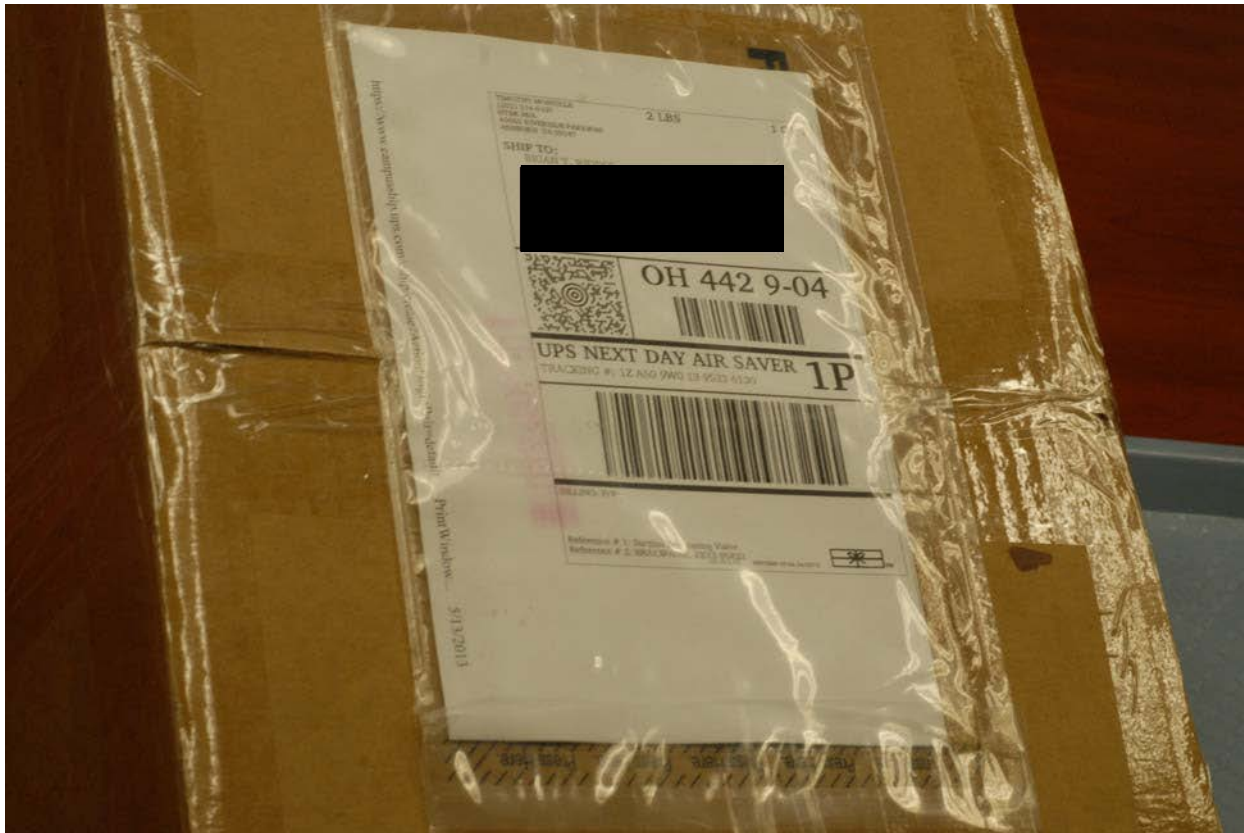
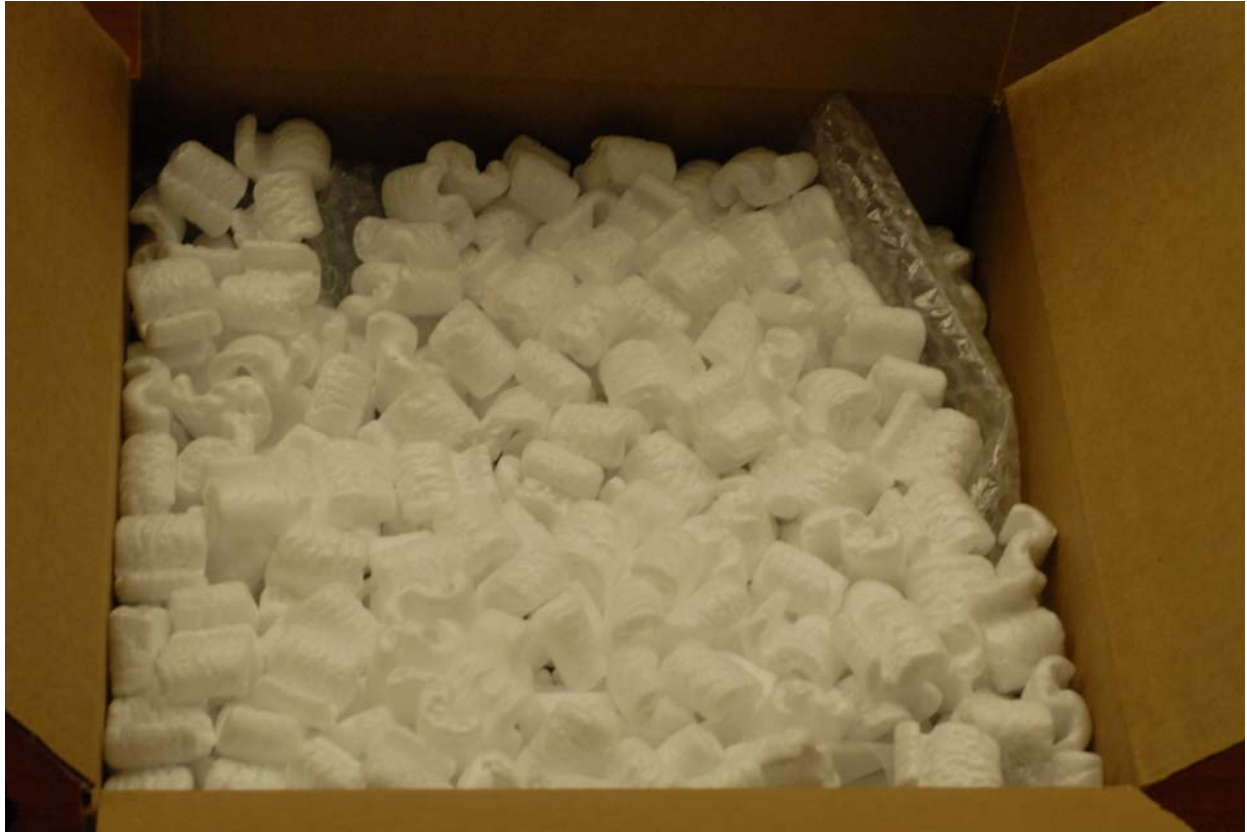
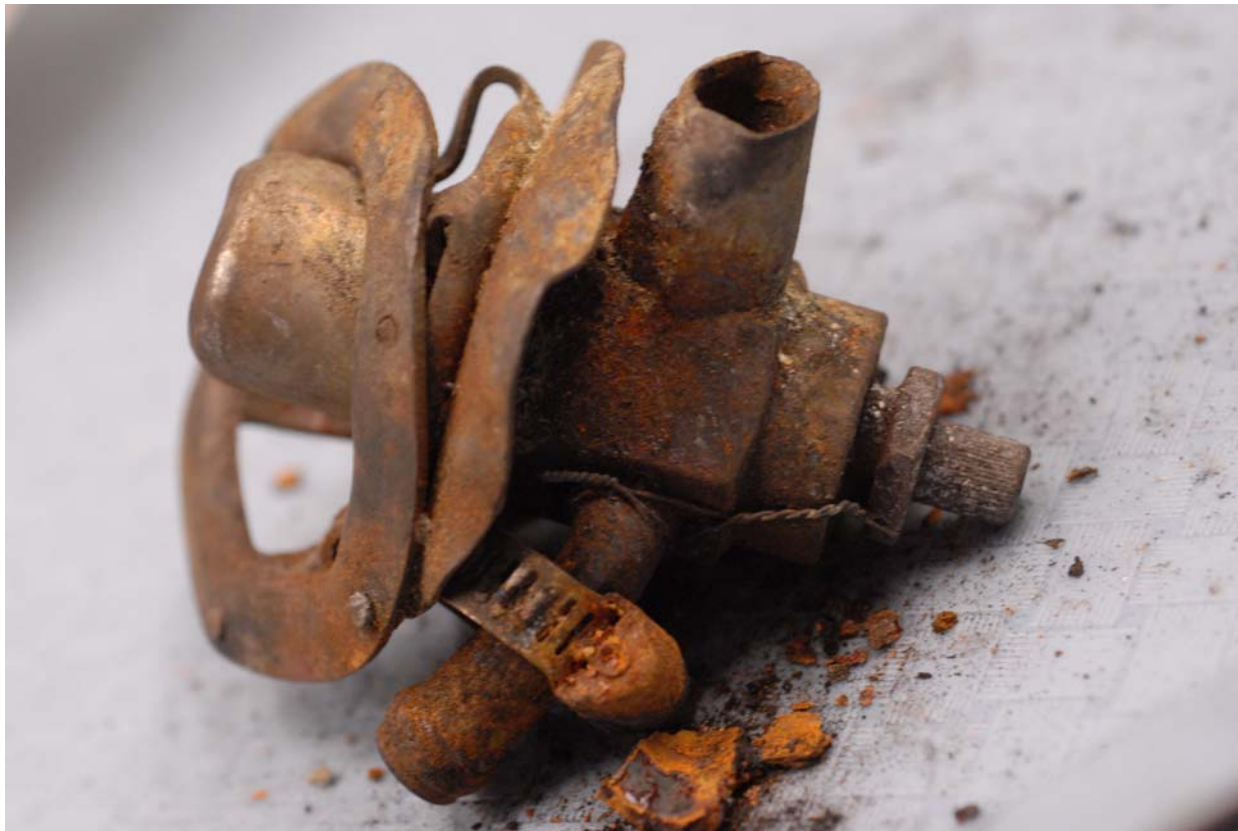
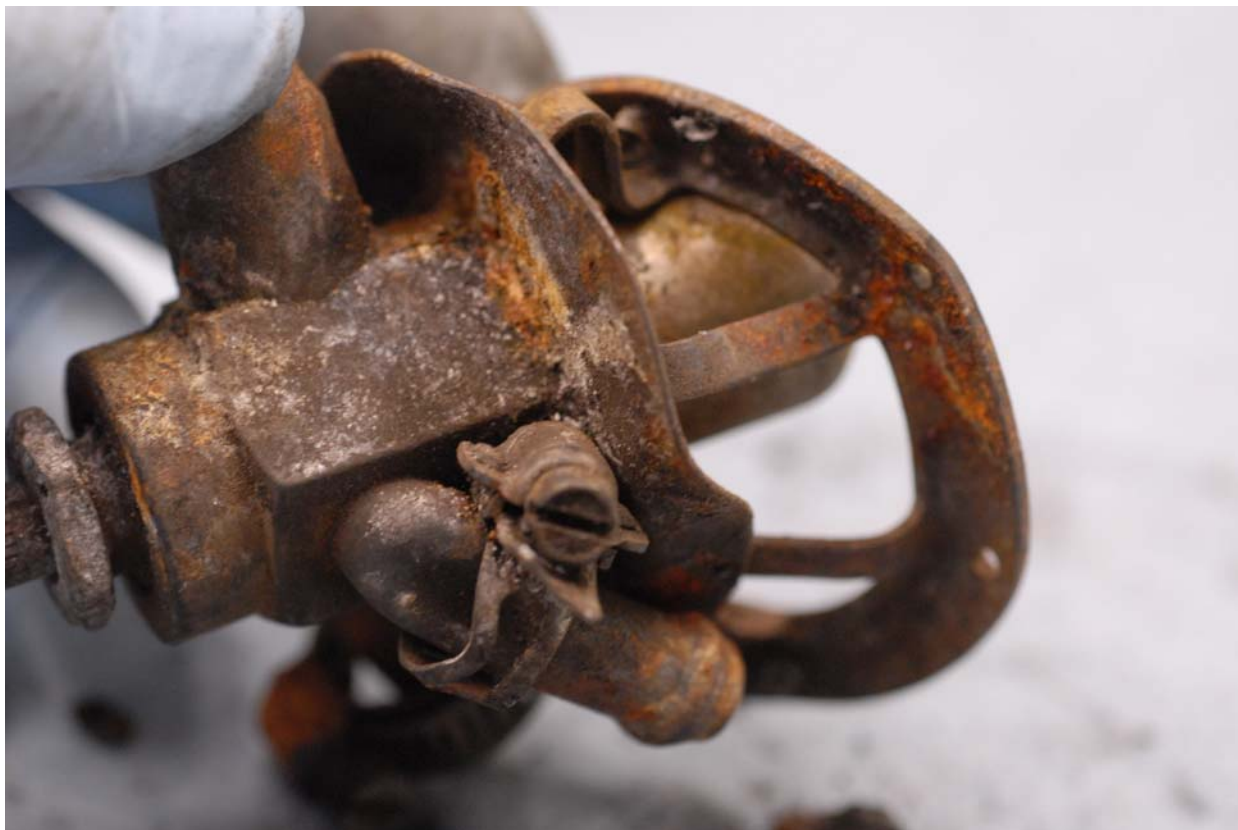
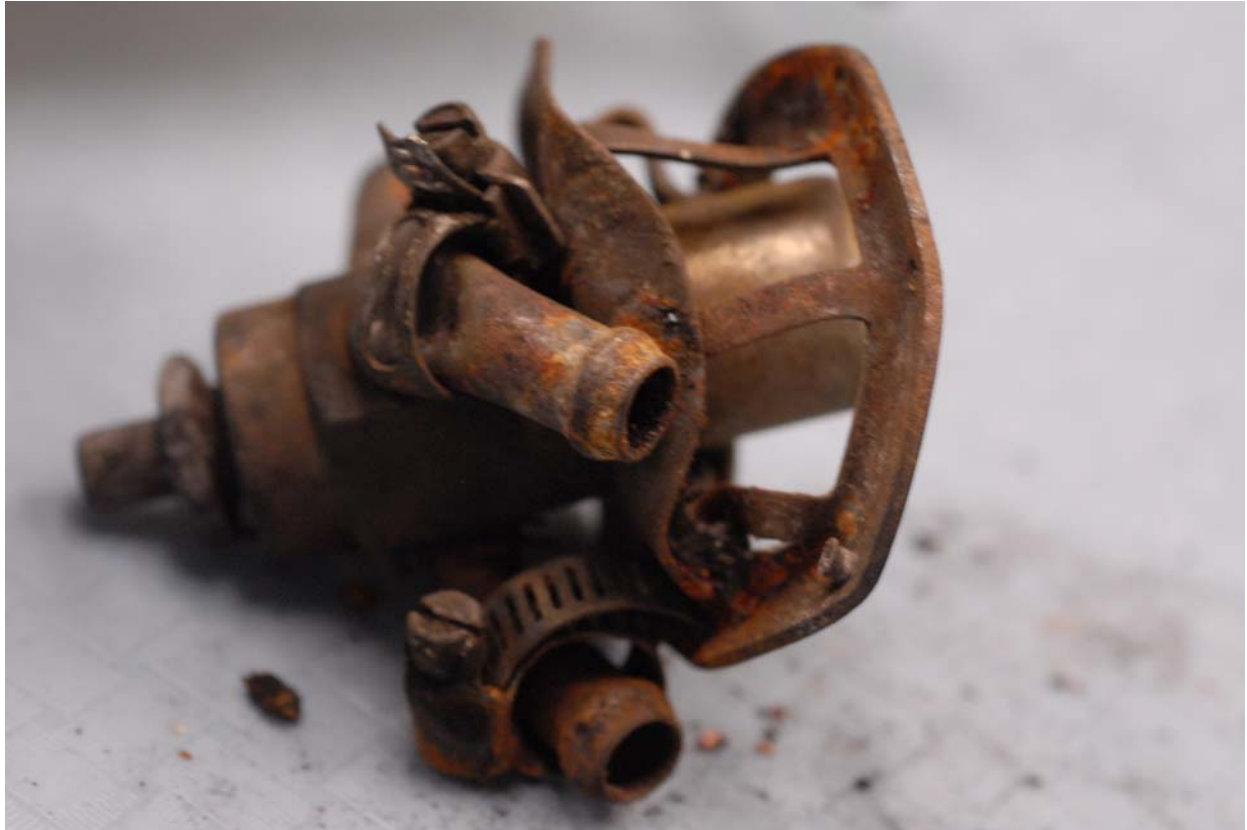
The unit as received appeared to have been crushed and reportedly it was exposed to fire. Refer to Photos N5714W\_10Jun13\_D009 through N5714W\_10Jun13\_D025. The Diaphragm Cover and Diaphragm were missing. Refer to Photo N5714W\_10Jun13\_D009. The Spider housing was crushed. Refer to Photo N5714W\_10Jun13\_D010. The Lock Wire securing the valve's setting was in place. Refer to Photos N5714W\_10Jun13\_D011 and N5714W\_10Jun13\_D012. Photo N5714W\_10Jun13\_D013 shows the internal thread of the Adjusting Screw, however we were unable to photograph the position of the Valve Spring that attaches the Diaphragm to the Adjusting Screw. The Valve Seat and Diaphragm Rivet can be seen in Photo N5714W\_10Jun13\_D014. The orifice that transmits the Vacuum Systems vacuum level to the top of the Diaphragm can be seen in Photos N5714W\_10Jun13\_D015 and

N5714W\_10Jun\_D001, Vacuum Regulator as received

N5714W\_10Jun\_D002, Vacuum Regulator as received

N5714W\_10Jun\_D003, Vacuum Regulator as received

N5714W\_10Jun\_D004, Vacuum Regulator as received

N5714W\_10Jun\_D005, Vacuum Regulator as received

N5714W\_10Jun\_D006, Vacuum Regulator as received

N5714W\_10Jun\_D007, Vacuum Regulator as received

N5714W\_10Jun\_D008, Vacuum Regulator as received

N5714W\_10Jun\_D017, Vacuum Regulator as received

N5714W\_10Jun\_D018, Vacuum Regulator as received

N5714W\_10Jun\_D019, Vacuum Regulator as received

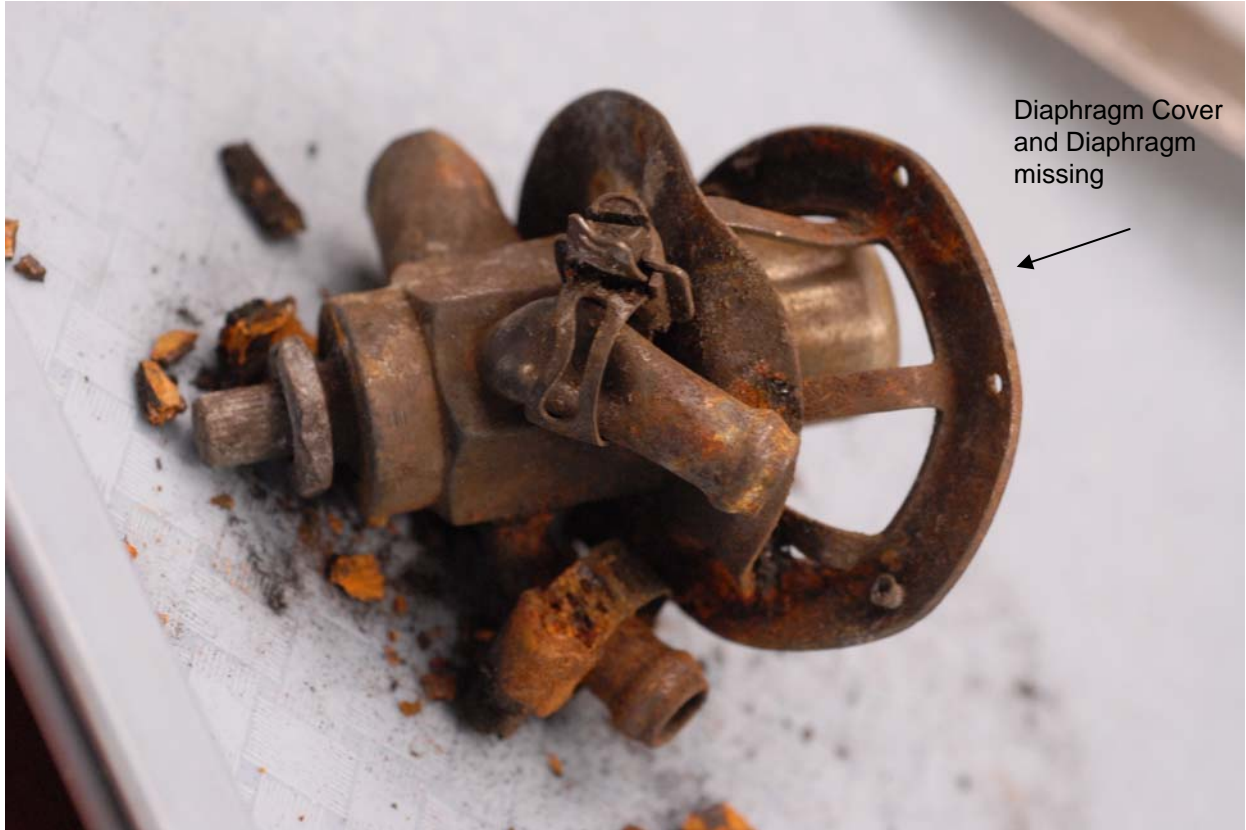
Diaphragm Cover  
and Diaphragm  
missing

N5714W\_10Jun\_D009, Diaphragm Cover and Diaphragm missing

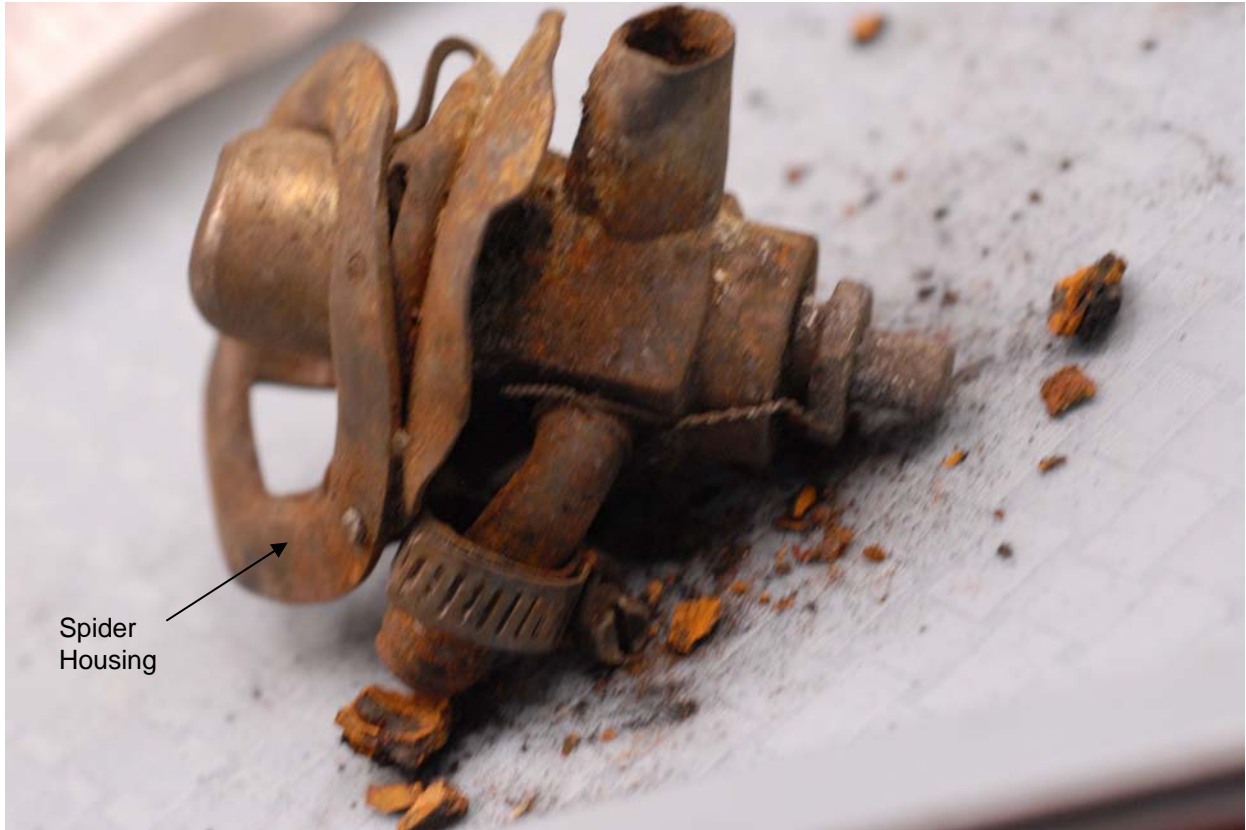
Spider  
Housing

N5714W\_10Jun\_D010, Spider Housing Crushed

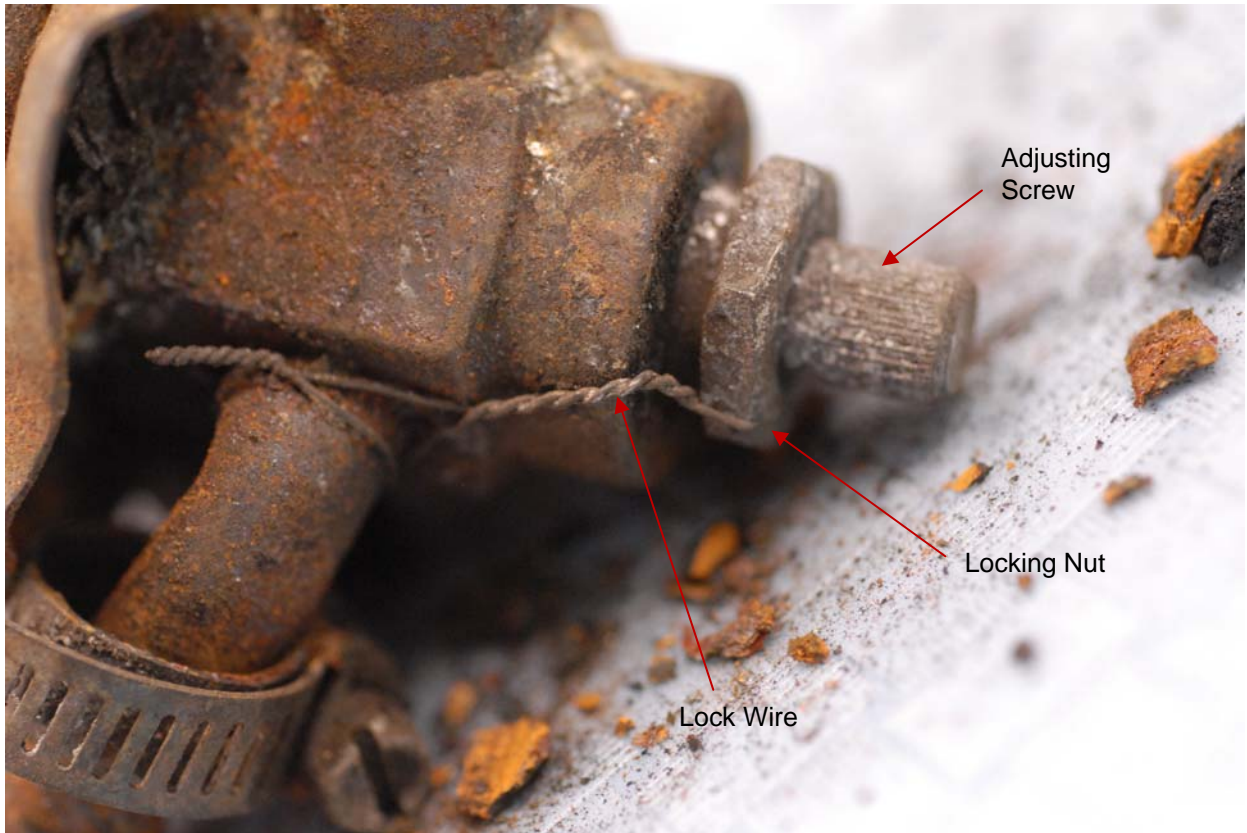
N5714W\_10Jun\_D011, Lock Wire in place

- The extensive damage to the Vacuum Regulator did not allow testing of the unit.
- The Lock Wire being in place is no indication of the Vacuum Regulators vacuum setting.
- The position of the Spring that attaches the Diaphragm to the Adjusting Screw is no indication of the Vacuum Regulator vacuum setting. Due to variations in the Spring, Diaphragm and Vacuum Regulator Assembly.

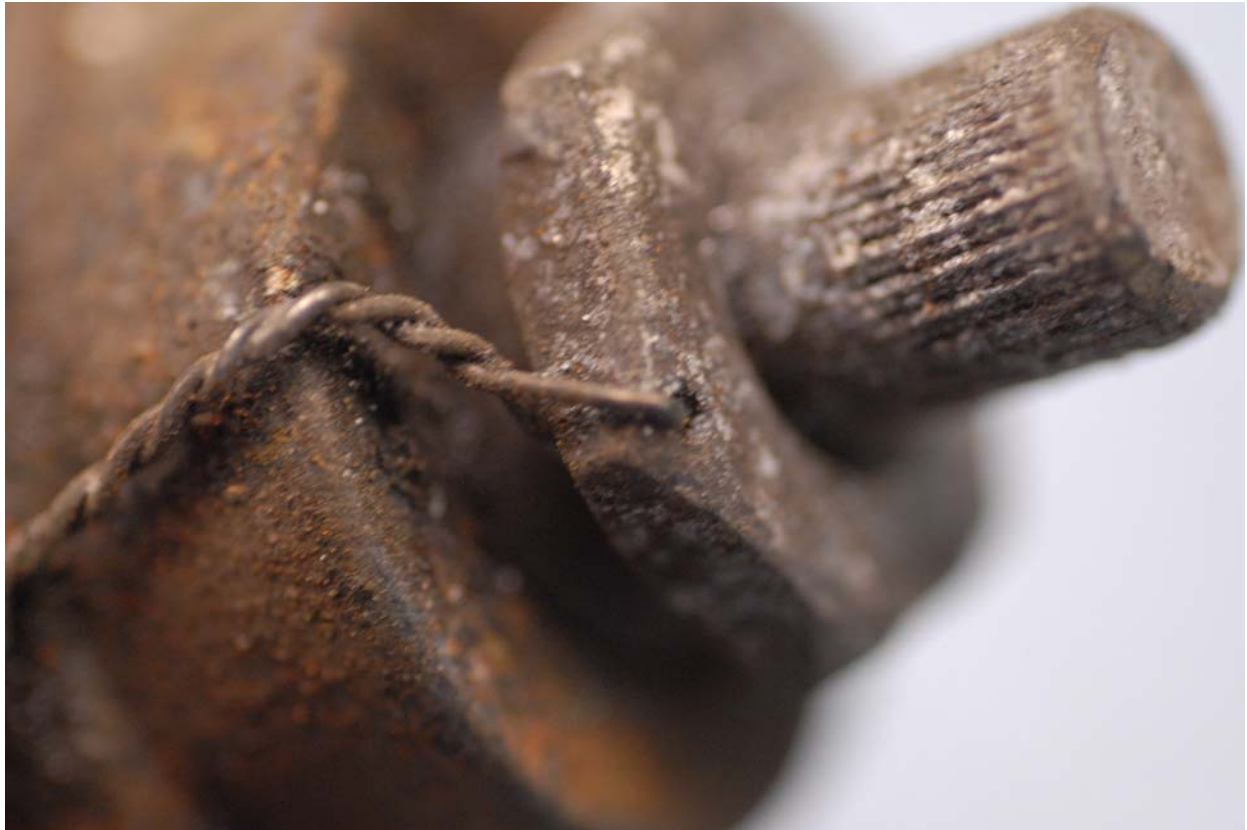
N5714W\_10Jun\_D012, Lock Wire in place

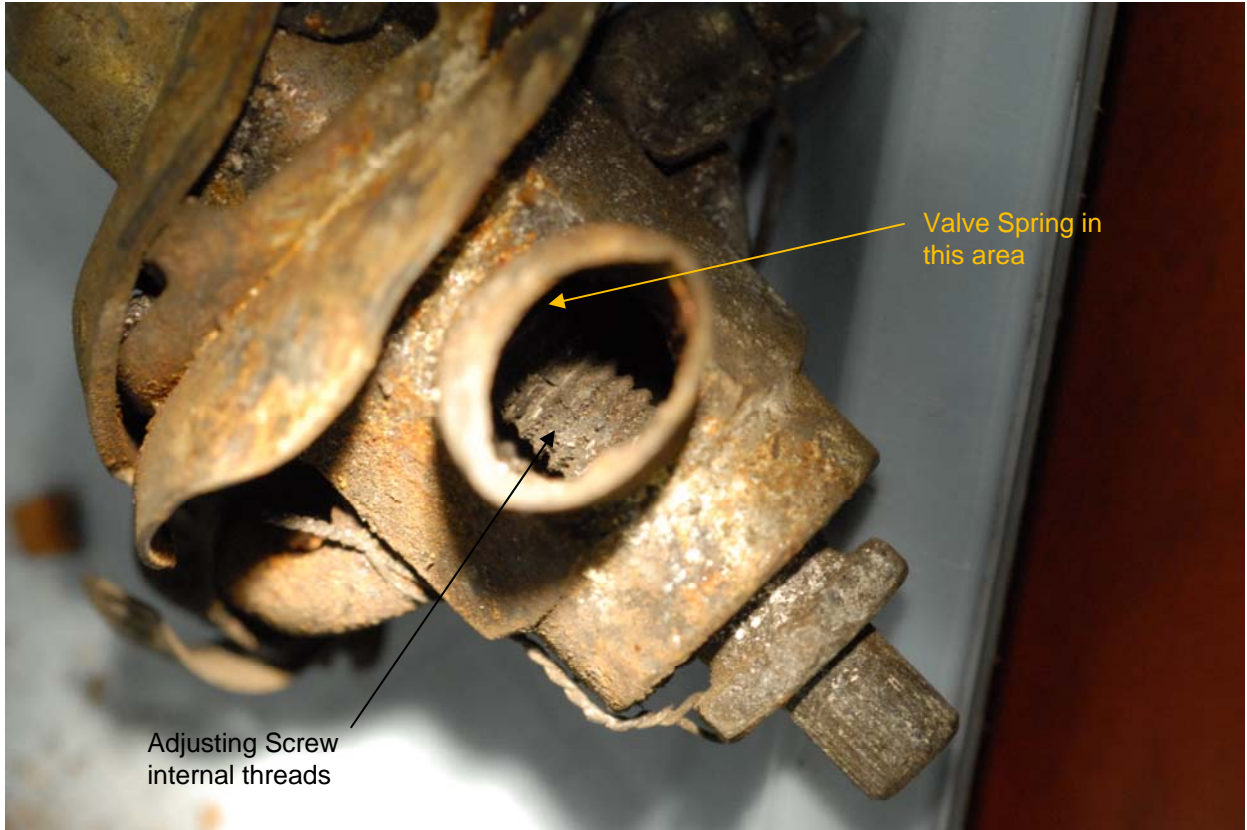
N5714W\_10Jun\_D013, Internal Thread of Adjusting Screw

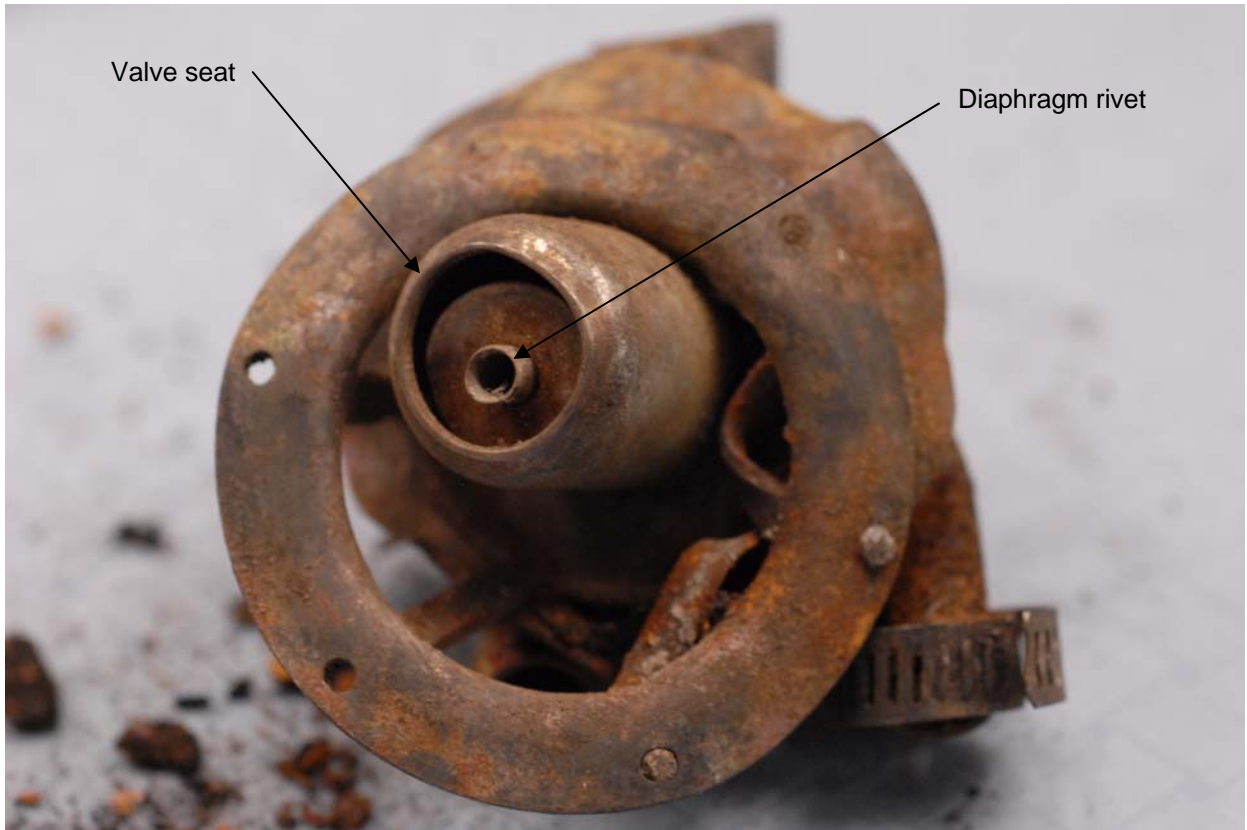
N5714W\_10Jun\_D014, Valve seat and Diaphragm Rivet

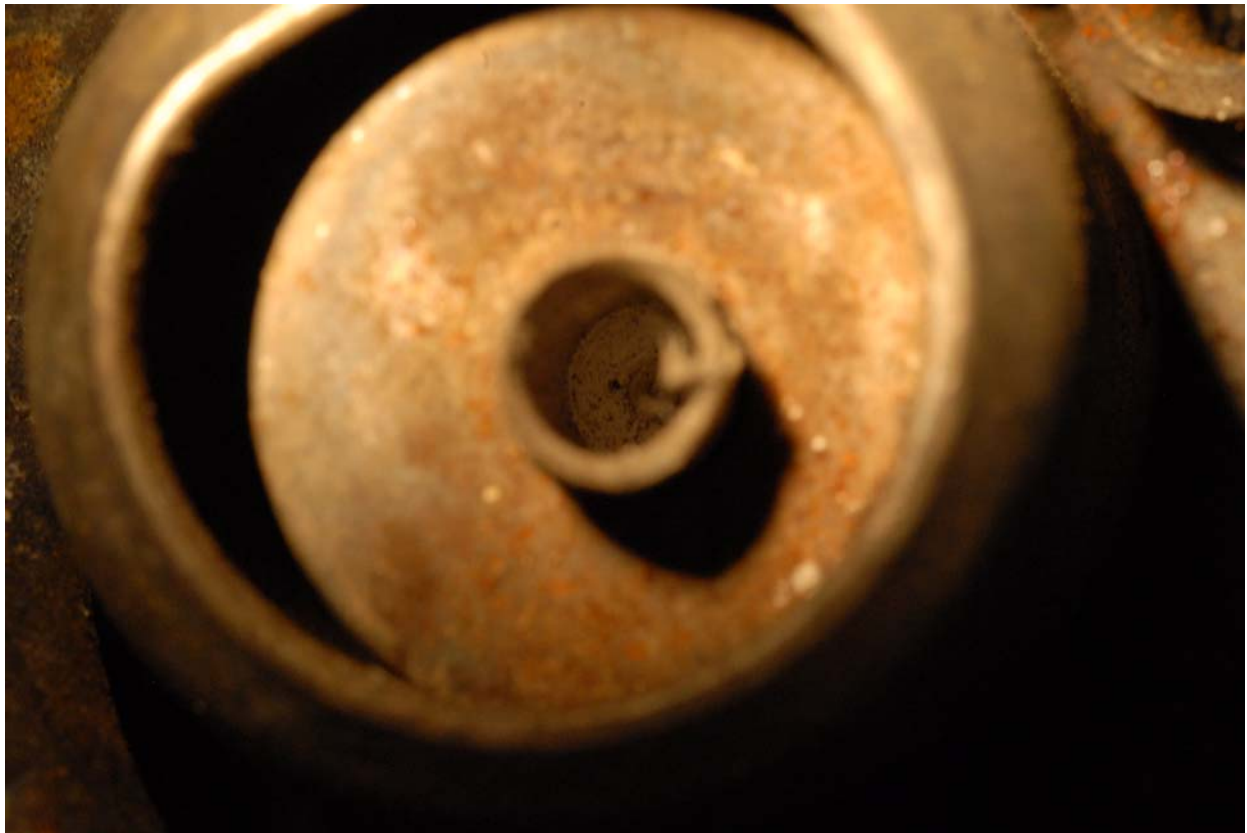
N5714W\_10Jun\_D015, Diaphragm Rivet Orifice

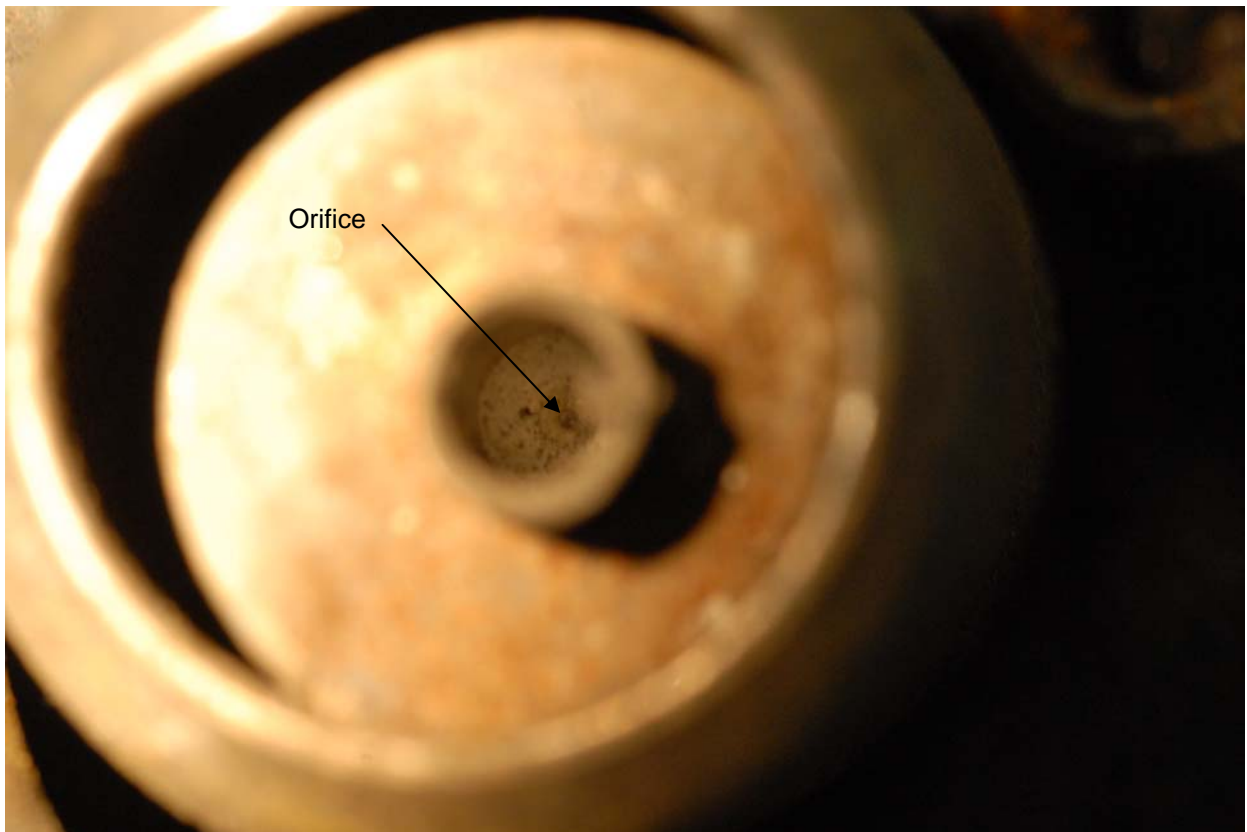
N5714W\_10Jun13\_D016. The Lock Wire diameter measured approximately 0.022", refer to Photo N5714W\_10Jun13\_D020. Rivets that hold the Diaphragm Cover, Diaphragm and Spider Housing together along with the holes for missing Rivets can be seen in Photos N5714W\_10Jun13\_D021 through N5714W\_10Jun13\_D025.

N5714W\_10Jun\_D016, Diaphragm Rivet Orifice

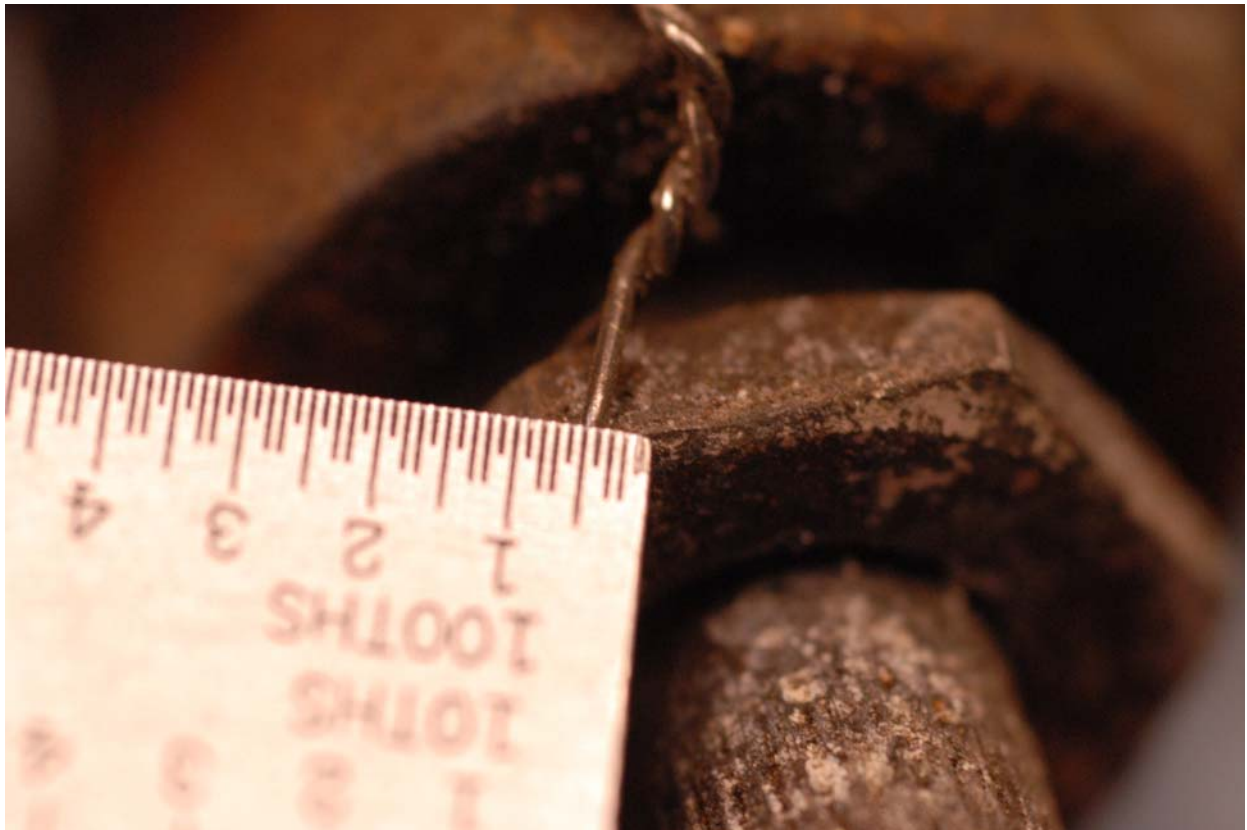
N5714W\_10Jun\_D020, Lock wire Diameter

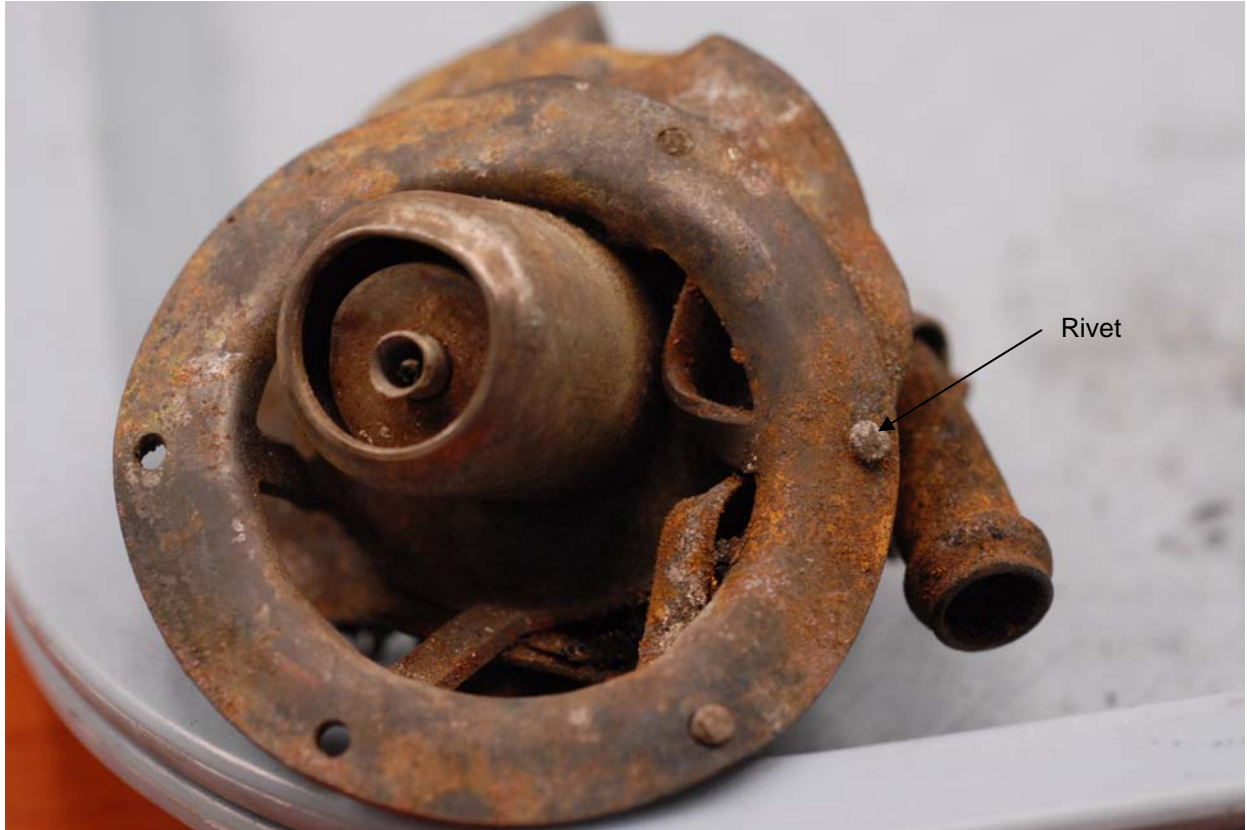
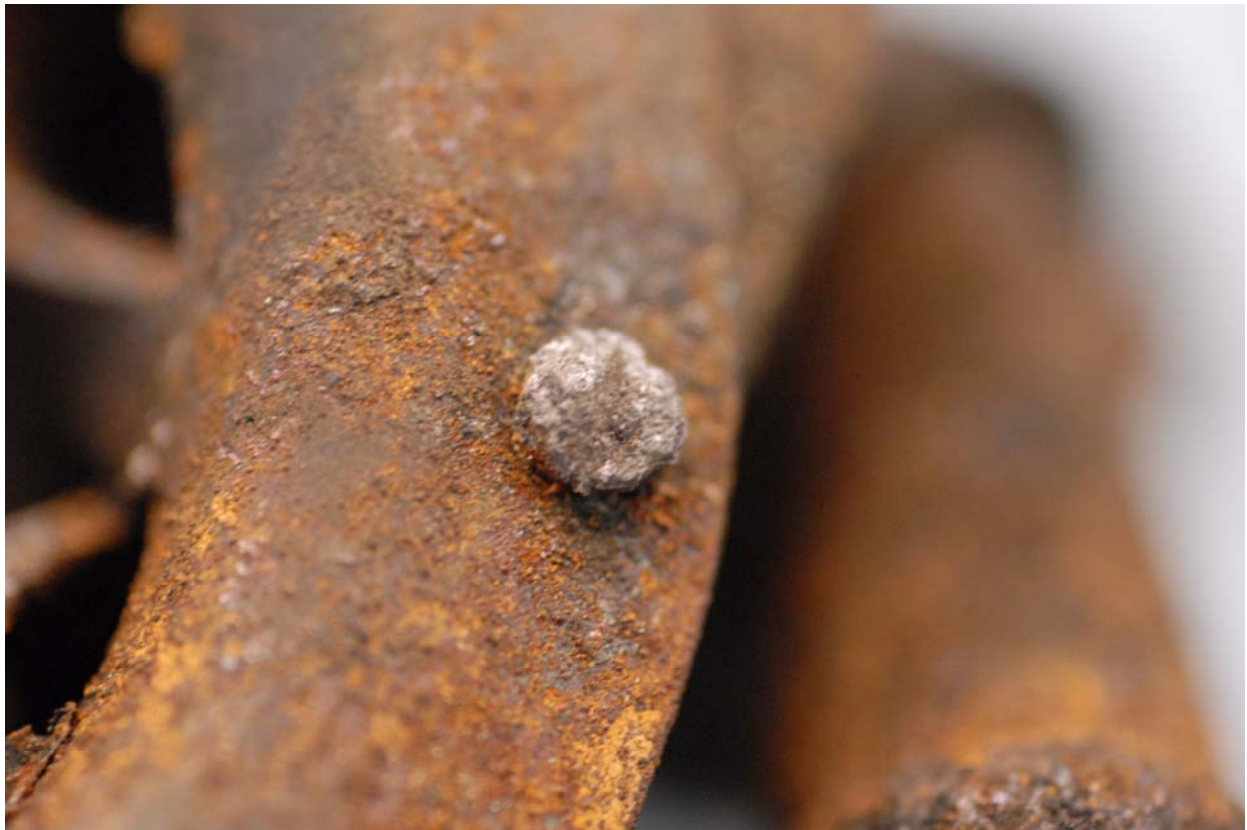
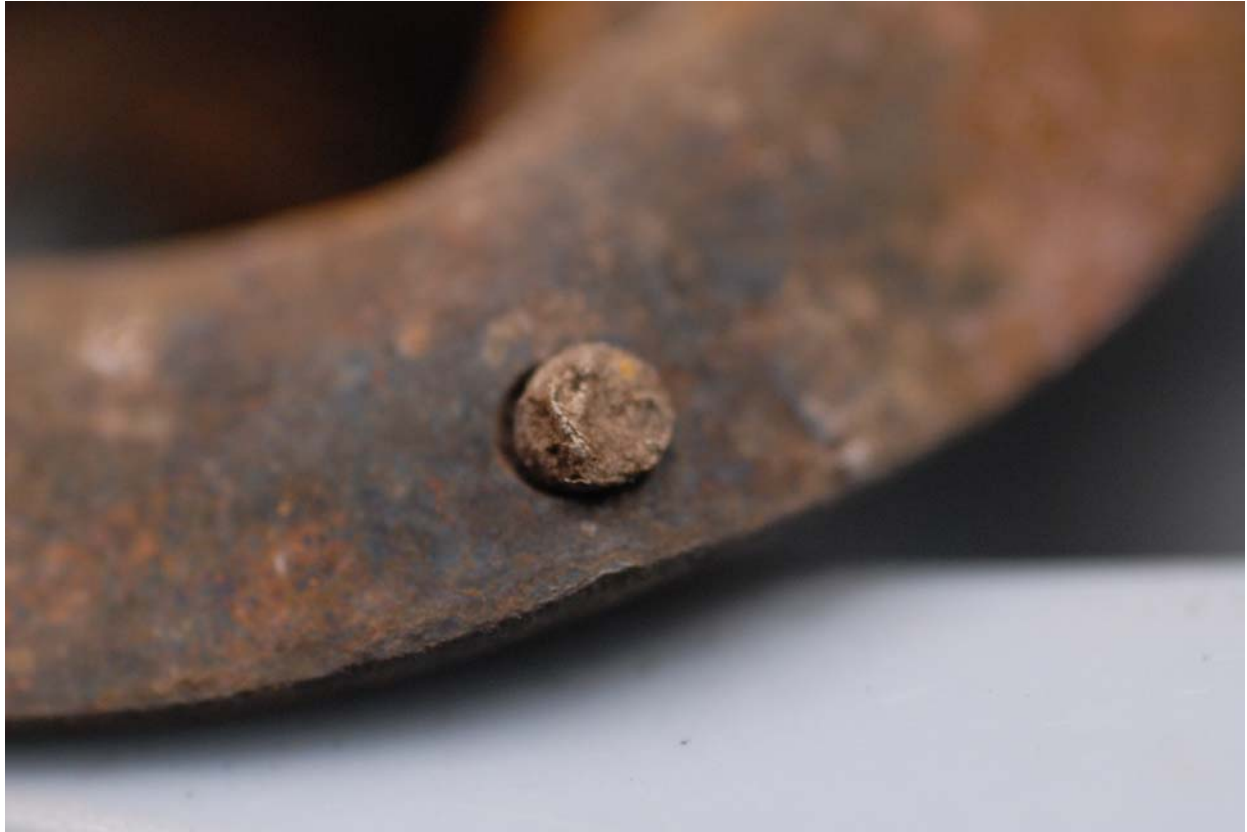
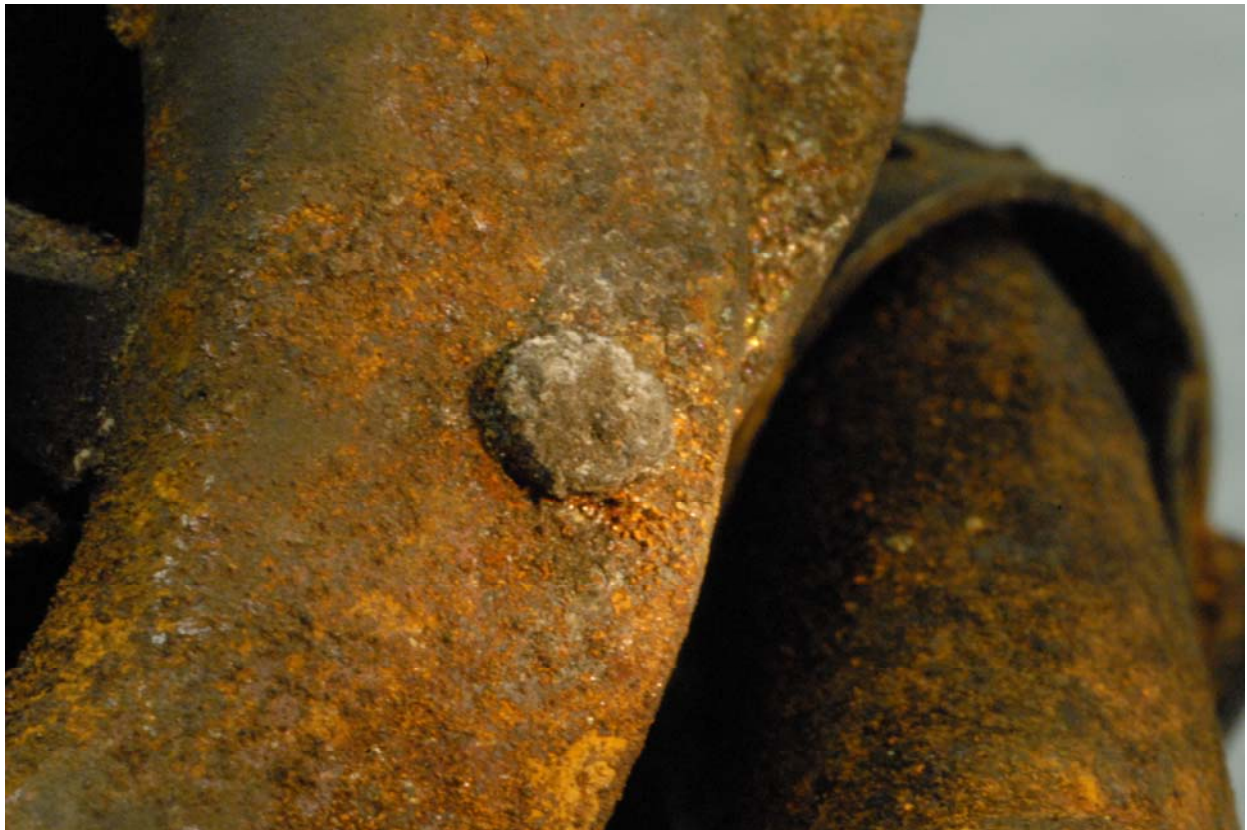
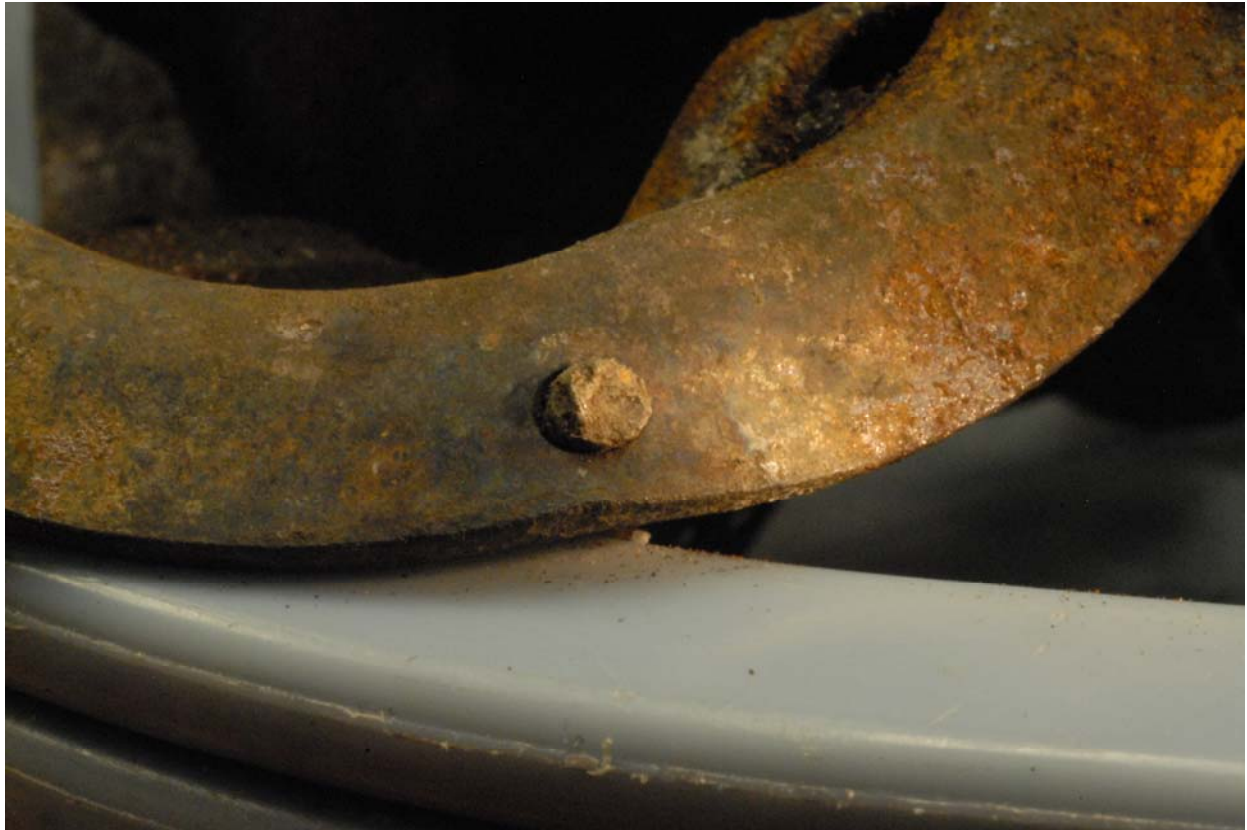
N5714W\_10Jun\_D021, Rivets for attaching Diaphragm and Diaphragm Cover

N5714W\_10Jun\_D022, Rivet for attaching Diaphragm and Diaphragm Cover

N5714W\_10Jun\_D023, Rivet for attaching Diaphragm and Diaphragm Cover

N5714W\_10Jun\_D024, Rivet for attaching Diaphragm and Diaphragm Cover

N5714W\_10Jun\_D025, Rivet for attaching Diaphragm and Diaphragm Cover
