NATIONAL TRANSPORTATION SAFETY BOARD

Locomotive Event Recorders

Specialist's Factual Report
By Cassandra Johnson

Location: Panhandle, Texas
Date: June 28, 2016
Operator: BNSF Railway

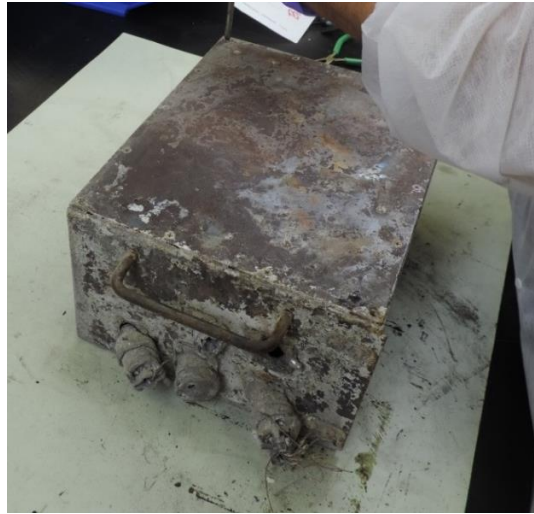
The Wabtec Train Trax locomotive event recorder from the third locomotive, BNSF 3967, suffered severe thermal damage (see figure 1). The manufacturer's part number and serial

number were unreadable. The recorder was sent to the National Transportation Safety Board (NTSB) Vehicle Recorder Division for readout and evaluation.

Figure 1. BNSF 3967's locomotive event recorder as received

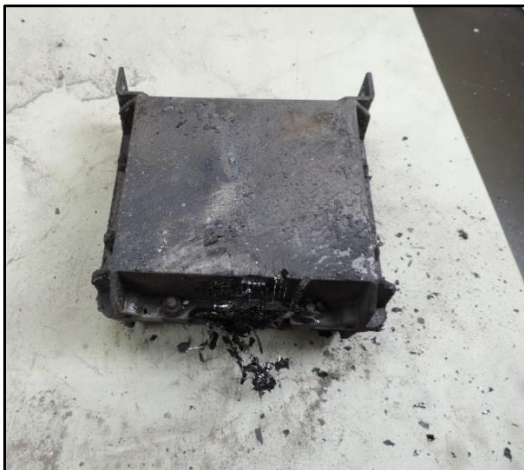
BNSF 3967's certified crashworthy event recorder memory module was removed from the outer casing (see figure 2). Next the certified crashworthy event recorder memory module was opened and the memory module was removed (see figures 3 and 4). With the assistance of Wabtec, the locomotive event recorder manufacturer, the memory chips were removed and placed onto a surrogate board (see figure 5). Then BNSF 3967's memory module was successfully downloaded (see figure 6).

Figure 2. BNSF 3967's certified crashworthy event recorder memory module

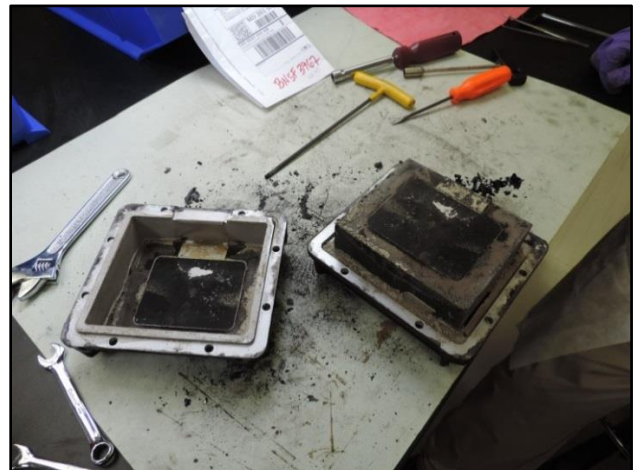
Figure 3. BNSF 3967's certified crashworthy event recorder memory module opened

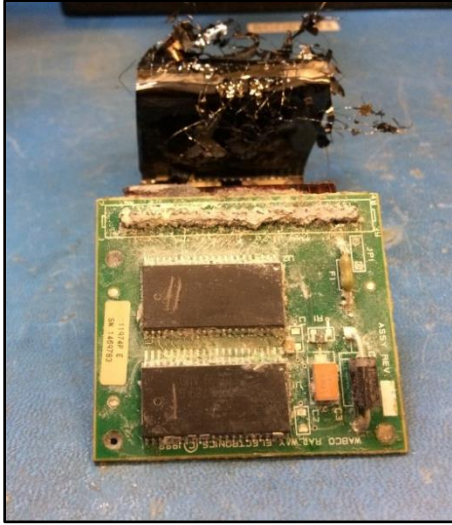
Figure 4. BNSF 3967's memory module

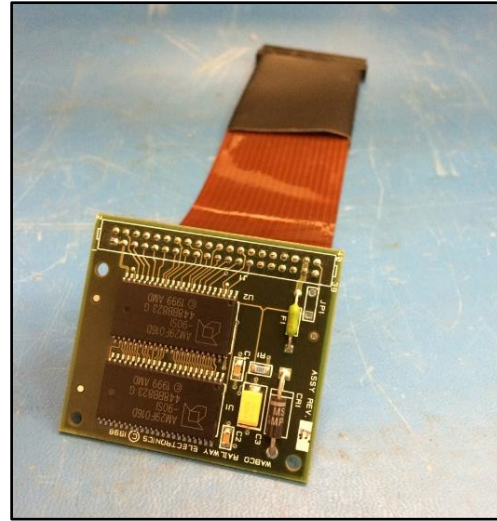
Figure 5. BNSF 3967's memory chips removed and placed on surrogate board

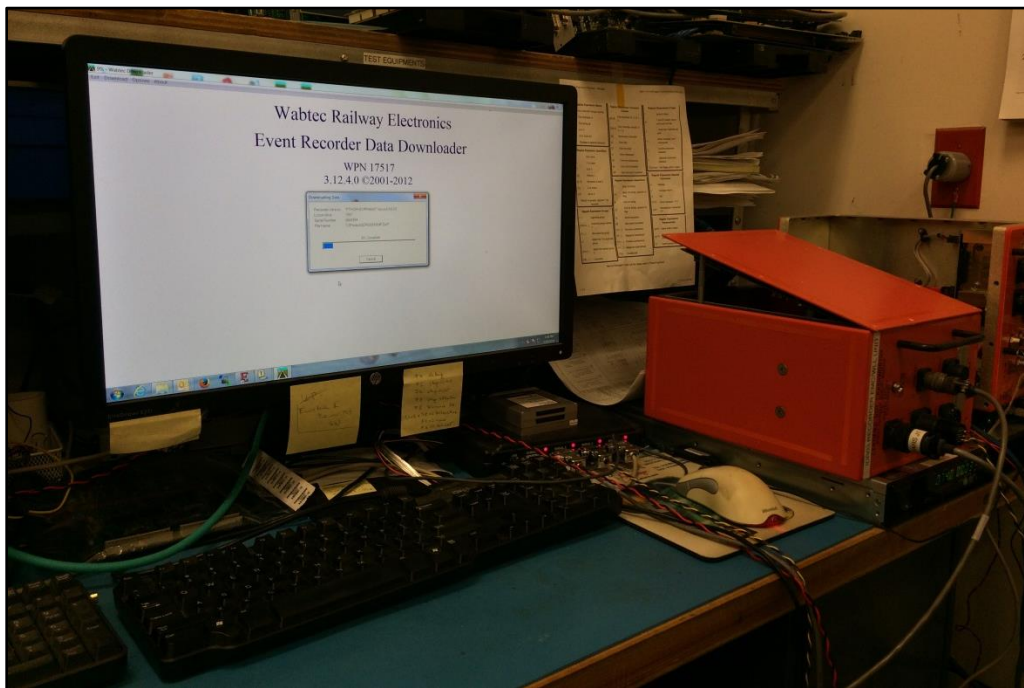
Figure 6. Downloading BNSF 3967's memory module

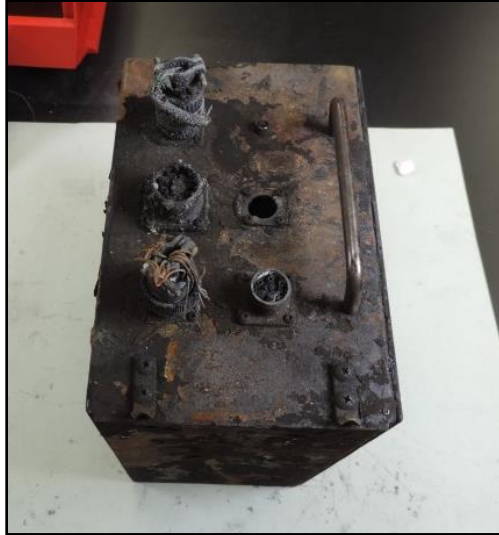
The Wabtec Train Trax locomotive event recorder from the second locomotive, BNSF 7553, suffered severe thermal damage (see figure 7). The manufacturer's part number and serial number were unreadable. The recorder was sent to the NTSB Vehicle Recorder Division for readout and evaluation.

Figure 7. BNSF 7553's locomotive event recorder as received

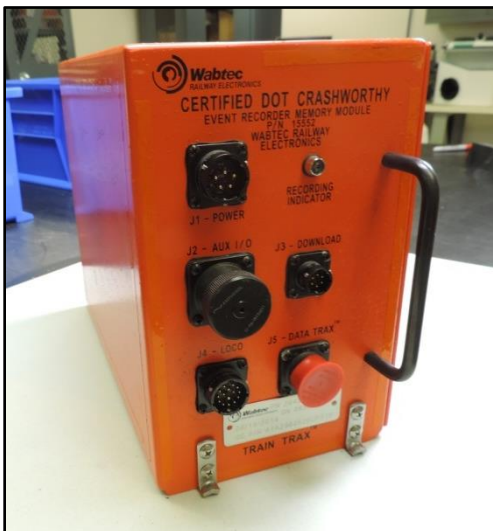
The locomotive event recorders from the fourth and fifth locomotives, BNSF 8191 and BNSF 5212, were undamaged; however, investigators were unable to download either recorder during the on-scene aspect of the investigation. Therefore, these recorders were sent to the NTSB Vehicle Recorder Division for readout and evaluation (see figures 8 and 9). BNSF 8191's recorder was a Wabtec Train Trax recorder with part number 26432-9 Y and serial number 0852357. BNSF 5212's recorder was a Wabtec Permanent Core Memory Module with part number 17853P and serial number 0364712. Both recorders were successfully downloaded.

Figure 8. BNSF 8191's locomotive event recorder as received

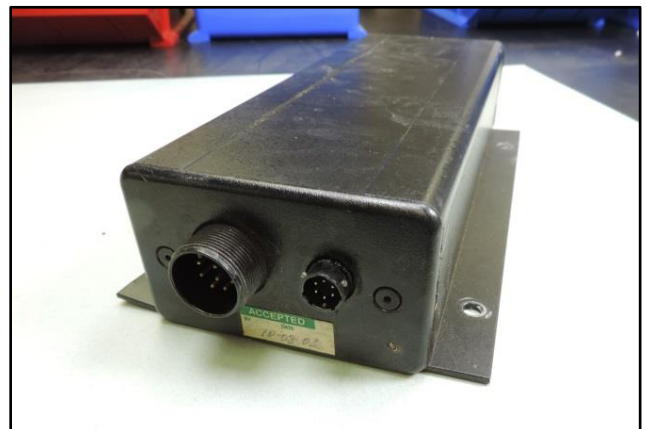
Figure 9. BNSF 5212's locomotive event recorder as received

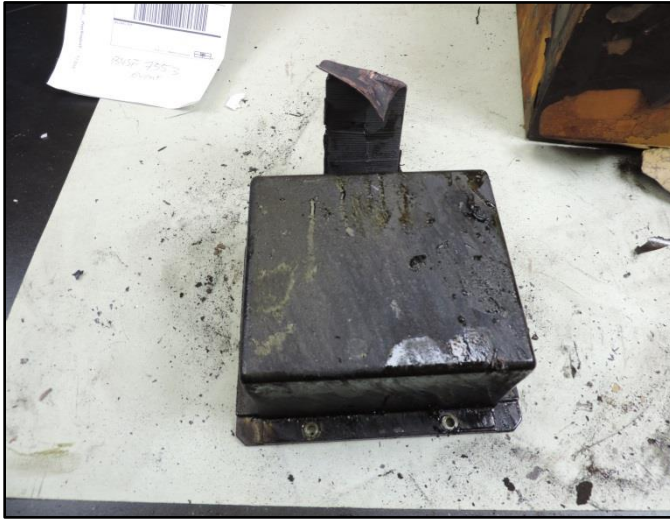
BNSF 7553's certified crashworthy event recorder memory module was removed from the outer casing (see figure 10). Next the certified crashworthy event recorder memory module was opened and the memory module was removed (see figures 11 and 12). With the assistance of Wabtec, the ribbon cable was removed and a new one attached (see figure 13). Then BNSF 7553's memory module was successfully downloaded (see figure 14).

Figure 10. BNSF 7553's certified crashworthy event recorder memory module

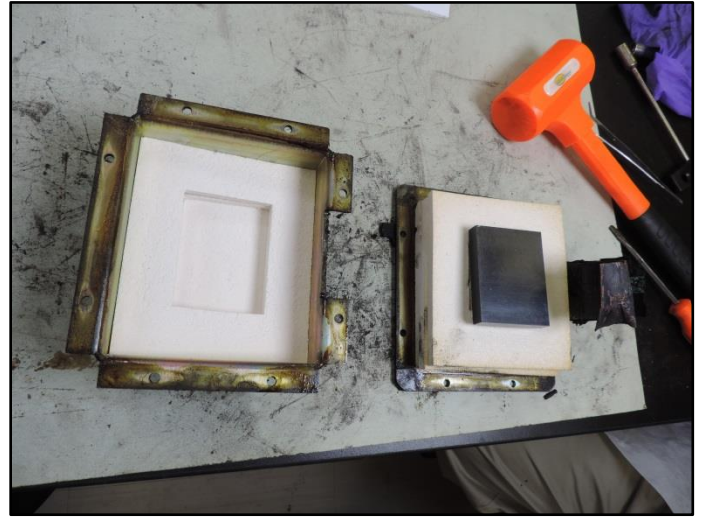
Figure 11. BNSF 7553's certified crashworthy event recorder memory module opened

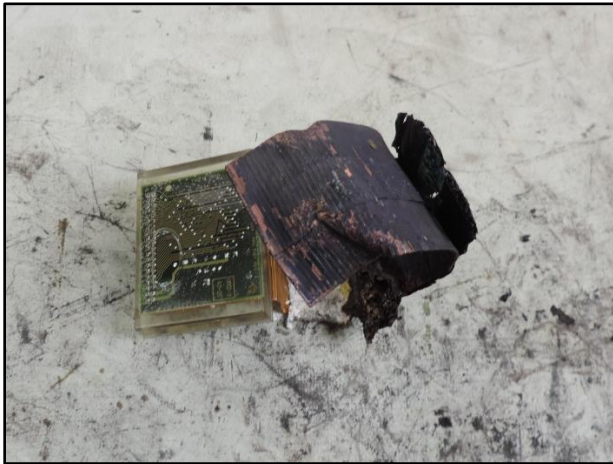
Figure 12. BNSF 7553's memory module

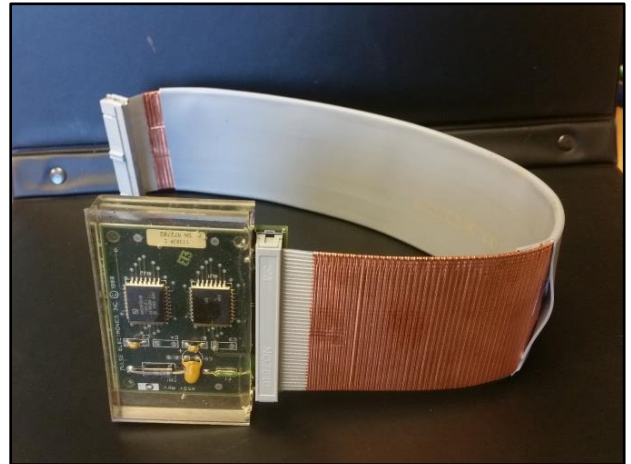
Figure 13. BNSF 7553's memory module with new ribbon attached

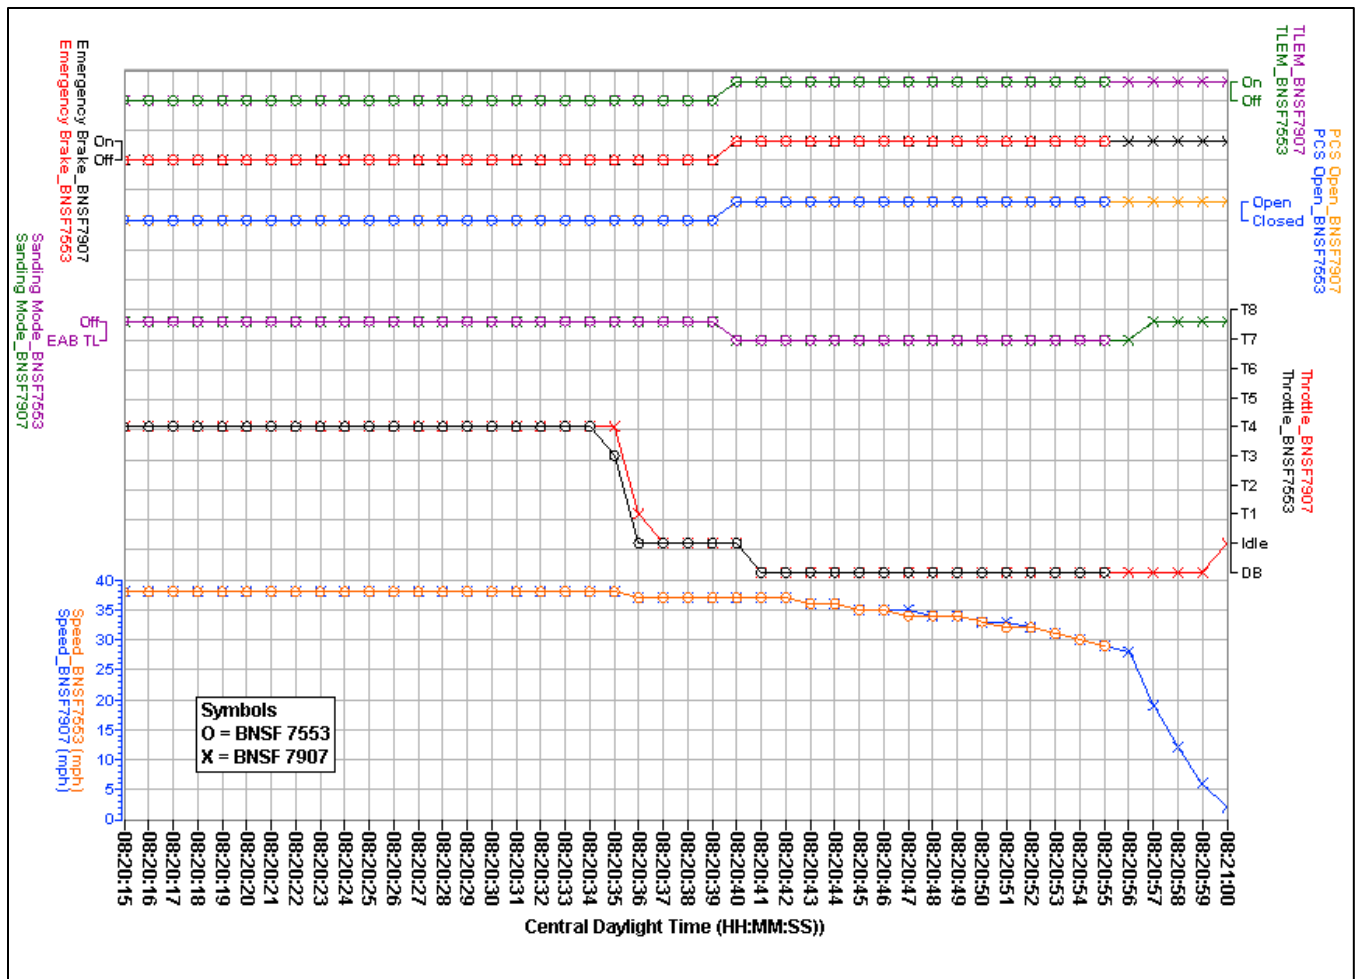
To correlate the locomotive event recorder data between BNSF 7553 and BNSF 7907, select parameters (TLEM, emergency brake, PCS, throttle position, sanding mode, and speed) from both recorders were plotted together. In order to align BNSF 7553's locomotive event recorder data to BNSF 7907's locomotive event recorder data, 3,597 seconds was subtracted from BNSF 7553's locomotive event recorder time (see figure 16).

Figure 16. Time correlation between BNSF 7907 and BNSF 7553

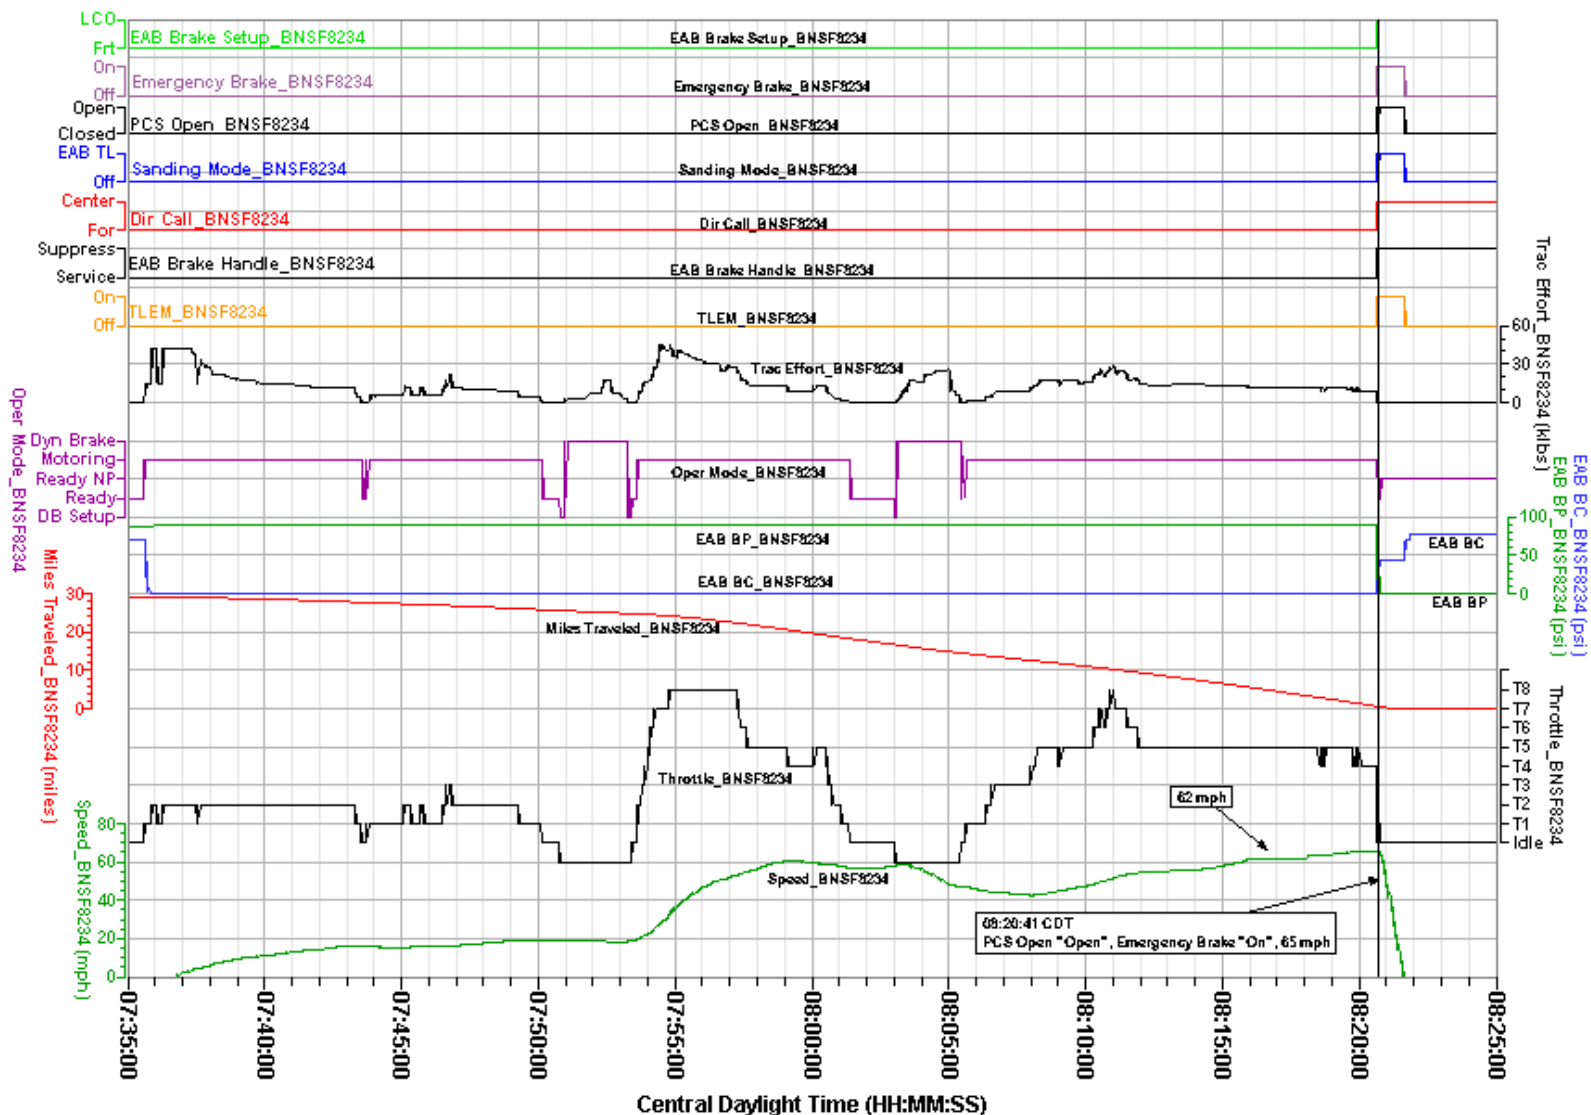
Figures 17 and 18 contain BNSF 3967's locomotive event recorder data. Figures 19 and 20 contain BNSF 8234's locomotive event recorder data. Figures 17 and 19 cover about 50 minutes of data from 07:35:00 CDT to 08:25:00 CDT (BNSF 3967's data ends at 8:20:55 CDT). Figure 18 has an expanded scale focusing on 10 minutes of data from 08:11:00 CDT to 08:21:00 CDT. Figure 20 also has an expanded scale focusing on 10 minutes of data from 08:12:00 CDT to 08:22:00 CDT.

Figure 19: BNSF 8234's locomotive event recorder parameters (50 minutes)

BNSF 8234: 50 Minutes (07:35:00 to 08:25:00)

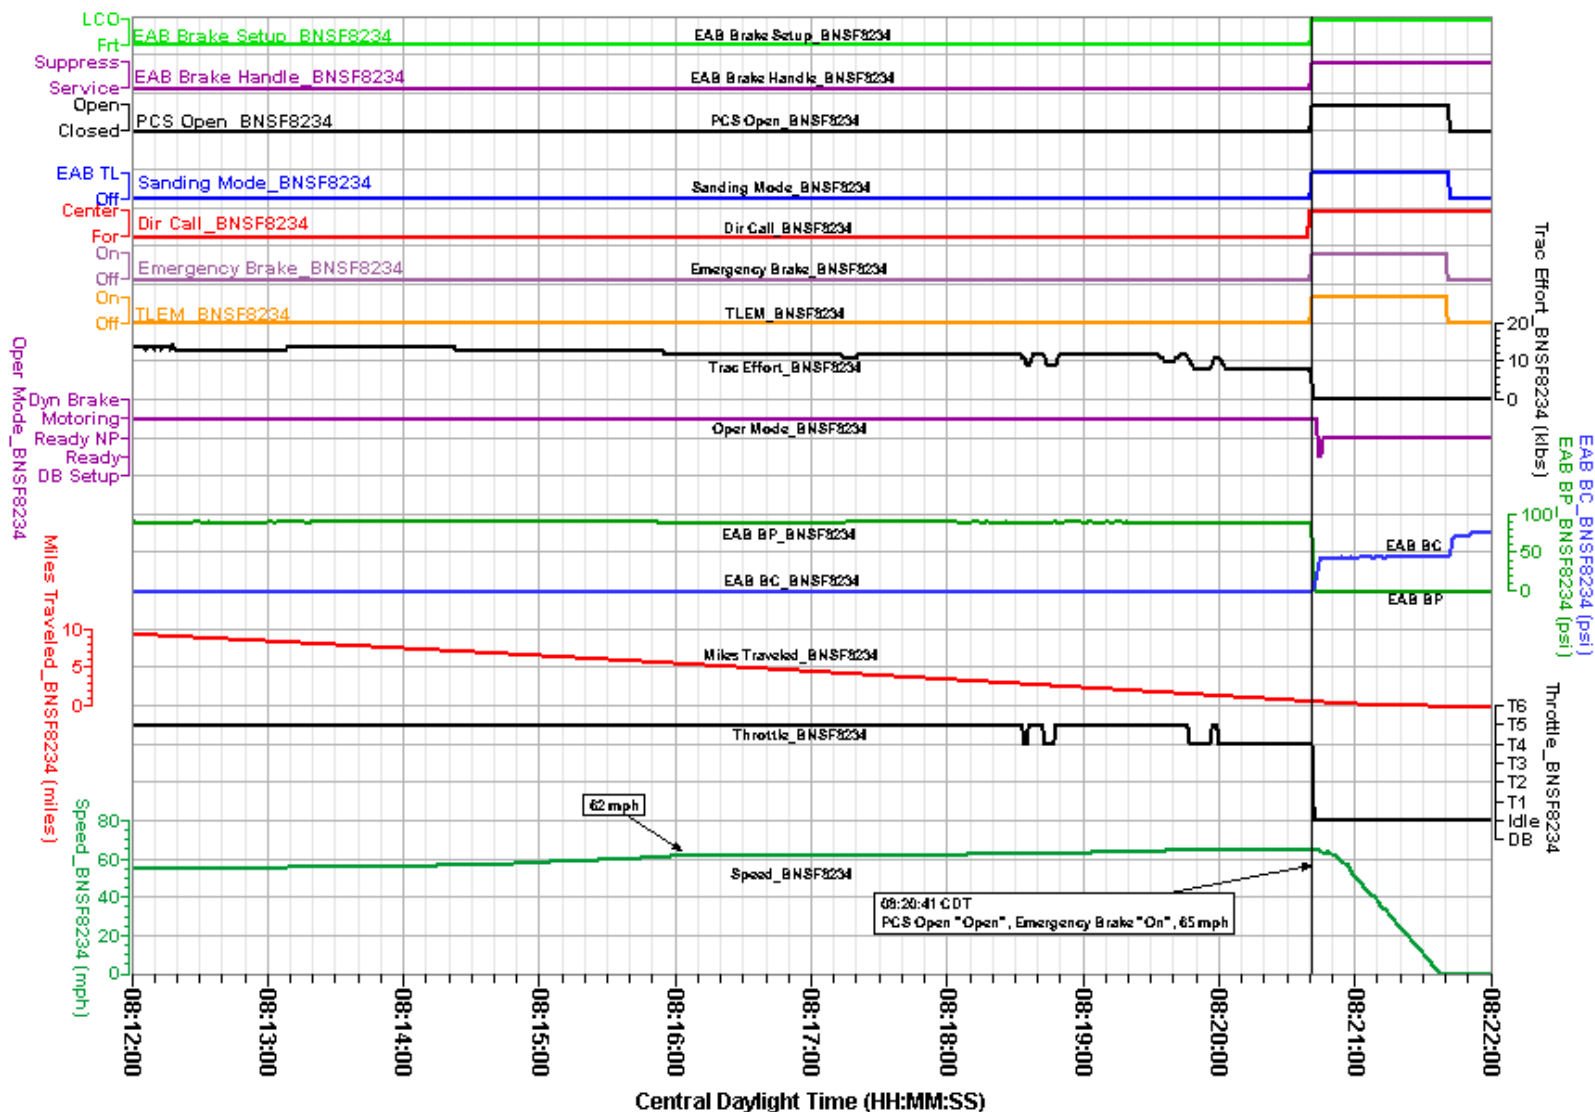
Figure 20: BNSF 8234's locomotive event recorder parameters (10 minutes)

BNSF 8234: 10 Minutes (08:12:00 to 08:22:00)

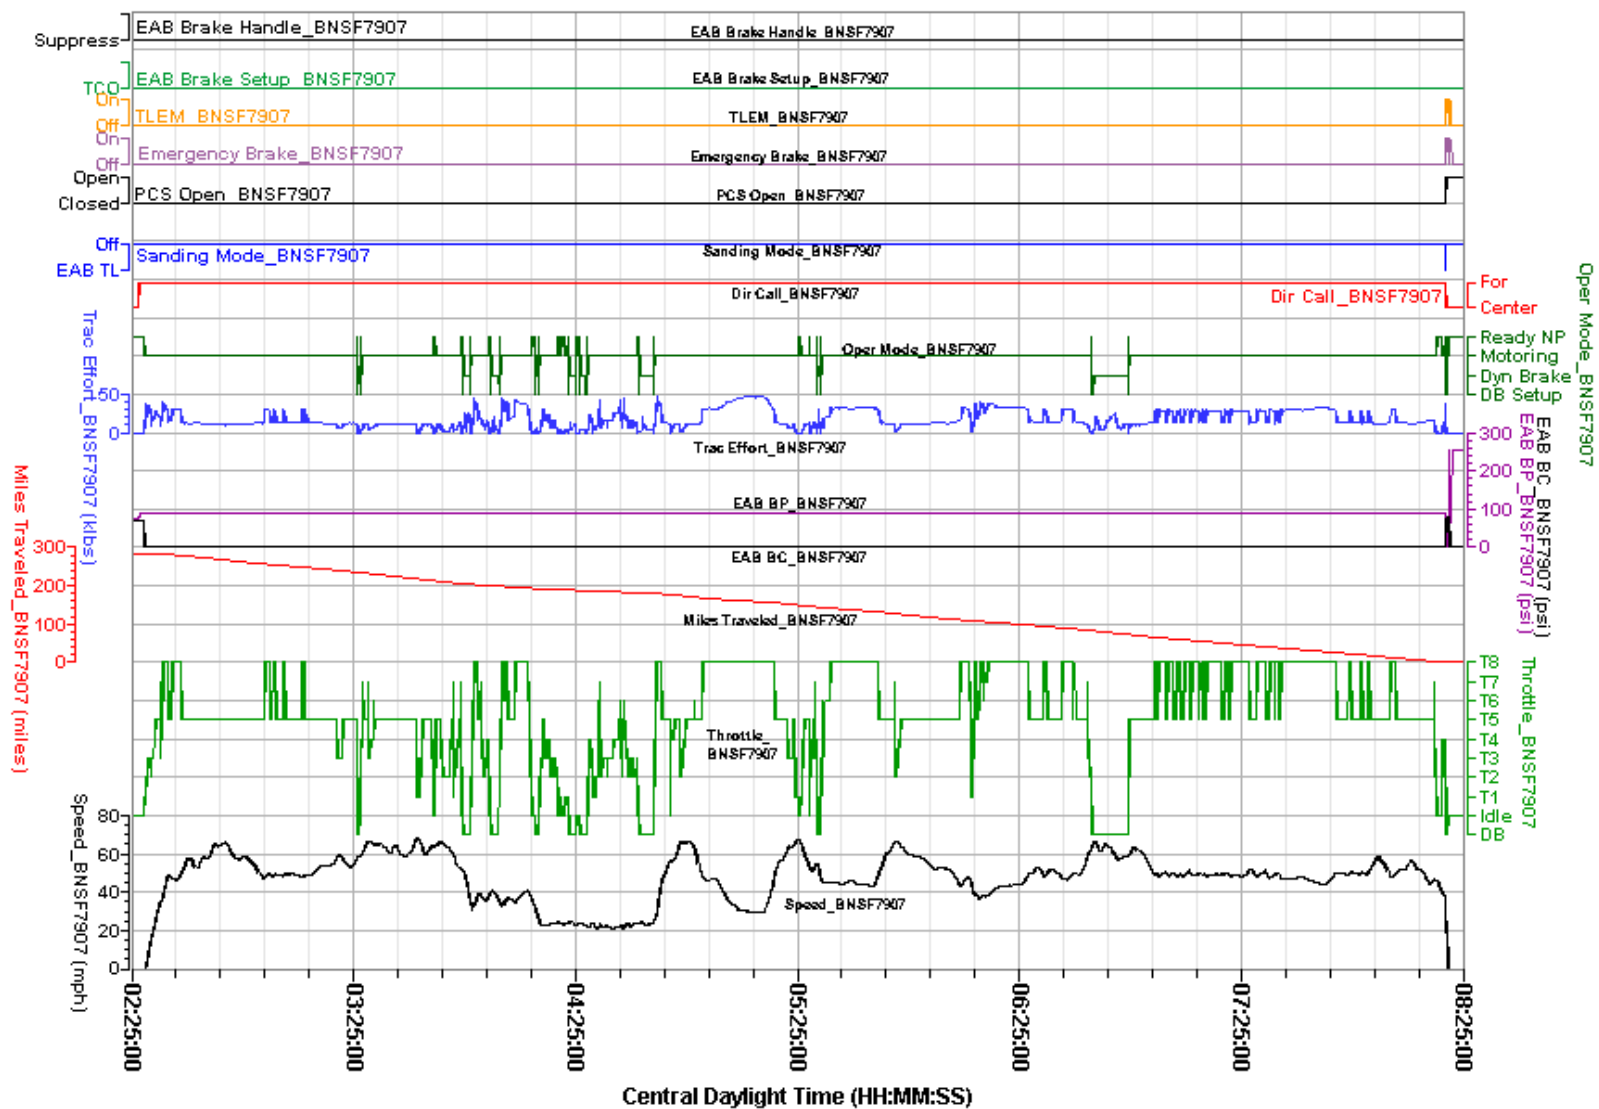
Figures 21 and 22 contain BNSF 7553's locomotive event recorder data. Figures 23 and 24 contain BNSF 7907's locomotive event recorder data. Figures 21 and 23 cover 6 hours of data from 02:25:00 CDT to 08:25:00 CDT (BNSF 7553's data ends at 8:20:55 CDT). Figure 22 has

Figure 23: BNSF 7907's locomotive event recorder parameters (6 hours)

BNSF 7907: 6 Hours (02:25:00 to 08:25:00)
