NATIONAL TRANSPORTATION SAFETY BOARD

Weather Study

DCA16FA199

Location: Italy, Texas
Date: July 6, 2016
Time: 1148 central daylight time
1648 Coordinated Universal Time (UTC)
Airplane: Bell 525 experimental Aircraft; Registration: N525TA

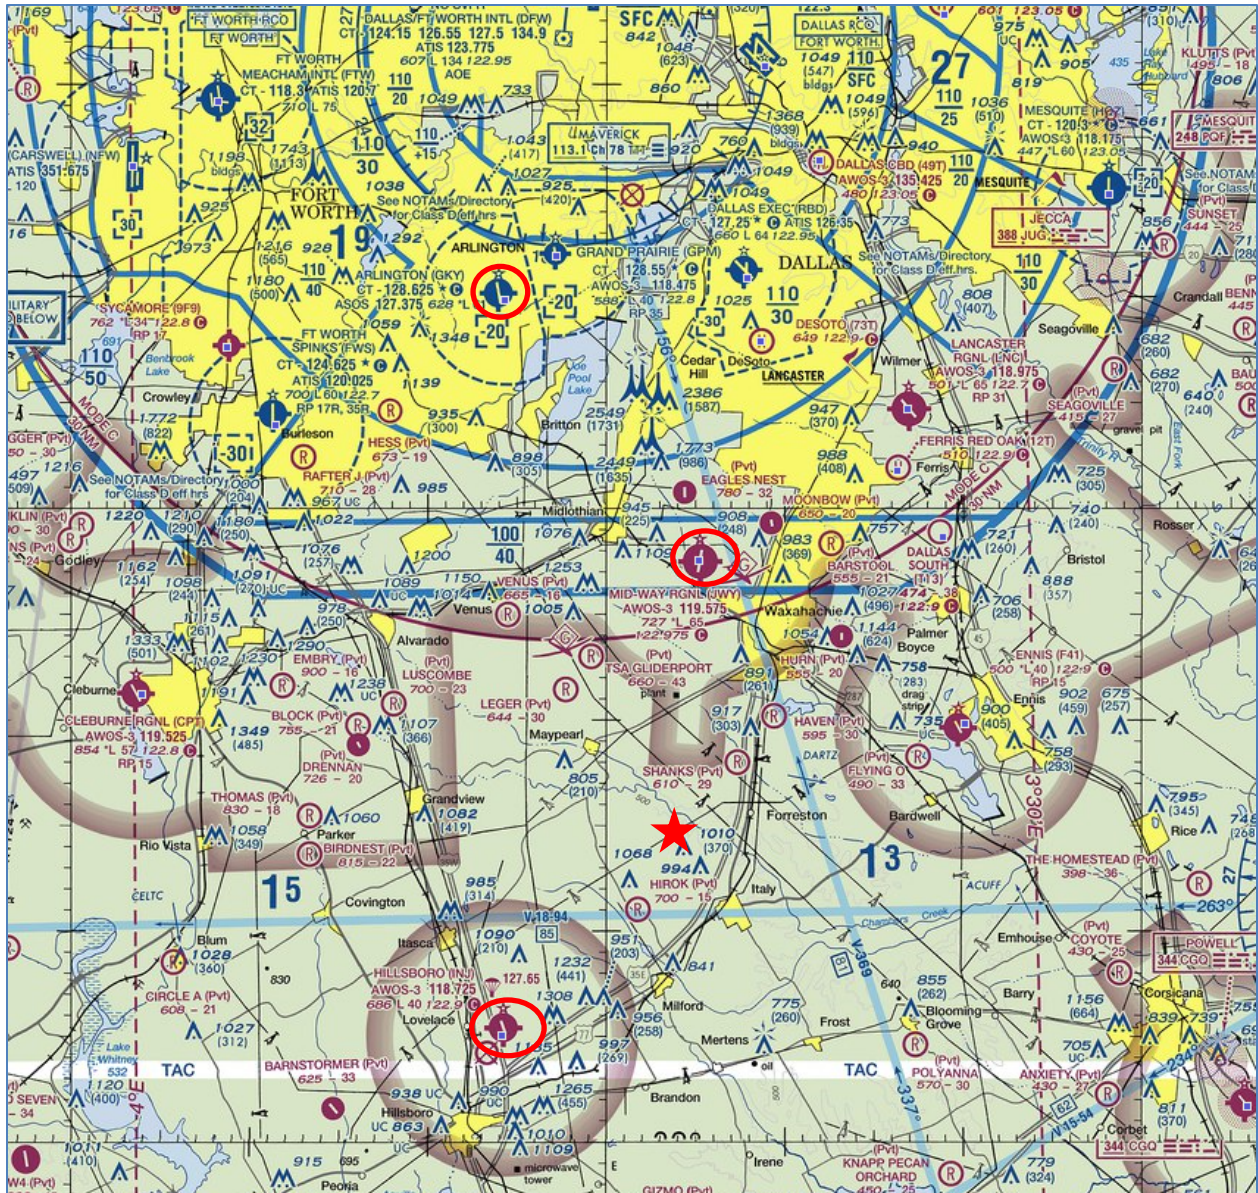
The regional sectional map over Texas is included as figure 6 depicting the location of the accident site by a red star, and the closest weather reporting locations at Hillsboro (INJ), Mid-Way Regional (JWY), and Arlington (GKY) depicted within a red circle. The accident site is located within an area of relatively level terrain with two towers under 1,000 feet to the southeast between the accident site and the town of Italy, Texas located approximately 4 ½ miles southeast.

Figure 6 - Sectional map of the local area with accident site marked
