**NATIONAL TRANSPORTATION SAFETY BOARD  
OFFICE OF HIGHWAY SAFETY  
WASHINGTON, D.C.**

**HIGHWAY FACTORS GROUP CHAIRMAN'S  
FACTUAL REPORT**

Location: 17000 Block 480<sup>th</sup> Street, Oakland, Pottawattamie County, Iowa  
Vehicle 1: 2004 IC, Model 3S530, 65 passenger school bus  
Operator 1: Riverside Community School District  
Date: December 12, 2017  
Time: Approximately 6:52 a.m. CST  
NTSB #: **HWY18MH003**

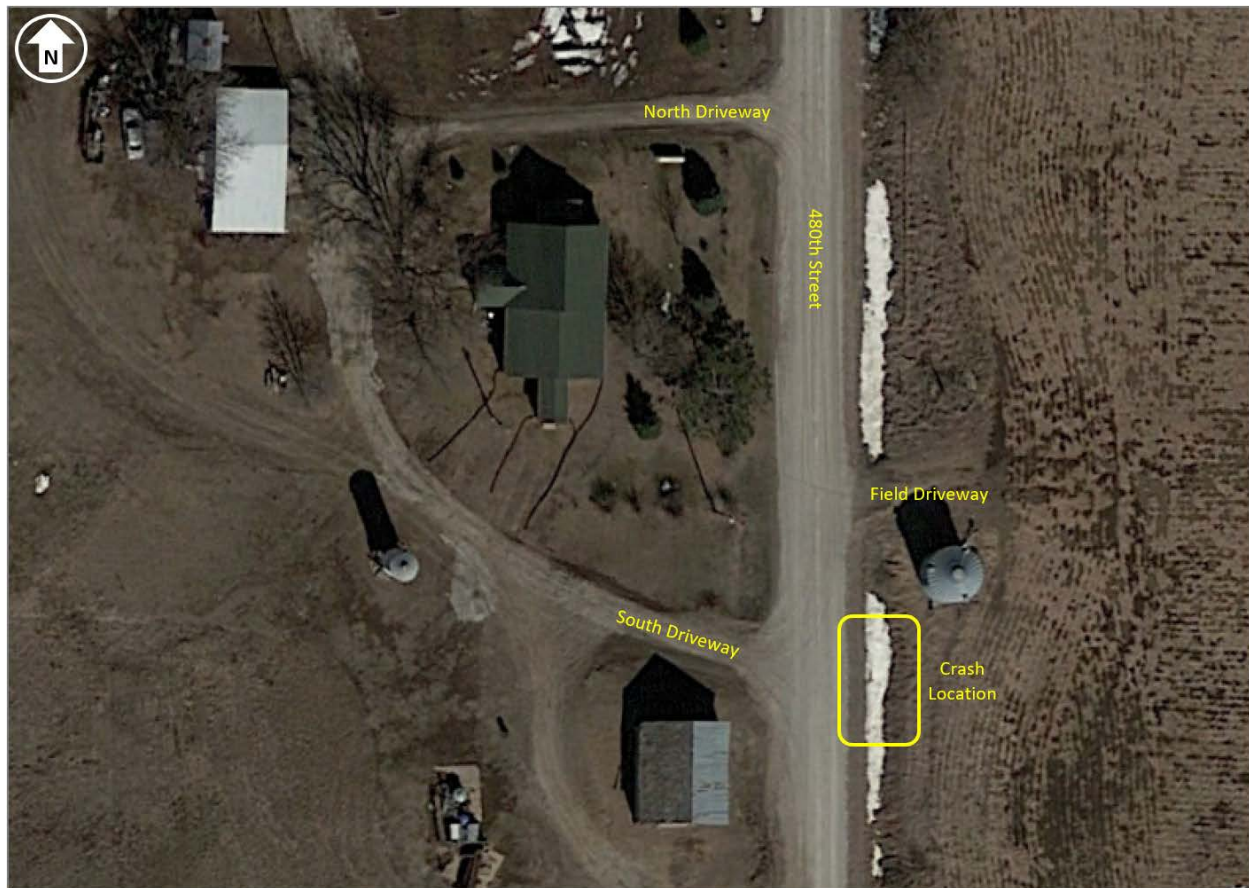
**Figure 2:** Satellite Image of the Crash Location (modified from Google Earth - Image Date: 3/8/2015)

and southbound travel lane.<sup>3</sup> At the crash location, the northbound and southbound lanes were both approximately 12-feet and 13.5-feet wide respectively. An approximate 2.5-foot wide earthen and gravel shoulder flanked the east side of the gravel roadway. It should be noted that, while present, the earthen and gravel shoulders were difficult to discern from both sides of the roadway, both north and south of the crash location. An approximate 3-foot deep drainage ditch ran parallel to the east edge of the roadway. Two driveways on the west side of the road provided access to a residence at 17840 480<sup>th</sup> Street. The collision occurred in the ditch across from the south driveway. A field driveway was located on the east side of the roadway across from the residence. The crest of a vertical curve was located approximately 166-feet north of the crash location. There was an approximate 8.9% grade both north and south of the vertical curve. The crash location was located on the vertical curve, and northbound traffic had an approximate 4.2% uphill grade at the collision location.<sup>4</sup> The satellite image in **Figure 2** shows the layout of the roadway, residence, and driveways. The crash occurred during the hours of darkness and there was no artificial highway lighting along 480<sup>th</sup> Street in the vicinity of the crash location.

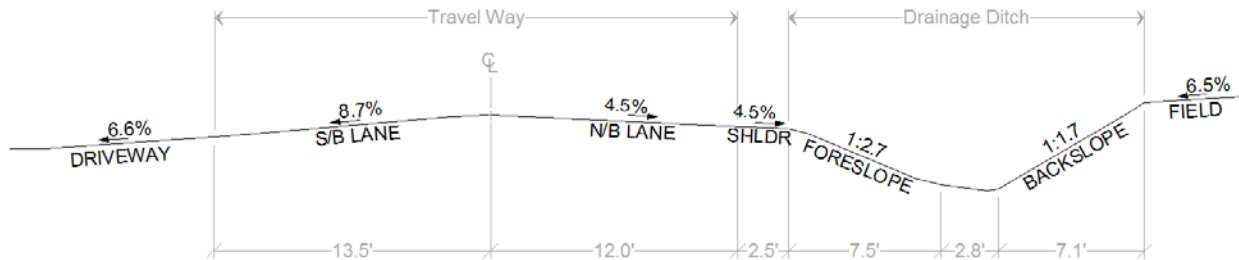
**Figure 3:** Cross-section of Driveway, Roadway, and Drainage Ditch at Crash Location

The Pottawattamie county Sheriff’s Office and Council Bluffs Police Department mapped the area of the crash using a 3-dimensional laser scanner, from which a highly accurate 3-D model can be produced. The roadway, driveways, roadway evidence, and surrounding features were also surveyed by a Pottawattamie County Secondary Roads survey crew to further document the area surrounding the crash location.<sup>5</sup> A cross-section of the south driveway, roadway, and drainage ditch is shown in **Figure 3**.

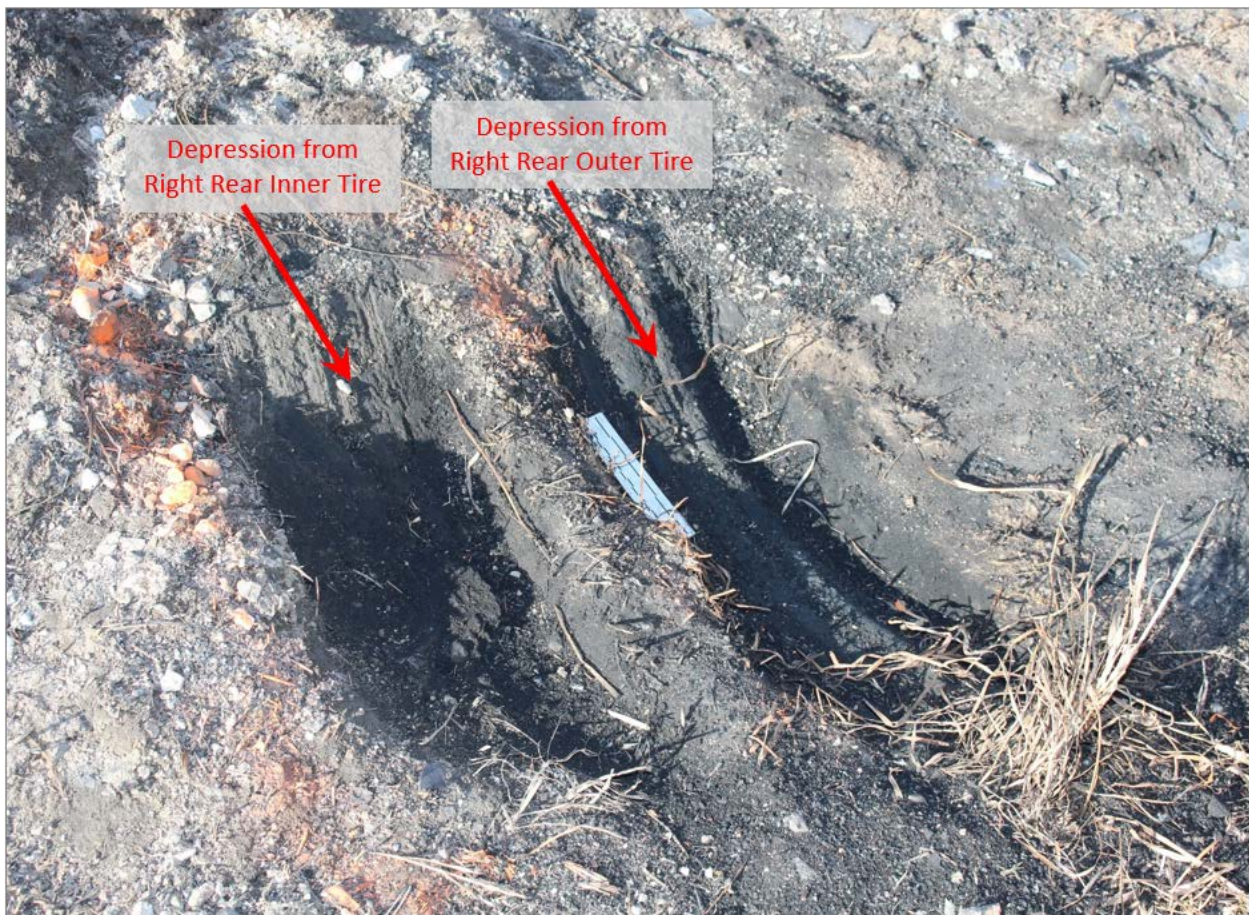
**Figure 5:** Right Rear Tire Depressions Near the Bottom of the Ditch Foreslope

The locations of the school bus's left rear tires were still visible, in the form of two parallel patches of unburned grass, on the east shoulder, near the edge of the drainage ditch. The locations of the school bus's right rear tires were visible in the form of two distinct depressions in the soil near the bottom of the foreslope of the drainage ditch. These depressions were nearly filled with various pieces of debris from the post-crash fire. After using a soft-bristled brush to carefully remove the debris from the depressions, large portions of tire treads were found still lining the bottom of the depressions in the soil, as shown in **Figure 5**.<sup>13</sup> The depression formed by the right inner dually tire was approximately 24-inches long, 9-inches wide, and 2-inches deep. The depression formed by the right outer dually tire was approximately 27-inches long, 9-inches wide, and 2-inches deep.

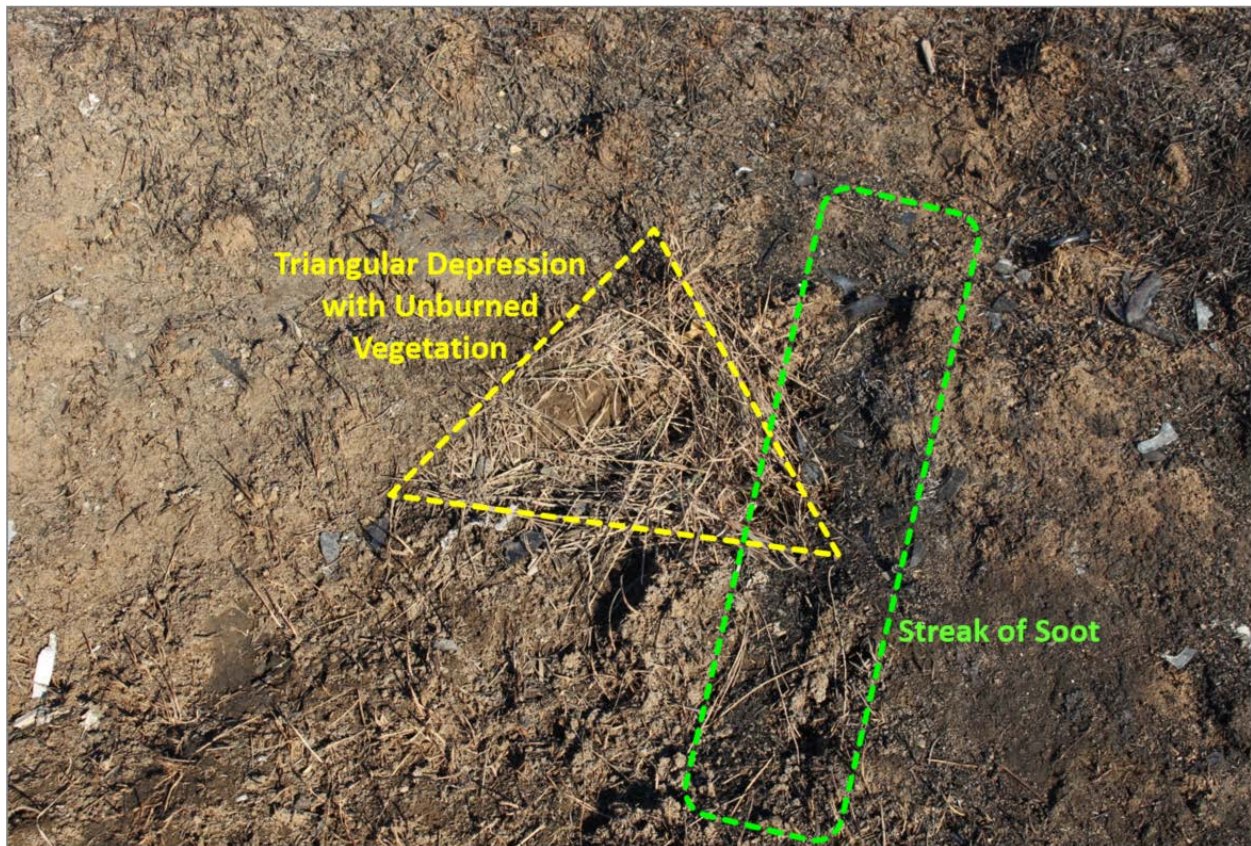
**Figure 6:** Triangular Depression and Soot Deposits Located on Backslope of Ditch

Investigators also located a triangular depression in the backslope of the ditch that contained unburned, dried vegetation.<sup>14</sup> The location of the triangular depression was consistent with the location of the lower right corner of the school bus's bumper following the collision and

post-crash fire.<sup>15</sup> A streak of what appeared to be soot deposits was located approximately 18-inches inward of the outer edge of the corner depression, and slightly below the bottom of the corner depression as shown in **Figure 6**.<sup>16</sup> The streak of suspected soot was approximately 22-inches long, and 5-inches wide. Investigators obtained a sample of the material and forwarded it to the NTSB Materials Laboratory for analysis.
