**COLLISION WITH CRASH ATTENUATOR – MARCH 12, 2018
FACTUAL REPORT**

Mountain View, CA

HWY18FH011

**NATIONAL TRANSPORTATION SAFETY BOARD
OFFICE OF HIGHWAY SAFETY
WASHINGTON, D.C.**

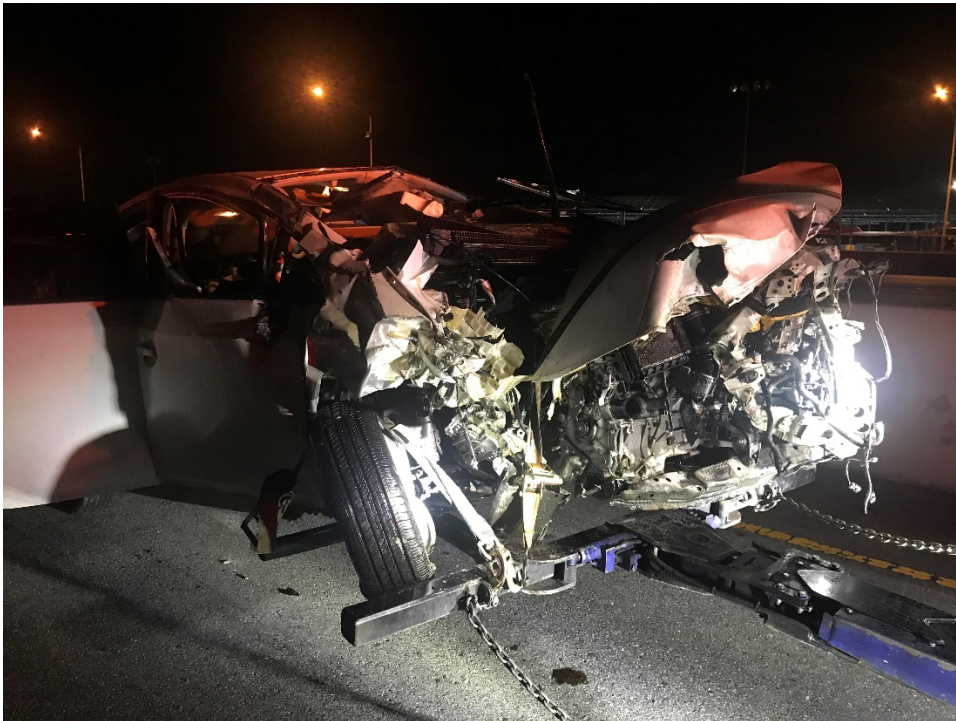
Figure 1. Photo showing front end damage to Toyota Prius at scene of collision with crash attenuator on March 12, 2018 – eleven days prior to fatal March 23rd crash at same location.

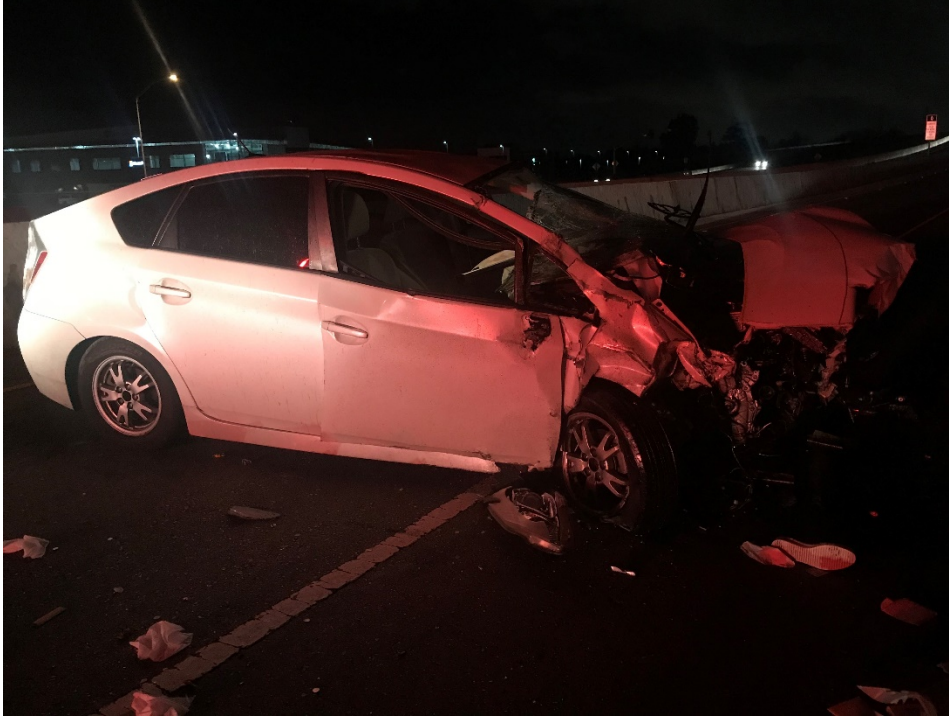
Figure 2. Photo showing right front-end damage to Toyota Prius at scene of collision with crash attenuator on March 12, 2018 – eleven days prior to fatal March 23rd crash at same location.

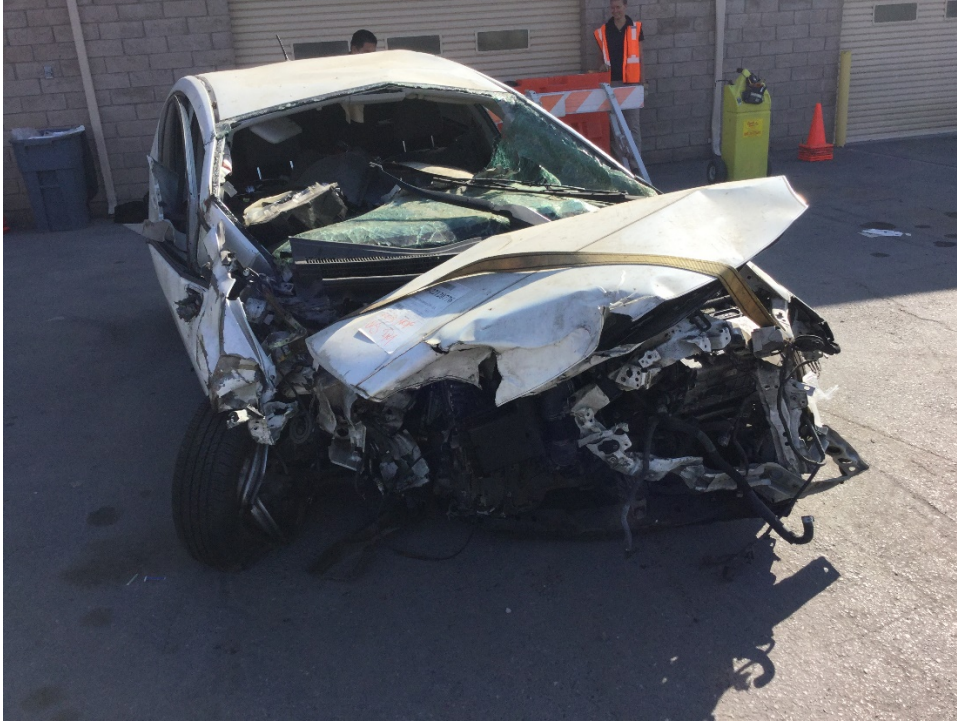
Figure 3. Photo showing front-end damage to Toyota Prius during inspection of vehicle at impound facility on August 1, 2018.

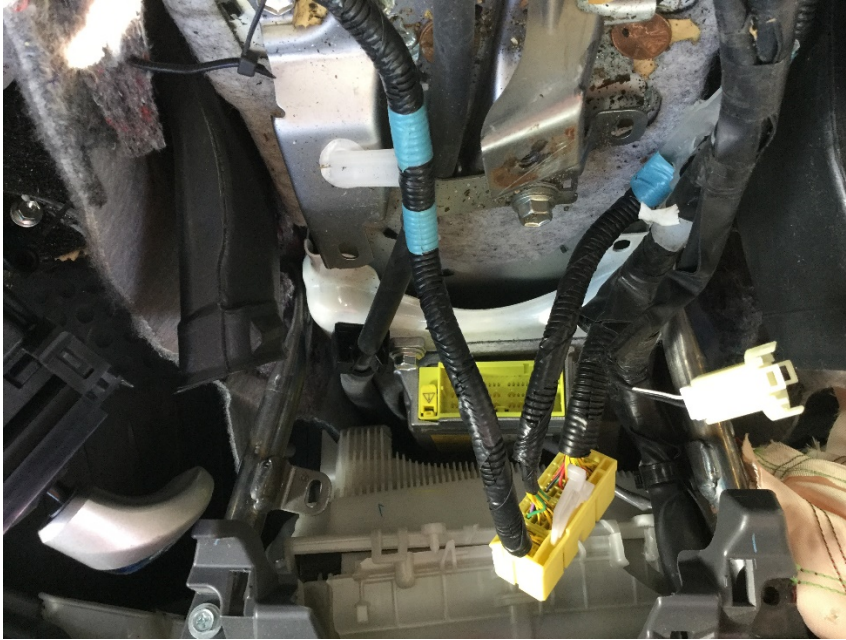
Figure 4. Photo showing the location of the airbag control module in the center console beneath the dash on the Toyota Prius during inspection of vehicle at impound facility on August 1, 2018.

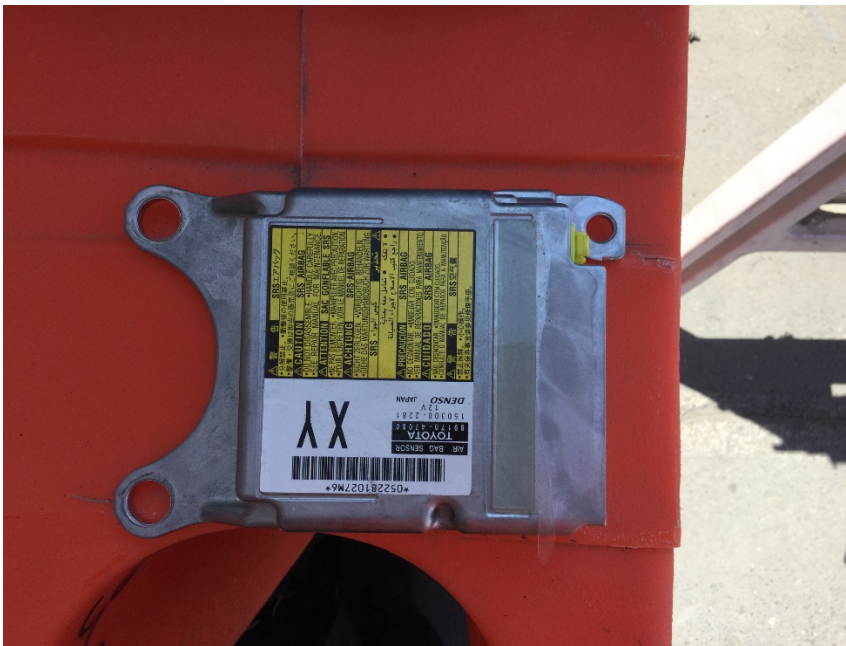
Figure 5. Photo showing the location of the airbag control module after it was removed from the Toyota Prius during inspection of vehicle at impound facility on August 1, 2018.

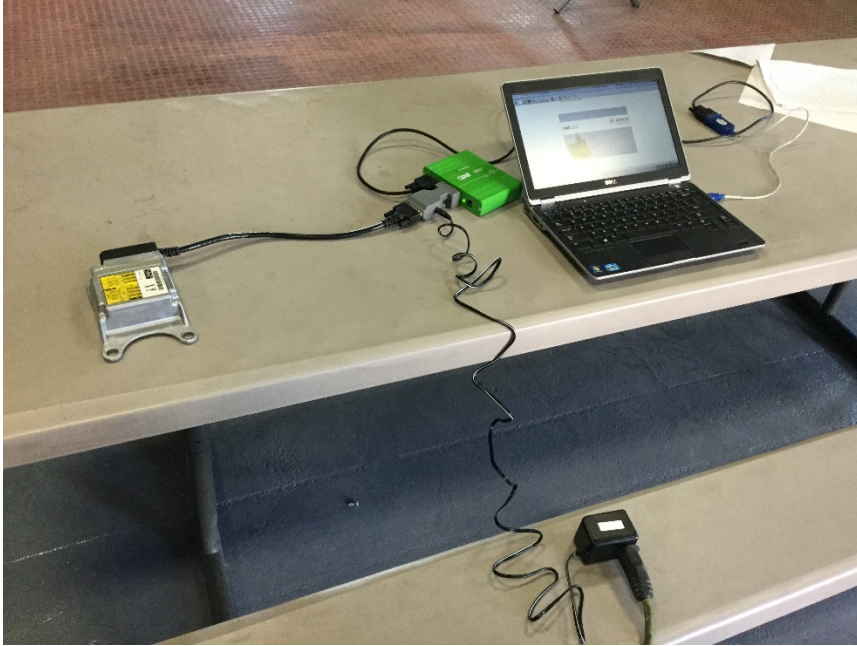
Figure 6. Photo showing the imaging of the airbag control module at the impound facility on August 1, 2018.

As a result of the imaging of airbag control module, a crash data retrieval report was obtained depicting the recorded data from the March 12, 2018 crash. The following pages contain the 19-page report.

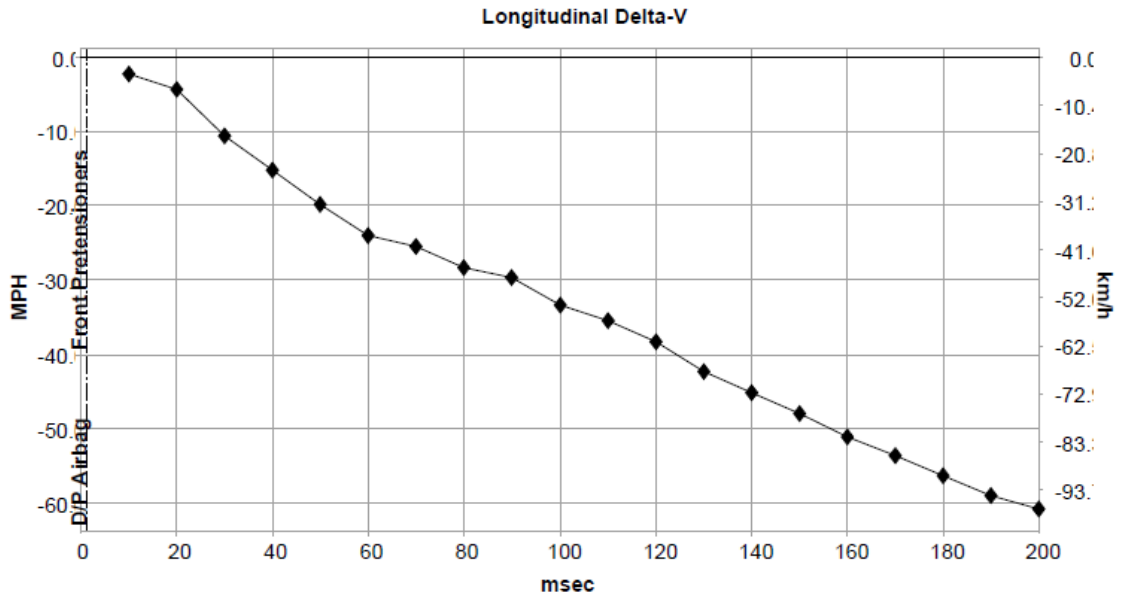
Longitudinal Crash Pulse (Most Recent Event, TRG 3 - table 1 of 2)

Recording Status, Time Series Data	Complete
Max Longitudinal Delta-V (MPH [km/h])	-60.8 [-97.8]

Time (msec)	Longitudinal Delta-V (MPH [km/h])
10	-2.2 [-3.6]
20	-4.4 [-7.0]
30	-10.5 [-17.0]
40	-15.2 [-24.4]
50	-19.9 [-32.0]
60	-24.0 [-38.6]
70	-25.5 [-41.1]
80	-28.4 [-45.6]
90	-29.6 [-47.6]
100	-33.3 [-53.6]
110	-35.4 [-57.0]
120	-38.3 [-61.6]
130	-42.2 [-68.0]
140	-45.1 [-72.5]
150	-48.0 [-77.2]
160	-51.1 [-82.2]
170	-53.6 [-86.2]
180	-56.3 [-90.6]
190	-58.9 [-94.7]
200	-60.8 [-97.8]

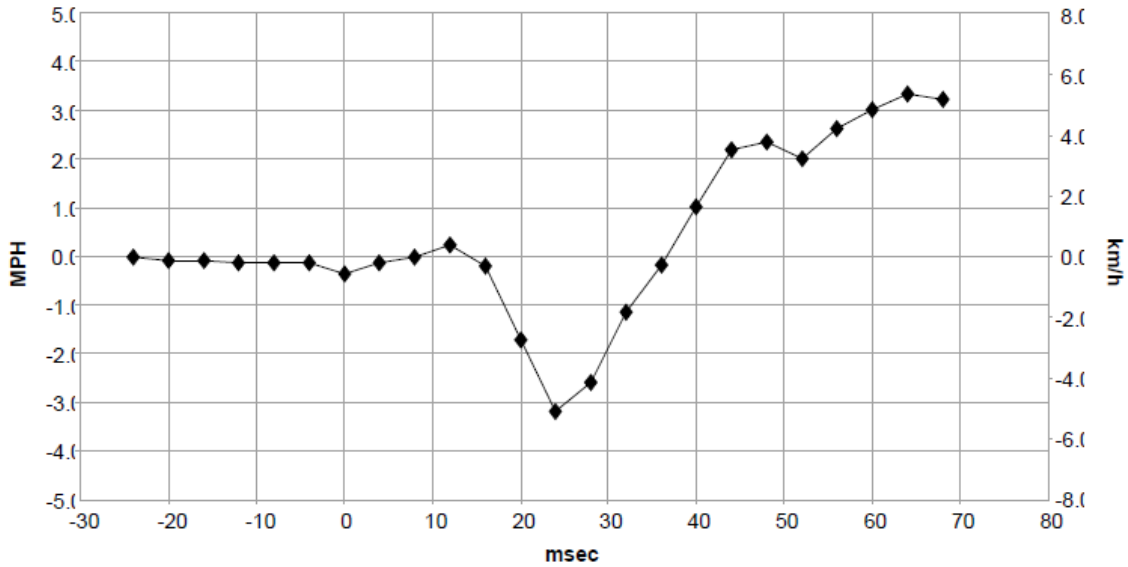
Recording Status, Time Series Data	Complete
Time from TRG to Next Sample (msec)	0
Max Lateral Delta-V, B-Pillar Sensor (MPH [km/h])	-5.7 [-9.1]
Max Lateral Delta-V, C-Pillar Sensor (MPH [km/h])	-10.9 [-17.5]

Time (msec)	Lateral Delta-V, Airbag ECU Sensor (MPH [km/h])	Lateral Delta-V, B-Pillar Sensor (MPH [km/h])	Lateral Delta-V, C-Pillar Sensor (MPH [km/h])
-24	0.0 [0.0]	0.0 [0.0]	0.0 [0.0]
-20	-0.1 [-0.1]	0.0 [0.0]	0.0 [0.0]
-16	-0.1 [-0.1]	0.0 [0.0]	0.0 [0.0]
-12	-0.1 [-0.2]	0.0 [0.0]	0.0 [0.0]
-8	-0.1 [-0.2]	0.0 [0.0]	0.0 [0.0]
-4	-0.1 [-0.2]	0.0 [0.0]	0.0 [0.0]
0	-0.4 [-0.6]	0.0 [0.0]	0.0 [0.0]
4	-0.1 [-0.2]	-0.1 [-0.2]	-0.4 [-0.7]
8	0.0 [0.0]	-0.5 [-0.8]	-0.9 [-1.4]
12	0.2 [0.4]	-0.1 [-0.2]	-0.9 [-1.5]
16	-0.2 [-0.3]	0.4 [0.6]	-1.2 [-1.9]
20	-1.7 [-2.8]	-1.3 [-2.1]	-2.2 [-3.6]
24	-3.2 [-5.1]	-4.4 [-7.0]	-3.9 [-6.2]
28	-2.6 [-4.2]	-5.7 [-9.1]	-5.0 [-8.0]
32	-1.1 [-1.8]	-5.1 [-8.3]	-5.7 [-9.2]
36	-0.2 [-0.3]	-3.7 [-6.0]	-6.7 [-10.8]
40	1.0 [1.7]	-4.0 [-6.4]	-7.5 [-12.0]
44	2.2 [3.5]	-4.4 [-7.0]	-8.1 [-13.0]
48	2.3 [3.8]	-3.7 [-6.0]	-8.8 [-14.2]
52	2.0 [3.2]	-3.5 [-5.6]	-10.0 [-16.1]
56	2.6 [4.2]	-4.1 [-6.6]	-10.7 [-17.2]

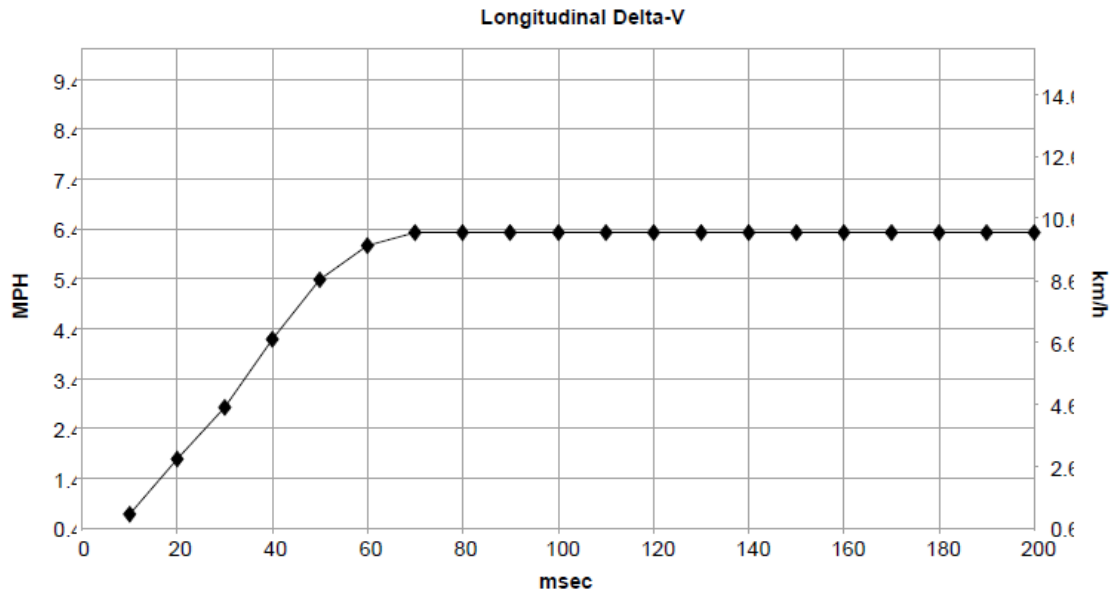
Longitudinal Crash Pulse (2nd Prior Event, TRG 1 - table 1 of 2)

Recording Status, Time Series Data	Complete
Max Longitudinal Delta-V (MPH [km/h])	6.3 [10.2]

Time (msec)	Longitudinal Delta-V (MPH [km/h])
10	0.7 [1.1]
20	1.8 [2.9]
30	2.8 [4.6]
40	4.2 [6.8]
50	5.4 [8.7]
60	6.1 [9.8]
70	6.3 [10.2]
80	6.3 [10.2]
90	6.3 [10.2]
100	6.3 [10.2]
110	6.3 [10.2]
120	6.3 [10.2]
130	6.3 [10.2]
140	6.3 [10.2]
150	6.3 [10.2]
160	6.3 [10.2]
170	6.3 [10.2]
180	6.3 [10.2]
190	6.3 [10.2]
200	6.3 [10.2]
