# Aviation Investigation Preliminary Report

| <b>Location:</b> | Jersey City, NJ | <b>Accident Number:</b> | ERA25MA171 |
| <b>Aircraft:</b> | Bell 206L-4 | <b>Injuries:</b> | 6 Fatal |

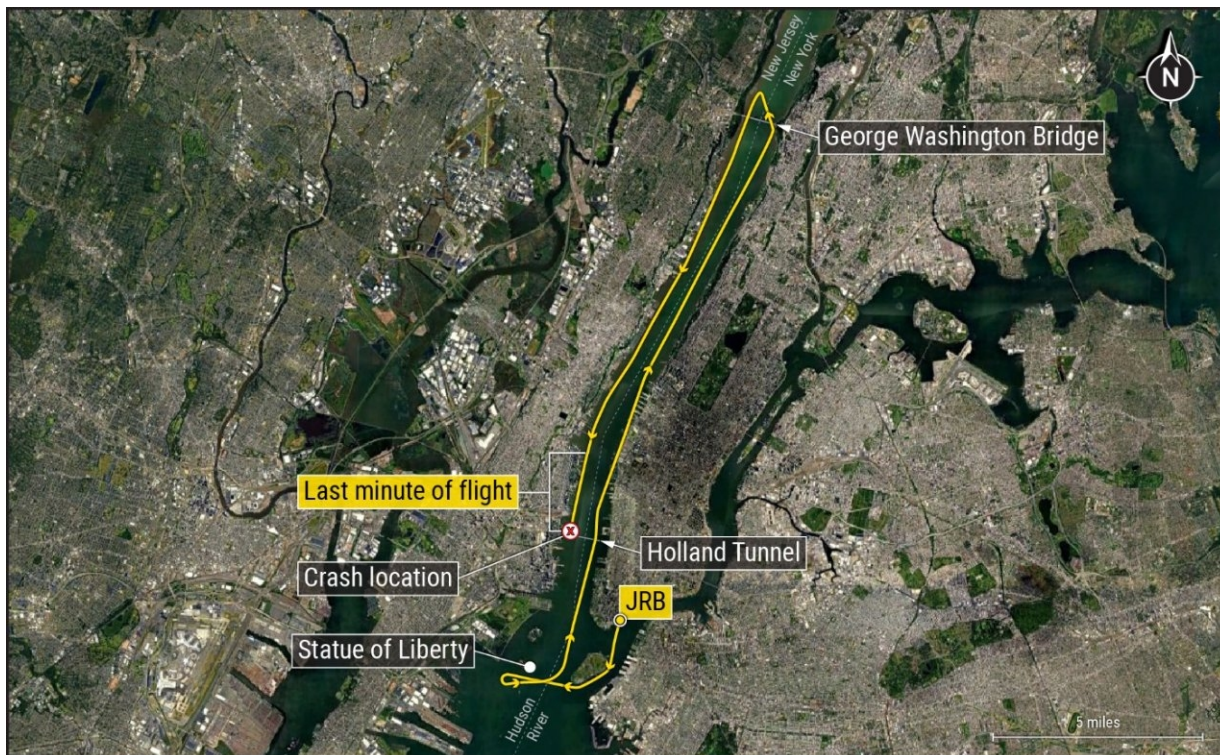
Preliminary Automatic Dependent Surveillance-Broadcast (ADS-B) flight track data obtained from the Federal Aviation Administration (FAA) revealed the helicopter departed Downtown Manhattan/Wall Street Heliport (JRB), New York, New York, about 1458. The helicopter flew a teardrop pattern south of the Statue of Liberty, then proceeded north along the east side of the Hudson River adjacent to Manhattan, past the George Washington Bridge, where it performed a u-turn, then headed south along the New Jersey side of the river (figure. 1).

**Figure 1. ADS-B flight track overview of entire route of flight from takeoff through loss of signal near the accident location.**

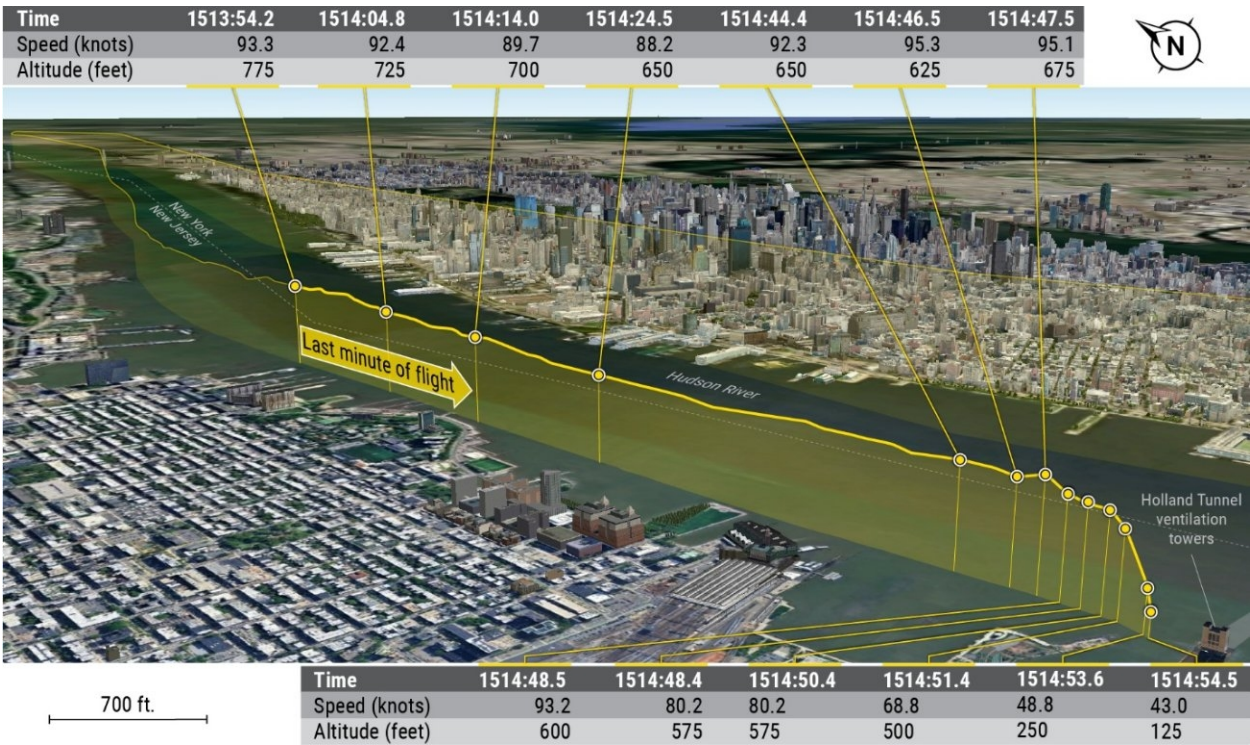
Figure 2 depicts the plot of the helicopter's ADS-B-observed flight path for the final 1 minute of flight, with the reported time, altitude and groundspeed superimposed. As the helicopter approached the Holland Tunnel ventilation towers near Jersey City, New Jersey, it was at a geometric altitude between 625 and 650 ft. The helicopter's altitude increased to 675 ft msl

before it entered a rapid descent. The data ended at 1514:54.5 and the helicopter’s last observed altitude was 125 ft.

**Figure 2. ADS-B flight track and geographic data highlighting the last minute of the flight through breakup, uncontrolled decent and loss of signal.**
