MIR-24-12

## Contact of *Queen City* Tow with Vane Dike

On March 28, 2023, about 0224 local time, the towing vessel *Queen City* was downbound on the Ohio River in high-water conditions, pushing an 11-barge tow, when the tow struck the Vane Dike at the arrival point for the McAlpine Locks and Dam in Louisville, Kentucky, and broke apart.<sup>1</sup> No pollution or injuries were reported. Total damages to the barges and cargo were estimated to be \$1.98 million.

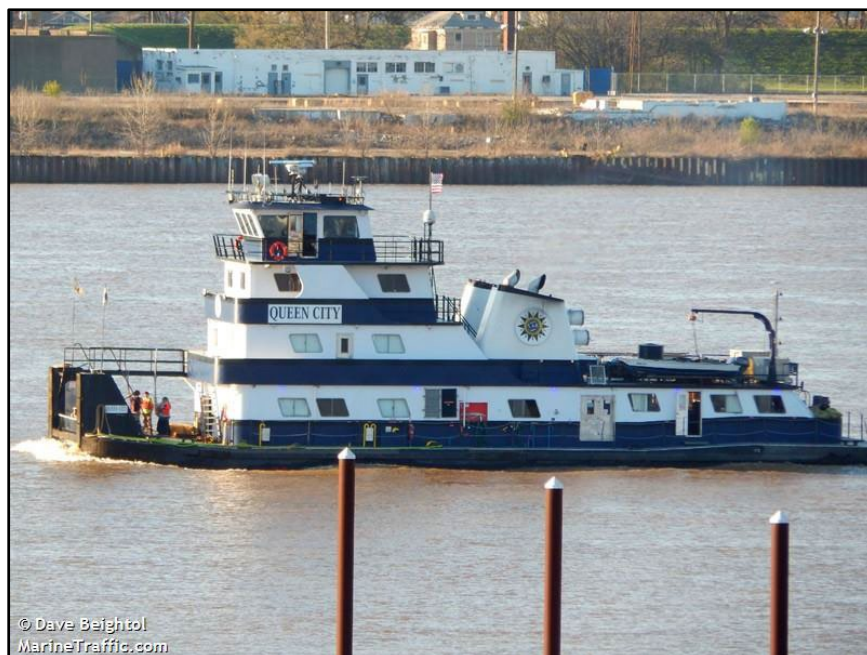
**Figure 1.** *Queen City* underway before the contact. (Source: Dave Beightol)

Owned and operated by C&B Marine Equipment, LLC, the *Queen City*, built in 1974, was a 103-foot-long, steel-hulled towing vessel (see figure 1). The vessel had two steering and four flanking rudders, and two 1,500-hp diesel engines each driving a propeller.

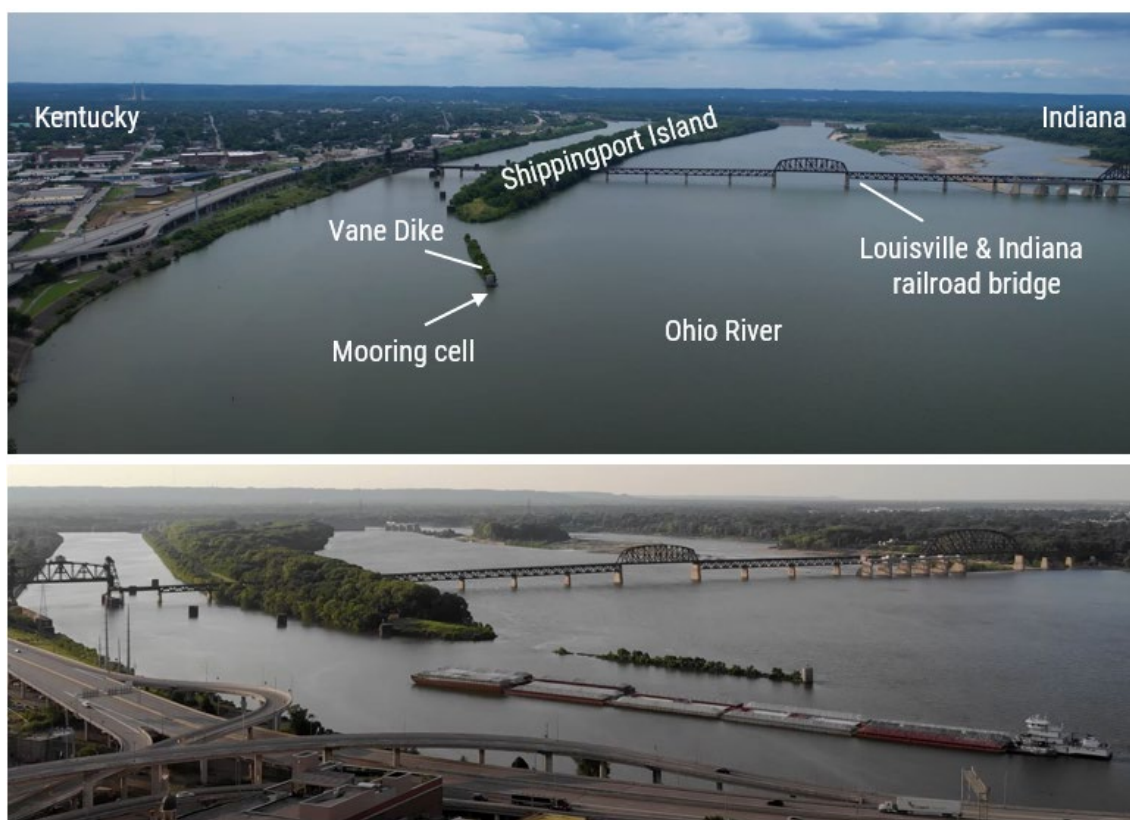
**Figure 3.** McAlpine Locks and Dam. Shown in the bottom image is a similar-size towing vessel and tow configuration (three across) as that of the *Queen City* at the time of the contact. (Sources: [Top] Nimbusphere, YouTube; [Bottom] TAPP Channel, YouTube)

The Vane Dike is located in a river bend just off the eastern end of the entrance to Portland Channel, which leads to the McAlpine Locks (see figures 2 and 3). The dike, measuring 200 yards by 10 yards, extends eastward from the end of Shippingport Island, the northern land boundary of the Portland Channel. A mooring cell is at the end of the dike. The US Coast Guard Lifesaver Memorial Light sits on top of the cell.

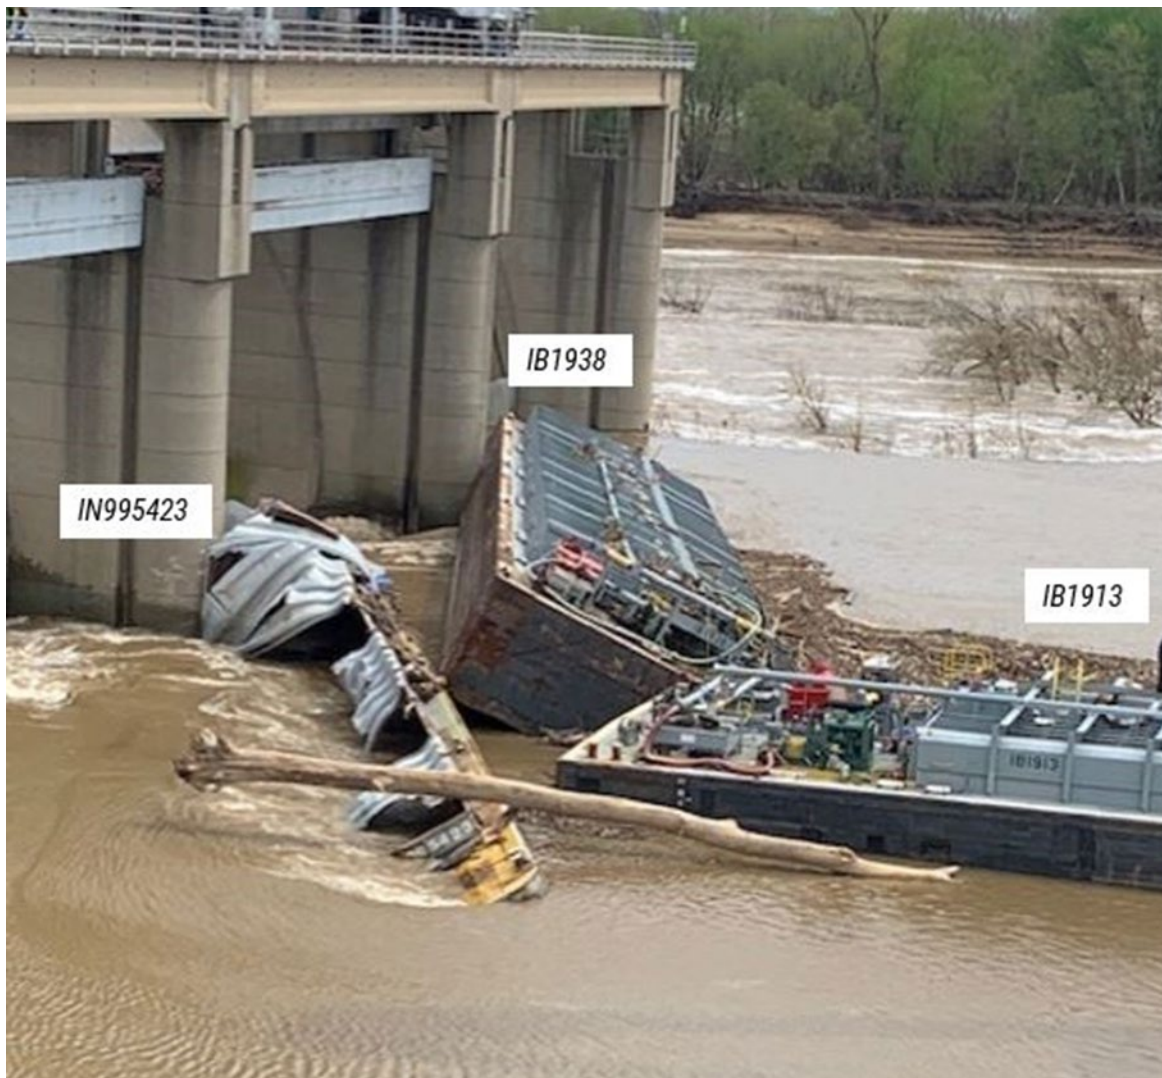
**Figure 6.** Barges *IN995423* and *IB1938* against the lower dam gates. *IB1913* is receiving methanol from *IB1938* through a cargo transfer hose. (Background source: Coast Guard)

Due to the immediate threat to public safety associated with the flammability of methanol, air and water monitoring began, and the river was closed. A unified command was established that included local, state, and federal agencies, as well as representatives of the vessel owner/operator. The vessel's owner/operator activated the vessel response plan. The designated salvor responded on scene, completed water and air monitoring, conducted vessel surveys, developed lightering and salvage plans, lightered the methanol barge while it was pinned against the dam, and salvaged all damaged barges from the waterway (see figure 6).
