Island Express Helicopters
Sikorsky S-76B, N72EX
Calabasas, CA
January 26, 2020

Meteorology

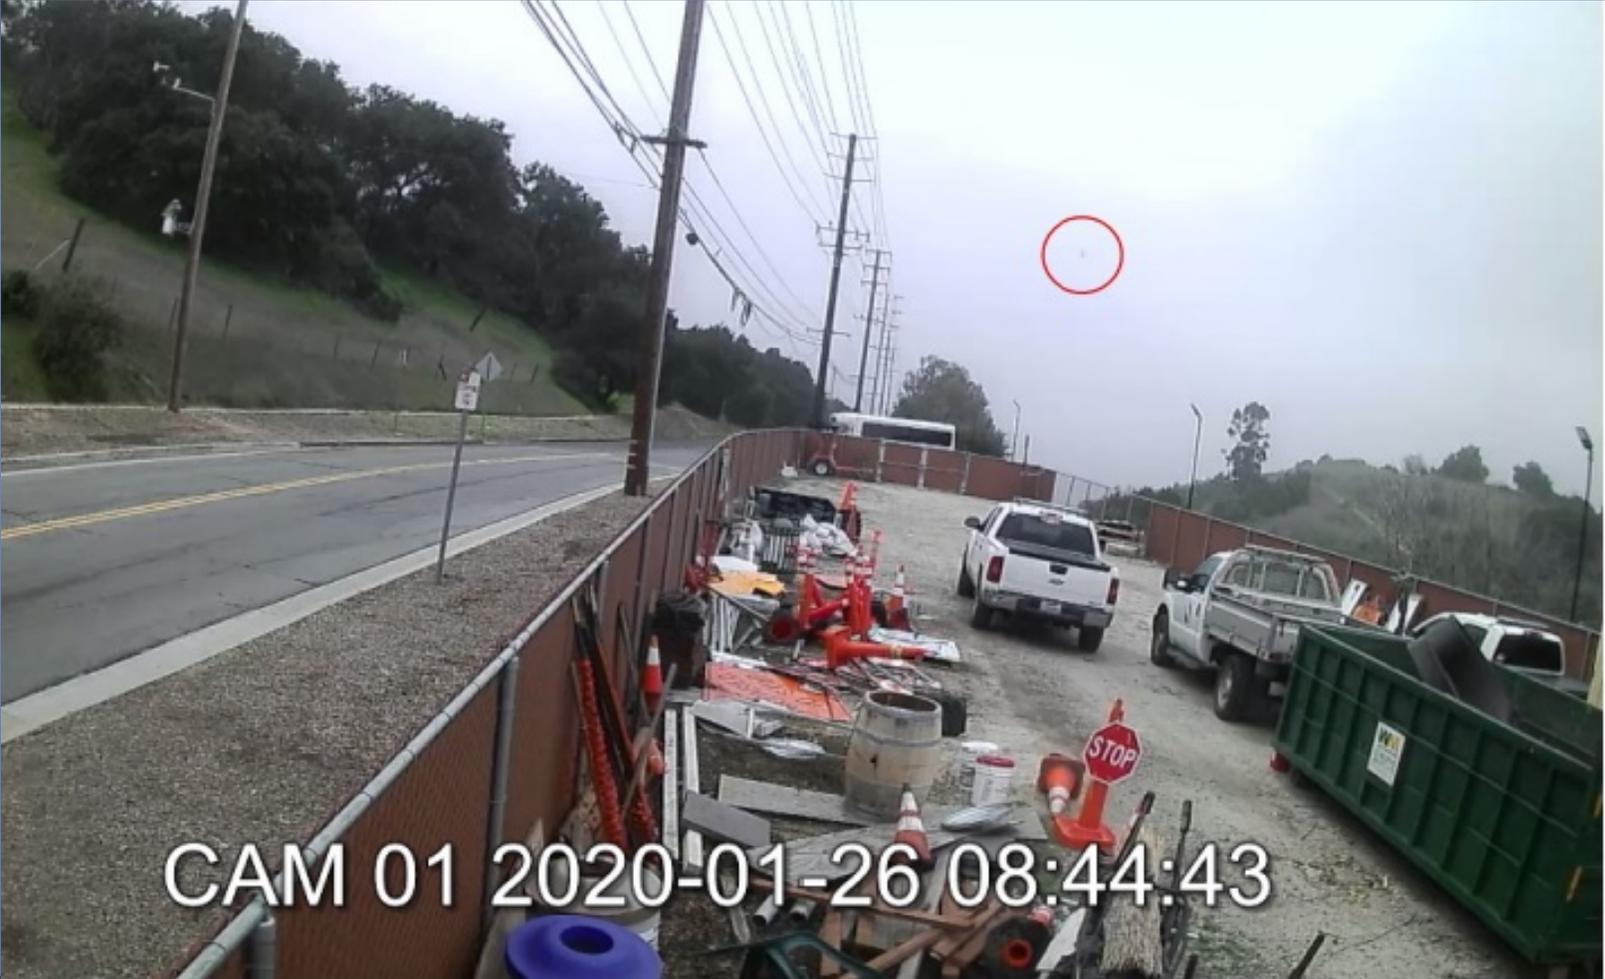
Initial Entry into IMC

CAM 01 2020-01-26 08:44:43

- Helicopter flying “below or at the cloud line”
- “Disappeared into heavy clouds” described as “thick wall”

- Helicopter began climb from 1,400 ft msl to 2,300 ft msl
- Unknown if intermittent ground contact possible below 2,000 ft msl
- Above 2,000 ft msl, instrument meteorological conditions prevailed
