National Transportation Safety Board

FACTUAL REPORT AVIATION

1 NTSB Accident/Incident Number: FTW87FA088

On March 30, 1987, at 1257 Central Standard Time, a Piper PA-28-181, N8191V was destroyed when it collided with the ground following an in-flight wing separation while in low level cruise flight near Marlin, Texas. The airplane, owned and operated by the Griffin Pipeline Patrol Company and flown by a commercial pilot, had departed Borger, Texas, at 0845 CST, on a pipeline patrol flight to Conroe, Texas, with a planned refueling stop in Cleburne, Texas. The operation required that the pilot fly down the 570 mile pipeline at low altitude and observe abnormalities or incursions into the right of way. There was no flight plan filed and VMC conditions prevailed throughout the area. The pilot, the sole occupant, received fatal injuries and there was no fire.

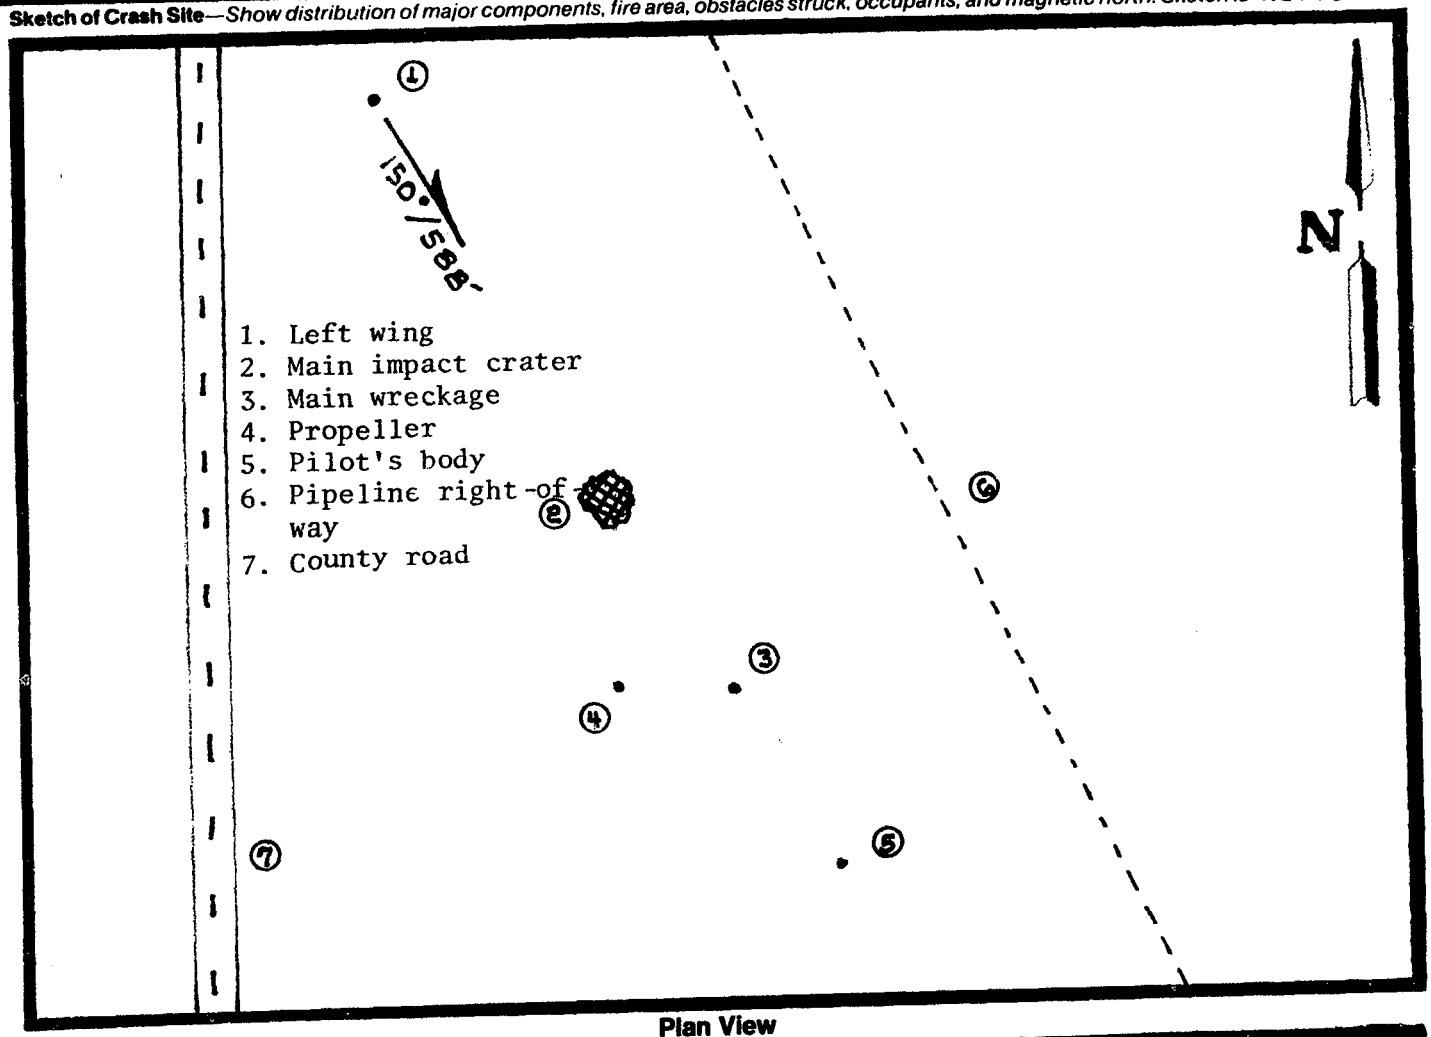
Crash Site Plan/Elevation

the pipeline right-of-way in a southerly direction. About 1 mile south of the highway, a witness observed a wing separate from the airplane and it nosed over and descended below a tree line. The airplane impacted in an open field on a westerly heading in a right wing low, nose low attitude. The separated left wing was located 588 feet north northwest of the main impact crater.

The airplane impacted in an open field on a heading of about 270 degrees, in a right wing low, nose low attitude. After principal impact, the main wreckage bounced and came to rest 60 feet southeast of the impact crater. The separated left wing was located 588 feet to the north northwest of the main impact point and about 300 feet southwest of the pipeline's 453 mile post. At the point where the accident occurred, the pipeline ran about 155 degrees magnetic. The point where the pipeline crossed State Highway 147 was mile post 452, one mile north of the location of the separated left wing. With the exception of the left wing and the propeller, which had separated on impact, the airplane remained intact during the impact sequence. The cockpit/cabin area was destroyed during impact and the pilot, with his seat, was thrown clear of the wreckage.

The separated left wing had impacted in an open field wing root first, bounced, and came to rest against a barbed wire fence. Examination of the wing revealed that it was intact on impact except for the left flap. The outer 1/3rd of the flap was located about 30 feet southeast of the wing and the inboard section remained attached to the fuselage and was found with the main wreckage. All of the remaining flight control surfaces remained attached in their respective positions. Control continuity was established from all of the control surfaces up through the center section of the airplane with one exception. The left aileron control cables remained attached to the fuselage, but had ripped out of the left wing along with the aileron bell crank.
