LW14
C2017 (Green)
Left lower Wing Skin around Boost Pump Access doors

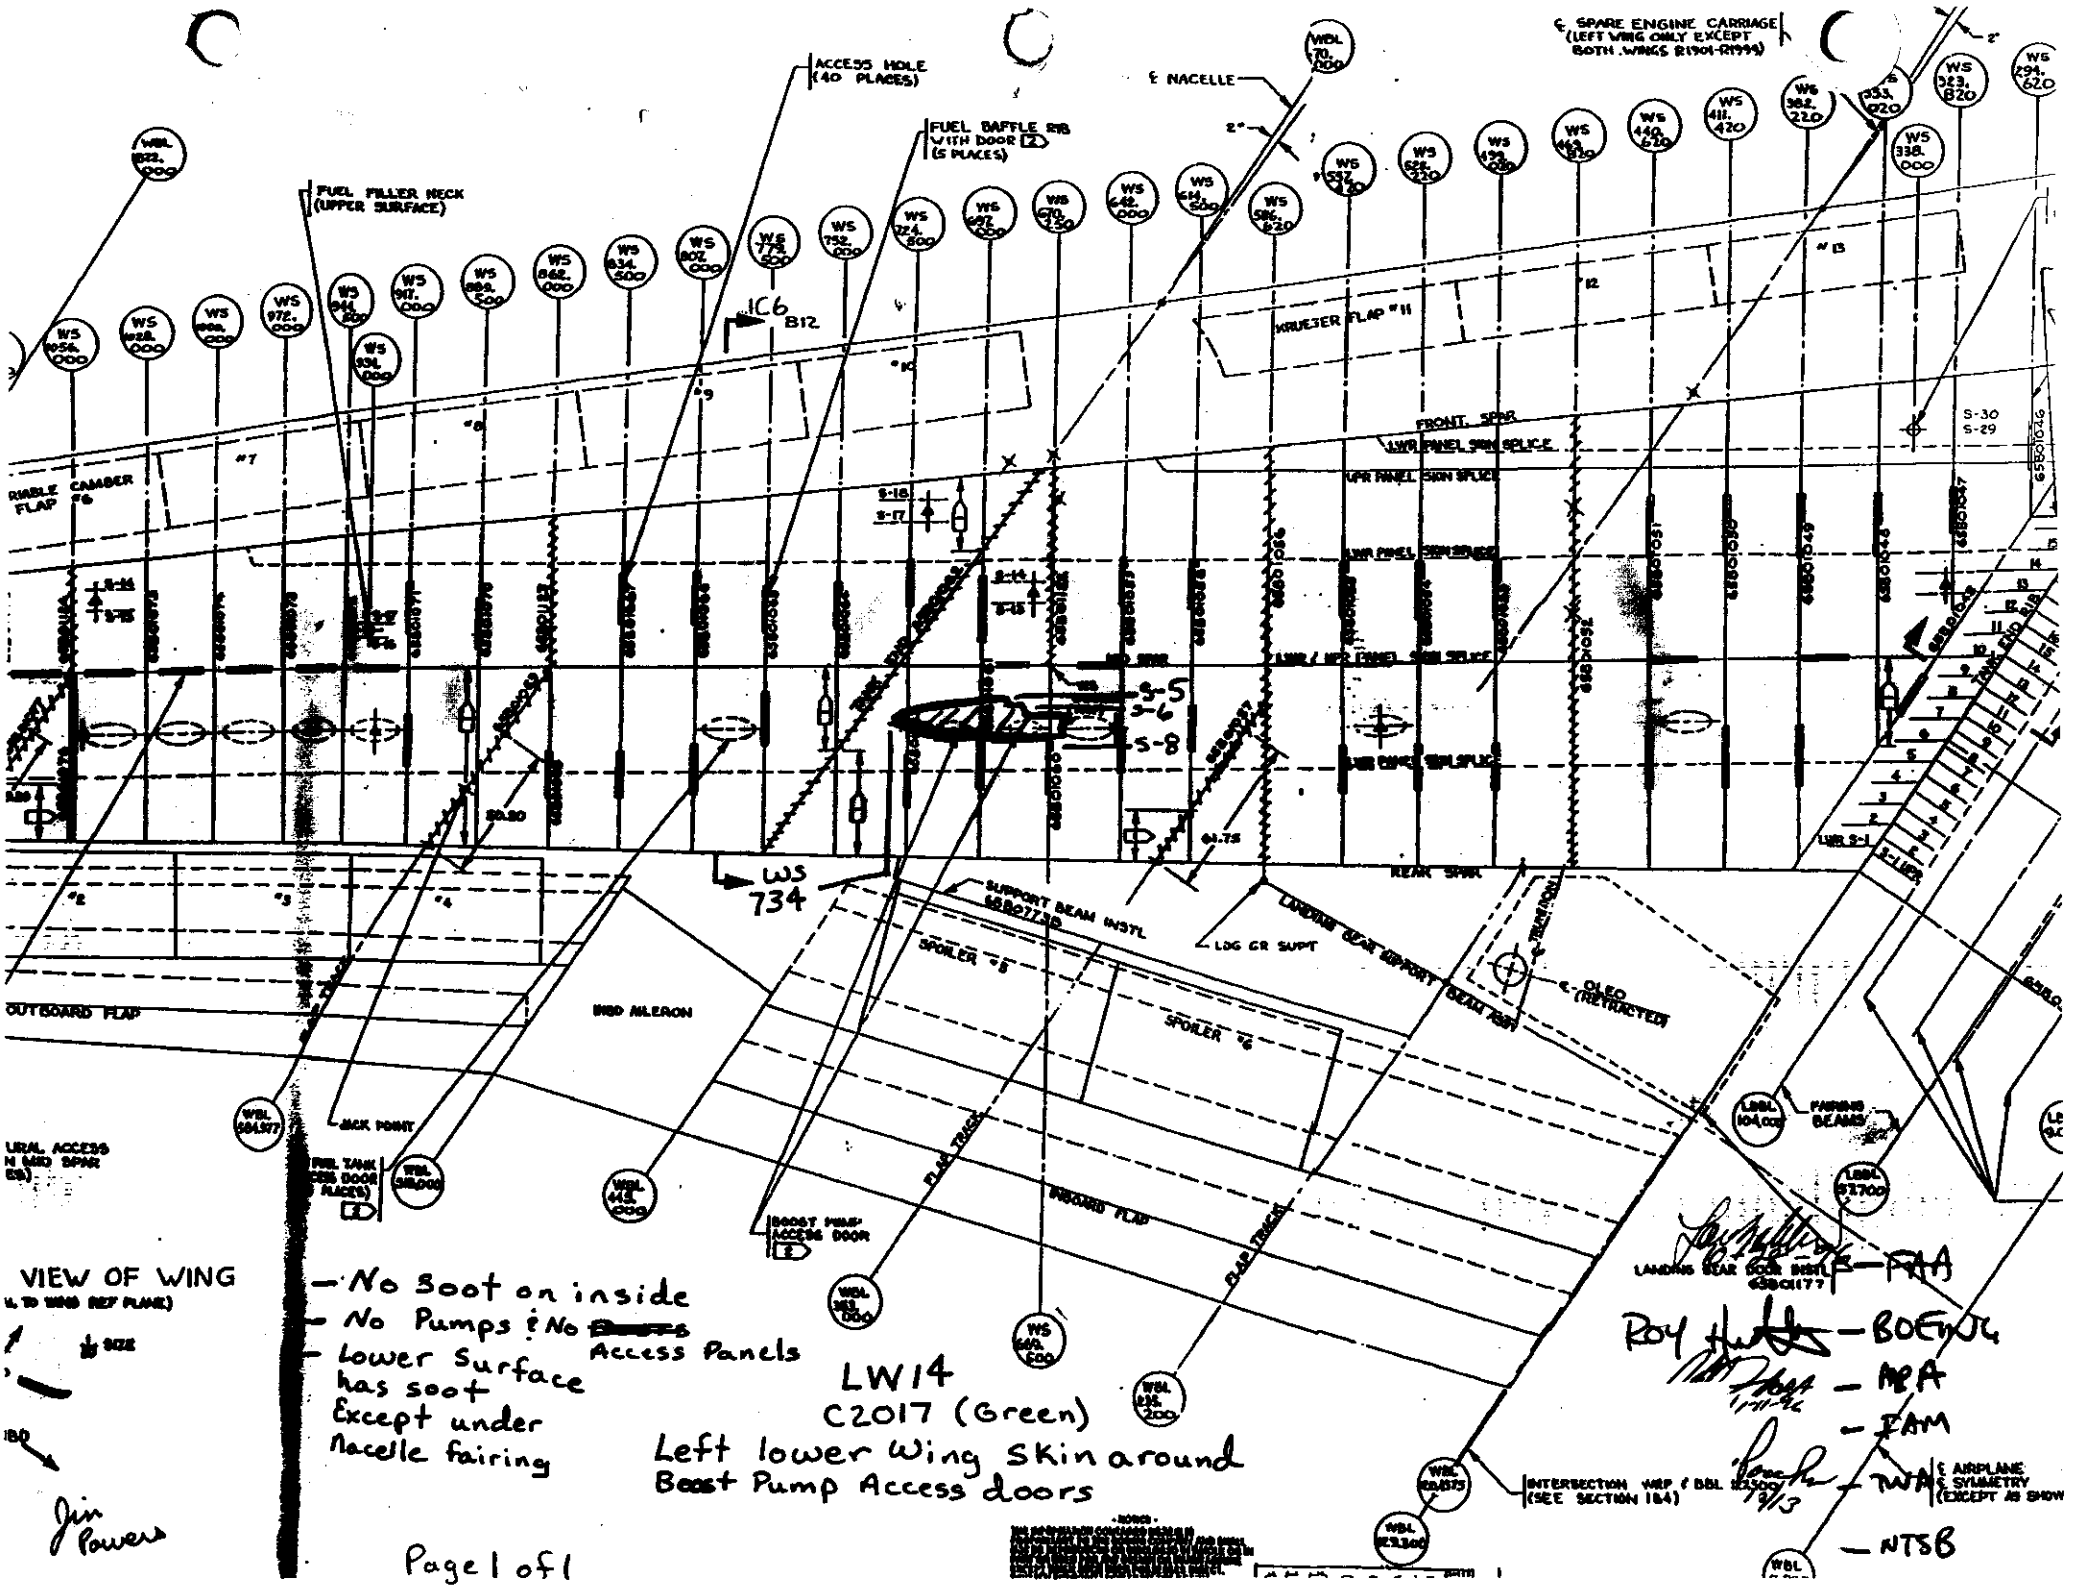
VIEW OF WING

- No Soot on inside
- No Pumps ? No ~~Doors~~ Access Panels
- Lower Surface has soot Except under Nacelle fairing
