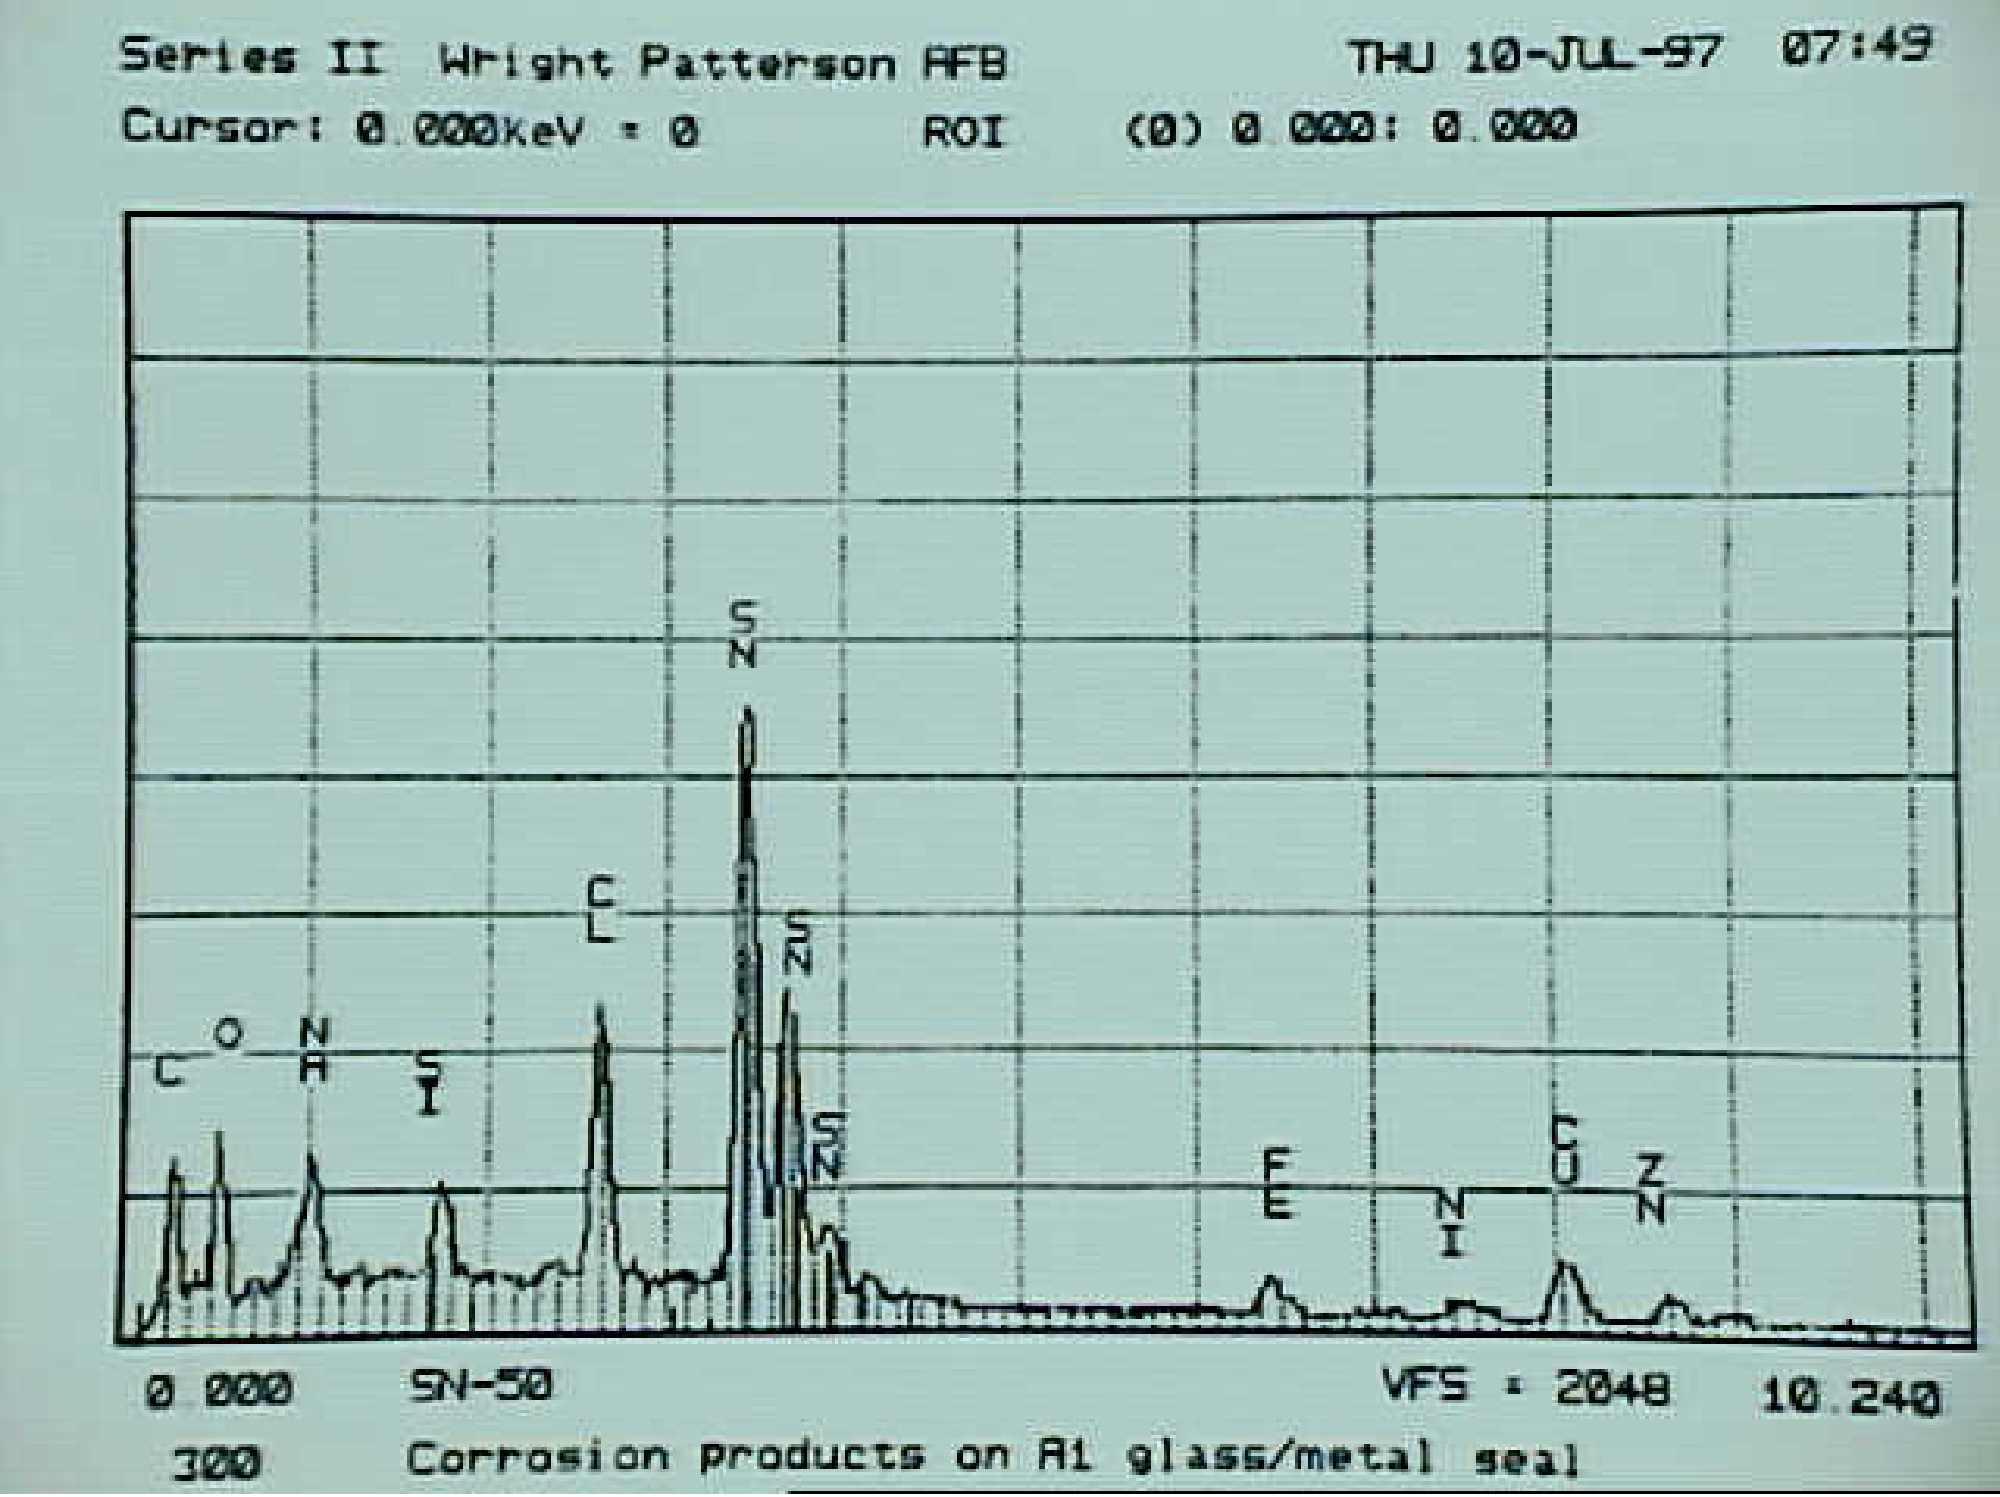
Systems 9 - Exhibit No. 9B - Photo 9. Figure 9b. Corrosion products on glass to metal seal of N.O.
