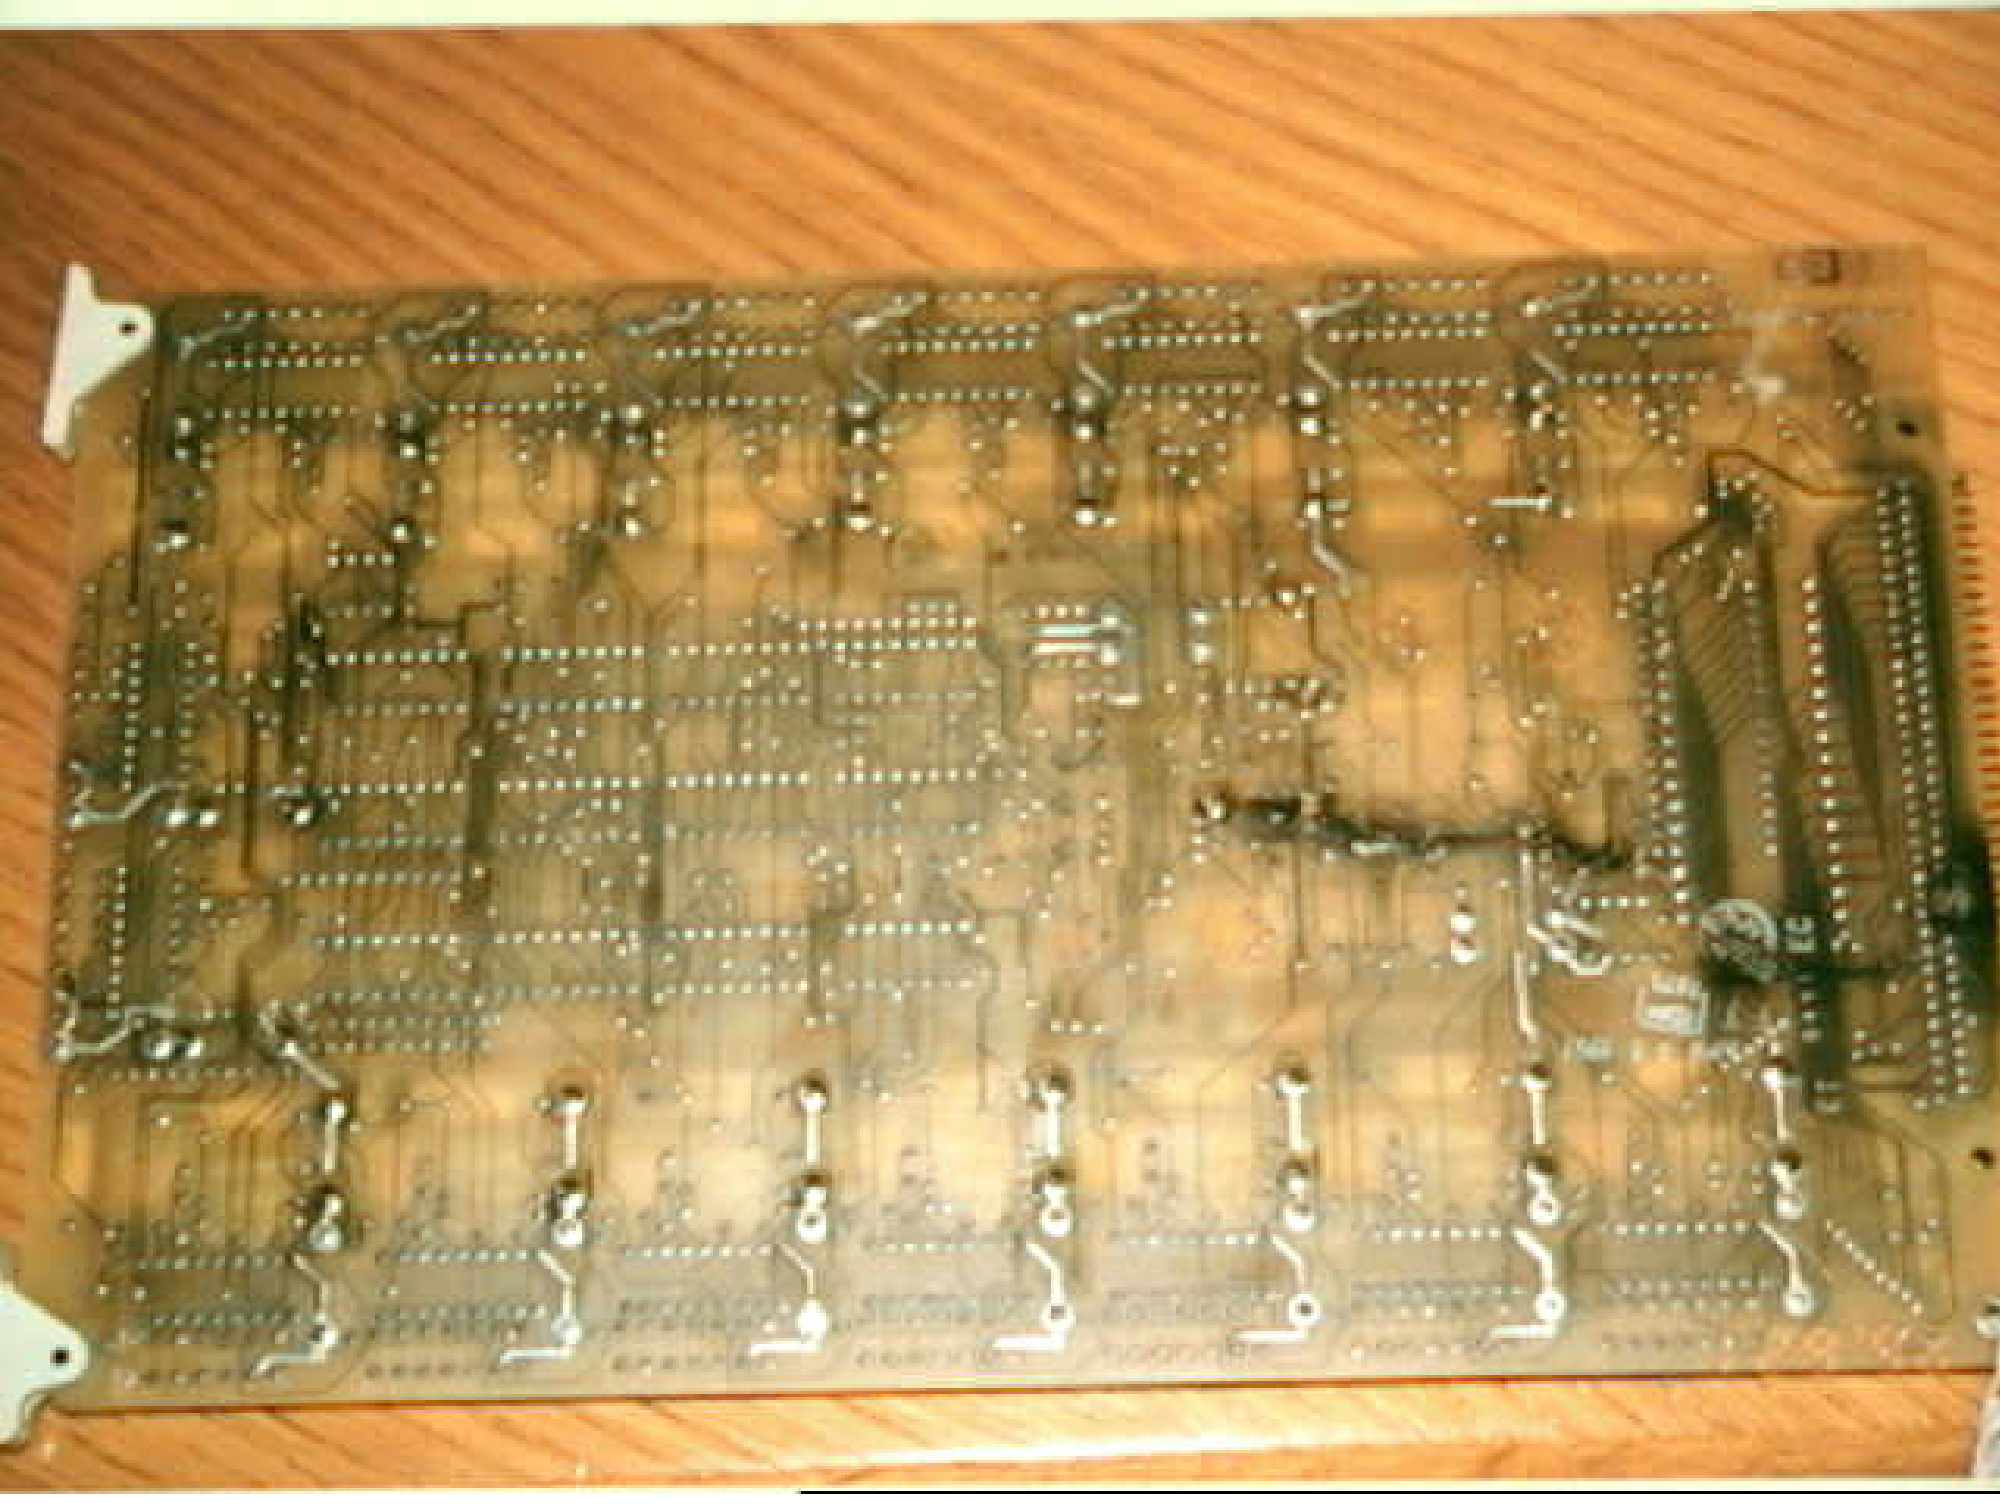
Systems 9 - Photo 44. Airplane 19. B-767 thrust reverser indication printed circuit card with burned track. Burned track was connected to the burned wire bundle through other wiring.
