Approved: November 14, 2024 Preliminary Report PLD25FR001

Enbridge Inc. Natural Gas-Fueled Home Explosion

South Jordan, Utah
November 6, 2024

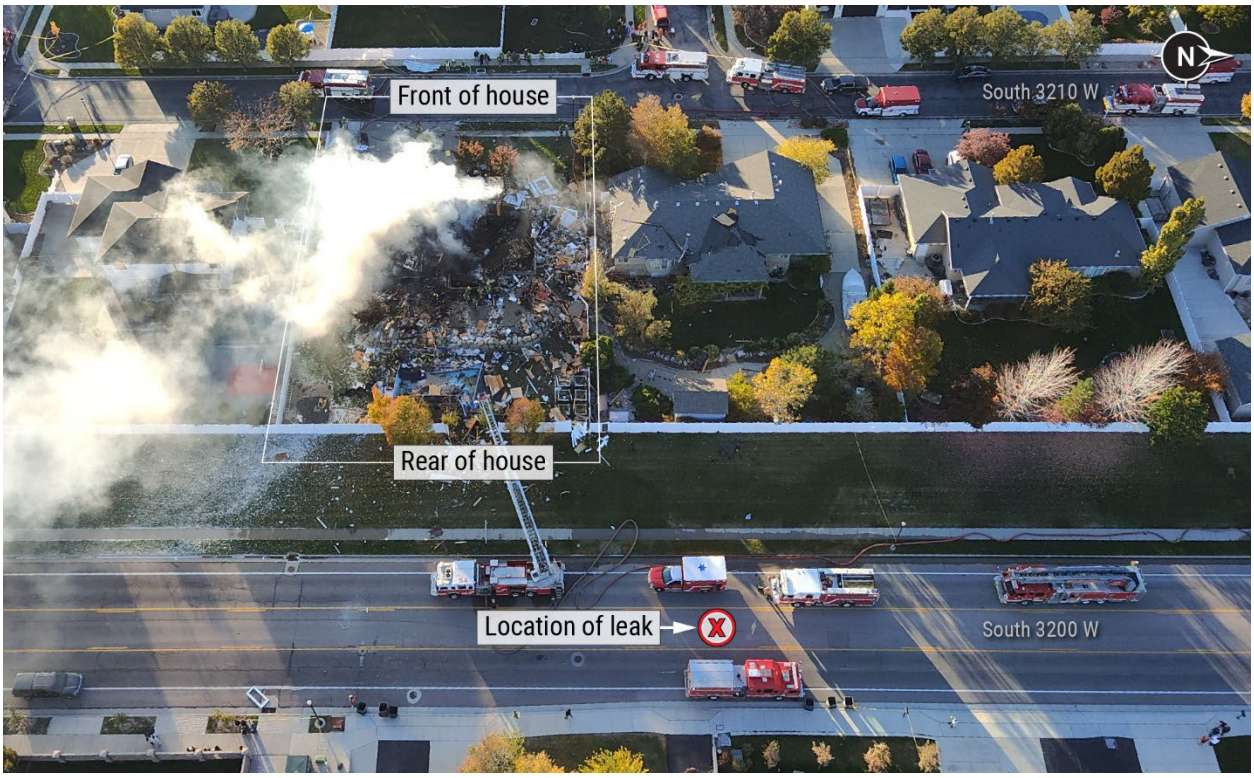
On November 6, 2024, about 3:09 p.m., a natural gas-fueled explosion fatally injured one person and destroyed a home in South Jordan, Utah.[1] There were no other injuries reported. Several nearby residences were damaged, and families were displaced. (See figure.) The South Jordan Fire Department responded and arrived on scene in about 6 minutes. Enbridge Inc. (Enbridge) subsidiary, Enbridge Gas Utah, provided natural gas service to the home.[2] Enbridge responded and arrived on scene about 3:45 p.m. and worked continuously to find and isolate the leak; Enbridge isolated the leak about 12:16 p.m. on November 7. At the time of the explosion, conditions were daylight and clear; the temperature was 41°F with no precipitation.

Figure. The scene on the day of the accident. (Drone photography courtesy of the South Jordan Police Department.)
