September 3, 2025 Highway Investigation Report HIR-25-05

Multivehicle Collision and Postcrash Fire on Interstate 70

Etna, Ohio
November 14, 2023

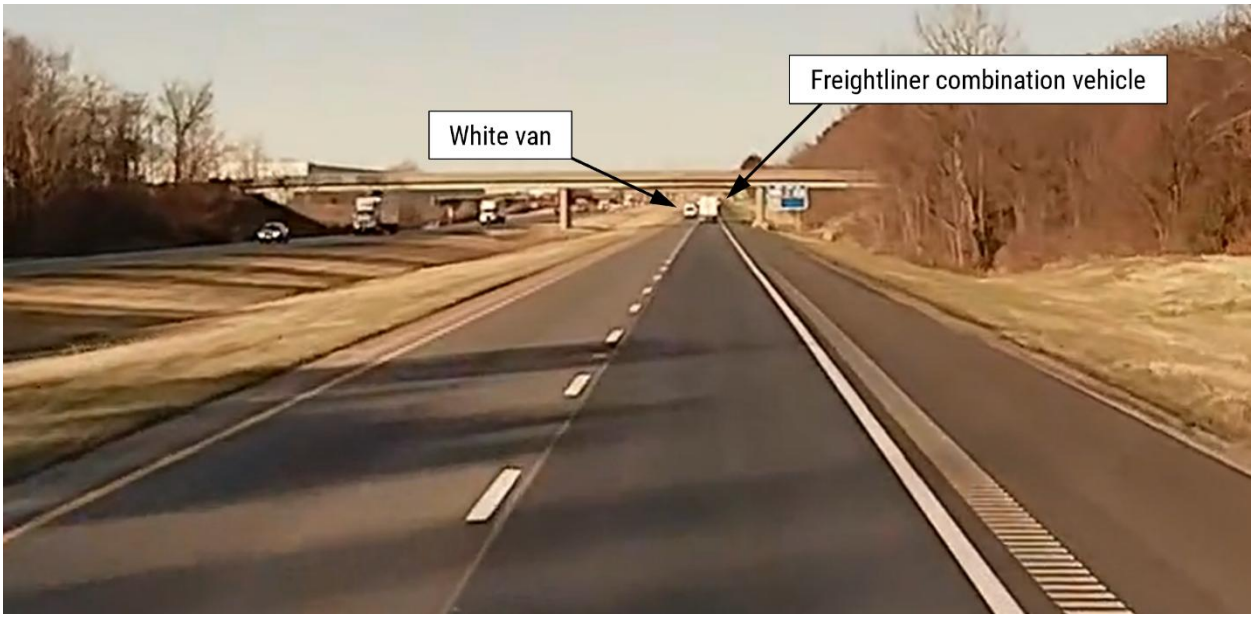
Figure 1. Video still from witness vehicle's forward-facing camera (annotated by NTSB), showing the Freightliner combination vehicle and the white van that moved from the right lane into the left lane, ahead of the Freightliner, about 7 seconds before the crash.

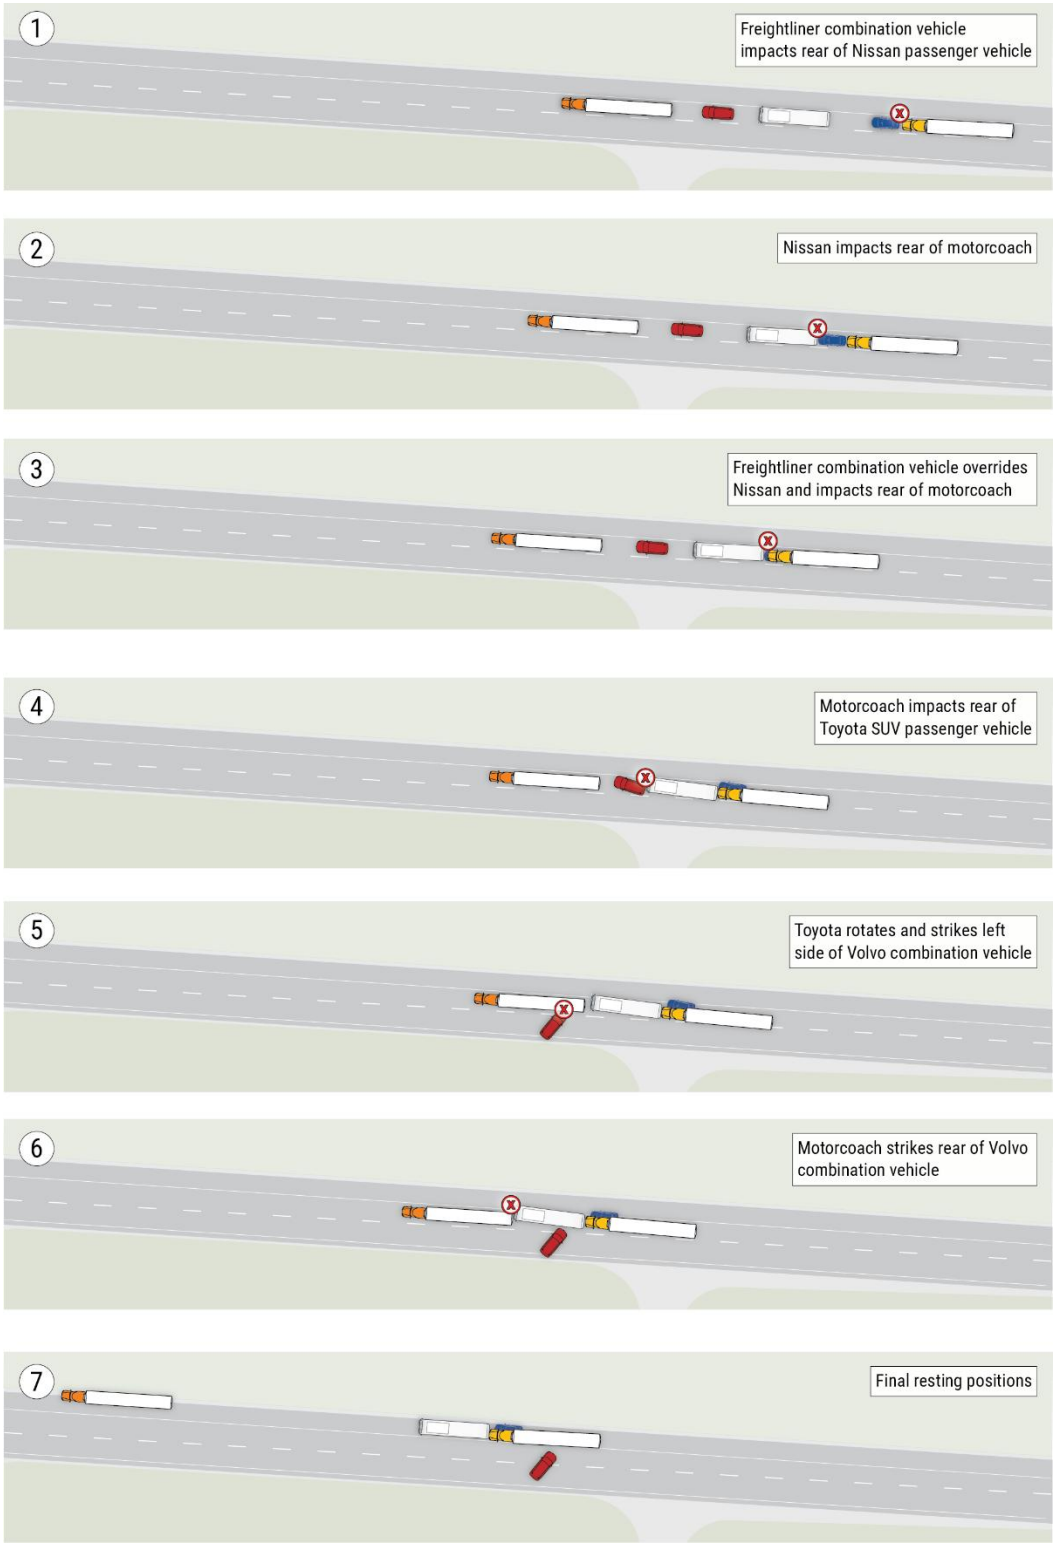
Figure 3. Sequence of impacts.

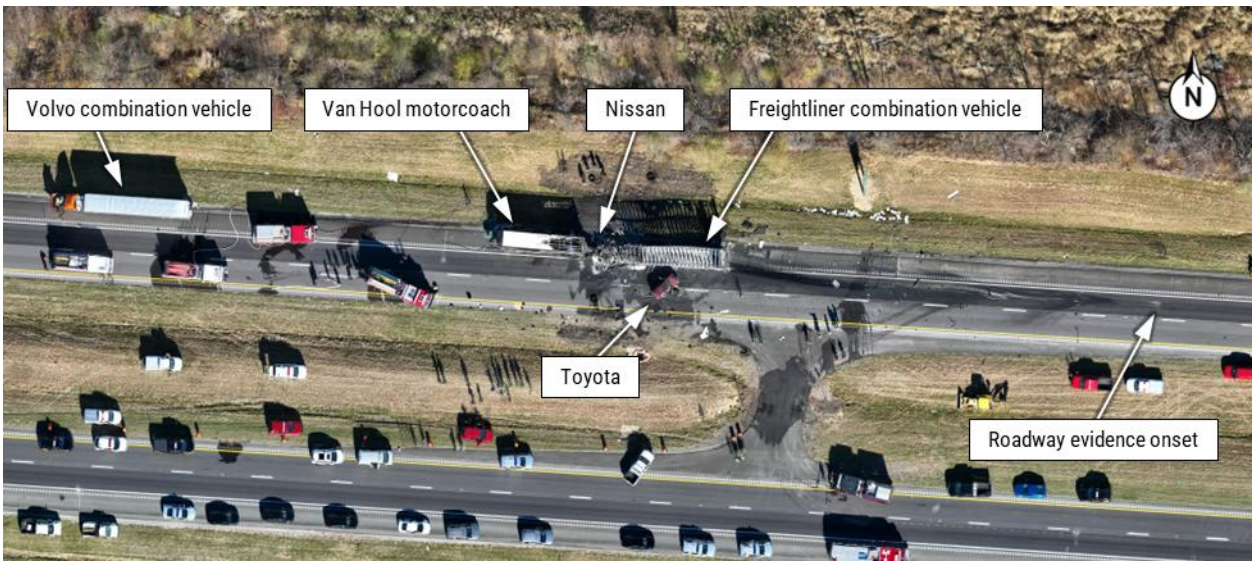
Figure 4. Overhead view of crash scene, vehicular positions of rest, and roadway evidence. (Source: Ohio State Highway Patrol; annotated by NTSB)

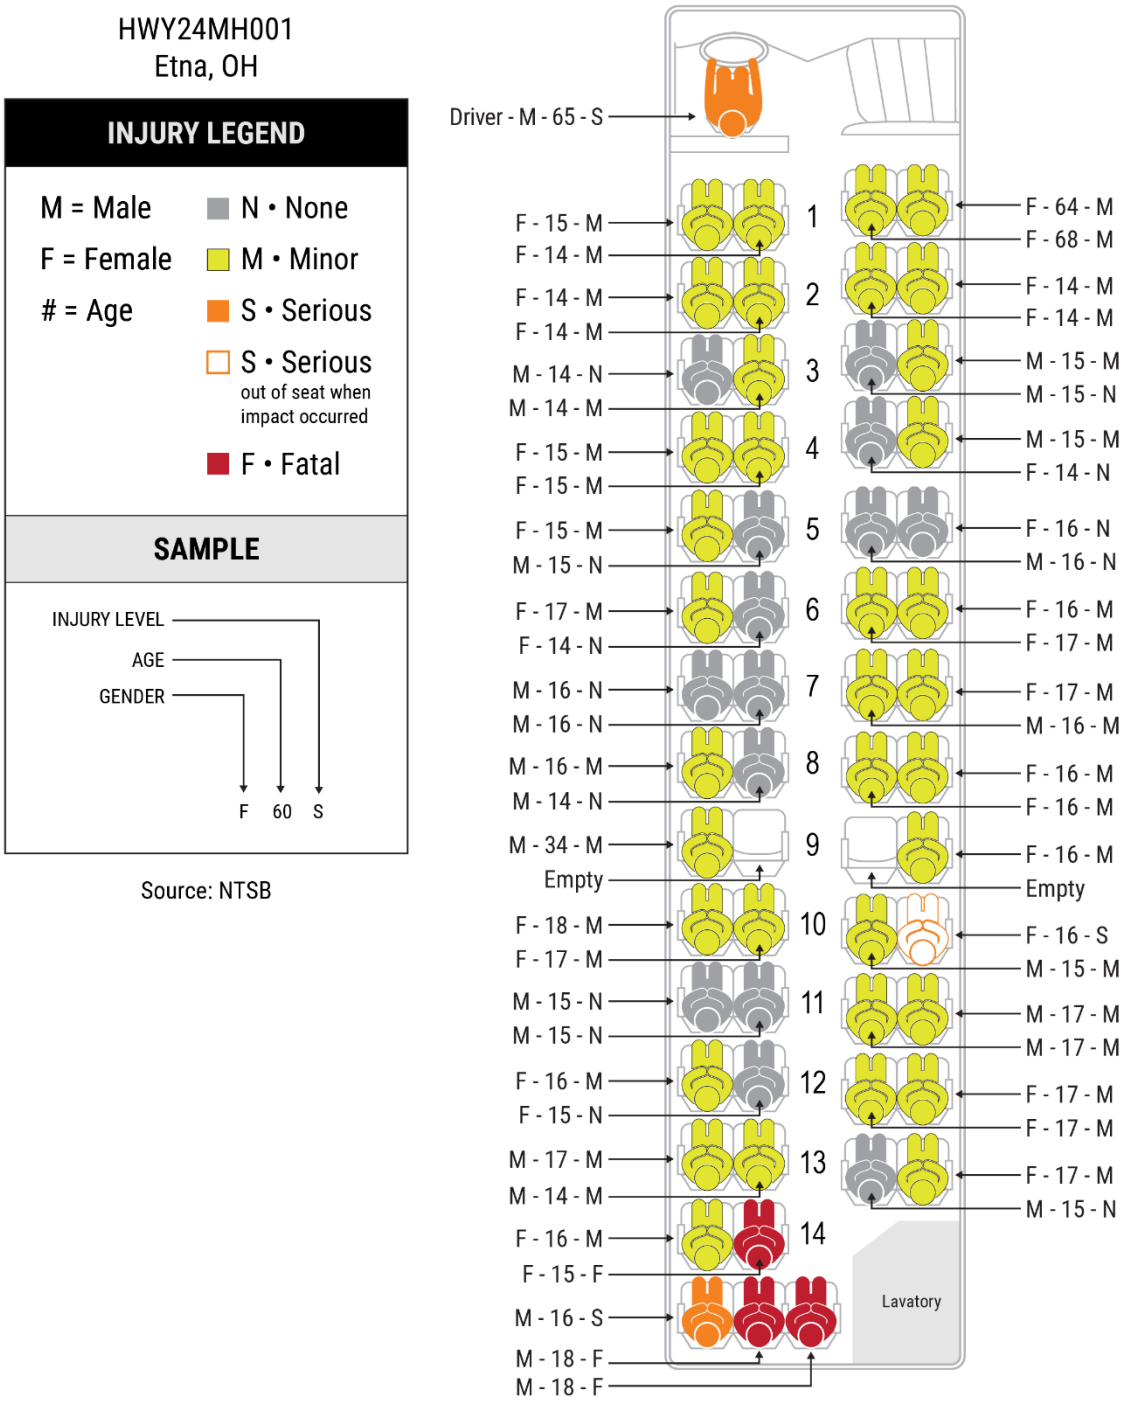
Figure 6. Motorcoach seating chart showing occupant injury severity.

One of the fatally injured motorcoach passengers, who was seated in the middle seat of row 15, sustained blunt force trauma to the torso and head. He was extricated from the motorcoach and given CPR. The other two fatally injured occupants, seated in rows 14 and 15, sustained blunt force trauma injuries to their

One surviving motorcoach occupant was initially seated in row 10 on the right side but was walking to the lavatory and attempting to open the door when the impact occurred. She sustained first-degree burns. Several students were evaluated but were determined not to have smoke inhalation injuries.

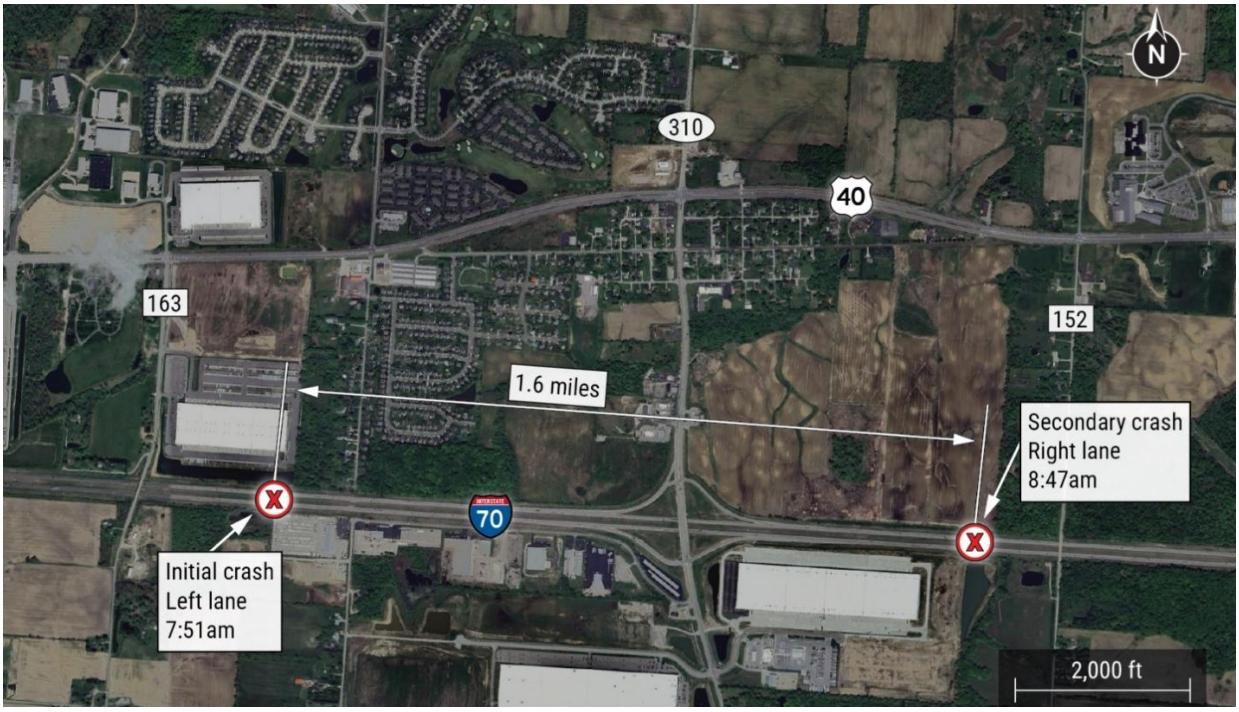
The 8:47 a.m. crash occurred at the end of a traffic queue that had formed due to an earlier crash involving only property damage that took place near milepost 117.2 (see figure 7). The initial crash, which occurred almost an hour earlier at 7:51 a.m., was a rear-end crash that involved four vehicles in the left lane, including one combination vehicle. All vehicles had been moved out of the travel lanes when an OSHP trooper arrived on scene at 8:14 a.m. Figure 8 shows the locations of the vehicles from the initial crash occupying the left shoulder and median. The vehicles were nearly on the solid yellow edge line and inches away from traffic traveling in the left lane of westbound I-70. Because all vehicles had moved out of the travel lanes before the OSHP trooper's arrival, the trooper pulled behind the vehicles in the median immediately after arriving at the scene and neither of the westbound lanes were blocked.

Figure 7. Locations of initial and secondary crashes on westbound I-70. (Source: Google Earth; annotated by NTSB)

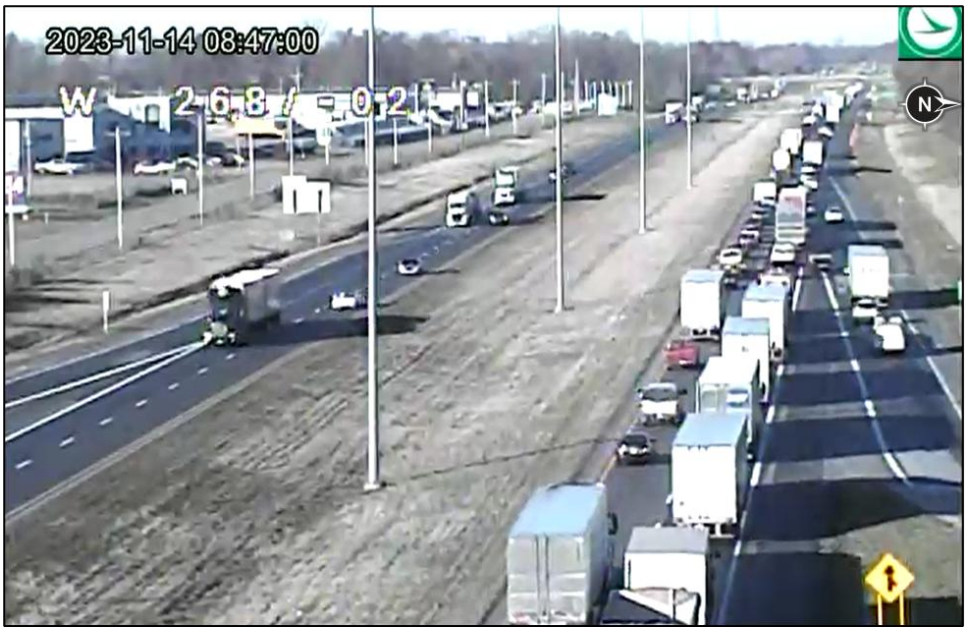
Although the vehicles involved in the initial crash were moved from the travel lanes in less than 30 minutes, a traffic queue formed. ODOT provided the NTSB with camera footage showing I-70 at the State Highway 310 interchange from 7:00 a.m. until 10:00 a.m. on November 14, 2023. (Figure 7 shows a map indicating the I-70–State Highway 310 interchange.) Figure 9 shows a still image of the camera footage at 8:47 a.m., looking west toward the location of the initial crash, which occurred about 1 mile west of State Highway 310. The 8:47 a.m. crash occurred about 0.6 miles east of State Highway 310.

Figure 9. Image from ODOT traffic camera footage, looking west and showing the traffic queue on I-70 at the State Highway 310 interchange at 8:47 a.m. on November 14, 2023. (Source: ODOT)

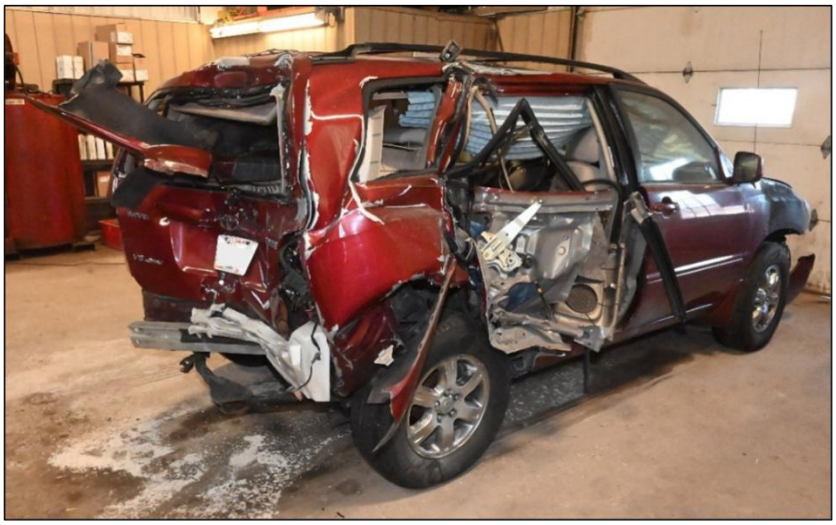
The 2006 Toyota Highlander passenger vehicle, which was traveling in front of the motorcoach, was struck at its right-rear corner by the left front of the motorcoach. The rear lift gate, bumper, and right-rear corner panel were crushed forward (see figure 14). The exterior door panel for the right-side rear passenger door was missing and the door was crushed. The Toyota also sustained minor fire damage.

Figure 14. Damage to rear of Toyota.
