Hazard Analysis and Mitigation Report

Aldyl A Polyethylene Gas Pipelines

Hazard Analysis & Mitigation Report On Aldyl A Polyethylene Gas Pipelines in California

Steven Haine, P.E.
California Public Utilities Commission

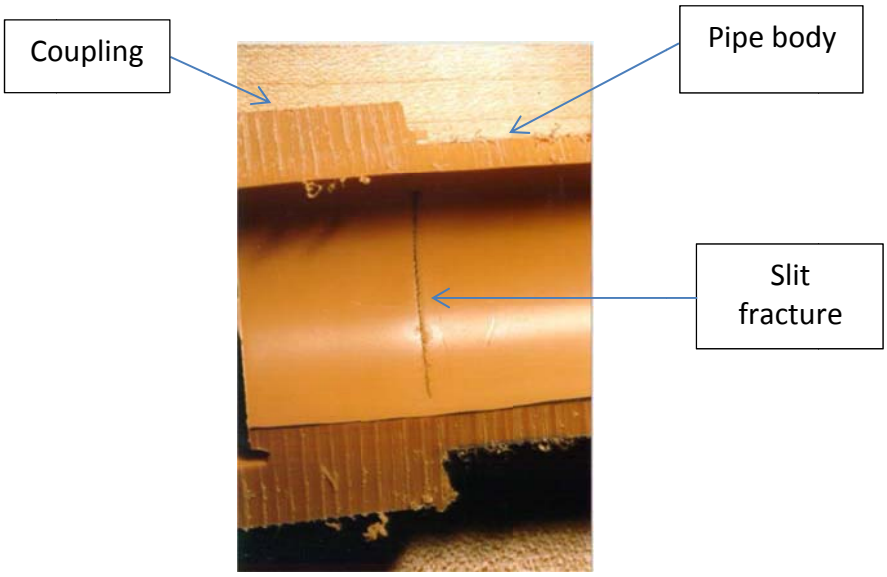
Figure 1: Enlarged view showing slit fracture on the interior of 1¼ Inch Aldyl A service pipe involved in the San Juan incident
