Issued: April 22, 2026 Railroad Investigation Report: RIR-26-05

Southeastern Pennsylvania Transportation Authority End-of-Track Collision

Location	Norristown, Pennsylvania
Date	May 11, 2025
Accident type	End-of-track bumping post collision
Train	Single railcar light rail vehicle 153
Crew and passengers	1 operator 15 passengers
Track	Transit track, signalized
Fatalities	0
Injuries	10 minor, including the operator; 2 serious
Property damage	$920,000

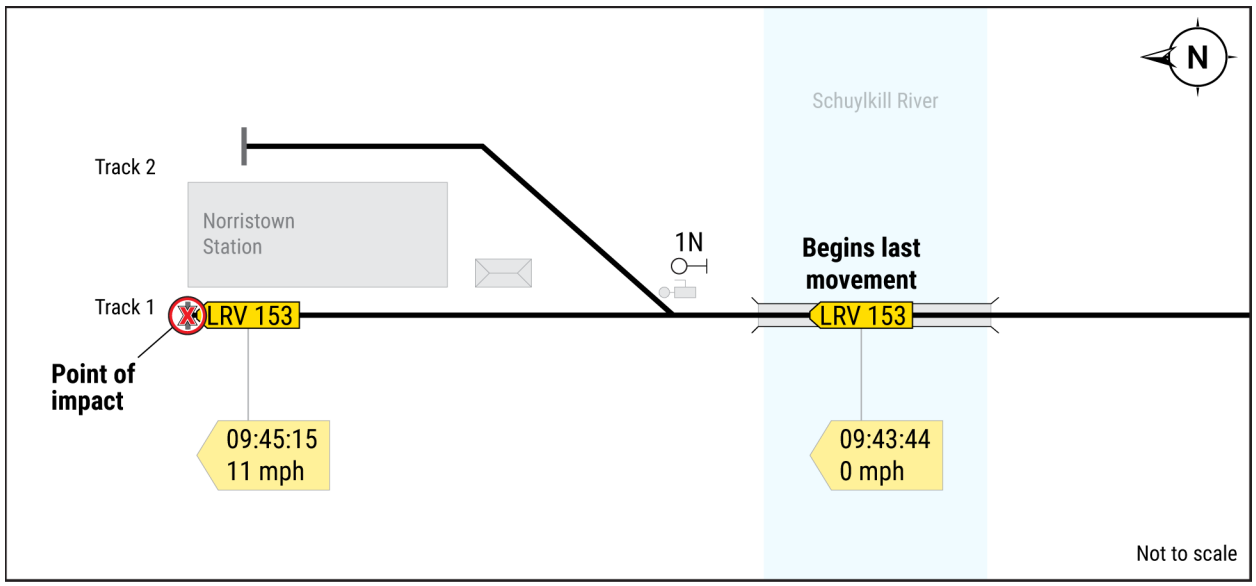
Figure 3. Diagram of LRV153's final movement.

Shortly before the accident, the LRV 153 operator stopped on the bridge and obtained dispatcher permission to proceed. He began his approach to the station at 9:43:44 a.m. During this movement, LRV 153 reached a maximum speed of 13 mph, and the event recorder showed the operator using master controller positions P1 and P2.[4] When the LRV passed the departure signals south of the platform, its speed remained steady at 11 mph with the event recorder showing the master controller in position P2.

[4] (a) The maximum authorized speed in the area was set by timetable at 15 mph. (b) A *master controller* is a combined throttle and brake control. On the type of LRV involved in this accident, the master controller is a lever with throttle positions P1–4 and brake positions B1–7 plus Emergency (maximum braking effort). (c) Postaccident tests of the event recorder on LRV 153 found that the master controller's positions P3 and P4 were being recorded as P2.

The event recorder did not record a brake application or other control manipulations before the collision with the bumping post at 9:45:15 a.m. The LRV's final movement is summarized in figure 3.
