Aviation Investigation Final Report

Location:	Houma, Louisiana	**Accident Number:**	CEN22LA430
Date & Time:	September 24, 2022, 18:11 Local	**Registration:**	N811TA
Aircraft:	Agusta AW139	**Aircraft Damage:**	Substantial
Defining Event:	Electrical system malf/failure	**Injuries:**	6 None
Flight Conducted Under:	Part 135: Air taxi & commuter - Non-scheduled

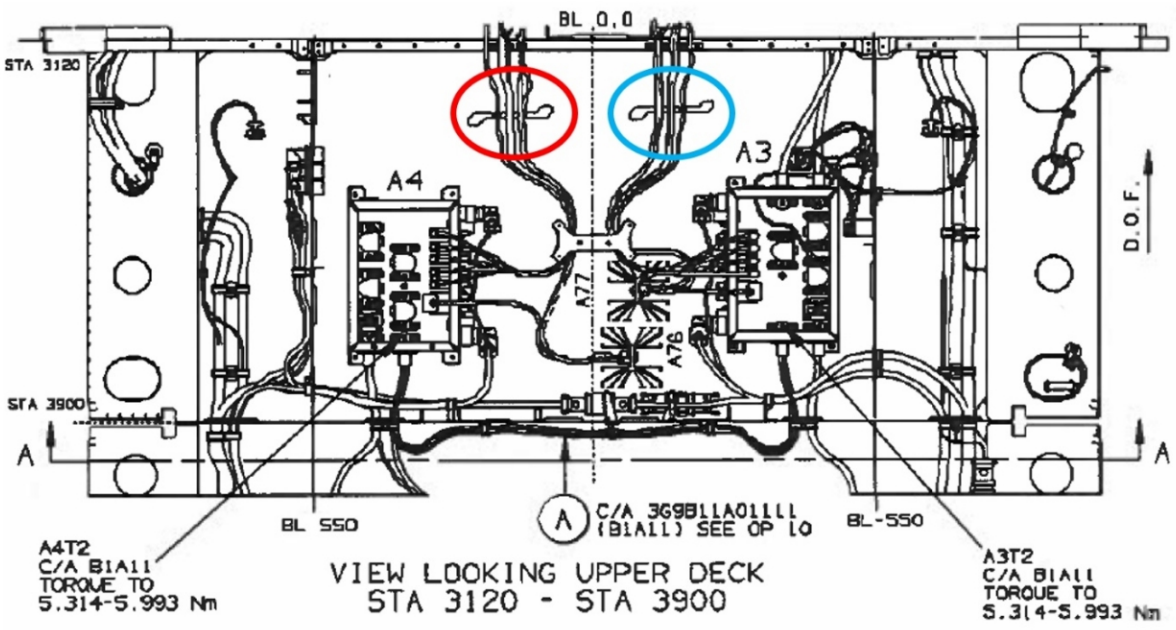
When the helicopter was assembled, the Completion and Finishing of Power C/A Card, No. 3G0630A04112C4R, contained instructions on the installation and routing of electrical power cables from the cockpit nose area to the cabin roof and subsequently to the power distribution panels. Figure 1 is a drawing excerpt from the job card depicting the cable routing in the cabin roof.

Figure 1. A drawing excerpt from the "Completion and Finishing of Power C/A Card" showing the power cable routing on the cabin roof with left and right wiring support strip assemblies. (Courtesy of Leonardo Helicopters, modified by NTSB)

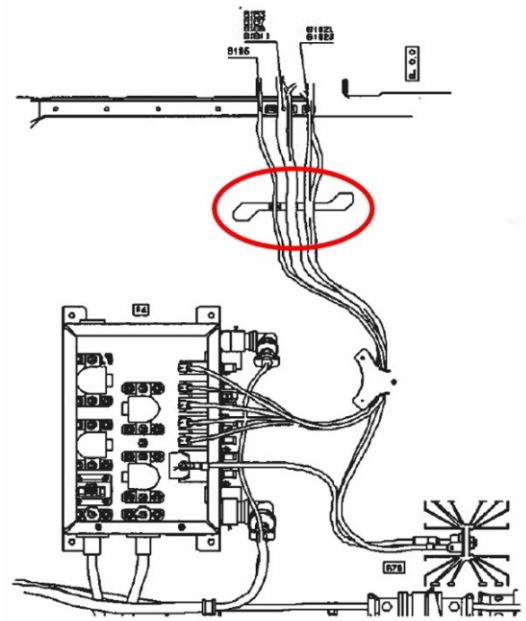
The assembly cards contained views of the left and right wiring support strip assemblies installed with power cables routed through them. In the views looking upwards (from within the cabin), the power cables were depicted as solid lines with the strip assemblies as solid lines behind them, implying that routing of the power cables were under the strip assemblies, as shown in Figure 2 and Figure 3. The shape of the left and right strip assemblies was identical on the assembly job card, despite the right strip assembly being a different shape than the left strip assembly. The assembly job cards provided no specific instruction to verify that the power cables were routed underneath the strip assemblies.

Figure 2. A detail excerpt from the Completion and Finishing of Power C/A Card showing the power cable routing under the right strip assembly. (Courtesy of Leonardo Helicopters, modified by NTSB)

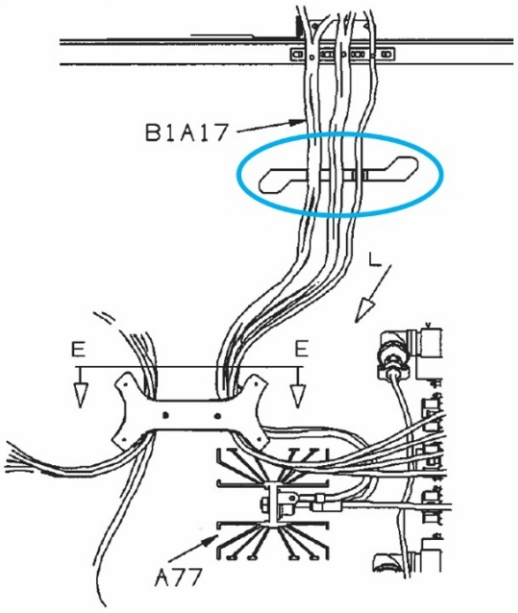
Figure 3. A detail excerpt from the Completion and Finishing of Power C/A Card showing the power cable routing under the left strip assembly. (Courtesy of Leonardo Helicopters, modified by NTSB)

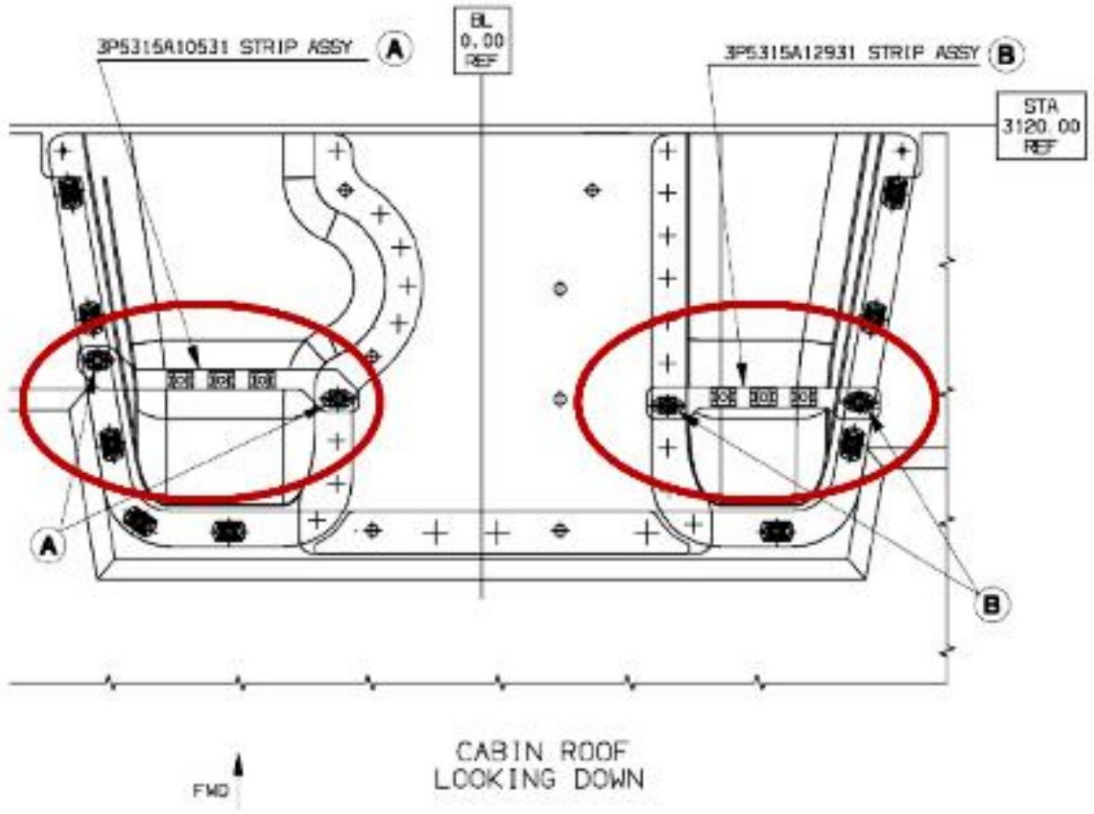
Figure 4. Diagram from 3NB Pax Ceiling Panel Closeout Job Card (Red ellipses were added for emphasis by NTSB)

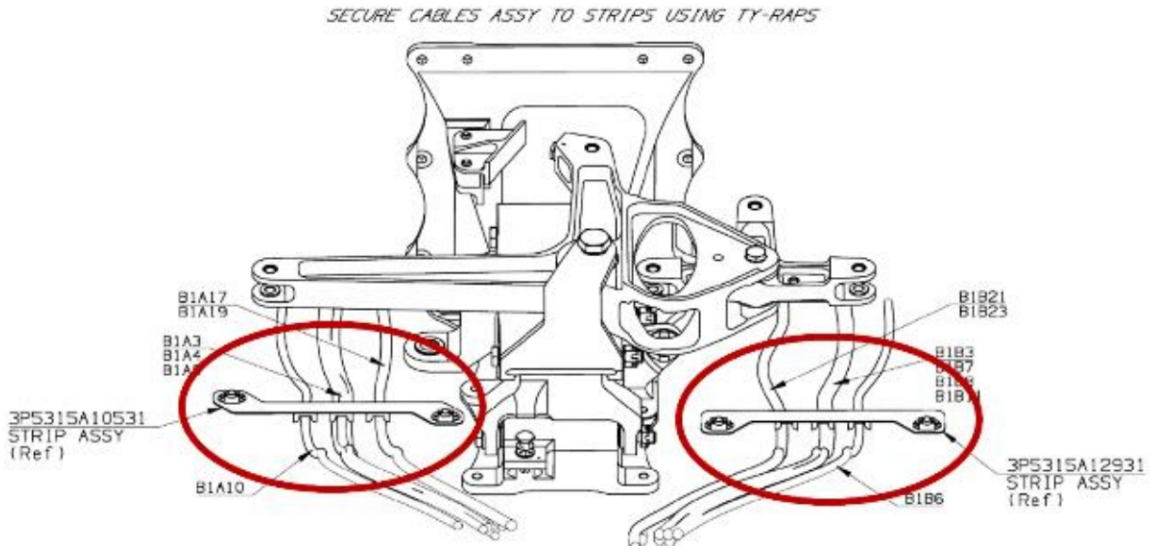
Figure 5. Diagram from 3NB Pax Ceiling Panel Closeout Job Card (Red ellipses were added for emphasis by NTSB)

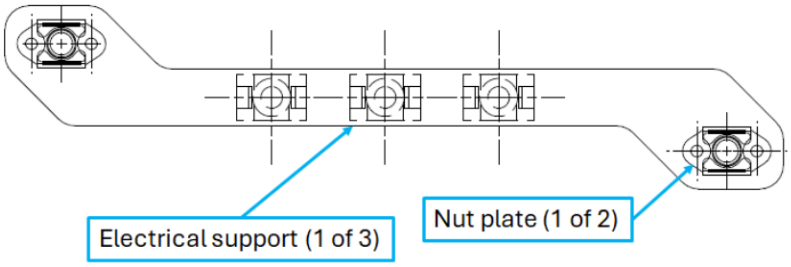
At the time of its manufacture, the manufacturing job card for the left-side wiring support strip assembly, No. 3P5315A10531, contained only a single planform view of the strip assembly, as shown in Figure 6. According to Leonardo Helicopters, the solid drawing lines for the nut plates (anchor nuts) versus the dashed drawing lines for the electrical supports implied that the electrical supports were mounted on the side opposite that of the nut plates.

Figure 6. The single view of the left strip assembly in its manufacturing job card. (Courtesy of Leonardo Helicopters, modified by NTSB)

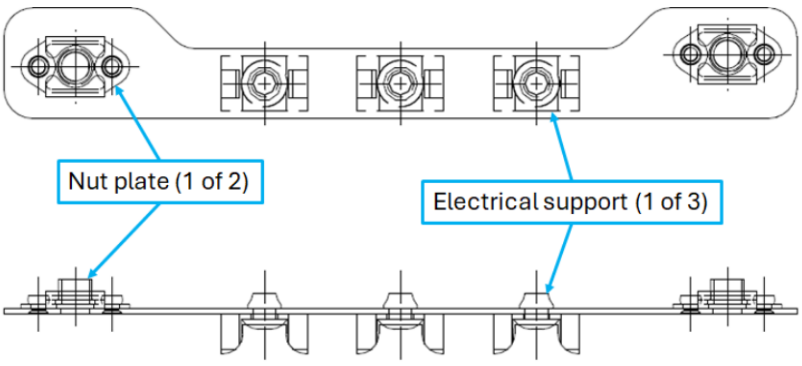
At the time of its manufacture, the manufacturing job card for the right-side wiring support strip assembly, No. 3P5315A12931, contained two views of the strip assembly, as shown in Figure 7. These two views of the strip assembly distinctly show that the electrical supports were mounted on the side opposite that of the nut plates.

Figure 7. The two views of the right strip assembly in its manufacturing job card. (Courtesy of Leonardo Helicopters, modified by NTSB)

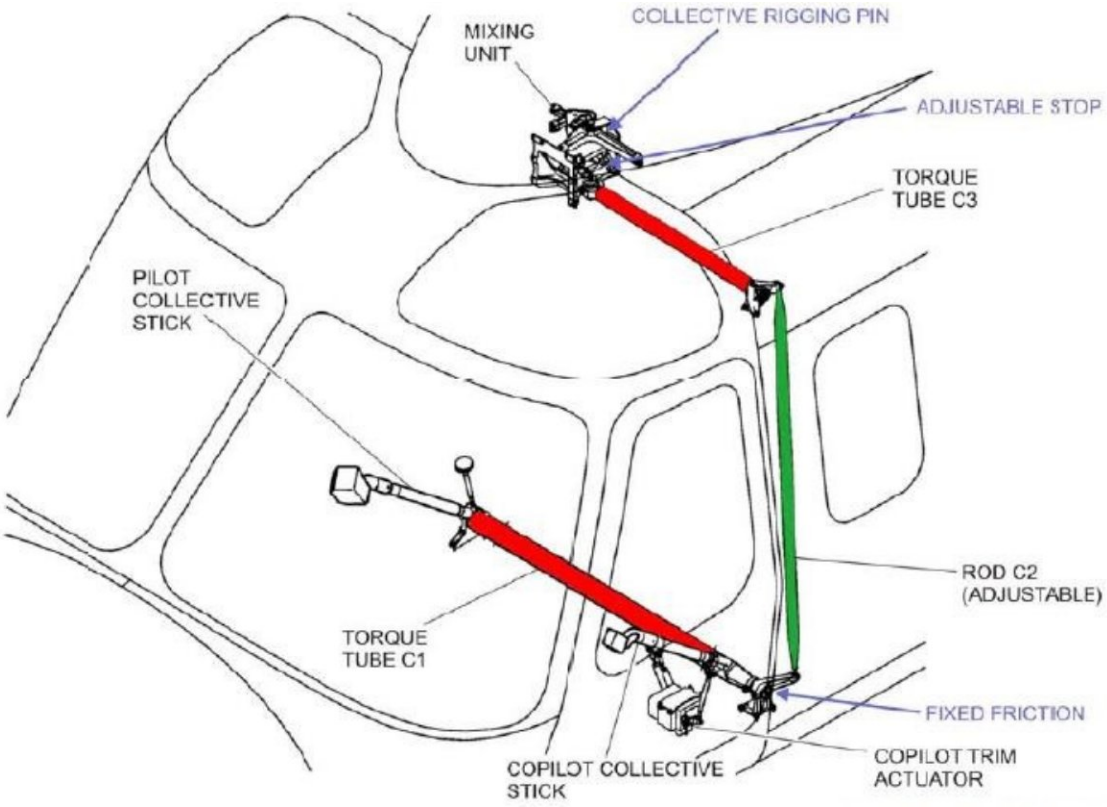
Figure 8. Collective Flight Controls

The pilot and copilot collectives are interconnected via the C1 torque tube located under the pilot seats, as shown in Figure 8. A single control rod, C2, runs vertically up the left side of the helicopter behind the left-seat pilot where it connects through a linkage to the C3 torque tube that runs laterally above and behind the right-seat pilot to the mixing unit.

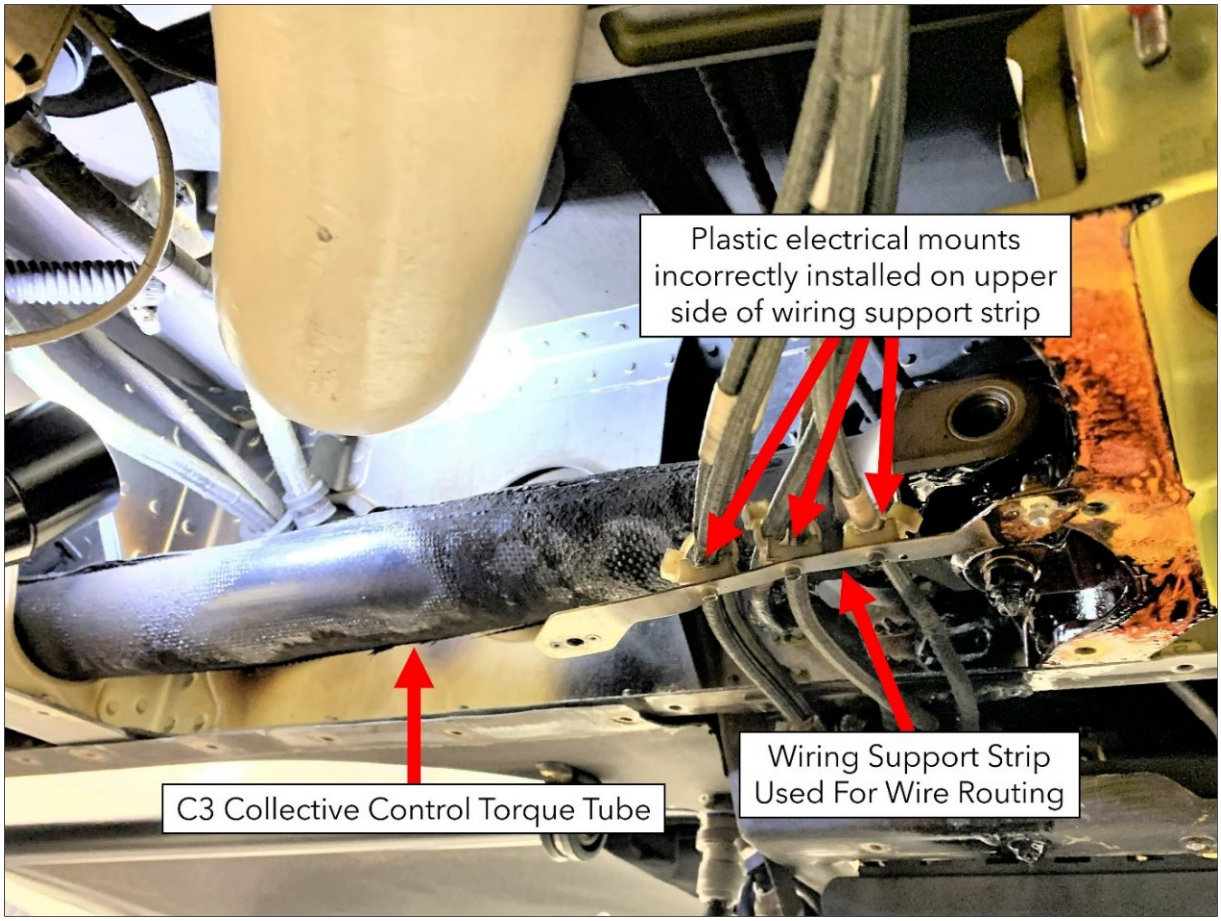
A visual examination revealed thermal damage and a longitudinal split of the C3 torque tube, as shown in Figure 9. The C3 torque tube was installed at both ends, with all fasteners installed and intact. A static test of the collective system without hydraulic pressure was conducted by moving the collective between the minimum and maximum pitch settings and observing the C3 torque tube. The outboard end of the C3 collective tube twisted while the inboard end by the mixing unit remained stationary with the C3 torque tube deformed torsionally along its length. The helicopter's cockpit flight controls are hydraulically-assisted via a dual hydraulic system; typically, the C3 torque tube does not rotate without hydraulic pressure engaged.

Figure 9. C3 collective torque tube and wiring support strip used for wire routing

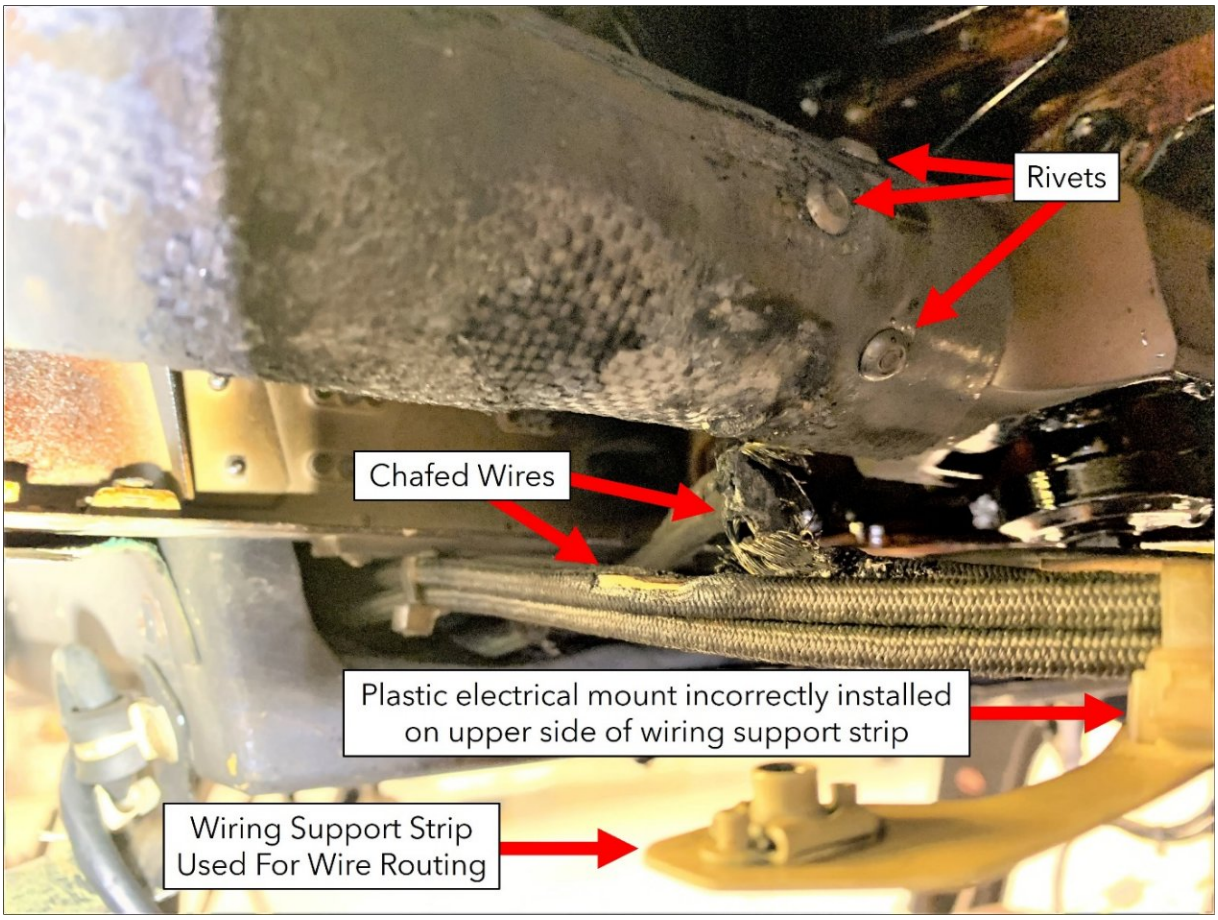
Electrical power to the helicopter is provided by two, 30 volt / 300 ampere direct current generators. Wire P190A6-G (p/n 3G9B11A1911) receives electrical power from the No. 1 generator through the T3 terminal on the No. 1 diode module and connects to the No. 5 distribution bar on the No. 1 essential bus in the cockpit overhead. Wire P190A6-G was found chafed through its insulation consistent with contact with the C3 collective torque tube, as shown in Figure 10. The chafed area was in line with a rivet line installed circumferentially on

the C3 torque tube, as shown in Figure 10 and Figure 11. In addition to melted resin from the C3 collective torque tube, soot was found laterally along the entire overhead and on the panels that covered the C3 torque tube.

Figure 10. Chafed wires and rivets on C3 collective torque tube

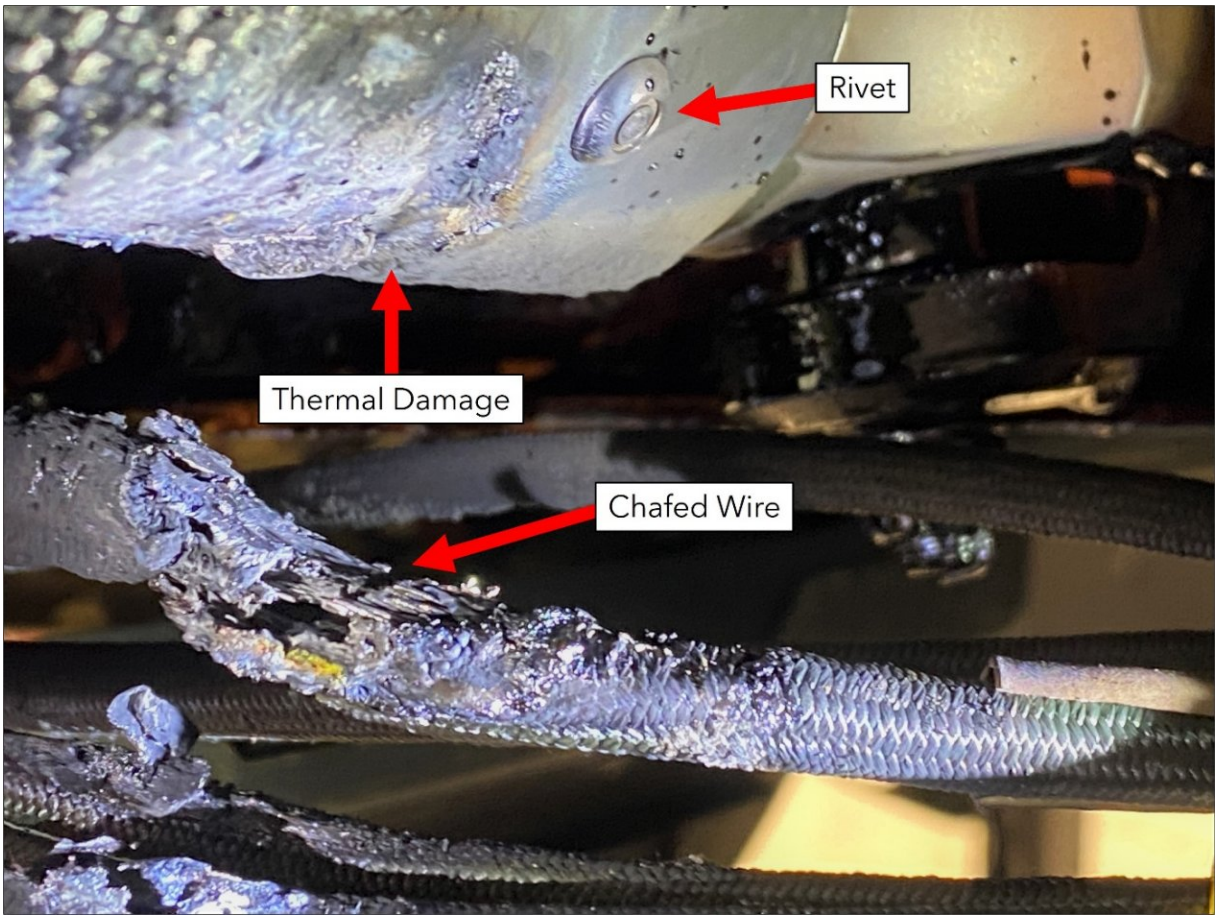
Figure 11. Chafed wires and thermal damage to C3 collective torque tube

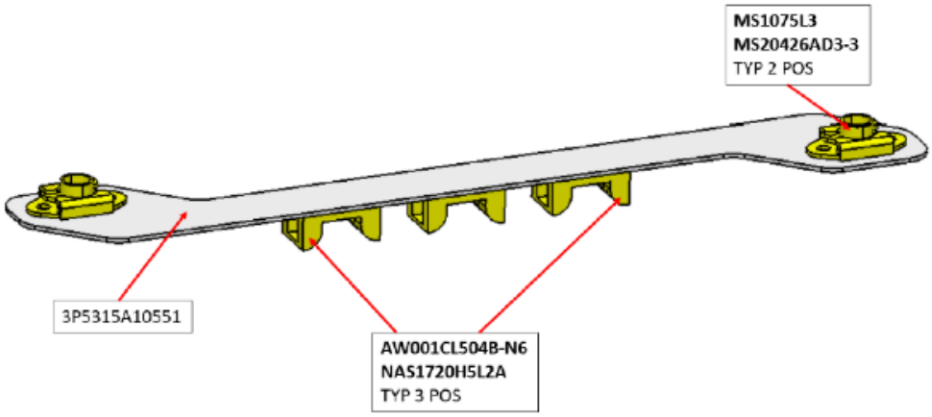
Figure 12. The 3D figure included with the updated strip assembly manufacturing card

The manufacturing job card, No. 3P5315A10531, was updated on October 24, 2022, to include a 3-dimensional (3D) graphic of the completed strip assembly, as shown in Figure 12.

The updated manufacturing card also includes the statement, "Note: Pay attention to correct assembly, the anchor nuts must be mounted on the side opposite to the electrical supports."

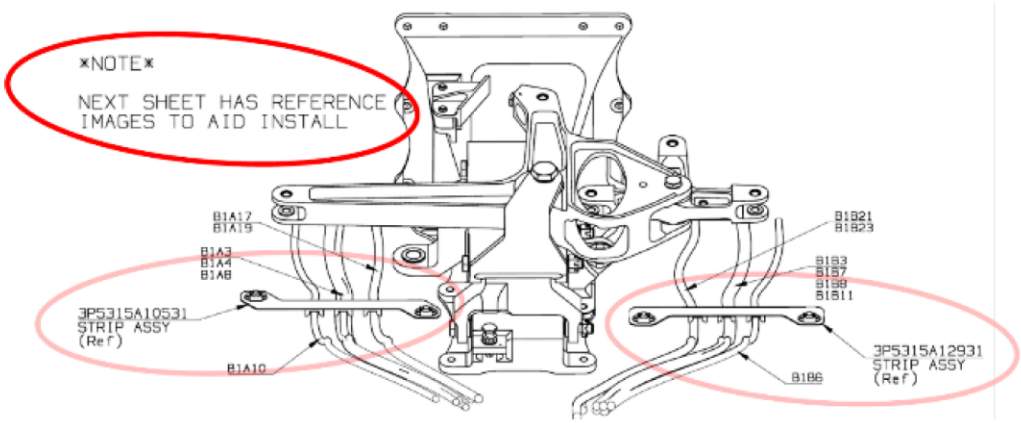
Figure 13. Updated diagram used in Production Assembly Job Card No. 3P5333A00134C1. Pale red ellipses depict the previous job card updates; dark red ellipses depict the Version 9 card revision.

Additionally, revisions to the Production Assembly 3NB Pax Ceiling Panel Closeout Job Card, No. 3P5333A00134C1, now include a note (Figure 13) and a reference photo (Figure 14) showing proper wiring routing below the support strips.

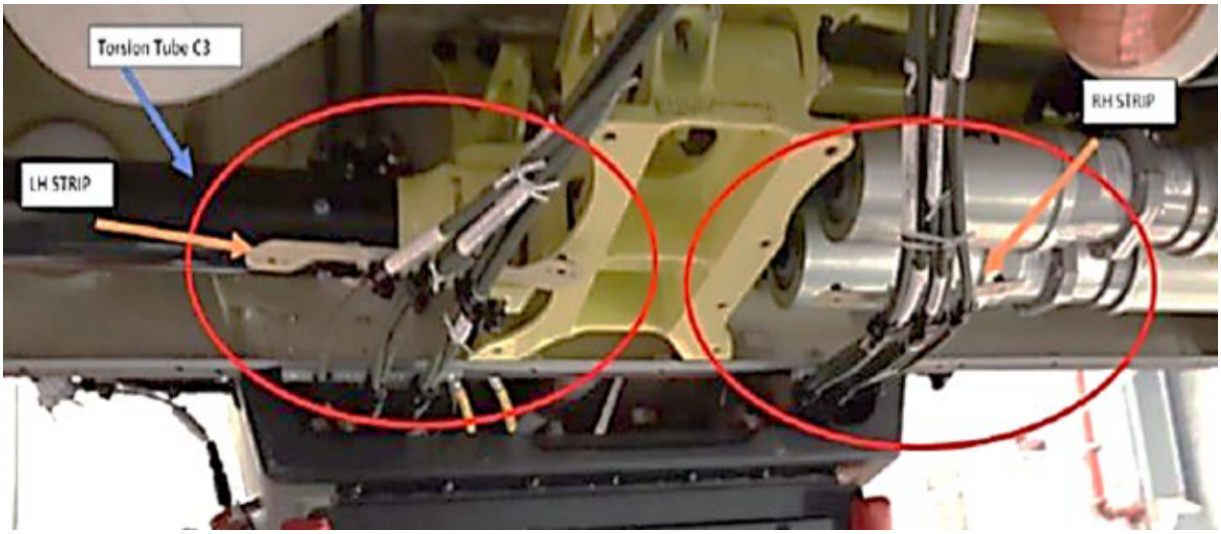
Figure 14. Reference photo included in Production Assembly Job Card No. 3P5333A00134C1, to aid installation of wiring. The reference photo was cropped by NTSB to show the specific area where the wiring support strips are located.
