Aviation Investigation Final Report

Location:	Provo, Utah	**Accident Number:**	WPR23FA080
Date & Time:	January 2, 2023, 11:35 Local	**Registration:**	N555NR
Aircraft:	EMBRAER EXECUTIVE AIRCRAFT INC EMB-505	**Aircraft Damage:**	Substantial
Defining Event:	Structural icing	**Injuries:**	1 Fatal, 2 Serious, 1 Minor
Flight Conducted Under:	Part 91: General aviation - Personal

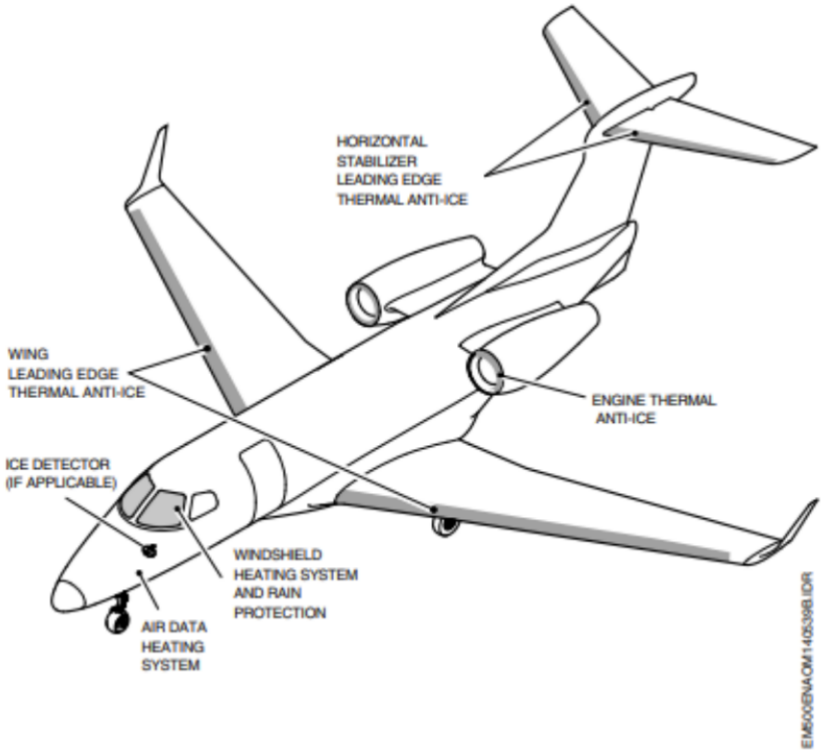
The airplane was equipped with a Wing and Horizontal Stabilizer Anti-Icing System (locations depicted in figure 1), which was designed to prevent ice formation and remove any ice formed on the leading edges of the wing and the horizontal stabilizer. The system was activated by a 3-position “Wing Stab” switch on the ice protection panel, which is located just below the lower right corner of the left primary flight display.

Figure 1: Airframe Ice and Rain Protection System Deice Systems (Source: Phenom 300 Pilot's Operating Handbook, Volume 1)

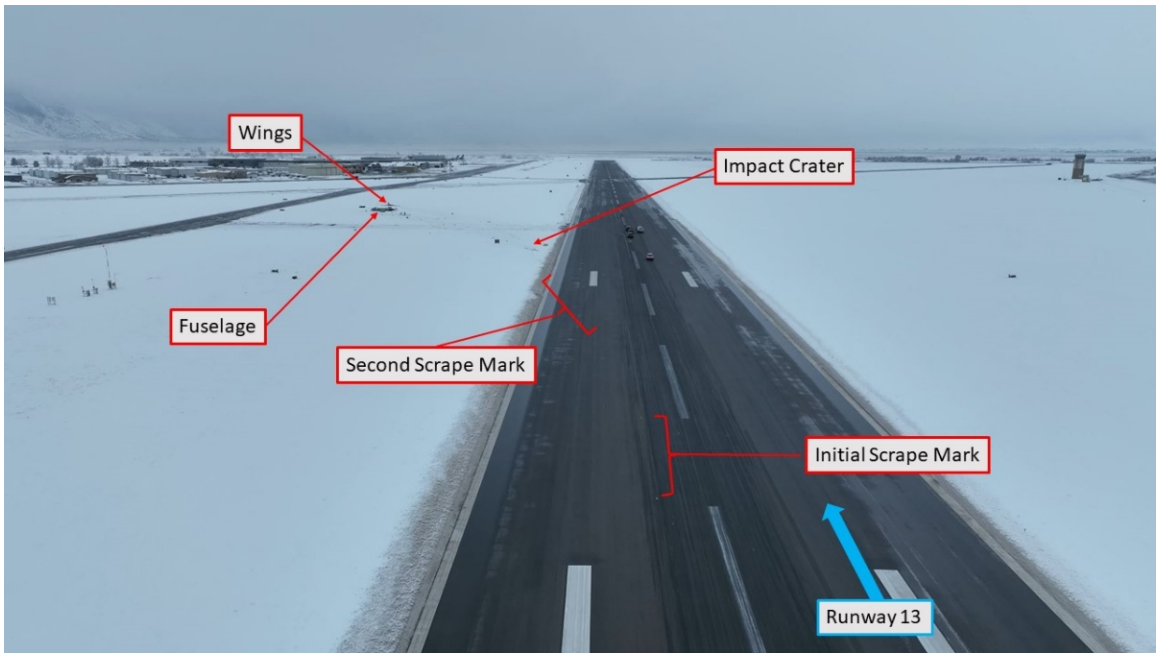
Investigators arrived onsite about 23 hours after the accident, and about 4 to 6 inches of fresh snow had fallen, masking impact marks, ground scars, and debris. Examination of the accident site revealed that the airplane impacted the runway surface about 2,626 ft from the approach end of runway 13 and about 20 ft left of the runway centerline. A scrape mark extended about 91 ft and was parallel to the runway centerline.

A second scrape mark was observed about 2,903 ft from the approach end of runway 13, and arced left to the left edge of the runway surface about 3,126 ft from the approach end of the runway. A swath of displaced snow and dirt extended from the runway's left edge about 100 ft to a large impact crater. The crater contained portions of airframe debris and various airframe components. Wreckage debris extended from the crater about 597 ft to the fuselage. The wings were separated from the airframe and were located about 106 ft beyond the fuselage. Both engines were separated and located adjacent to the fuselage.

Figure 2: Aerial overview of the accident site. Image courtesy of Provo Police Department with NTSB annotations.
