Aviation Investigation Final Report

Location:	Naples, Florida	**Accident Number:**	ERA24FA110
Date & Time:	February 9, 2024, 15:11 Local	**Registration:**	N823KD
Aircraft:	BOMBARDIER INC CL-600-2B16	**Aircraft Damage:**	Destroyed
Defining Event:	Powerplant sys/comp malf/fail	**Injuries:**	2 Fatal, 4 Minor
Flight Conducted Under:	Part 135: Air taxi & commuter - Non-scheduled

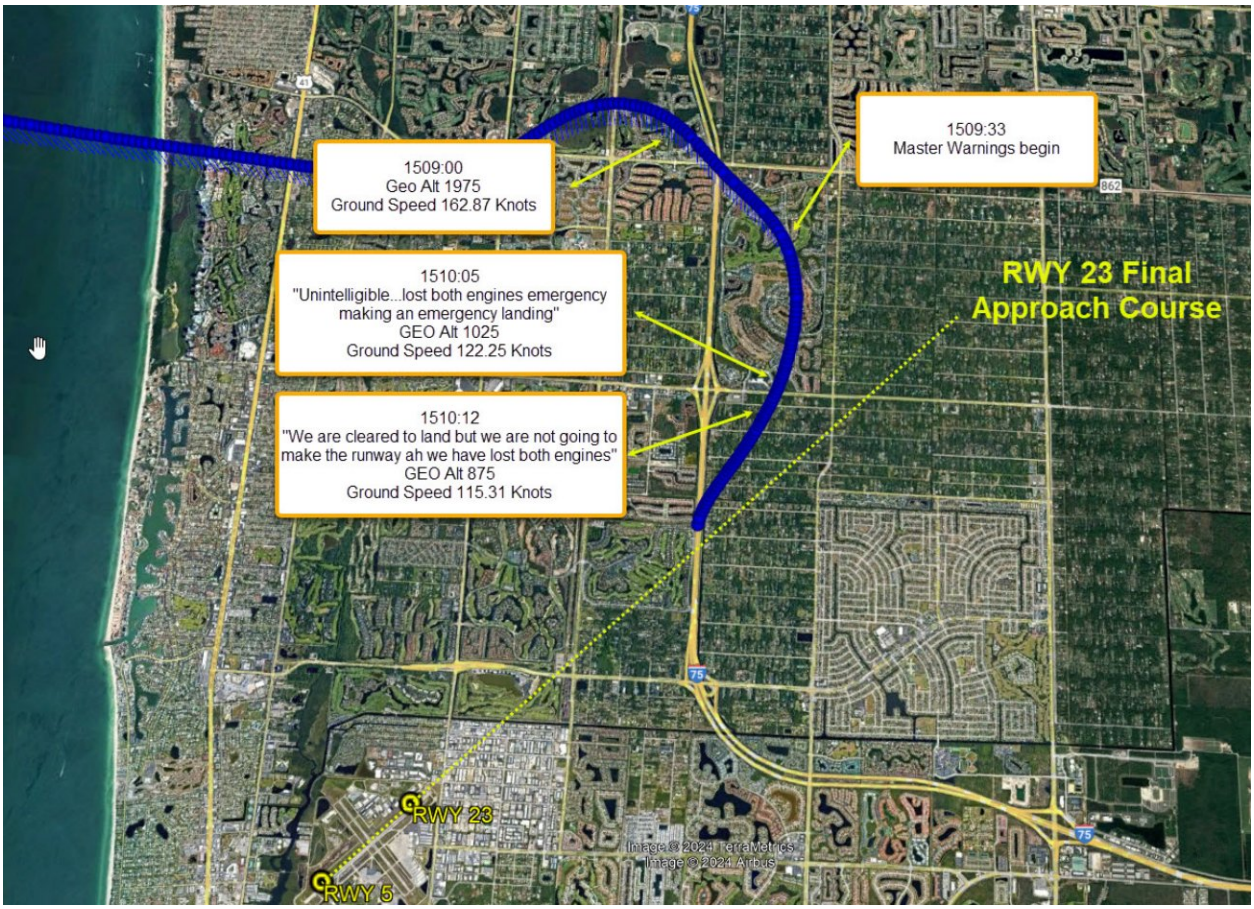
Twenty-three seconds later, at 1510:03, about 1,000 ft pressure altitude and 122 kts, on a shallow intercept angle for the final approach course, the crew announced, "…lost both engines… emergency… making an emergency landing" (see figure 1). The tower controller acknowledged the transmission and cleared the airplane to land. At 1510:12, about 900 ft and 115 kts, the crew replied, "eh we're clear to land but we're not gonna make the runway uh we've lost both engines."

Figure 1. ADS-B ground track (blue dots) with annotations of specific events during the approach, including time and the airplane's geometric altitude and ground speed (source: FAA).
