Aviation Investigation Final Report

Location:	Los Angeles, California	Incident Number:	DCA201A034
Date & Time:	December 4, 2019, 19:15 Local	Registration:	N71HD
Aircraft:	Airbus AS 350 B2	Aircraft Damage:	Minor
Defining Event:	Midair collision	Injuries:	3 None
Flight Conducted Under:	Part 91: General aviation - Aerial observation

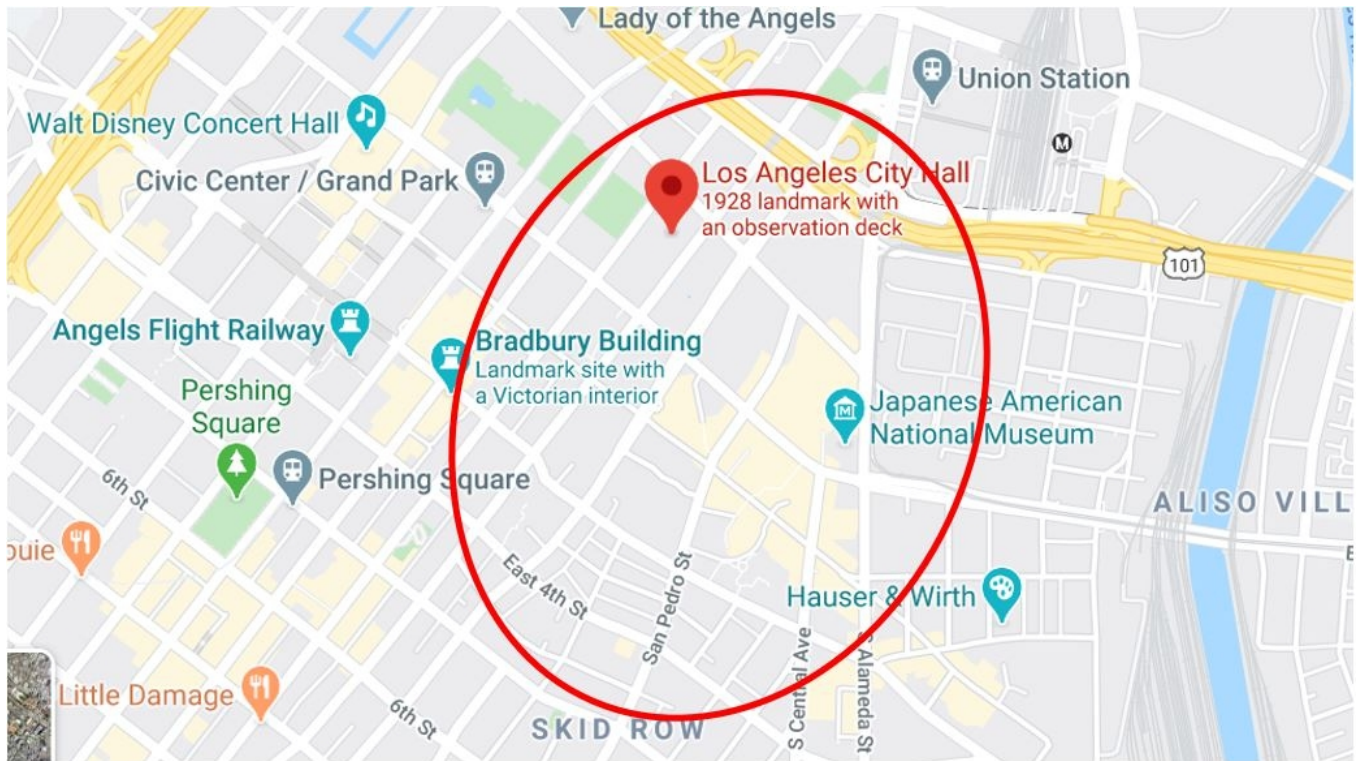
Figure 1 – Reported area of collision

He described the area of the event as east of City Hall bounded by Los Angeles St, Alameda St, Cesar Chavez Ave, and East 2nd St. This location was passed on to the Los Angeles Police Department to conduct a search of the area. No drone was found.

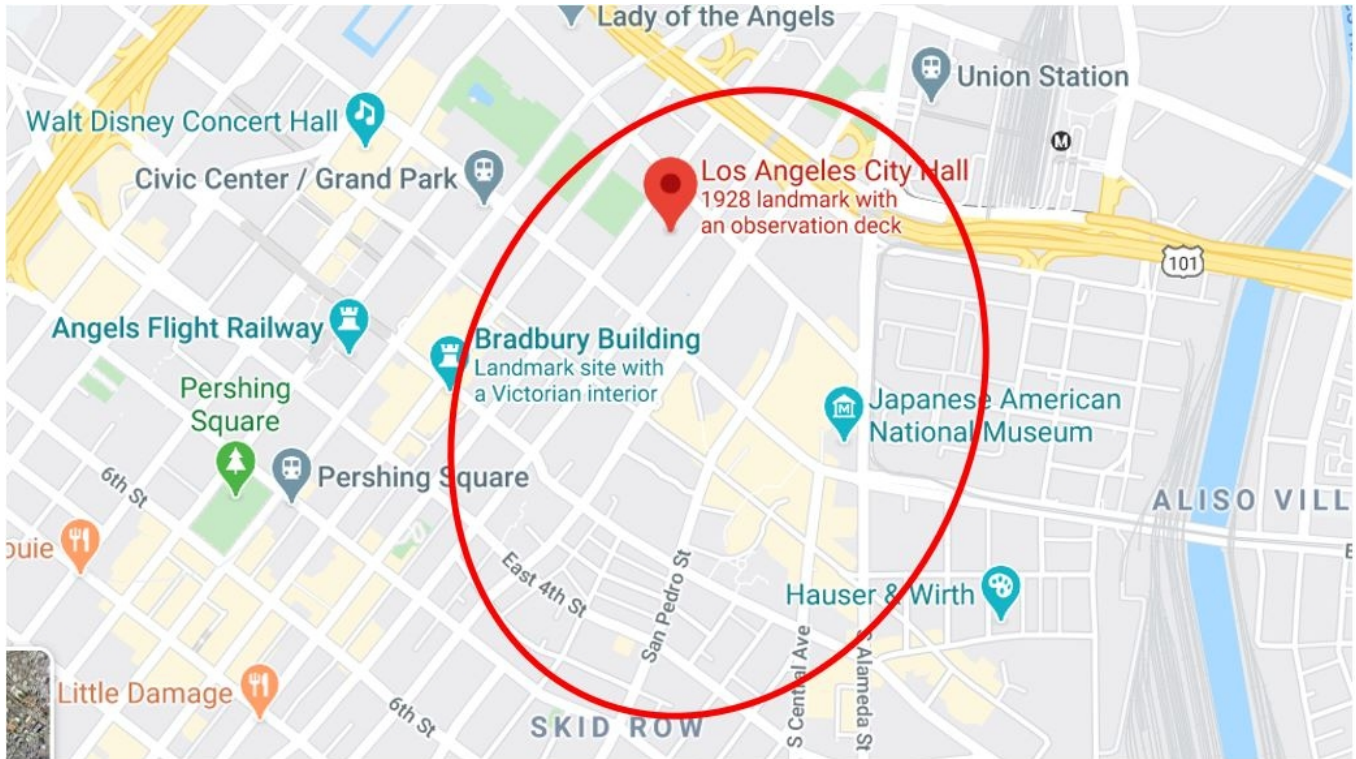
Figure 1 – Reported area of collision

He described the area of the event as east of City Hall bounded by Los Angeles St, Alameda St, Cesar Chavez Ave, and East 2nd St. This location was passed on to the Los Angeles Police Department to conduct a search of the area. No drone was found.
