Is Automated Driving Part of a Safe System Approach?

Member Michael Graham

April 3, 2023

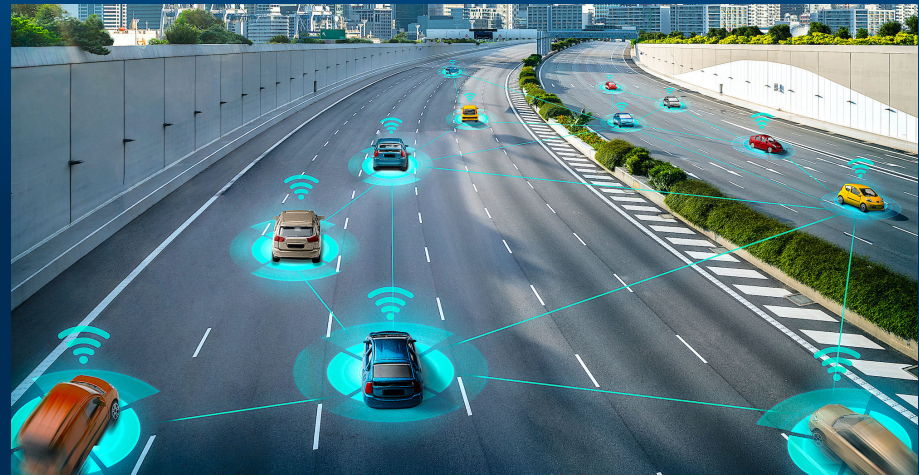
V2X Technology

- Camera, lidar, radar, etc. deployed in vehicles today will be used in AVs
- We must get this right to achieve widespread deployment of AVs
- AV industry so far unable to overcome limitations of onboard sensors
- V2X technology, through direct communication, is not limited by line of sight, inclement weather, or unexpected orientation of a vehicle
- V2X could provide solution for AV industry

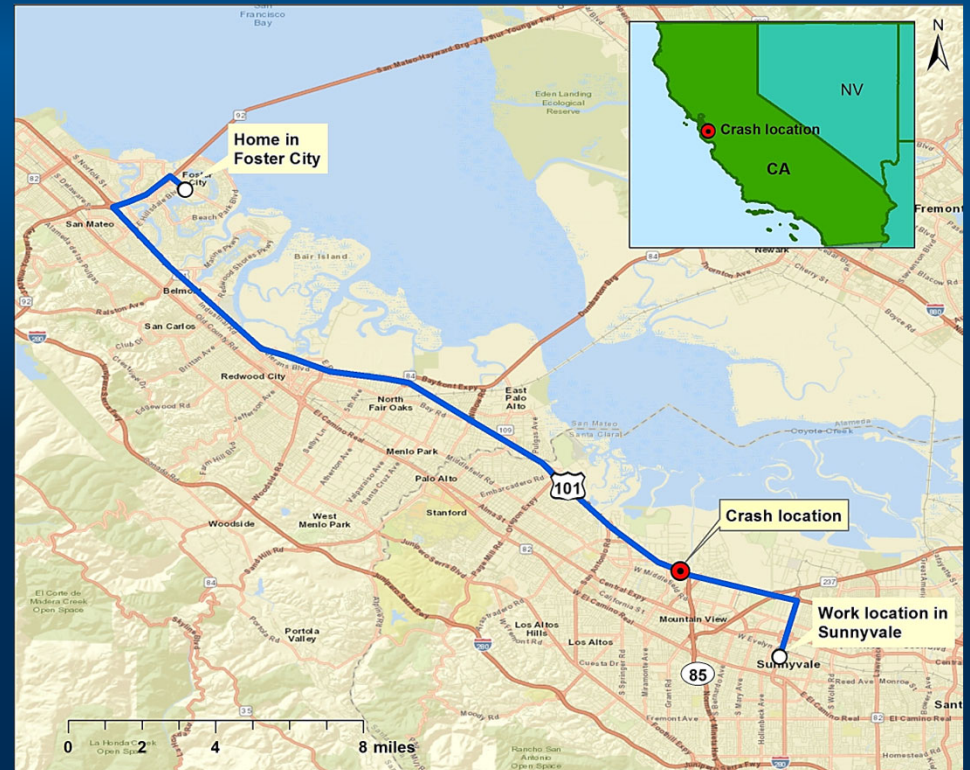
- Friday, March 23, 2018
- 9:27 a.m.
- Mountain View, California
- US-101 / SR-85 interchange
- 2017 Tesla Model X SUV
- 38-year-old driver
- Partial automation “Autopilot” engaged

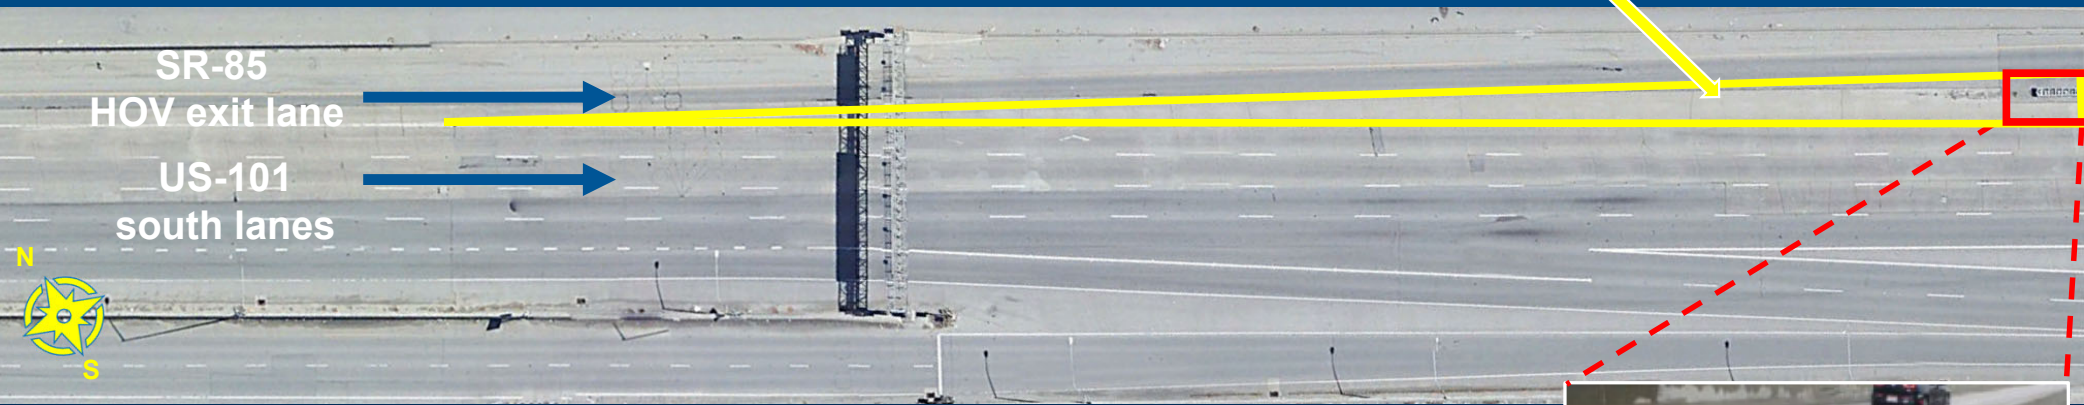
Crash Sequence

Crash attenuator was collapsed and nonoperational prior to the crash

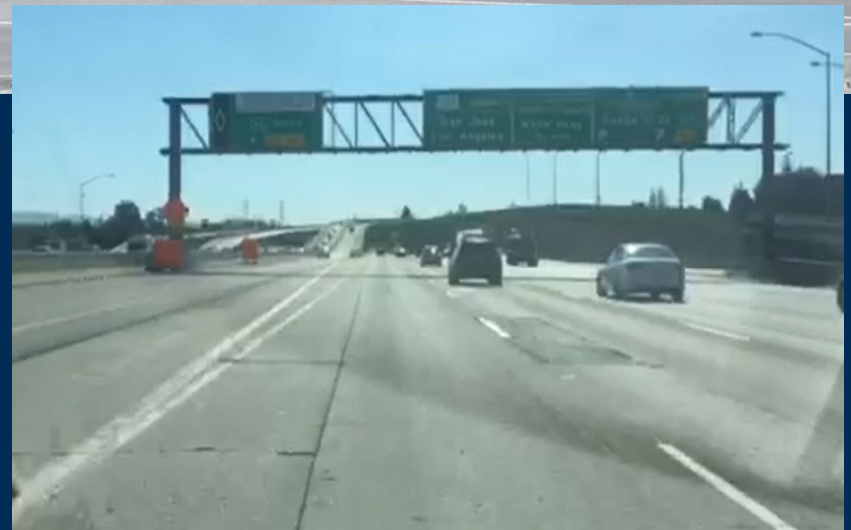
Time to crash: 7.9 seconds
Speed: 64.3 mph
Lead vehicle: 83.7 feet
Distance to crash: 748 feet

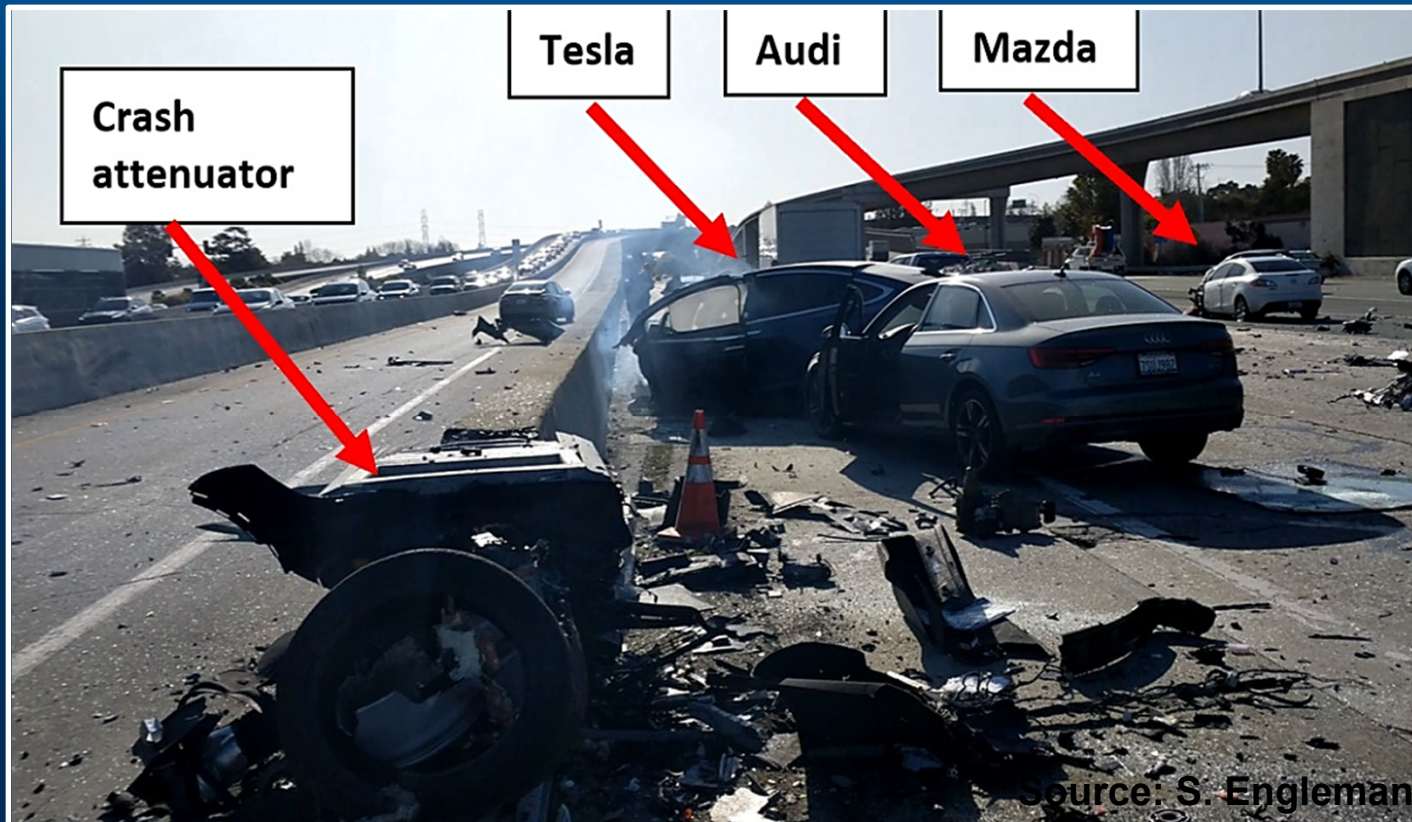
Crash Sequence

Impact speed: 70.8 mph

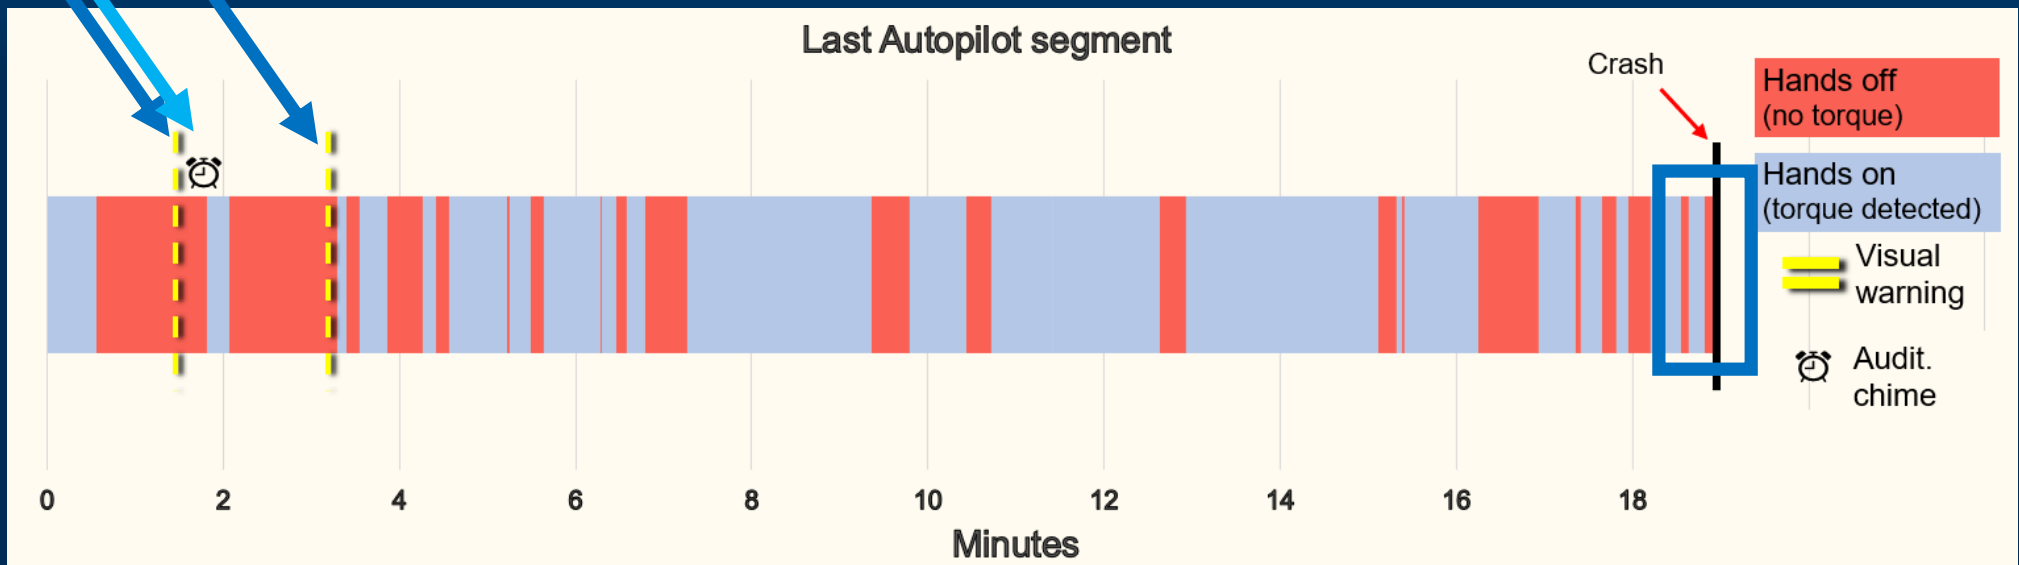
Driver Engagement

- The crash trip lasted 28.5 minutes
- Lack of response awareness, indicated by distraction and overreliance on automation
- Autopilot was engaged for the last nearly 19 minutes

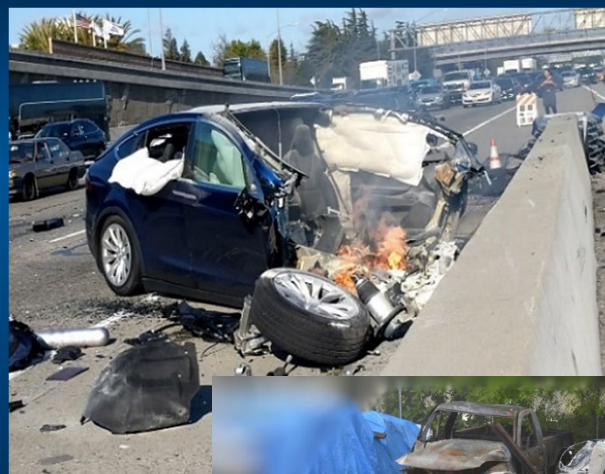
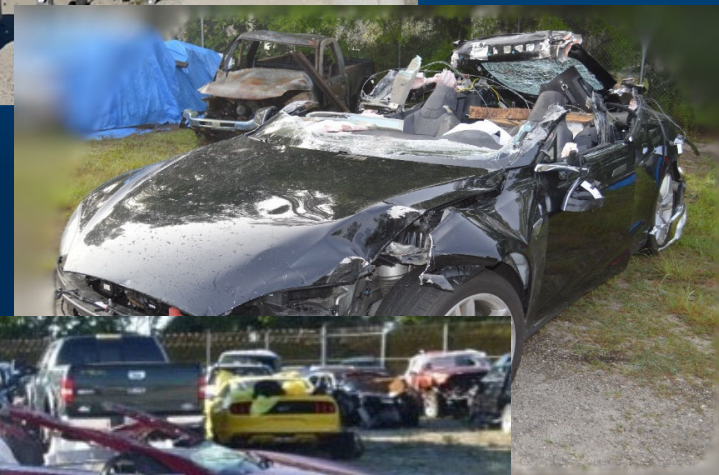
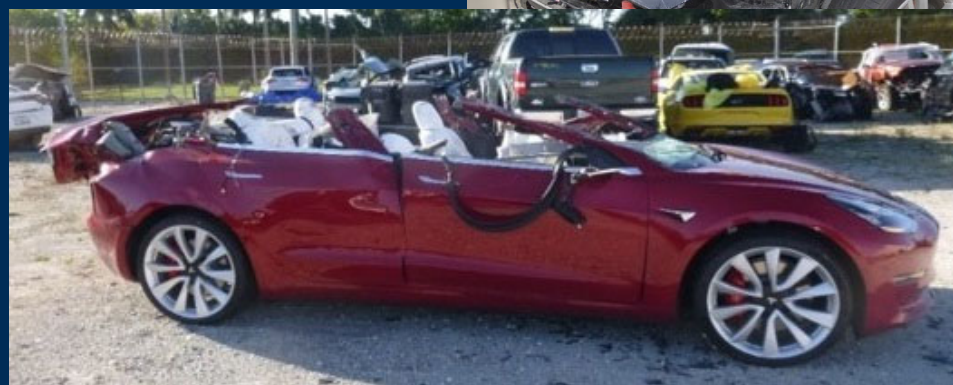
Overreliance on Automation

- Circumstances in Mountainview similar to those of other Level 2 crashes: Williston and Delray Beach, FL; Culver City, CA
- Driver-applied steering wheel torque not detected at time of impact –suggesting driver not engaged
- Prolonged inattentiveness by drivers
- Drivers were ineffective monitors
- Humans are poor monitors of automation
- An engaged driver remains a critical component even with advanced driver assistance systems

Probable Cause: The National Transportation Safety Board determines that the probable cause of the Mountain View, California, crash was the Tesla Autopilot system steering the sport utility vehicle into a highway gore area due to system limitations, and the driver's lack of response due to distraction likely from a cell phone game application and overreliance on the Autopilot partial driving automation system. Contributing to the crash was the Tesla vehicle's ineffective monitoring of driver engagement, which facilitated the driver's complacency and inattentiveness...

Recommendation to NHTSA and SAE: Develop performance standards for driver monitoring systems that will minimize driver disengagement, prevent automation complacency, and account for foreseeable misuse of the automation (H-20-3)

Recommendation to NHTSA: After developing the performance standards for driver monitoring systems recommended in Safety Recommendation H-20-3, require that all new passenger vehicles with Level 2 automation be equipped with a driver monitoring system that meets these standards. (H-20-4)

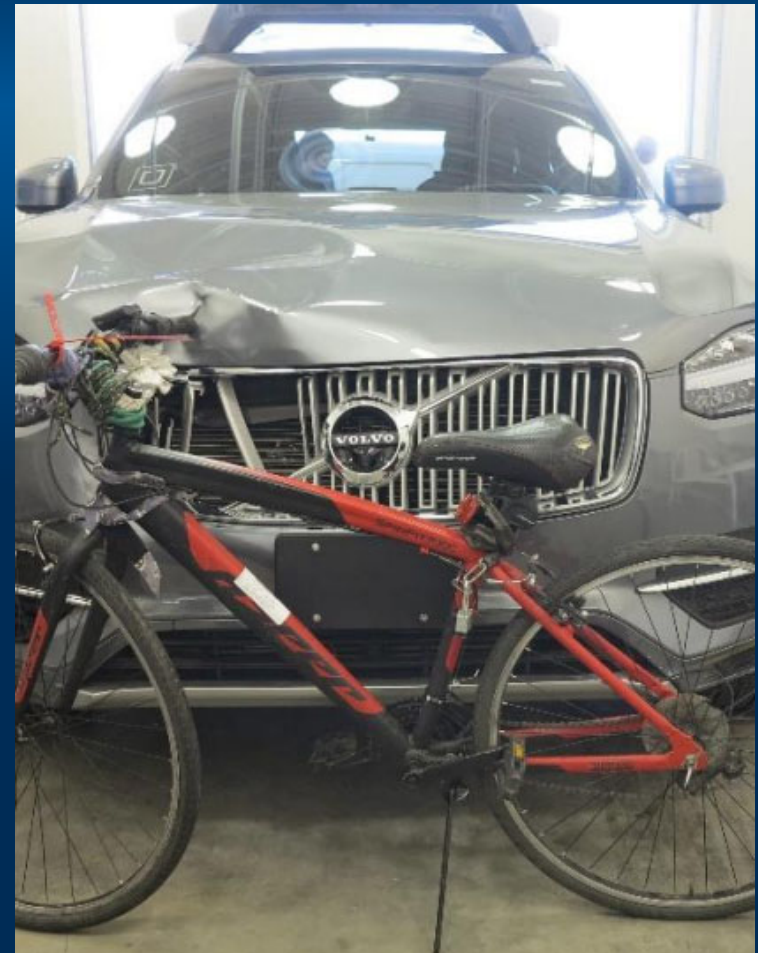
Inadequate Safety Culture:

- Individual monitoring SUV watching TV on her for phone for 1/3 of the trip and 5 of the final 6 seconds before impact
- Organization did not review in-ward facing camera nor detect violation of cell phone policy
- No safety division or safety manager
- No corporate safety plan

Finding: The Uber Advanced Technologies Group's inadequate safety culture created conditions— including inadequate oversight of vehicle operators—that contributed to the circumstances of the crash and specifically to the vehicle operator's extended distraction during the crash trip.

Recommendation to Uber ATG: Complete the implementation of a safety management system for automated driving system testing that, at a minimum, includes safety policy, safety risk management, safety assurance, and safety promotion. (H-19-52)
