1 **NATIONAL TRANSPORTATION SAFETY BOARD**

6  
7 Investigator in Charge Factual Report

9 Place : Port Richey, Florida  
10 Date : January 14, 2018  
11 Vessel : MV *Island Lady*  
12 NTSB No. : DCA18FM010  
13 Investigator : Brian Young  
14 IIC-OMS

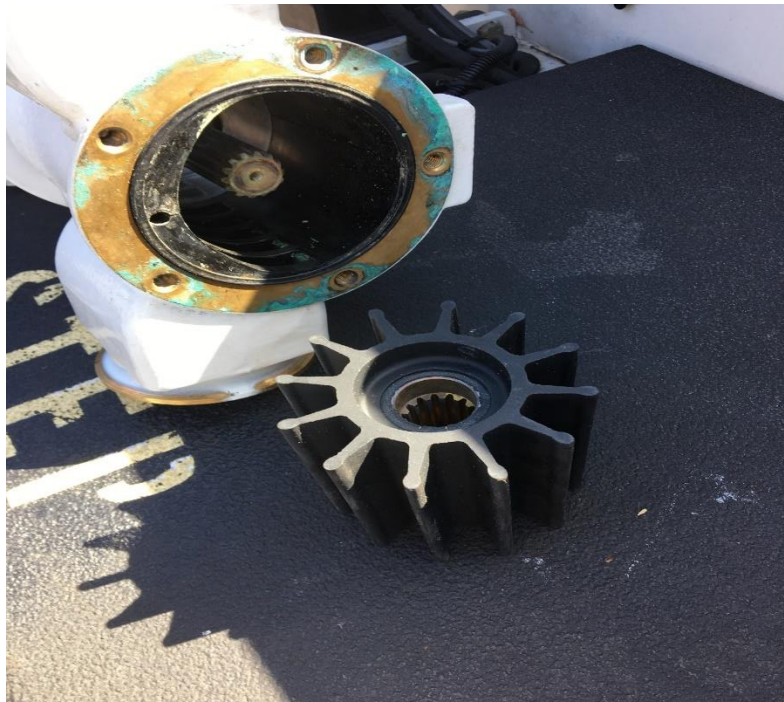
Figure 11. New raw-water pump housing and rubber impeller

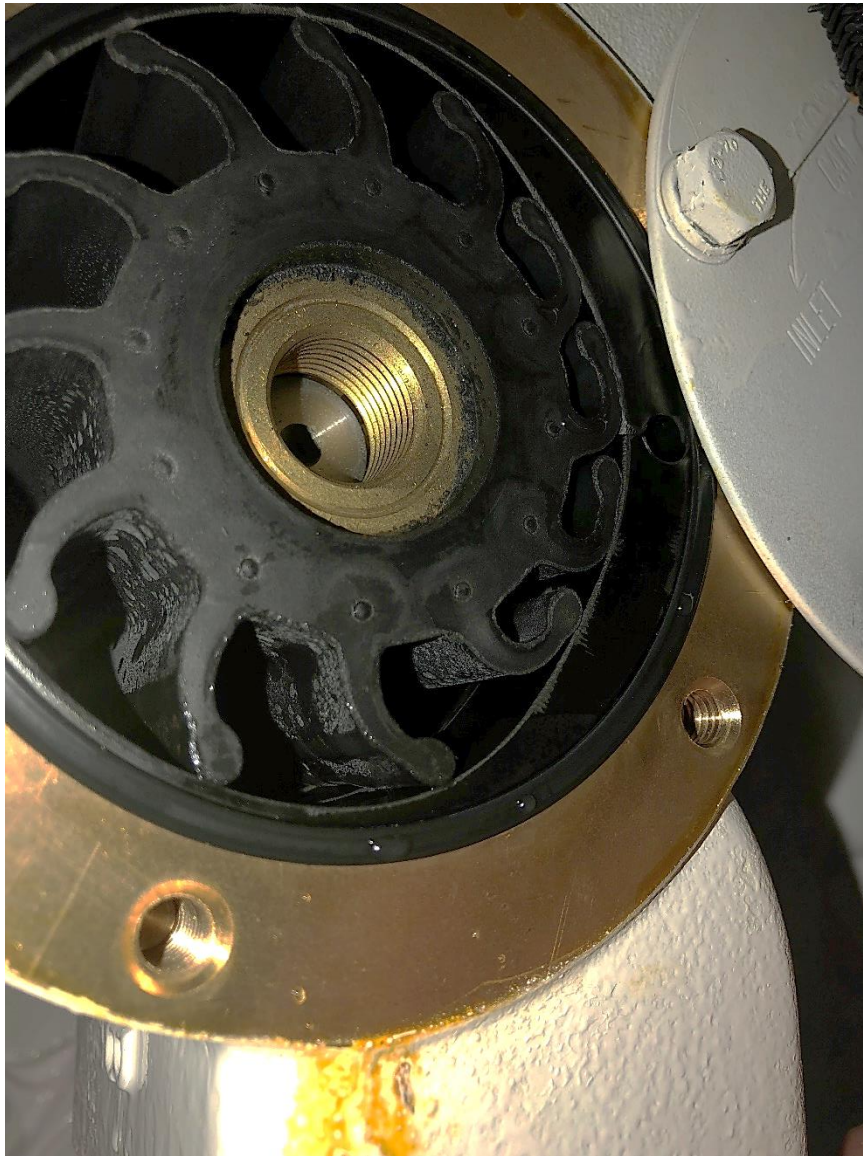
1 from that impeller. Ring Power provided a photo (**figure 22**) of a newly installed rubber  
2 impeller inside a raw-water pump housing to show the condition of a newly installed impeller.

1  
2 Figure 22. New raw-water pump impeller installed in its pump housing. (Photo provided by  
3 Ring Power)  
4
