S/S "NORWAY" - Main Boilers  
Cracks in Welds  
-----

Report Boiler 2A Prints from  
Ship file! Cracks

Examination of Linear Indications in Magnetic Particle Tests on  
Two Boilers of the SS "Norway"

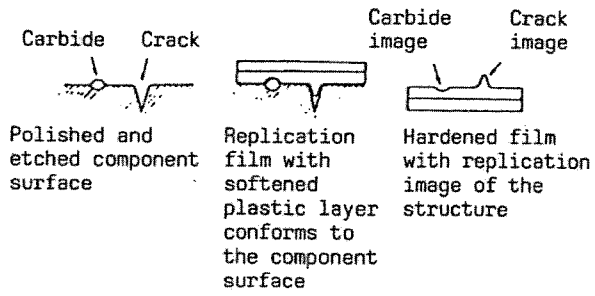
Fig. 1  
Principle of replication technique

Brief description of the technique used: After fine-grinding, the area under inspection was polished electrolytically and subsequently manually etched with 10 percent alcoholic HNO<sub>3</sub>. An about 0.1 mm thick film wetted with a solvent was pressed on this surface. After a contact time of approximately five minutes, an image of the structure and possible defects was produced on the film. As the basic diagram in Fig. 1 shows, the crack images stand out in relief on the film. In simple cases, interpretation is possible on site using a portable microscope. Complex phenomena however normally require an examination under a reflected light microscope at a magnification up to 1000 x or under a scanning electron microscope which means an examination in the laboratory.
