Tote, Inc.’s Response to the National Cargo Bureau, Inc.’s “Report on Review of Cargo Securing Manual and Cargo Stowage and Securing” dated August 4, 2016

On August 9, 2016, the National Transportation Safety Board (“NTSB”) posted on Accellion a report produced by the National Cargo Bureau, Inc. (“NCB”), dated August 4, 2016, and entitled “Report on Review of Cargo Securing Manual and Cargo Stowage and Securing” (“NCB Report”).

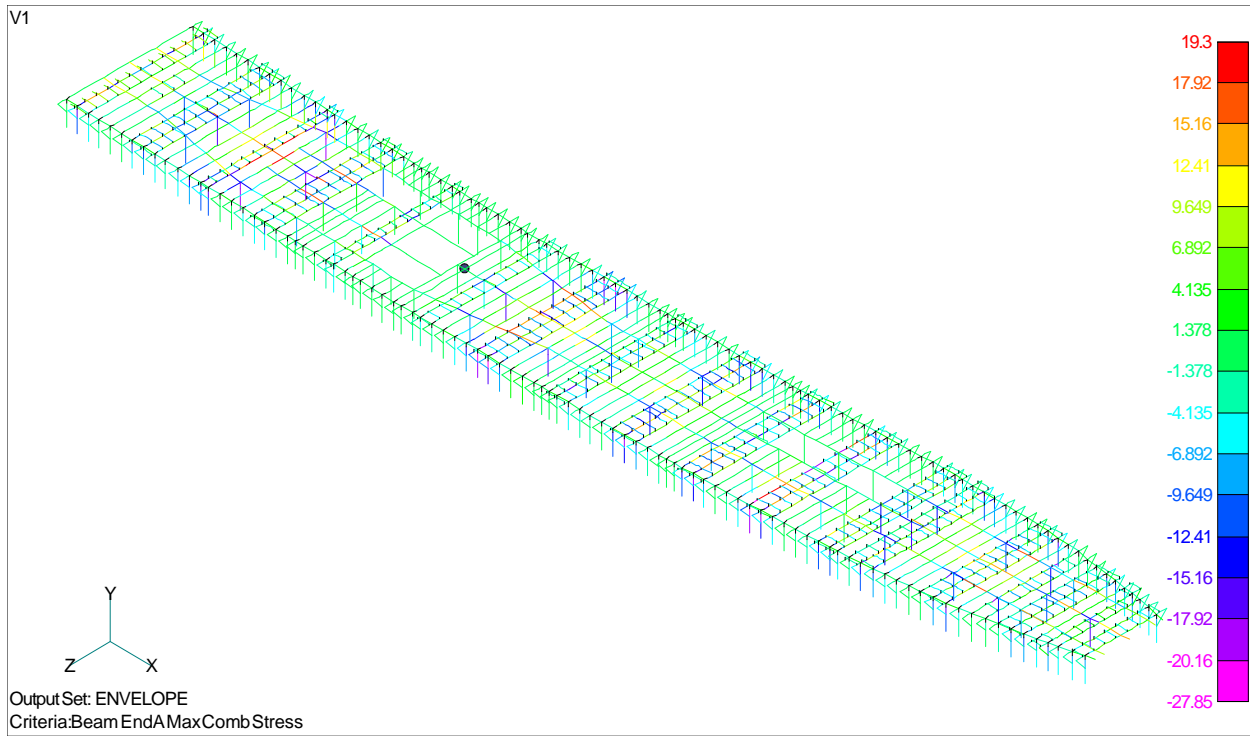
Figure 13 - Maximum combined stresses for all load cases

The following figures give the stress results for the load cases with these additional loads applied. The additional loads are applied to all container sizes and hence, all load cases described in this report. The maximum reported S1 shear stress is slightly higher than the allowable stress of 15 ksi. However, this occurs in the container support beams which are conservatively modeled as all having the same properties as the inboard-most beam. Since the outboard beams where the high stresses occur are actually much deeper than modeled, the actual stresses should be acceptable.

The studies done indicate that in this area, it is possible to increase the stack weights up to 160 kips in the 4 outboard-most stacks, outboard of the longitudinal girder, on the port side.
