Tote, Inc.’s Response to the National Cargo Bureau, Inc.’s “Report on Review of Cargo Securing Manual and Cargo Stowage and Securing” dated August 4, 2016

I. OVERVIEW

On August 9, 2016, the National Transportation Safety Board (“NTSB”) posted on Accellion a report produced by the National Cargo Bureau, Inc. (“NCB”), dated August 4, 2016, and entitled “Report on Review of Cargo Securing Manual and Cargo Stowage and Securing” (“NCB Report”).

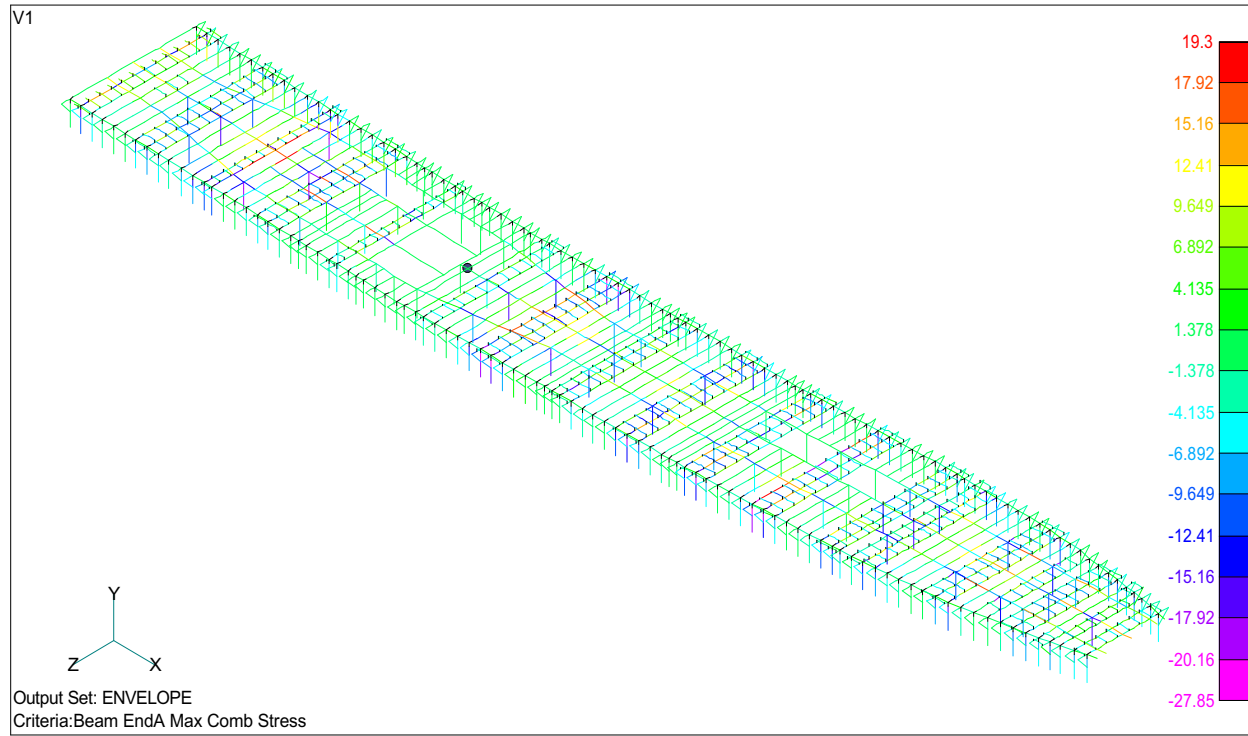
Figure 13 - Maximum combined stresses for all load cases

The following figures give the stress results for the load cases with these additional loads applied. The additional loads are applied to all container sizes and hence, all load cases described in this report. The maximum reported S1 shear stress is slightly higher than the allowable stress of 15 ksi. However, this occurs in the container support beams which are conservatively modeled as all having the same properties as the inboard-most beam. Since the outboard beams where the high stresses occur are actually much deeper than modeled, the actual stresses should be acceptable.
