#### NATIONAL TRANSPORTATION SAFETY BOARD OFFICE OF MARINE SAFETY WASHINGTON, D.C.

# OPERATIONS GROUP FACTUAL REPORT

## 2 NTSB Accident No.: DCA15MM017

3	Accid	ent Type:	Collision	
4 5 6	Locati	on:	Houston Ship Channel, Upper Galveston Bay at buoys 89 & 90 in the vicinity of Morgan's Point. Lat 29-40.35N, Long 94-58.74 W 51.6' N	
7	Vesse	l No. 1:	Liberian-registered bulk carrier Conti Peridot	
8 9			IMO No. 9452634, Official No. 92092, 623 feet long, 106 foot beam, 32,983 gross tons, steel construction, built in 2011	
10	Owners, No. 1:		Conti Peridot Shipping Ltd.	
11	Vesse	l No. 2:	Danish-registered chemical tanker Carla Maersk	
12 13			IMO No. 9171503, Official No. 19336 ZR 1999, 599 feet long, 106 foot beam, 29289 gross tons, steel construction, built in 1999	
14	Owners No. 2:		A.P. Moller – Maersk A/S	
15	Date:		March 9, 2015	
16	Time:		12:30:45 Central Daylight Time (CDT)	
17	Injurie	es:	None	
18	Comp	lement:	25, Carla Maersk	
19			24, Conti Peridot	
20			1 Houston Pilot aboard each vessel	
21	В.	OPERATIONS	GROUP	
22		Deck Operation	ons Group Chairman

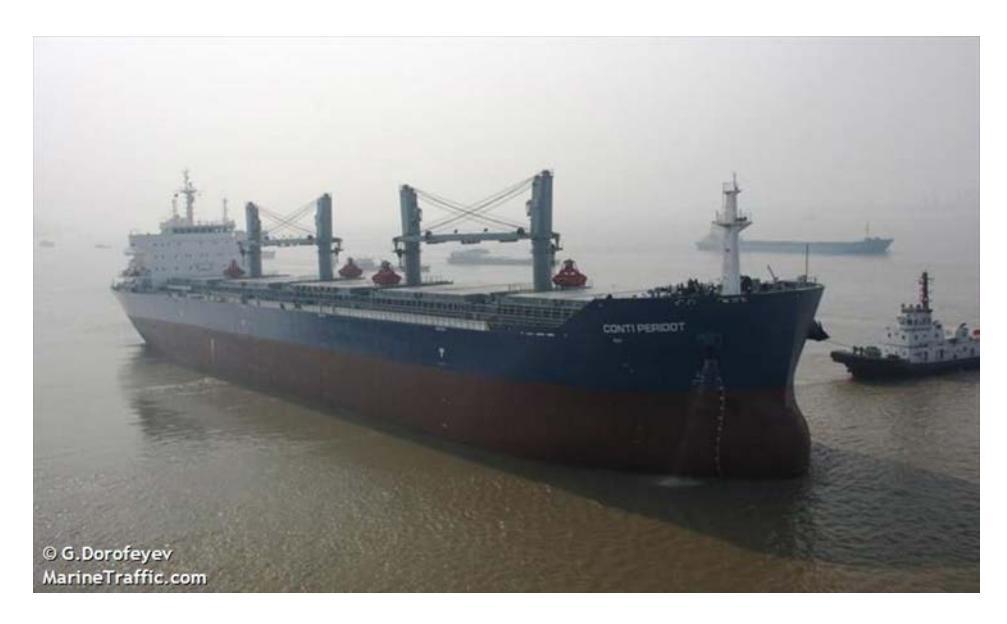
3 Figure 1. Bulk carrier Conti Peridot. The 623-foot-long vessel was powered by a single 9,480-kilowatt STX Man-B&W diesel engine and could make 14.2 knots. One pilot 4 5 joined the master and other crewmembers on the bridge for the transit to its berth at City Dock 24 in Houston, Texas. . 6 7 The *Conti Peridot* arrived at the outer anchorage to the port of Houston on the 4<sup>th</sup> of March, 2015 after having departed Manzanillo, Mexico on the 18<sup>th</sup> of February 8 9 and having transited the Panama, Canal. Due to visibility restrictions because of fog 10 and docking logistics, the vessel remained at anchor until notification of berthing and pilot boarding time. The vessel heaved anchor on March 9<sup>th</sup> about 0730 and got 11 12 underway towards the pilot station. The Houston pilot boarded the vessel at 0932 on in 13 the fairway channel outside the breakwater at approximately buoy's 1 and 2 while the 14 vessel was underway. Upon arriving on the bridge the master and pilot conducted a standard but required Master Pilot Exchange (MPX).<sup>1</sup> The pilot stated in interviews that 15 he was aware there was a 100 percent chance of rain but at the time of the boarding it 16

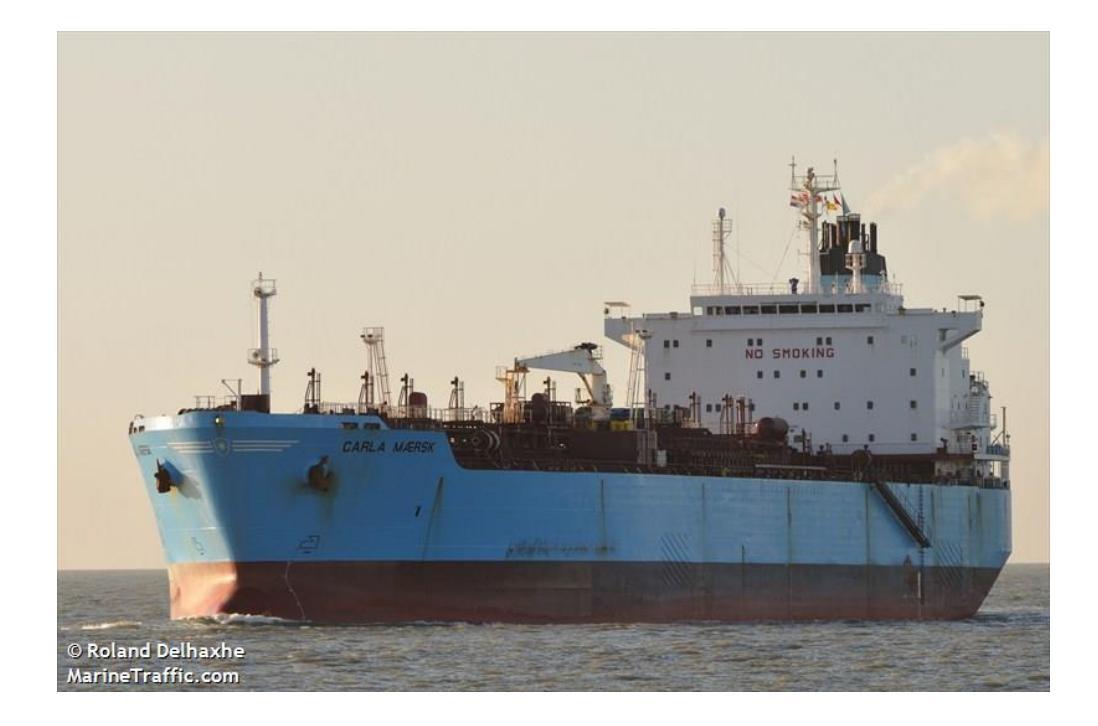
1 2 3 4	Figure 3. Chemical Fanker <i>Carla Maersk</i> , view of the port (left) bow, the 599 foot long vessel's hull is light blue hull with a white superstructure. The port gangway is down along with a pilot ladder in anticipation of either boarding or disembarking a pilot.
5	The Carla Maersk continued outbound through the channel at about 9 knots on
6	average with master and pilot on the bridge. About half way through the transit to
7	Morgan's Point the pilot heard that the Bar <sup>5</sup> was closed (1130) and knew that no more
8	inbound traffic other than what was already in the channel would be coming up to meet
9	him on the way down to the Gulf. With the low ceiling and rain he could see only half
10	the height of the San Jacinto monument, but eventually, once they got down to

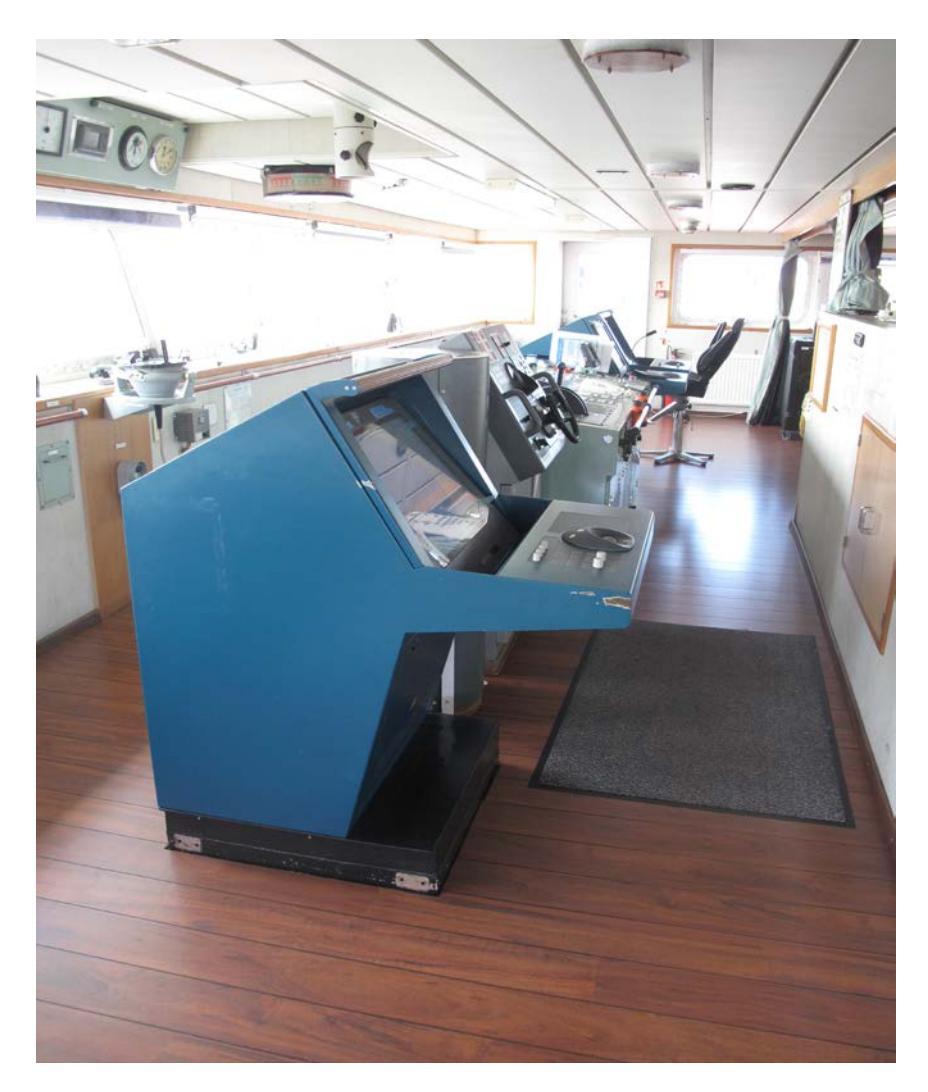
Figure 7. Picture of the *Carla Maersk* navigation bridge shown from port to starboard.
 Consoles are equipped with radars, ECDIS's steering stand located in the center and control console for telegraph.

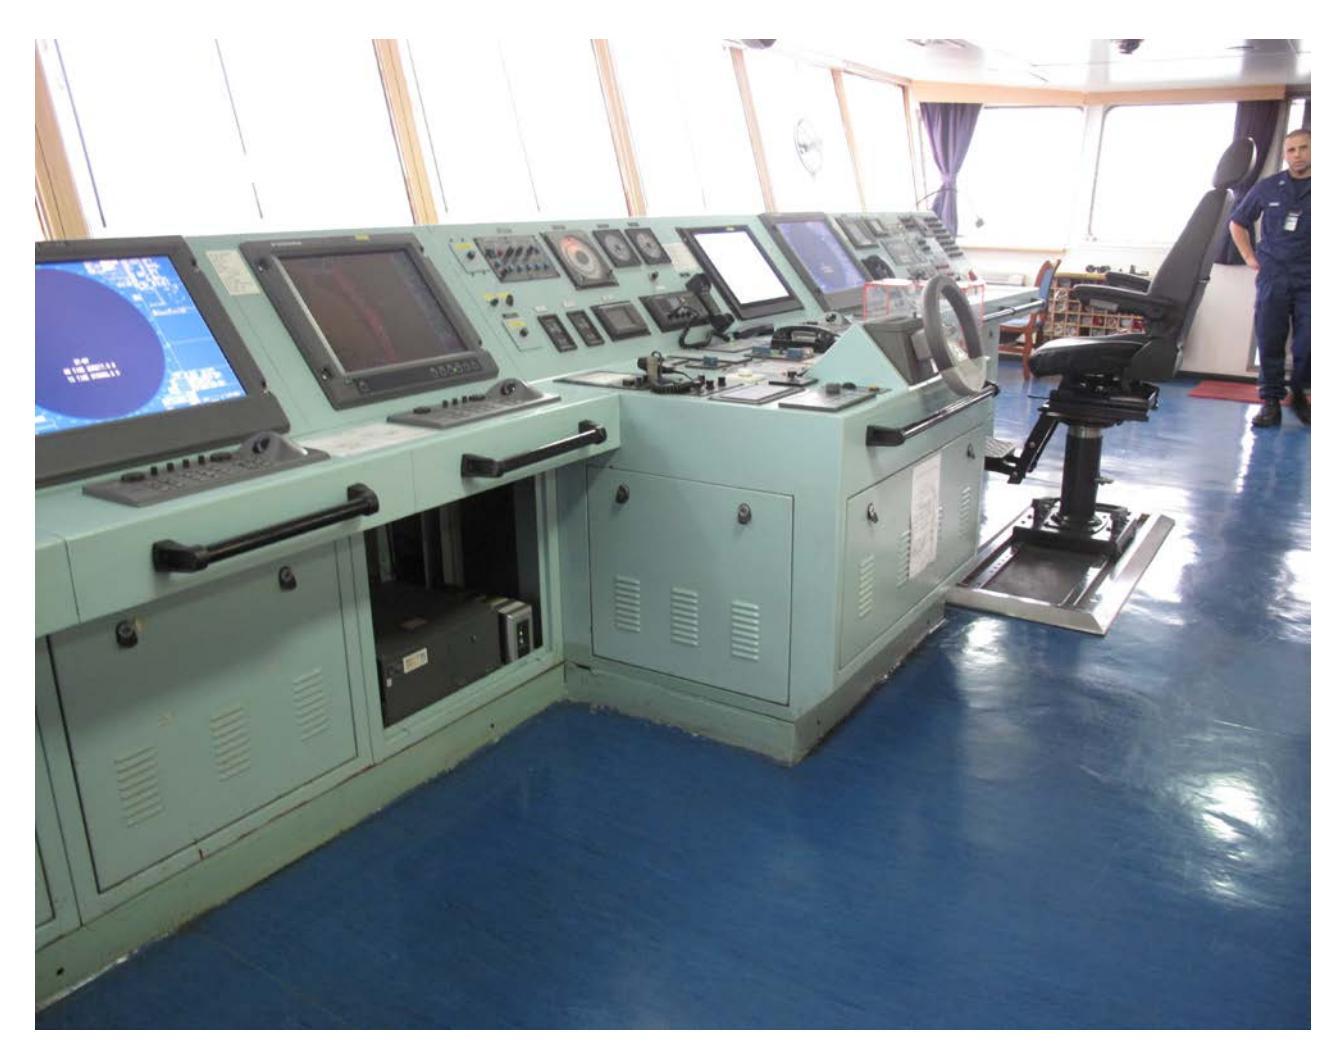
Figure 8. Picture of the *Conti Peridot* navigation bridge looking from port to
 starboard. Center consoles are equipped with radars and ECDIS along with centered
 steering stand and control panels for Telegraph and communications equipment

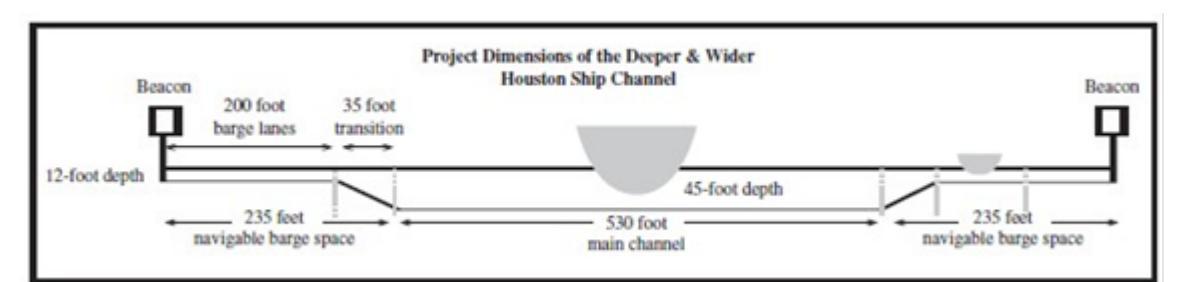
The main Houston Ship Channel in the area of the accident was 530 feet wide with a project depth of 45 feet. The barge lanes located on both sides of the main channel were 235 feet wide with a project depth of 12 feet.

**Figure 9.** Main and barge channel dimension of the Houston Ship Channel. From Navigating the Houston Ship Channel, Houston-Galveston Navigation Safety Advisory Committee, previously HOGANSAC now Lone Star.
