# National Transportation Safety Board

Group Chairman's Factual Report

Engineering Group

*Caribbean Fantasy*

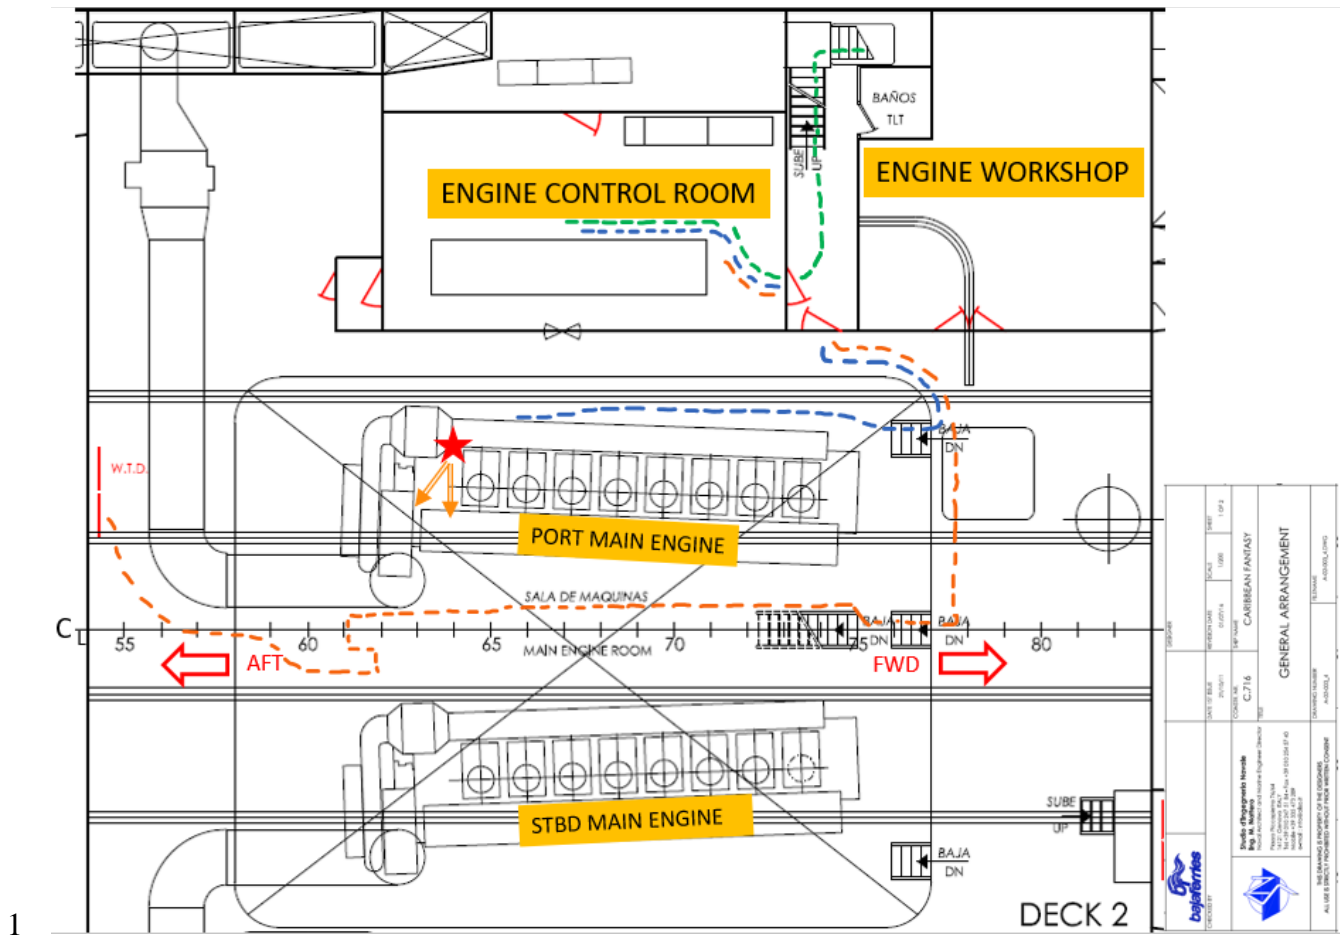
2 **Figure 3. Excerpt from the general arrangement drawing of the *Caribbean Fantasy's* main engine room**  
 3 **and adjacent spaces. The red star represents the location of the fuel spray from the port main engine**  
 4 **fuel oil supply end flange in the direction of the exhaust manifold and turbochargers. The port and**  
 5 **starboard main engines, engine control room, and engine workshop are depicted. The blue dotted line**  
 6 **indicates the path taken by the chief engineer and motorman to investigate the fuel oil spray. The green**  
 7 **dotted line indicated how the chief engineer, third engineer, and motorman exited the space. The orange**  
 8 **dotted line shows the wipers investigation path and evacuation route.**

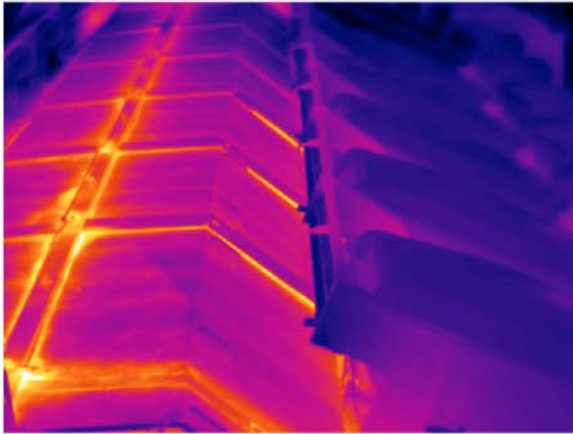
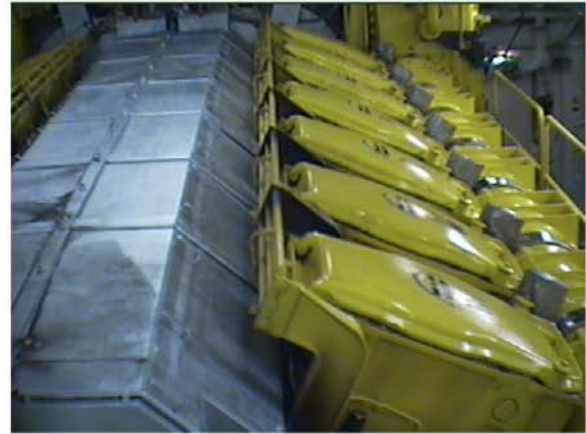
MAN B&W Diesel, as well as several other marine engine manufacturers, provided on-board thermographic analysis services in order to assist the owners and operators. However, there is no indication that a thermographic analysis was conducted on board the *Caribbean Fantasy*. Of note, no thermographic analysis was conducted after the major overhaul of the main engines at the shipyard in Tunisia. It is not uncommon for lagging and insulation be removed to access specific components of the engine and for existing lagging to be reused on the main engine as was with this overhaul.

1  
2 **Figure 22 MAN B&W customer service bulletin thermal imagery of the first version of a V-type 48/60**  
3 **engine. The cylinder covers and exhaust insulation is similar to the main engines on the *Caribbean***  
4 ***Fantasy*.**

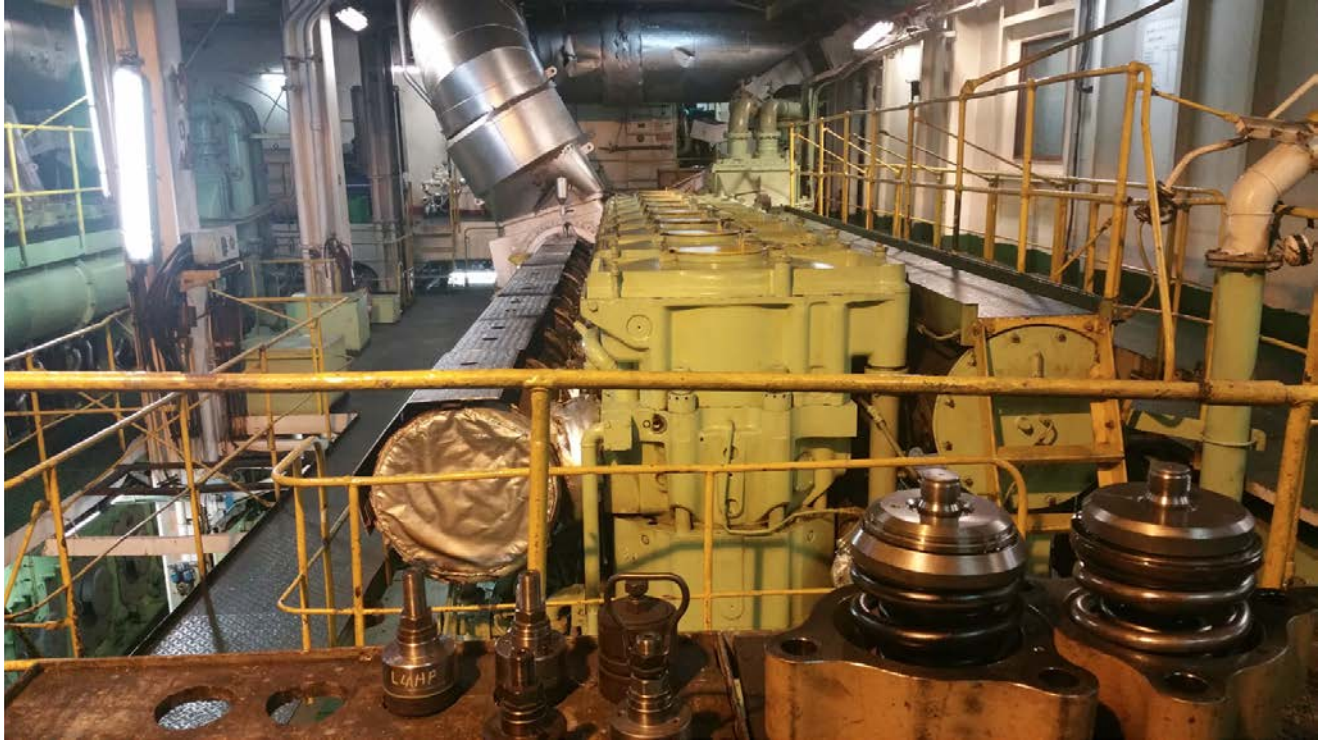
1  
2 **Figure 27. *Caribbean Fantasy's* PME photograph taken prior to the shipyard from the forward end of the**  
3 **engine's centerline in the aft direction (inboard, exhaust manifold side of the PME).**
