**3D LASER SCANNING
FACTUAL REPORT**

**Train Over-speed, Struck Passenger Waiting Area
Hoboken, NJ**

**DCA16MR011
(14 Pages)**

**NATIONAL TRANSPORTATION SAFETY BOARD
OFFICE OF RESEARCH AND ENGINEERING
WASHINGTON, D.C. 20594**

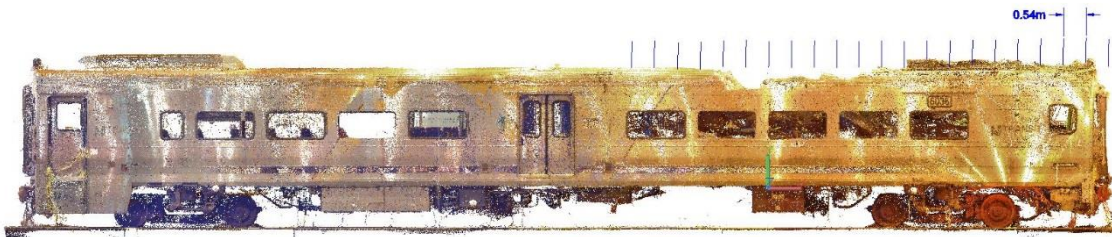
Figure 17: Vertical bars highlight the position of the cross section slices starting at the F-end of the lead cab car (right side of image). Each cross section slice is represents 0.54 meters.

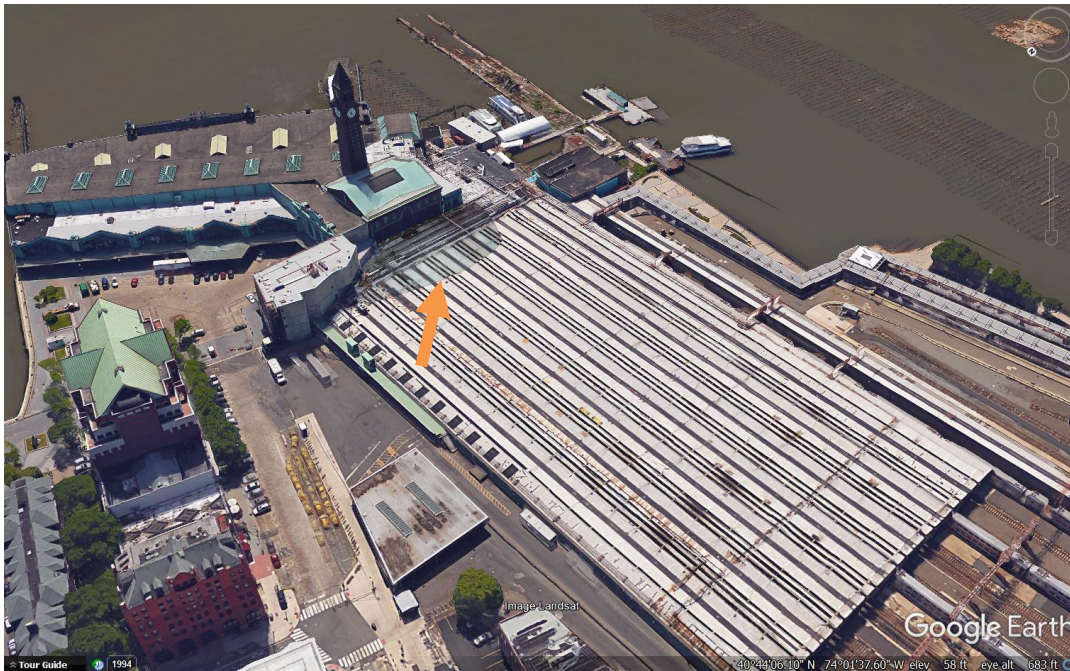
Figure 19: A Google Earth image overlaid with the orthomap of the drone documentation region is shown. The slightly darker region, highlighted by the orange arrow, near the Hoboken terminal is the region documented by the drone flyover.
