# National Transportation Safety Board

Group Chairman's Factual Report

Survival Factors

DCA16FM052

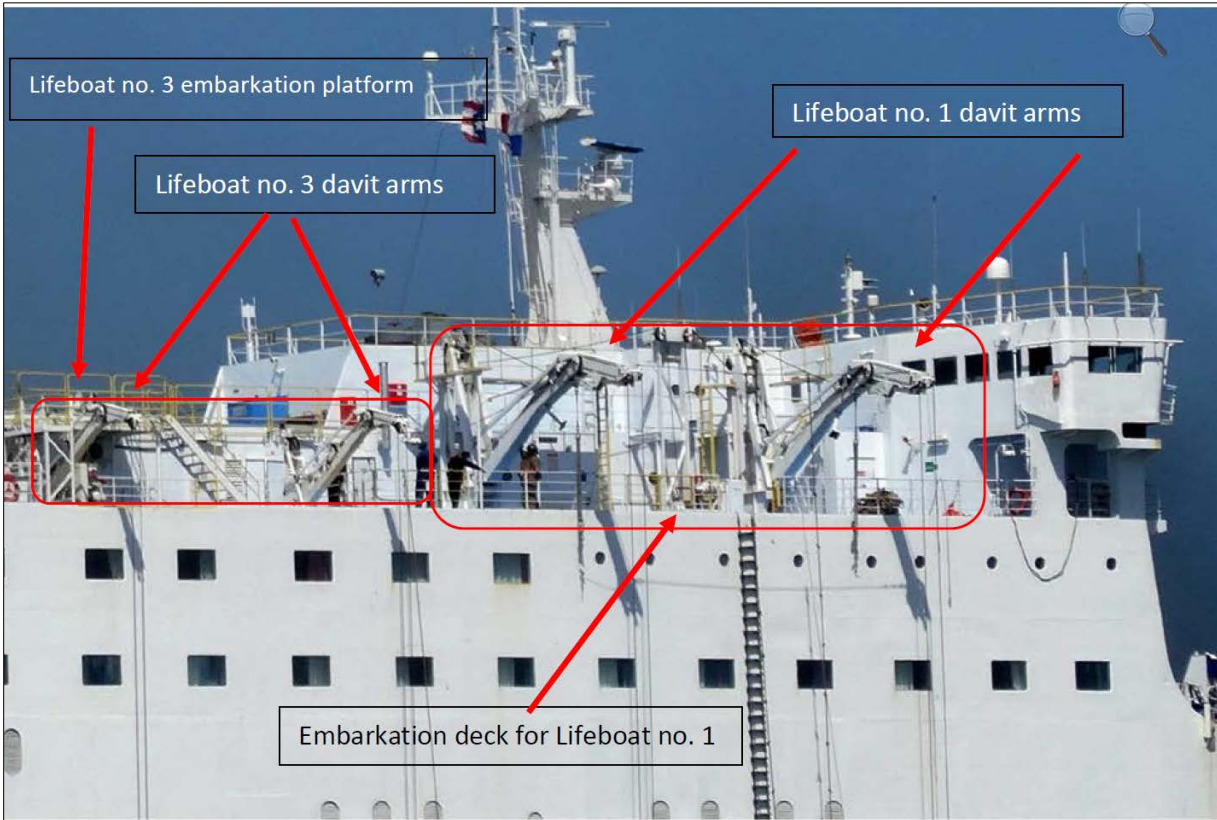
**Figure 3. Caribbean Fantasy starboard side (Photo by Coast Guard)**

9 All three life boats were close to accommodation and service spaces and just aft of the  
10 navigation bridge. Lifeboats no. 1 and no. 3, stowed in their davits on deck 7, were both located  
11 within muster station A. Lifeboat no. 2, also stowed on deck 7, was located within muster station B.

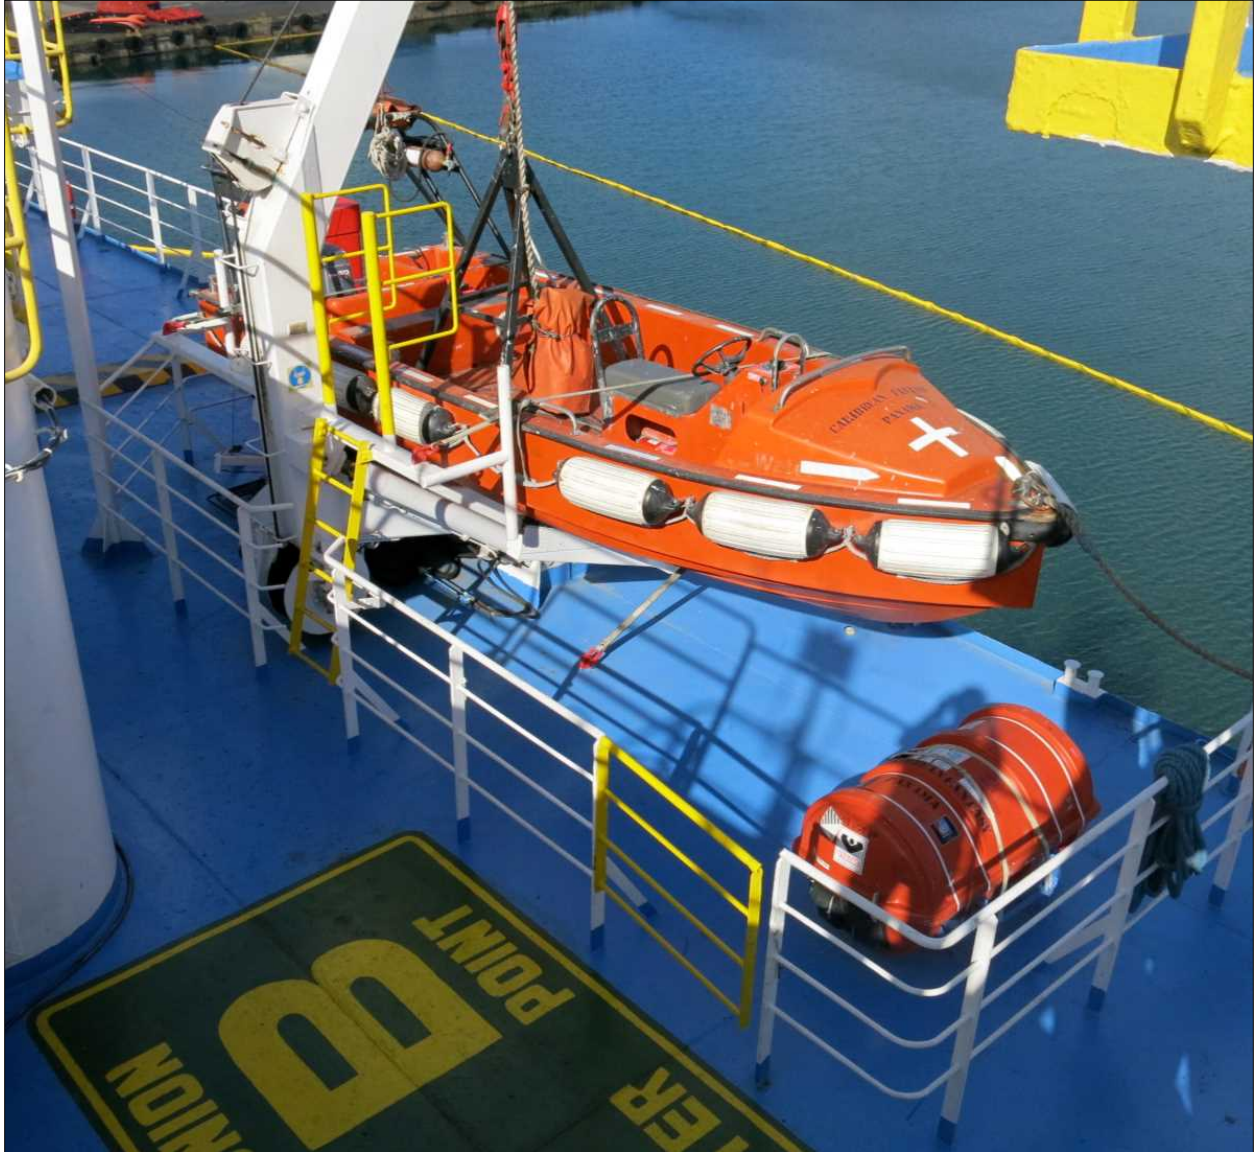
1 approved by RINA on February 2, 2016, included abandon ship rescue boat assignments, but the  
2 plan was not in use at the time of the accident. During the accident, the master chose to not launch  
3 the rescue boat, deciding to rely on Coast Guard small boats to assist with MES operations.

**Figure 8. Caribbean Fantasy fast rescue boat stowed in its davit.**

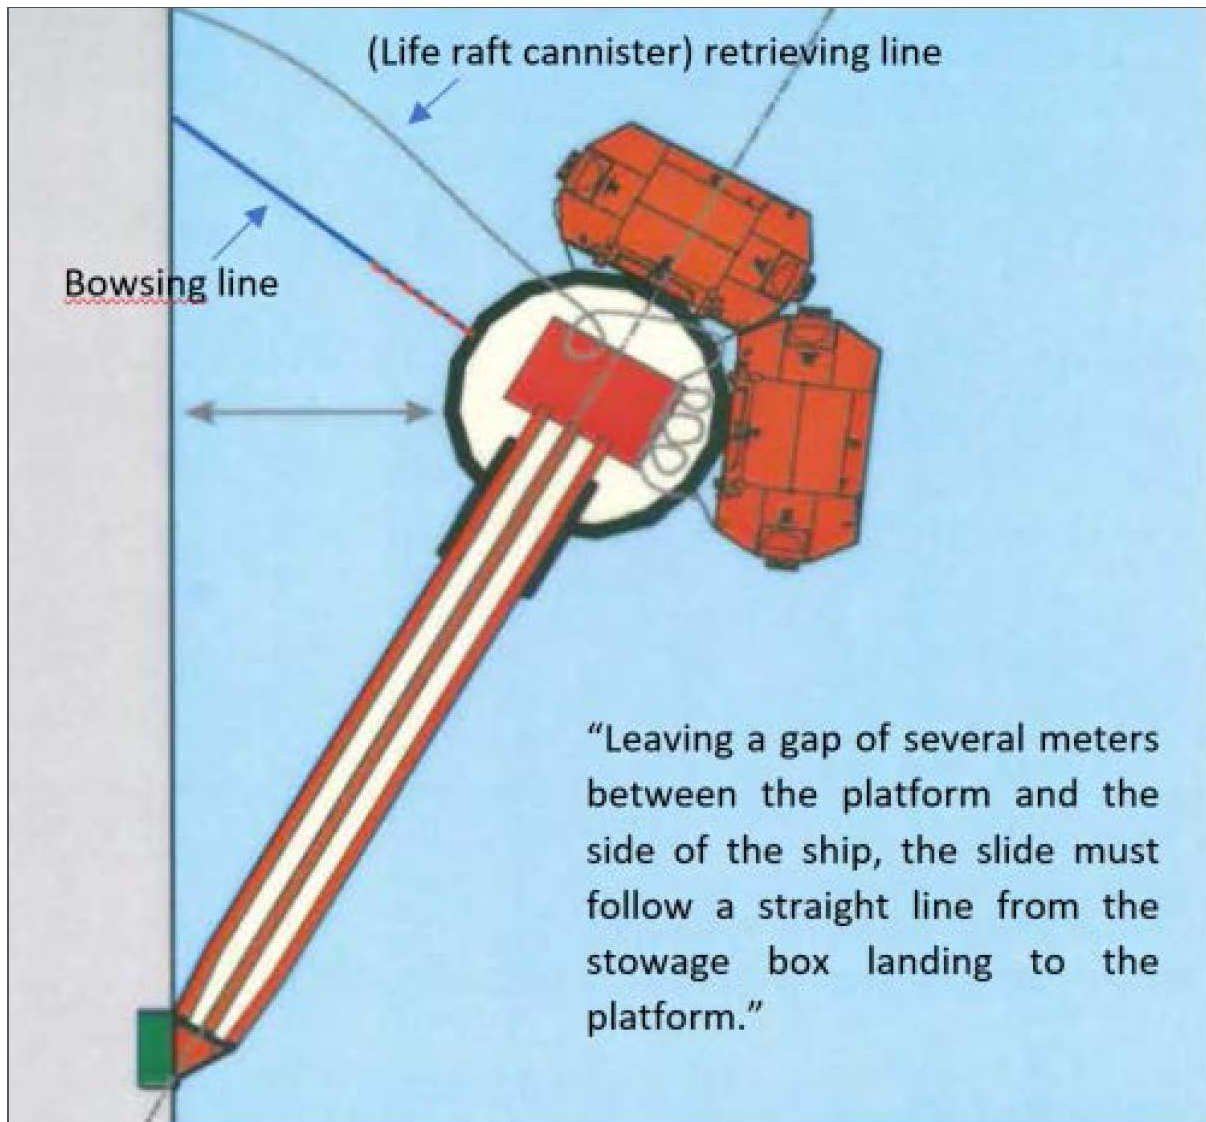
1           Once the captain ordered the MES deployed, the slide controller was to pull the release  
2 handle to inflate the slide and the platform. After the MES inflated, the slide controller assistant is  
3 to take up slack and tighten the bowsing line, using the bowsing line winch, to properly position  
4 the MES as shown in figure 10. The bowsing line was a line running from the ship to the MES  
5 loading platform on the water designed to keep the MES slide and platform in position when  
6 deployed. By adjusting the line, a crewmember could place the platform and connected slide in  
7 the best position and angle to expedite evacuation. The MES *Training and Operational Manual*  
8 stated, “the slide should follow a straight line from the stowage box landing to the platform,” which  
9 results in “leaving a gap of several meters between the platform and the side of the ship.” The  
10 winch operator was to haul in until the slack disappeared without tightening the bowsing line “too

11 much.” No other lines were used to position the slide. The VIKING representative told  
12 investigators that the crew should have hauled in the bowsing line “immediately after launching.”

1  
2 **Figure 10. Correct positioning of slide and platform by means of the bowsing line winch (*Caribbean***  
3 ***Fantasy MES Training and Operations Manual*)**

2 The staff captain told investigators the starboard side MES deployed well but the crew  
3 could not use the bowsing line because it was “cut.” One of the ABs assisting with the starboard  
4 side MES also noted that “the line where to keep it on the ship was broken.” A Coast Guard  
5 photograph of the MES taken during the evacuation show the bowsing line in two pieces, with a  
6 slack bowsing line on the starboard side of the ship (see figure 12).

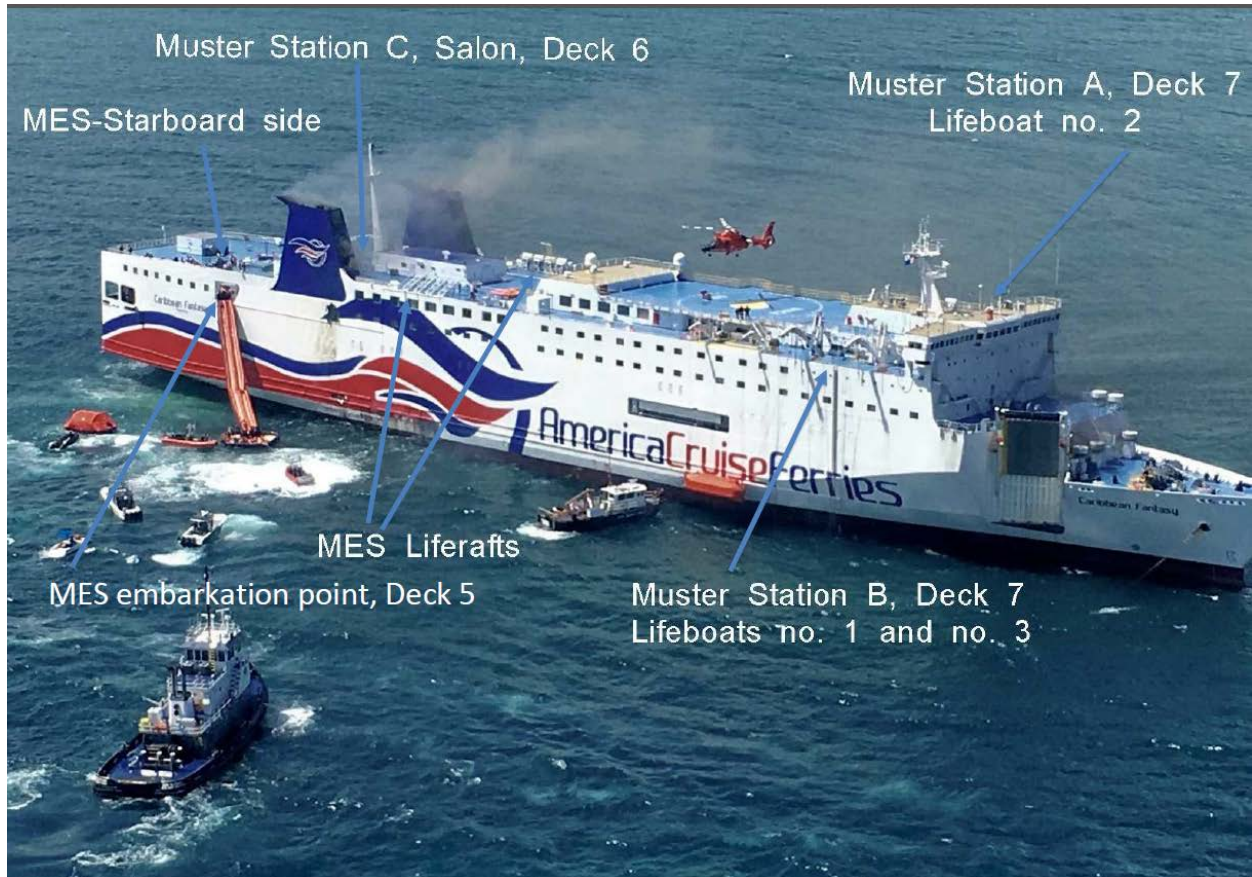
5  
6 **Figure 16. Muster station, MES, and lifeboat locations on board the *Caribbean Fantasy*. (Photo by**  
7 **Coast Guard)**

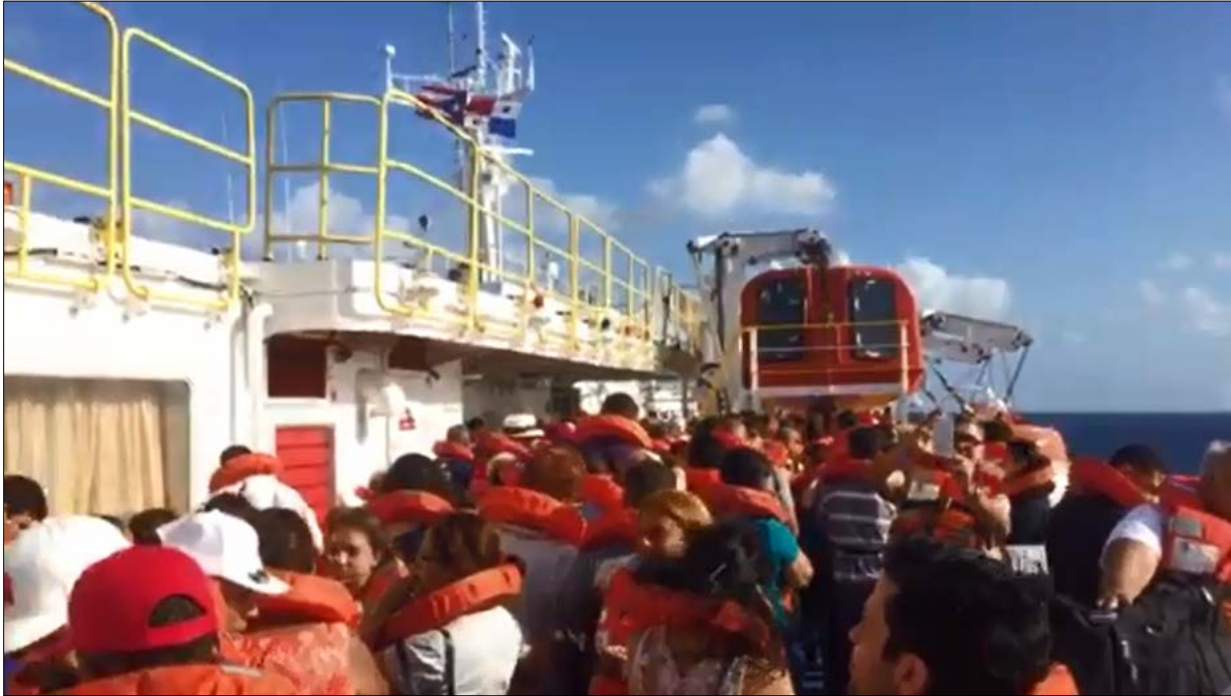
7 **Figure 22. Lifejackets being distributed to passengers on deck 7 behind lifeboat no. 3. The davit for**  
8 **lifeboat no. 1, which has been lowered to the embarkation deck, can be seen ahead of lifeboat no. 3.**  
9 **(Frame from *Caribbean Fantasy* passenger video provided by Coast Guard)**
