NATIONAL TRANSPORTATION SAFETY BOARD

MATERIALS LABORATORY FIRE FACTUAL REPORT

Report No. 17-055

Place : San Juan, Puerto Rico
Date : August 17, 2016
Vehicle : RO/RO Passenger Vessel *Caribbean Fantasy*
NTSB No. : DCA16FM052
Investigator : Nancy B. McAtee
Fire Group Chairman
RE-30

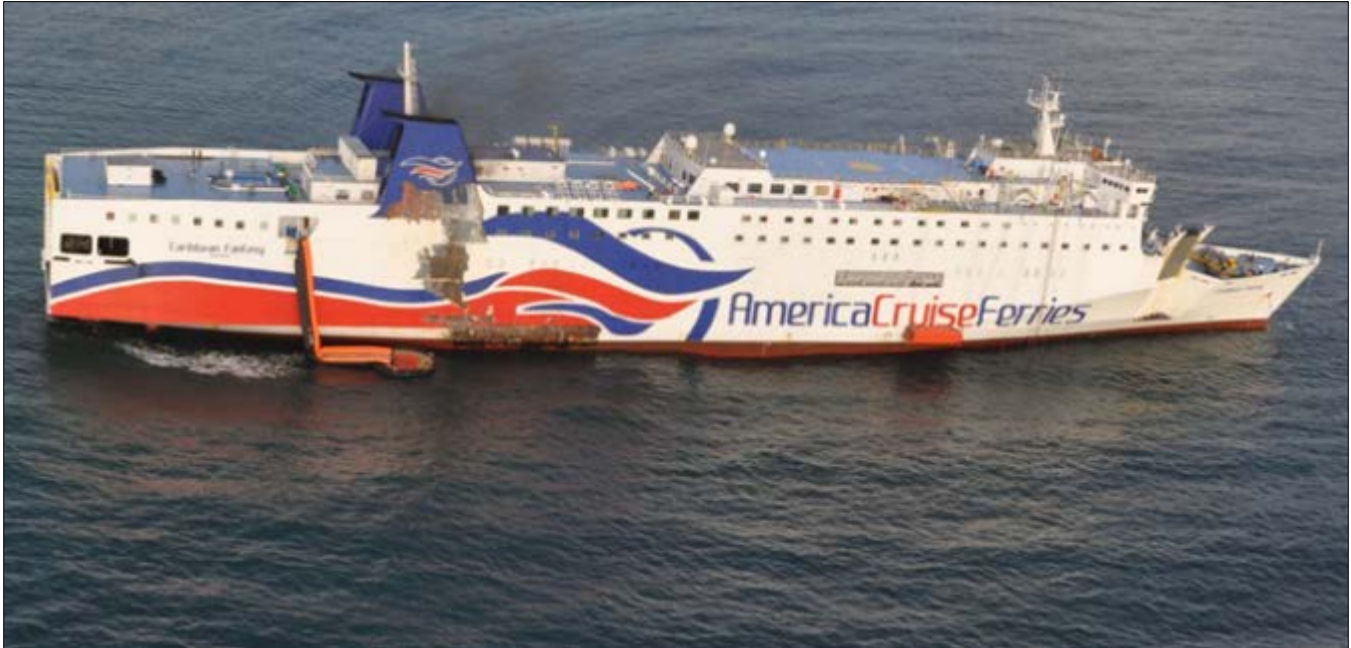
Figure 1. Overall photograph of *Caribbean Fantasy* postaccident.

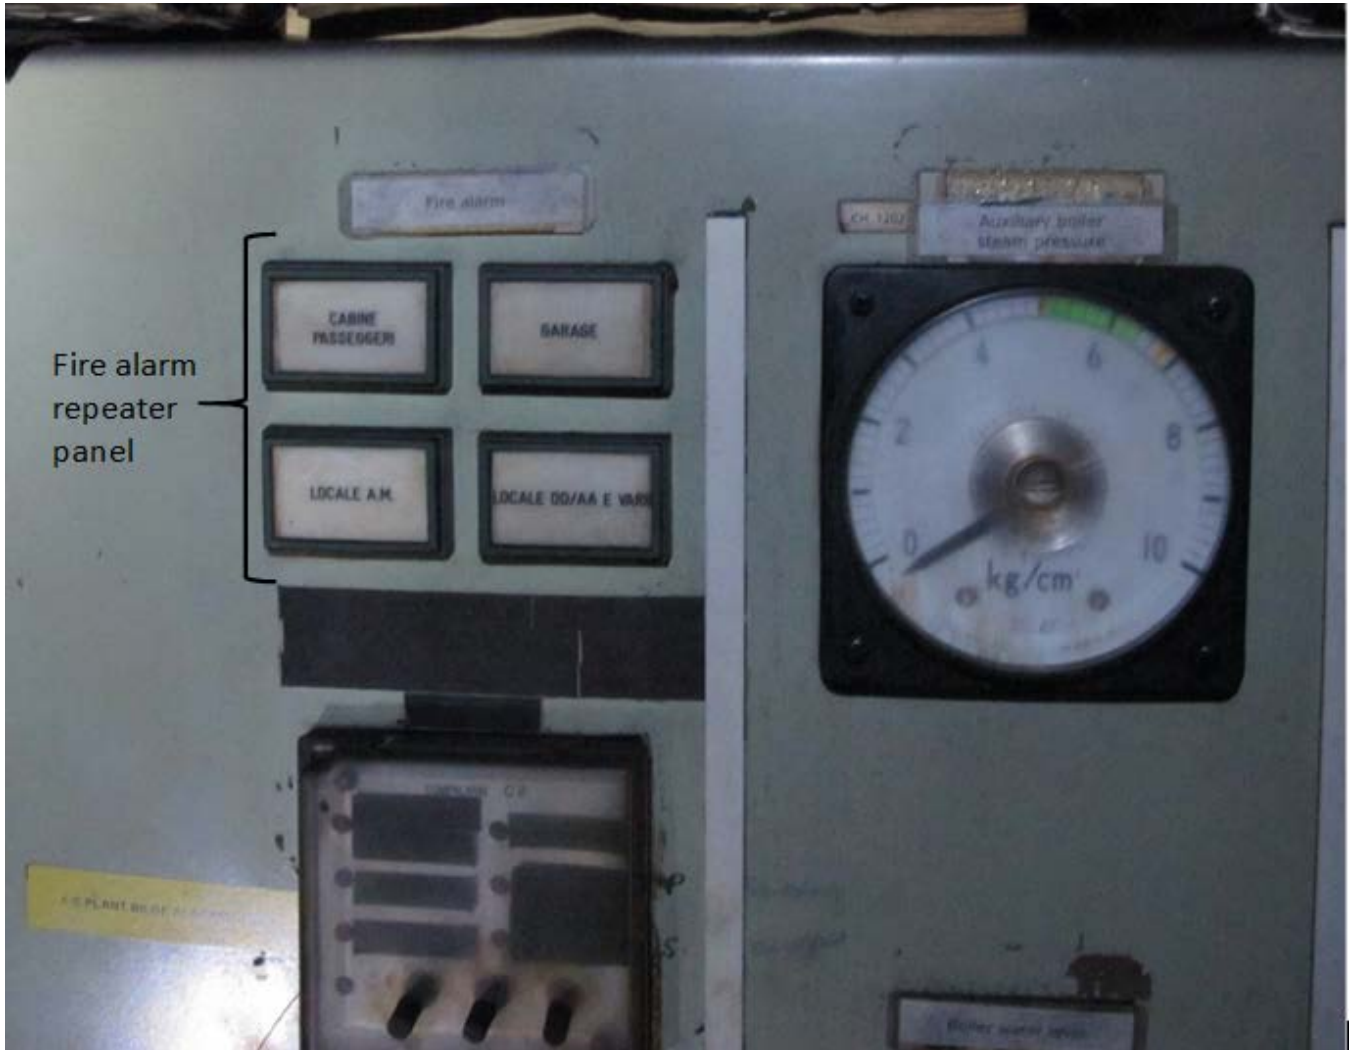
Figure 5. Photograph of fire alarm repeater panel in engine control room. Note the fire alarm repeater indicator text is in Italian.

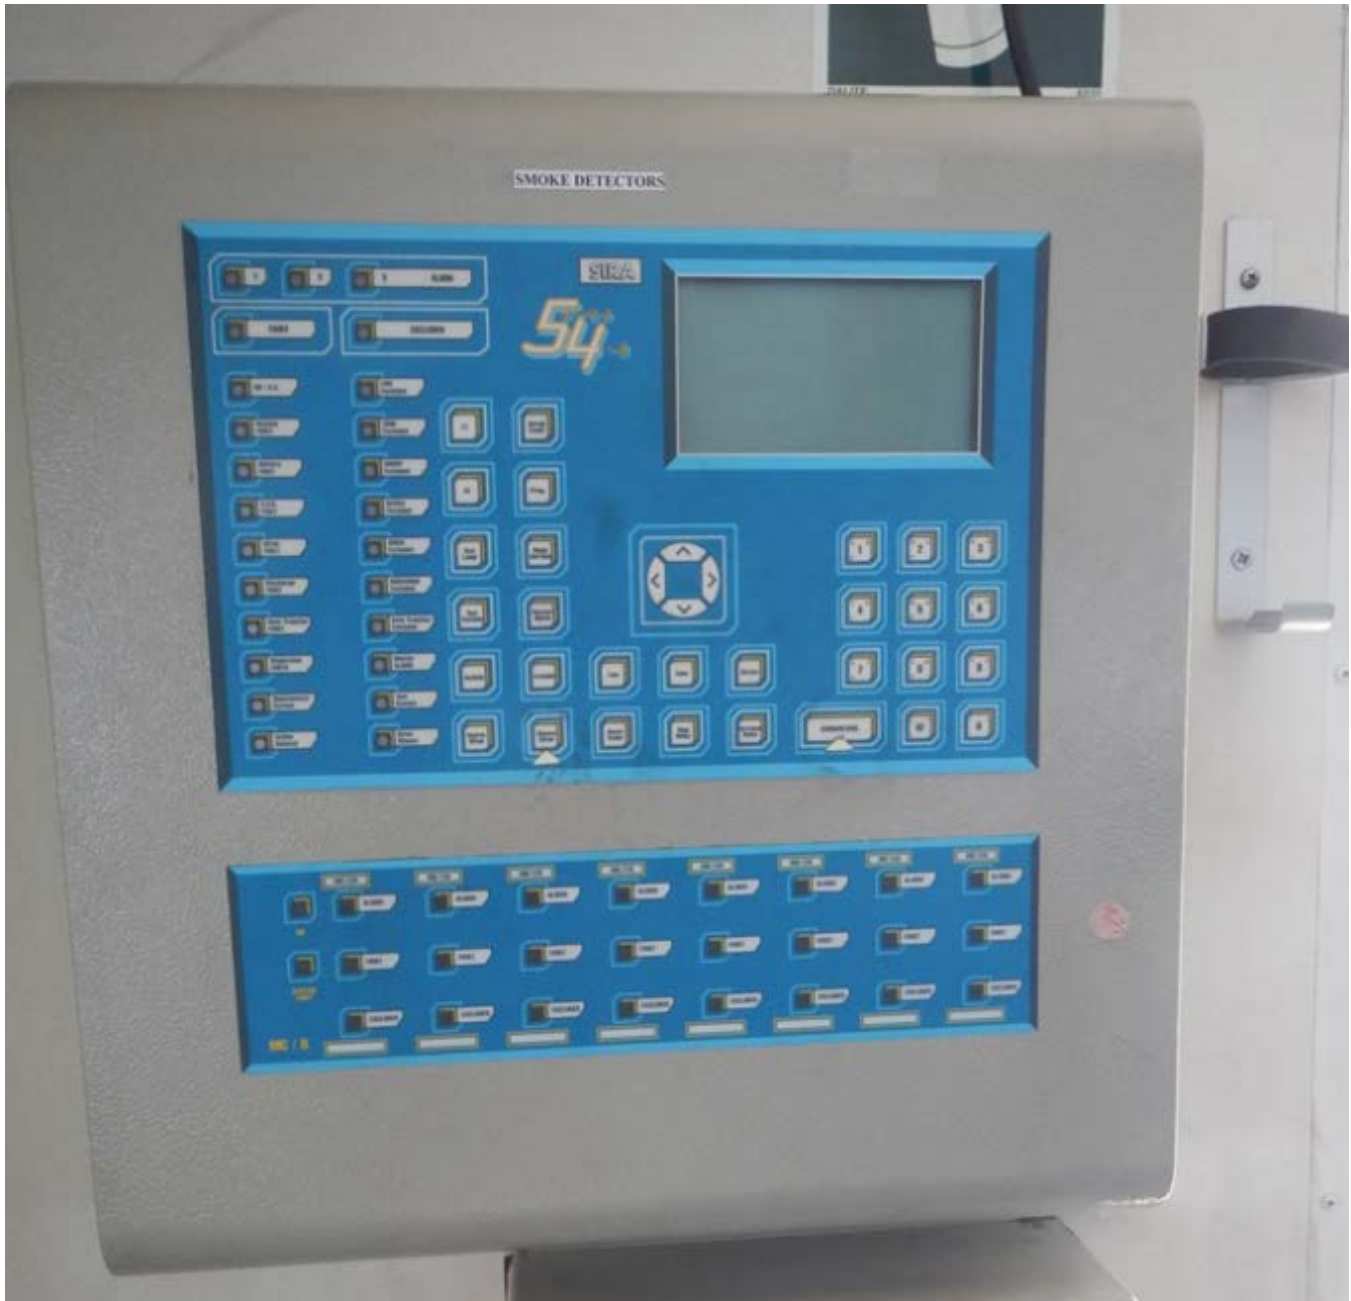
In addition to the Consilium system, there was a third panel located on the port side aft wall of the bridge as shown in Figure 7. This panel was a Sira Area 54 panel and it was labeled "SMOKE DETECTORS" with an adhesive label located above the panel. According to layout drawings for this panel, it provided alarm information for detectors located in the passenger/accommodation areas (decks 5–7).

Figure 7. Photograph of SIRA panel located on the bridge.

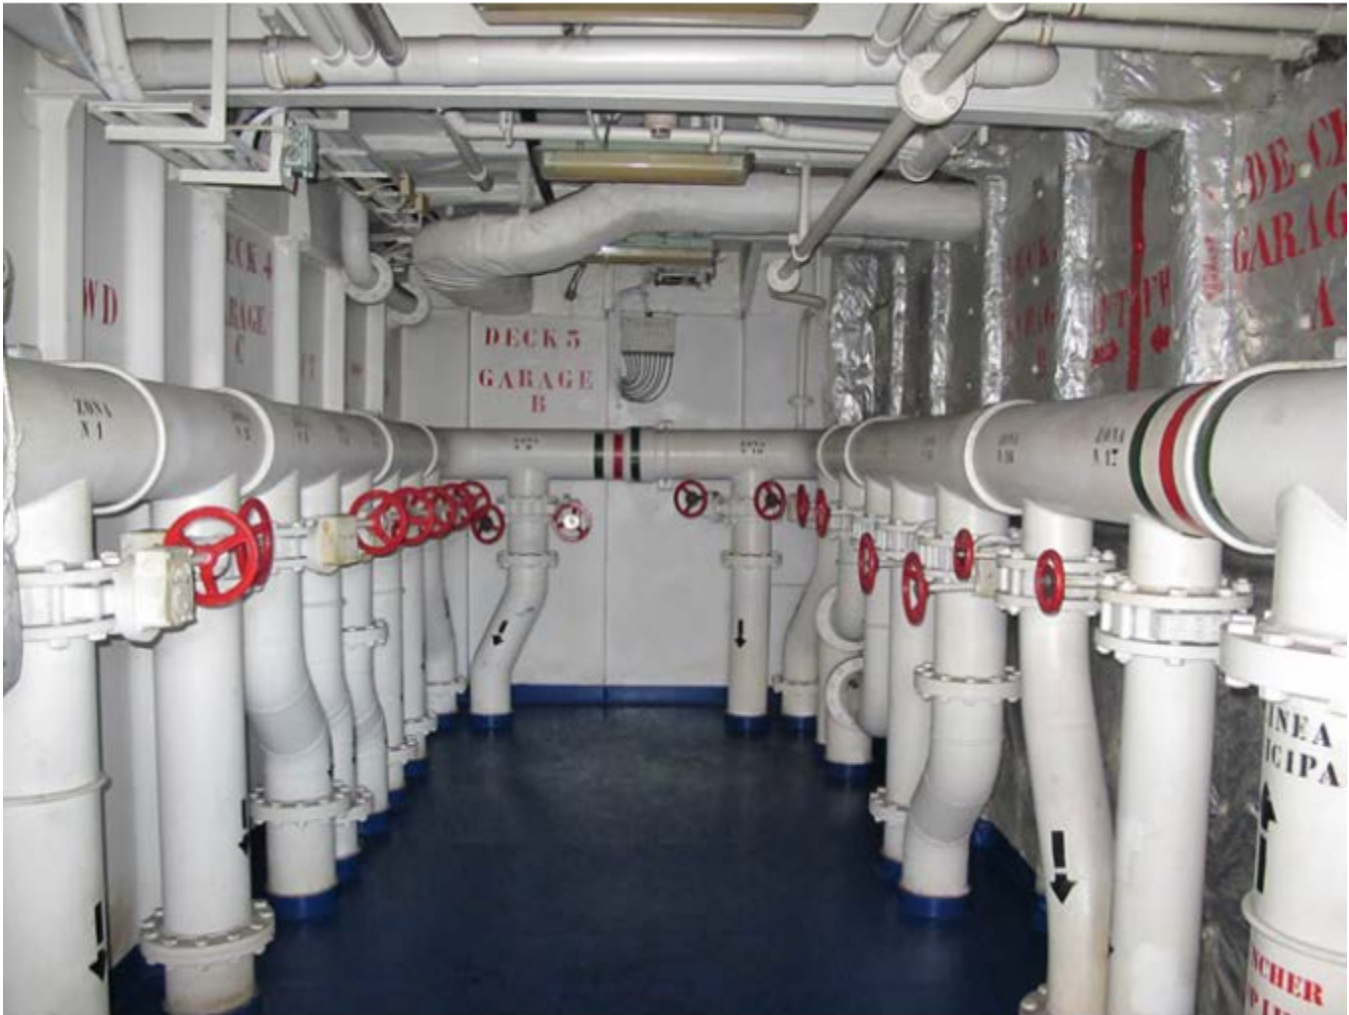
¹² The drencher system was originally designed to use salt water. However, during a U.S. Coast Guard inspection in 2013, a recommendation was made to switch the water source from salt water to fresh water to mitigate wide spread corrosion and blockages in piping and nozzles that lead to activation issues. No records or drawings from either the ship operator or class society of the changeover and necessary retrofitting required for this change were found.

Figure 20. Overall photograph of water drencher system control station.

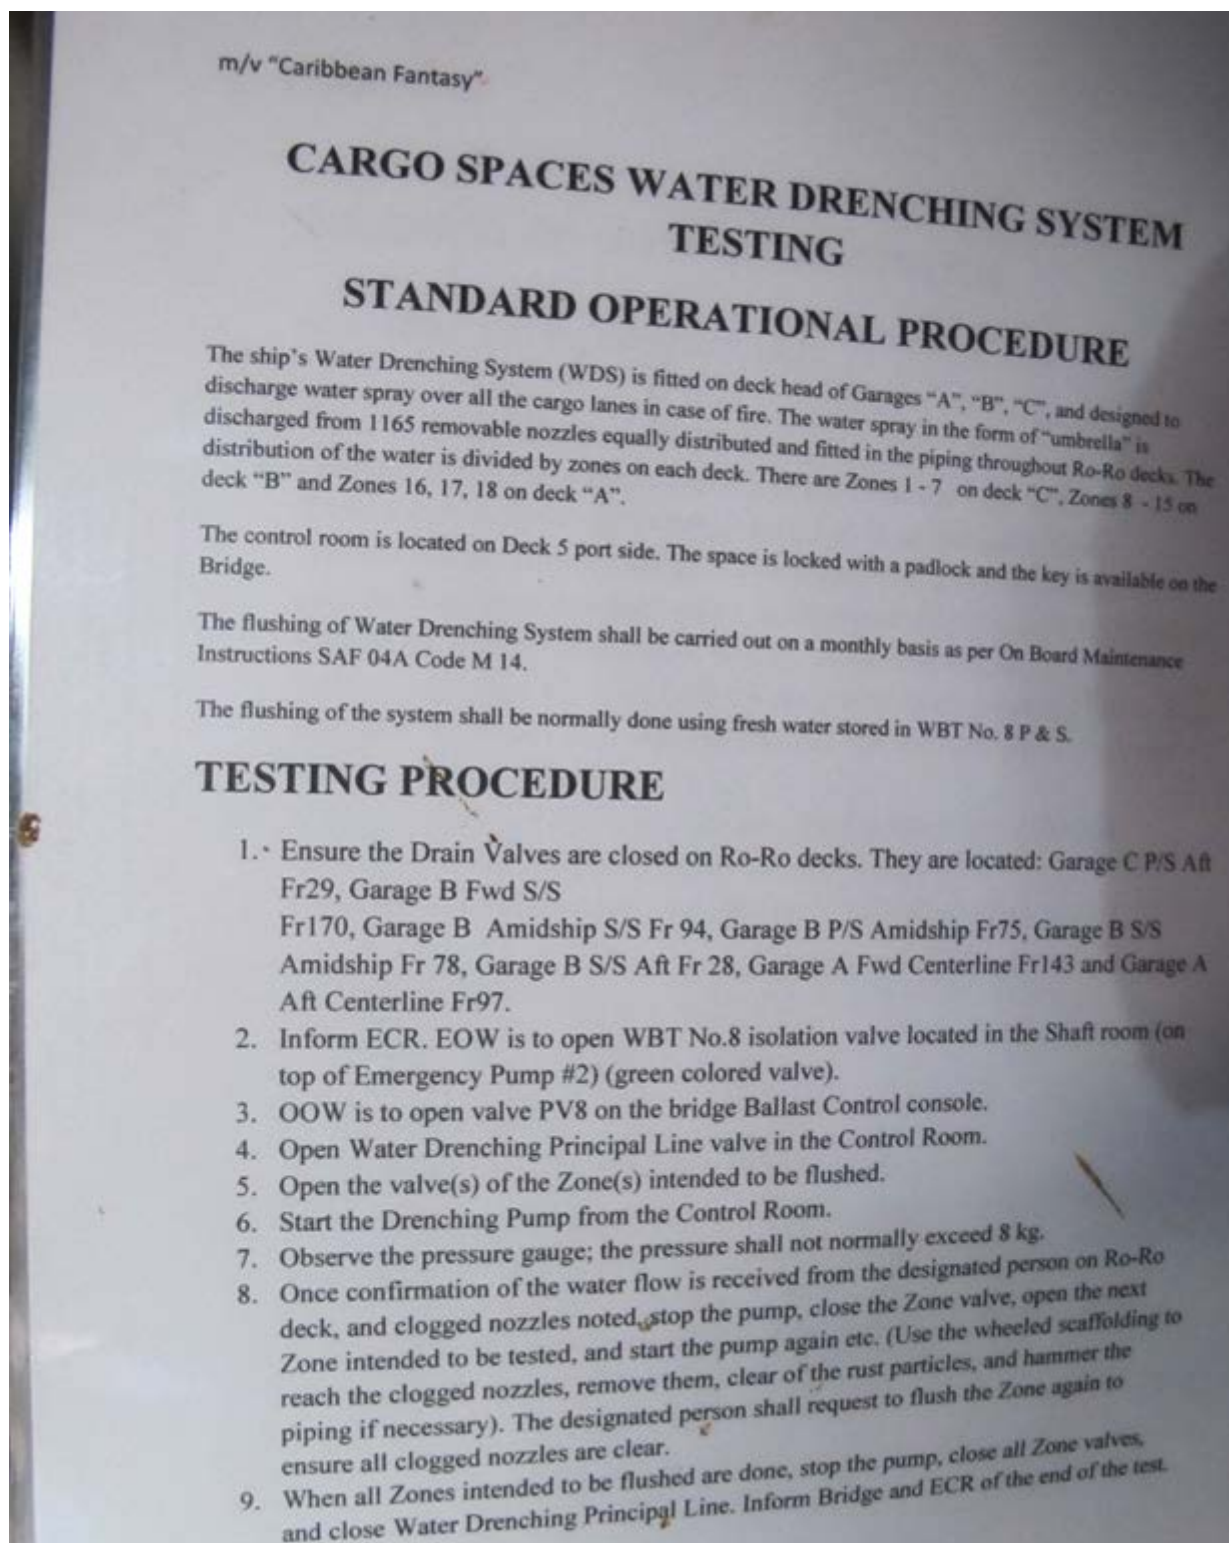
Testing procedure and instructions were posted in the drencher activation station (as shown in Figure 21); emergency operation instructions were the same as the testing procedure/instructions. The instructions were specifically for a testing procedure designed to keep the piping and nozzles free from debris. The system was tested weekly while dockside during the overnight stay in Santo Domingo, Dominican Republic. The drencher system on board the Caribbean Fantasy was known to have problems with corrosion and blockages in pipes from its sea water suction design which warranted inspection and flushing of the system on a weekly interval.

Figure 21. Photograph of water drencher system testing/operating procedure.

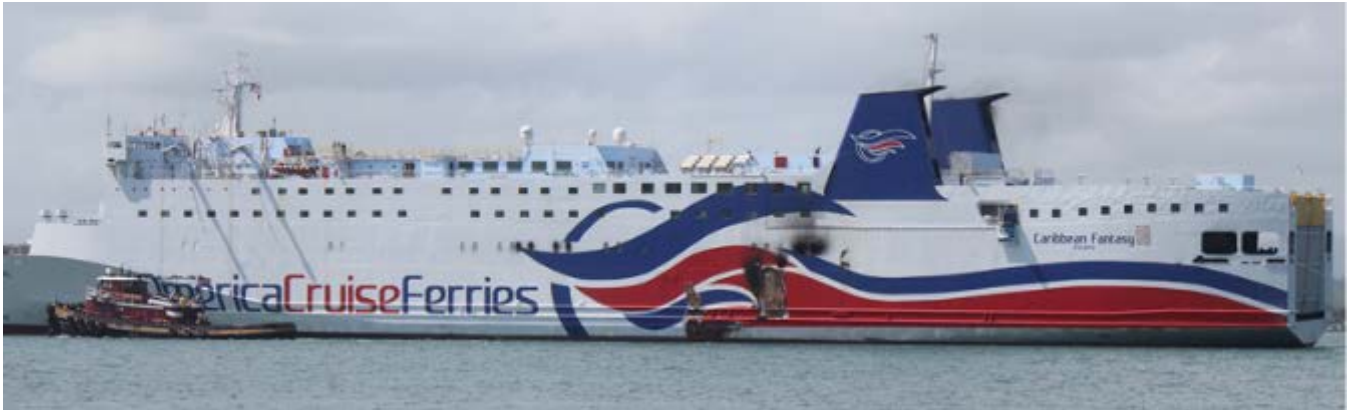
The exterior hull exhibited thermal related damage in areas adjacent to the engine casings (both port and starboard) and the main engine room. These areas exhibited blistered and burned paint with large areas of missing paint¹⁹. The damage extended from the level of the upper engine room up the entire height of the engine casing/exhaust stack. The damage to the exterior both port and starboard is shown in Figures 26 and 27. There was also exterior hull damage around frame 70 in the area of the port fuel bunker station.

¹⁹ Paint discolors approximately 250-400°F and begins to blister (bubble and peel) around 350-400 °F. These ranges are dependent on many factors including exposure time, flame vs radiant heat, paint type and layers of paint present. (*Engineering Analysis of Fires and Explosions*. Randall K. Noon, CRC Press, 1995).

Figure 27. Photograph of port side of ship while being towed into San Juan harbor on August 20. Smoke can be seen coming from the exhaust stacks on the upper deck.
