## MEMORANDUM

Subj: POST SINKING STABILITY ANALYSIS OF BOUNTY, O. N. 960956

**USCG MARINE SAFETY CENTER (MSC) POST SINKING STABILITY ANALYSIS**  
**OF BOUNTY, O. N. 960956**

**EXPLANATION OF ANALYSIS & ASSUMPTIONS**

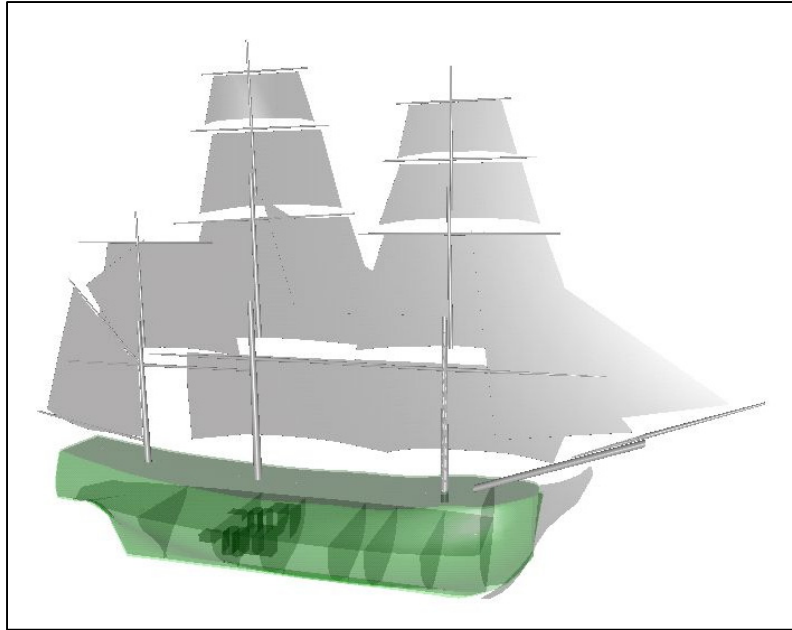
Figure 1 - Graphical representation of BOUNTY Model 2

Figure 1 shows Model 2 and includes the sail plan digitized from reference (d).

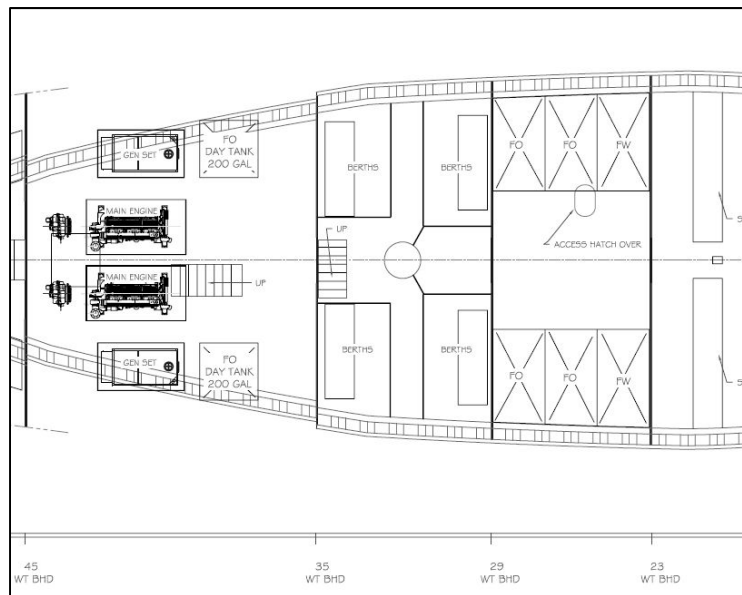
Figure 2 - Plan view of BOUNTY's arrangements prior to the 2012 modifications

During the 2012 drydock period, several modifications were made to the vessel. The freshwater and fuel tanks were removed from the compartment between frames 23 and 29 and re-installed in the compartment between frames 29 and 35. Additionally, four new 500 gallon freshwater tanks were installed in this compartment. The berths that had originally been installed in the compartment between frames 29 and 35 were rebuilt in the compartment between frames 23 and 29.

The fore topmast was removed, and replaced with the topmast from the mizzen. The main hatch grating and tonnage opening house were altered to restore tonnage “grandfathering”. In addition, after the BOUNTY was put back into the water, approximately 200 lead ingots, each weighing approximately 28 pound 10 ounces, were shifted from frame 25 to frames 41 and 48. Although, for the reasons mentioned above, BOUNTY’s stability letter was never in force, these weight changes rendered it invalid.
