**NATIONAL TRANSPORTATION SAFETY BOARD
Office of Research and Engineering
Vehicle Recorder Division
Washington, D.C. 20594**

GROUP CHAIRMAN'S FACTUAL REPORT OF INVESTIGATION

***S.S. El Faro* Wreckage Examination Report**

DCA16MM001

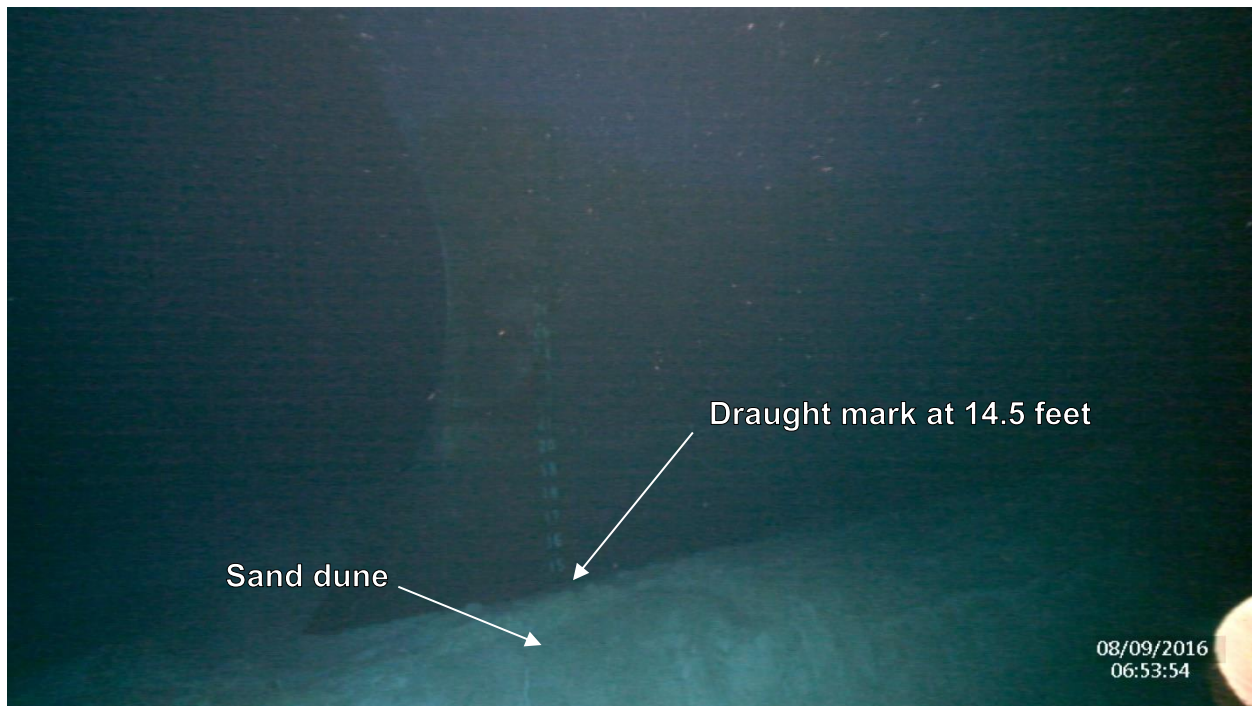
Figure 8. Region: Bow Source: Mission III Vehicle: CURV 21

The port forward draught mark shows that the bow is embedded in the seafloor to a depth of approximately 14.5 feet. There is an appearance of a sand dune on the port side of the bow, but not noticeable on the starboard side from this image. The dune appears to be approximately 1 to 2 meters high.

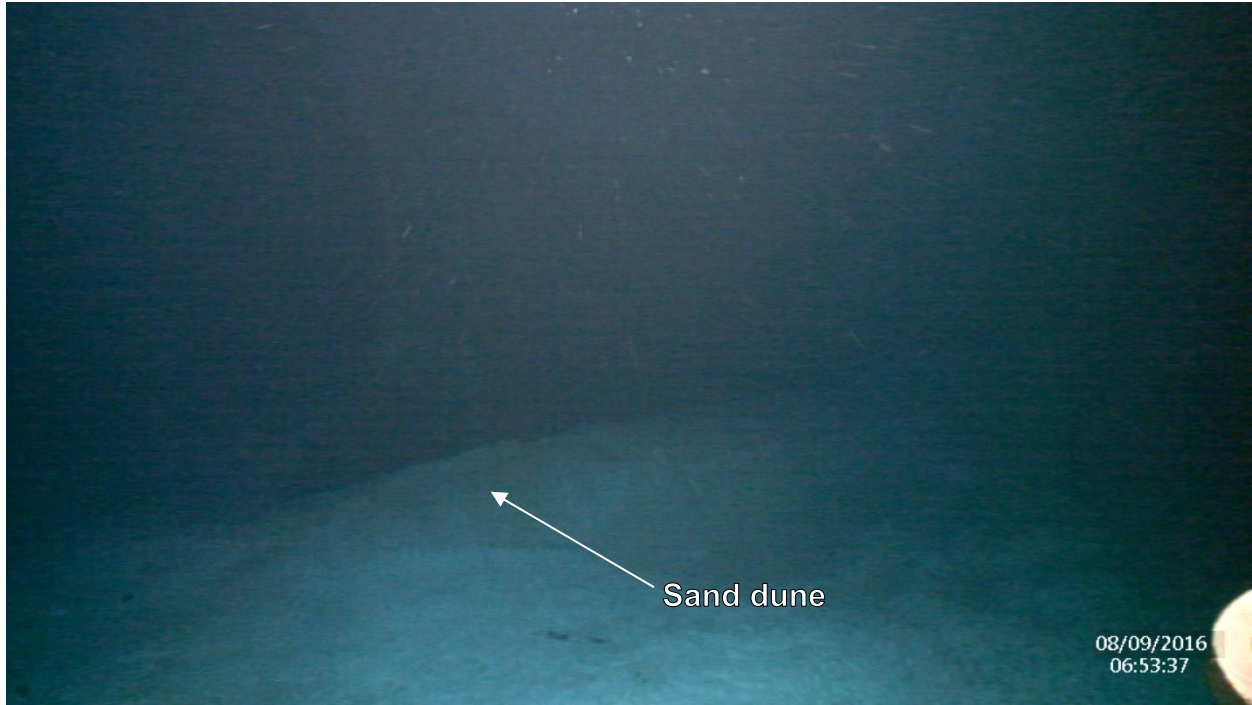
Figure 9. Region: Bow Source: Mission III Vehicle: CURV 21

A more pronounced view of the sand dune located on the port side of the bow.

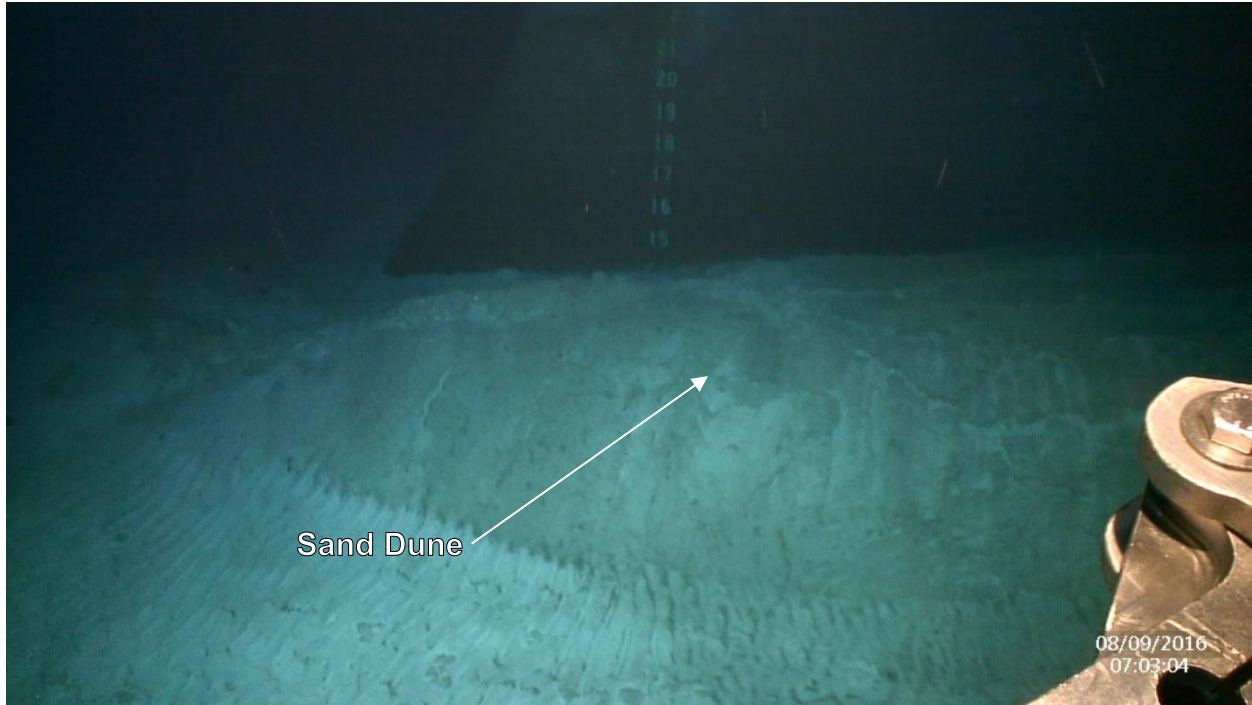
Figure 13. Region: Bow Source: Mission III Vehicle: CURV 21

An additional image of the approximate 1 to 2 meter high dune on the port side of the bow. As the camera moved away and slightly aft from the port bow, the dune was seen as being slightly larger in size.

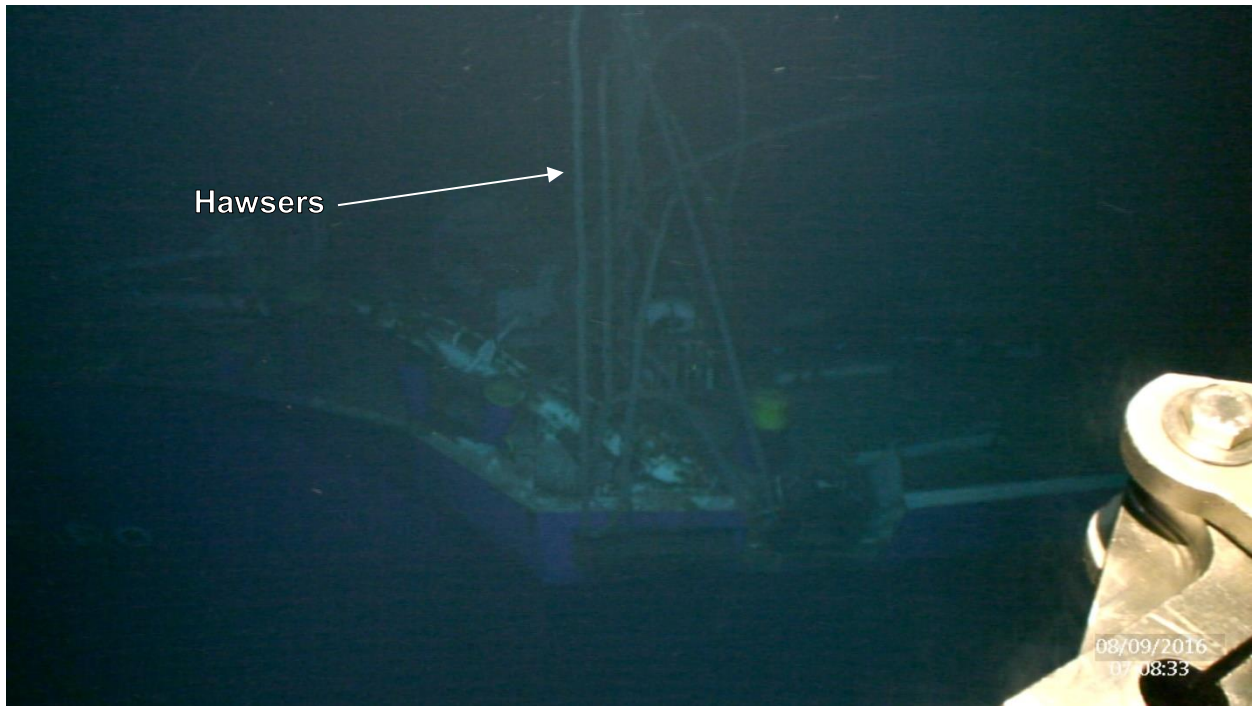
Figure 14. Region: Bow- Frame 15 to Source: Mission III Vehicle: CURV 21

Imagery shows port side of the ship, near the bow in the region of frame 15 to 20. The imagery was taken just above the port bulwark. Hawsers are streaming and the top of the foremast is laid to port toward the roller fairleads. The six man life raft and life raft canister, that should have been located between the mooring chocks and the anchor winch were not present.

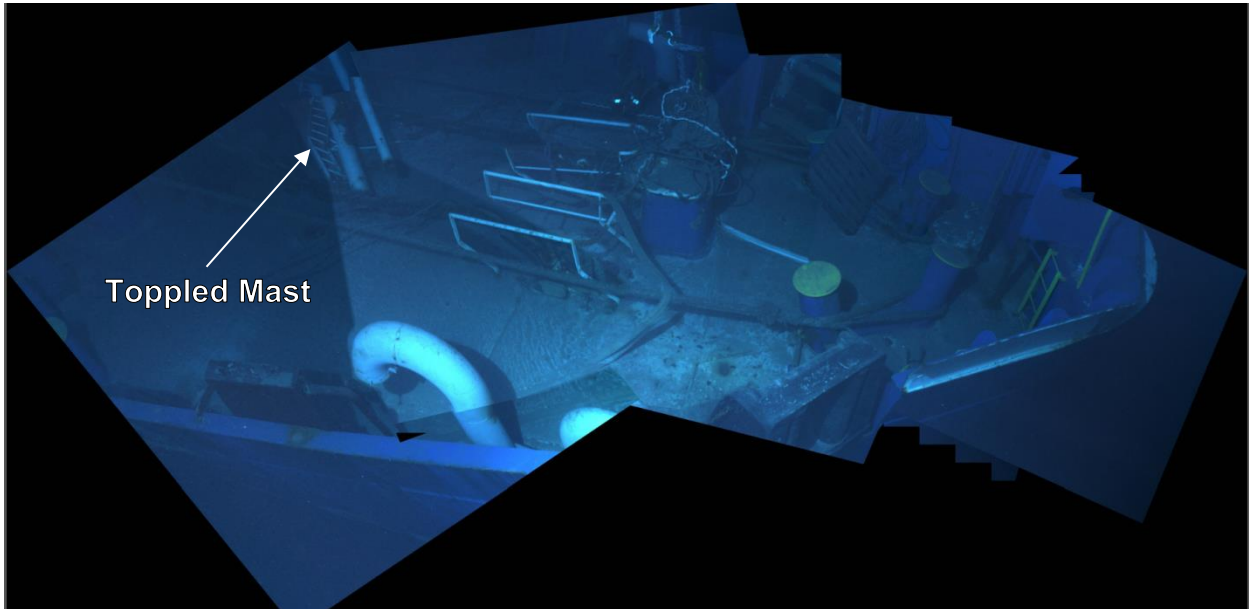
Figure 15. Region: Bow Source: Mission II Vehicle: Alvin Observation Vehicle - Mosaic

A mosaic created from multiple images taken from the starboard side of the ship above the bulwark. The image shows the foremast toppled aft and the general condition of the deck in the region of the bow.

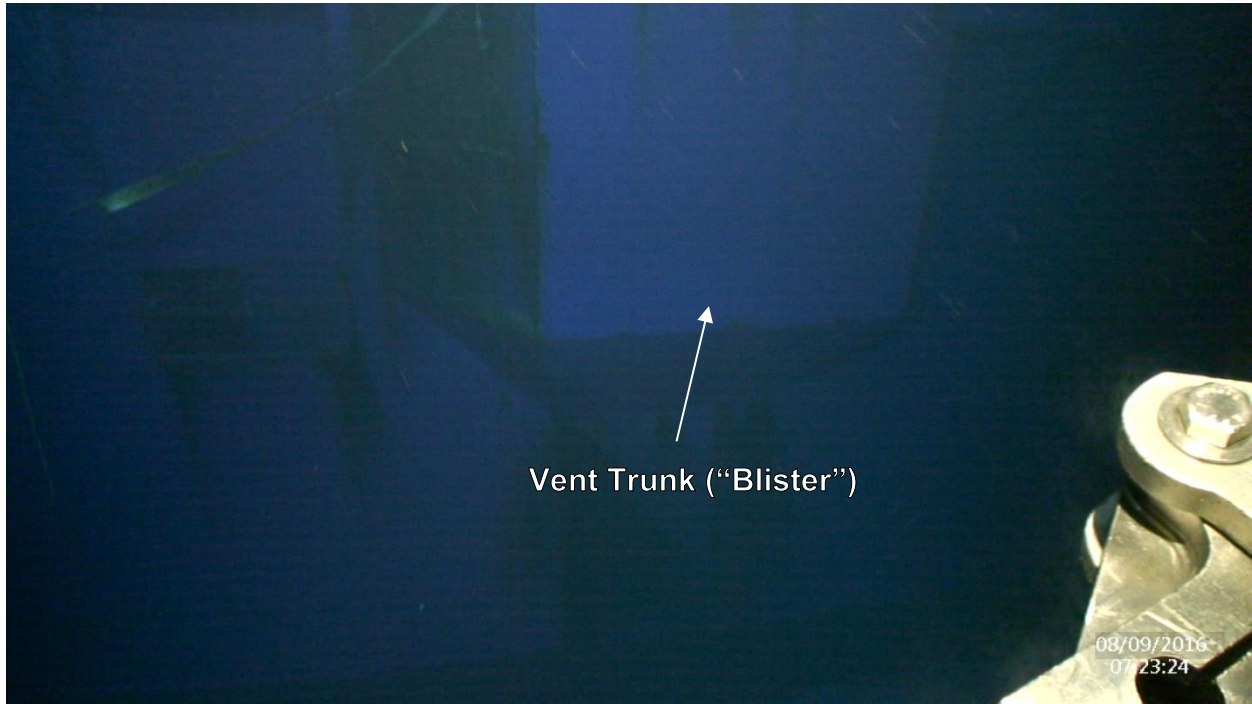
Figure 24. Region: Port – Frame 110. Source: Mission III Vehicle: CURV 21

Cargo hold supply vent trunk (“blister”) at frame 110 on the port side.

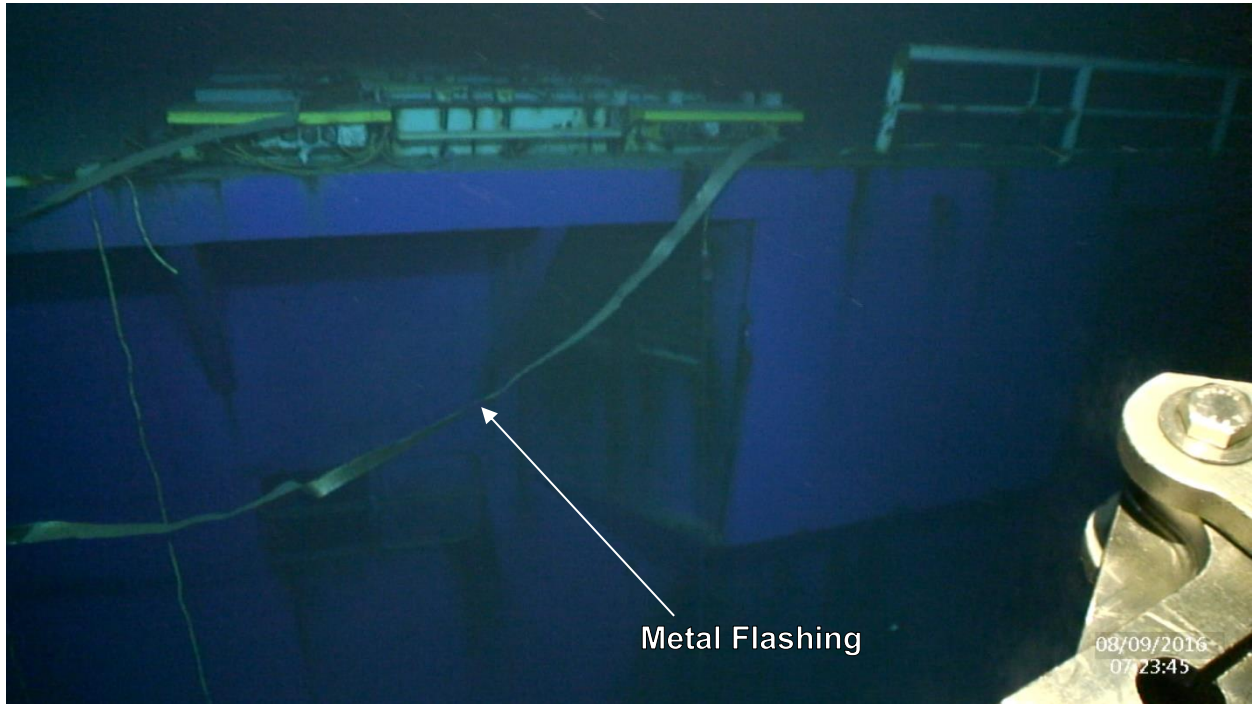
Figure 25. Region: Port – Frame 110. Source: Mission III Vehicle: CURV 2

Deck railing shown to begin at frame 110. Metal flashing (cargo³) visible hanging over the ship's deck.

³ Metal flashing contained in the remainder of the report was associated with ship's cargo.

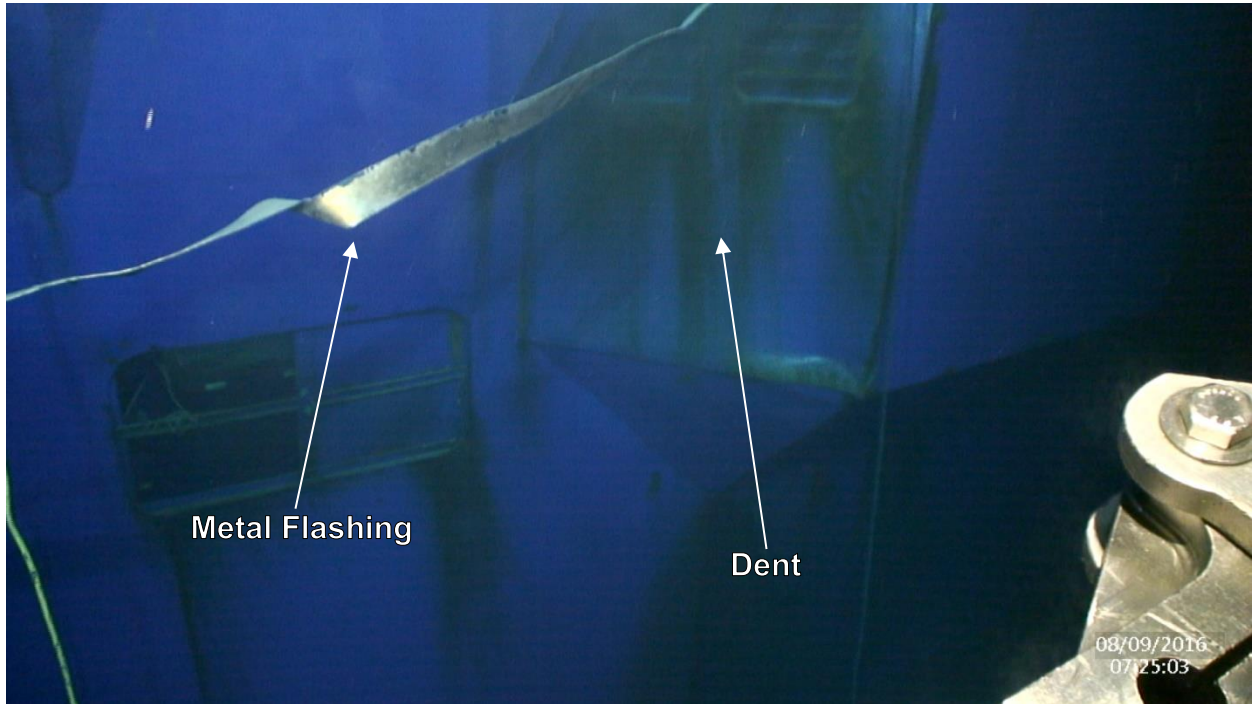
Figure 26. Region: Port – Frame 110. Source: Mission III Vehicle: CURV 21

Dent on forward face of blister/cargo hold supply vent at frame 110, port side. 4 inch metal flashing roll in foreground.

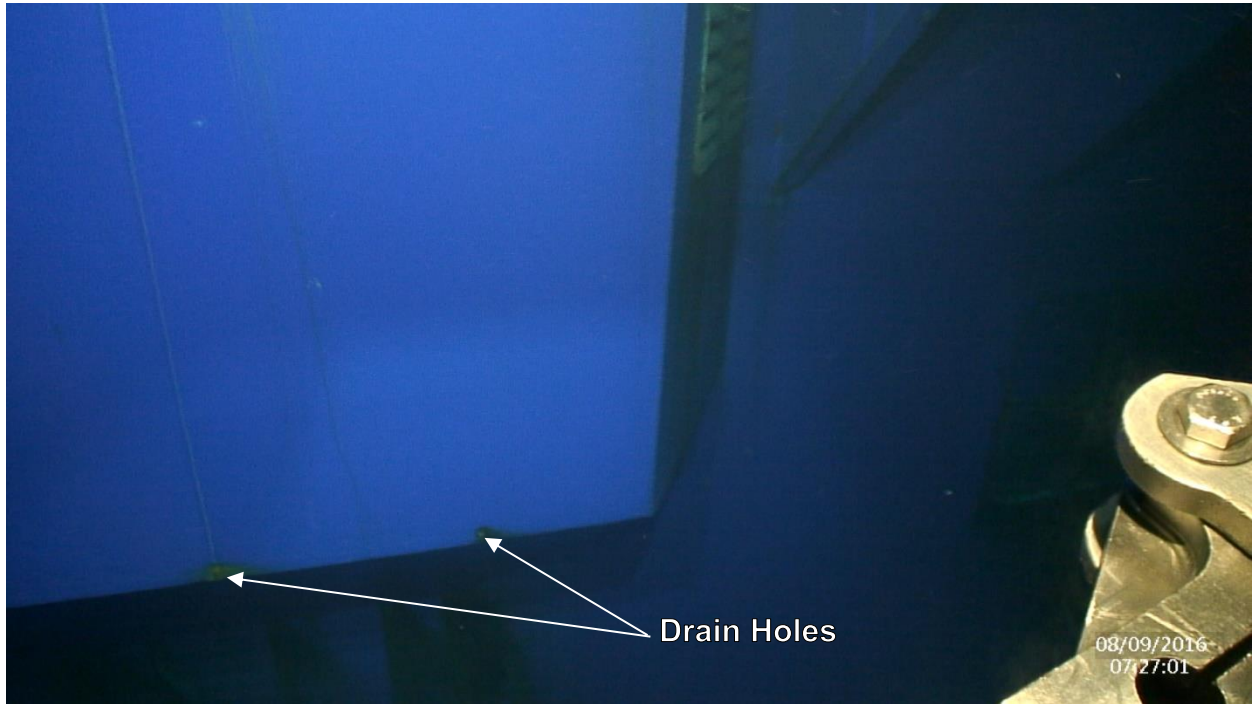
Figure 28. Region: Port – Frame 112. Source: Mission III Vehicle: CURV 21

Drain holes on the bottom seam/corner of blister/cargo hold supply vent trunk.

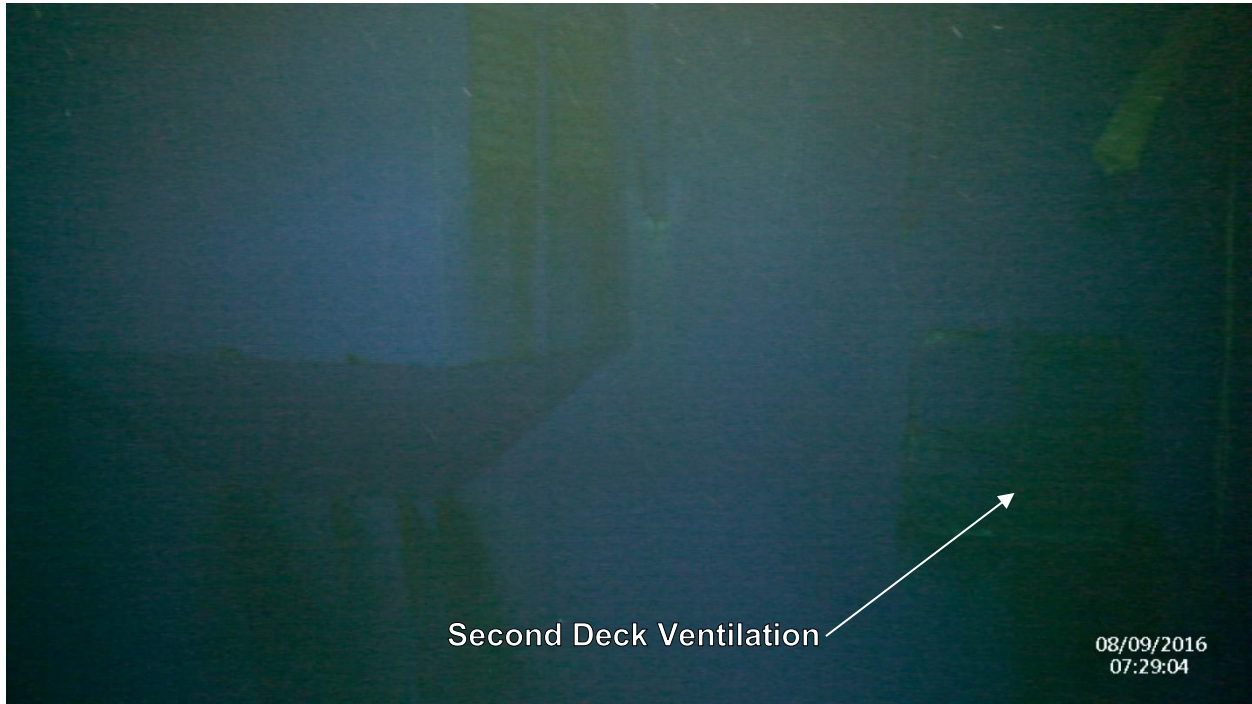
Figure 30. Region: Port – Frames 118 - 120. Source: Mission III Vehicle: CURV 21

Second deck ventilation opening with closed door between frames 118 and 120.

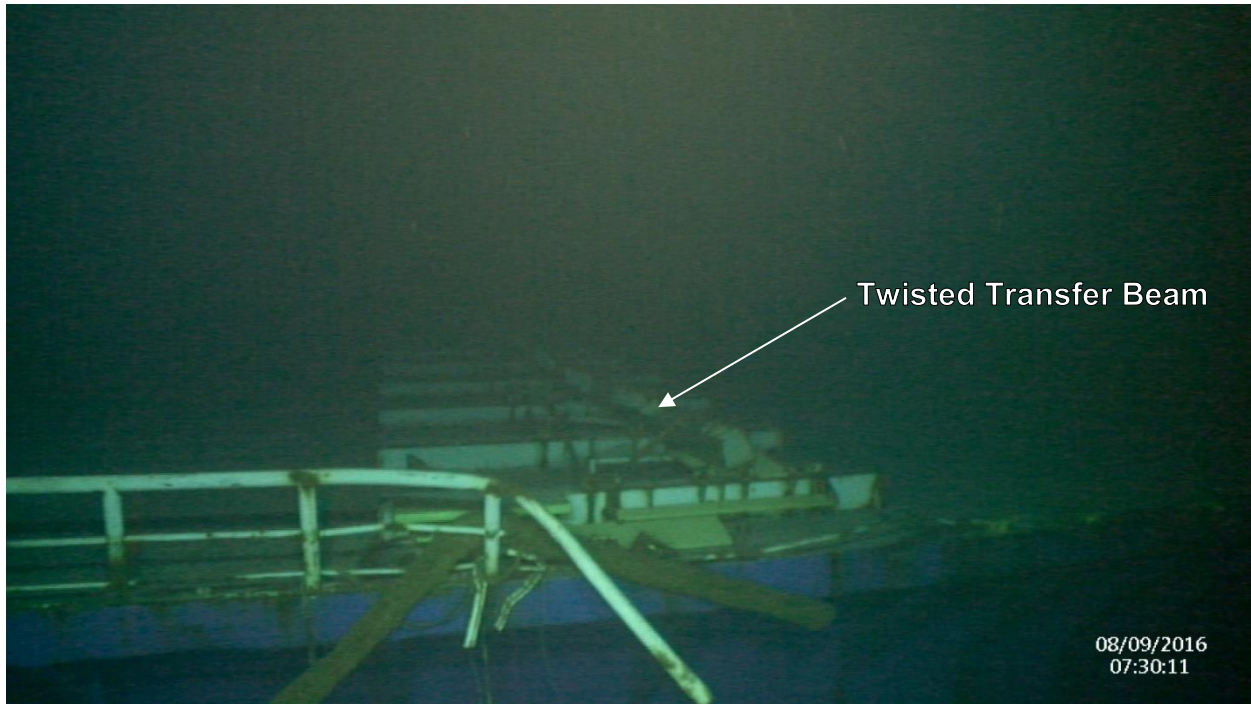
Figure 31. Region: Port – Bay 10 -11. Source: Mission III Vehicle: CURV 21

Twisted transfer beam between bays 10 and 11.

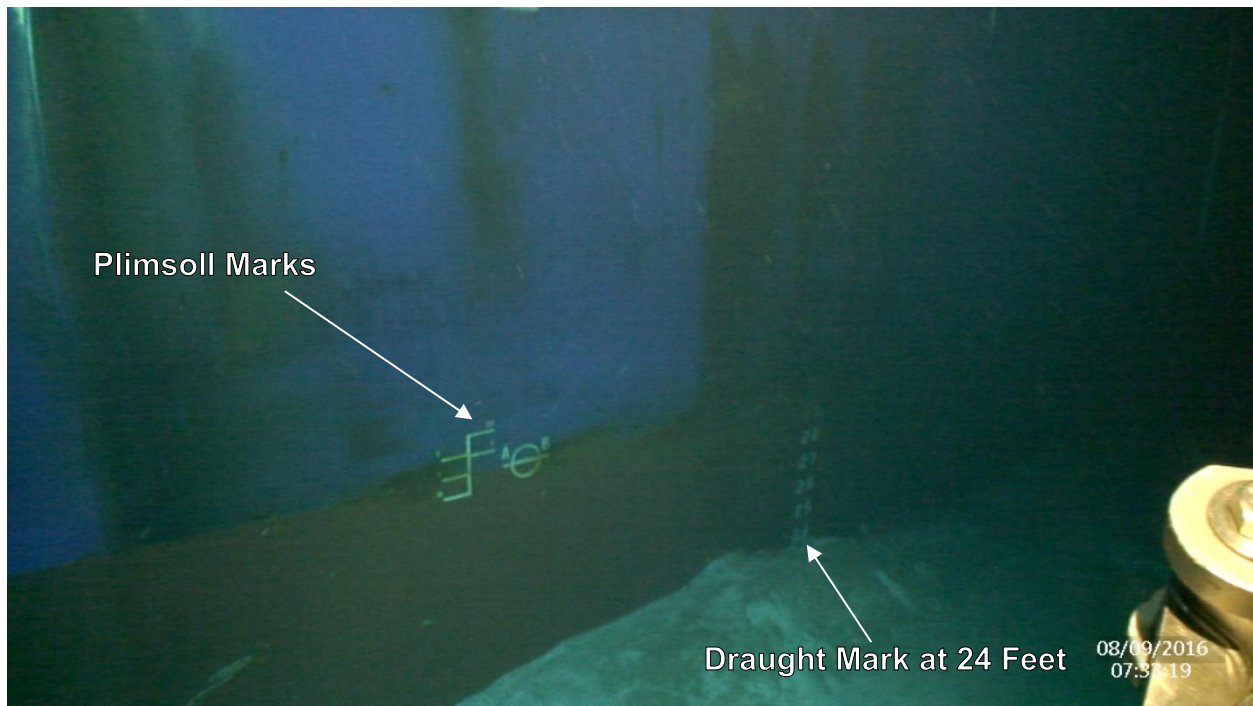
Figure 34. Region: Port – MidShip. Source: Mission III Vehicle: CURV 21

Plimsoll marks visible. Draught marks visible showing port midship mudline (draught) at approximately 24 feet.

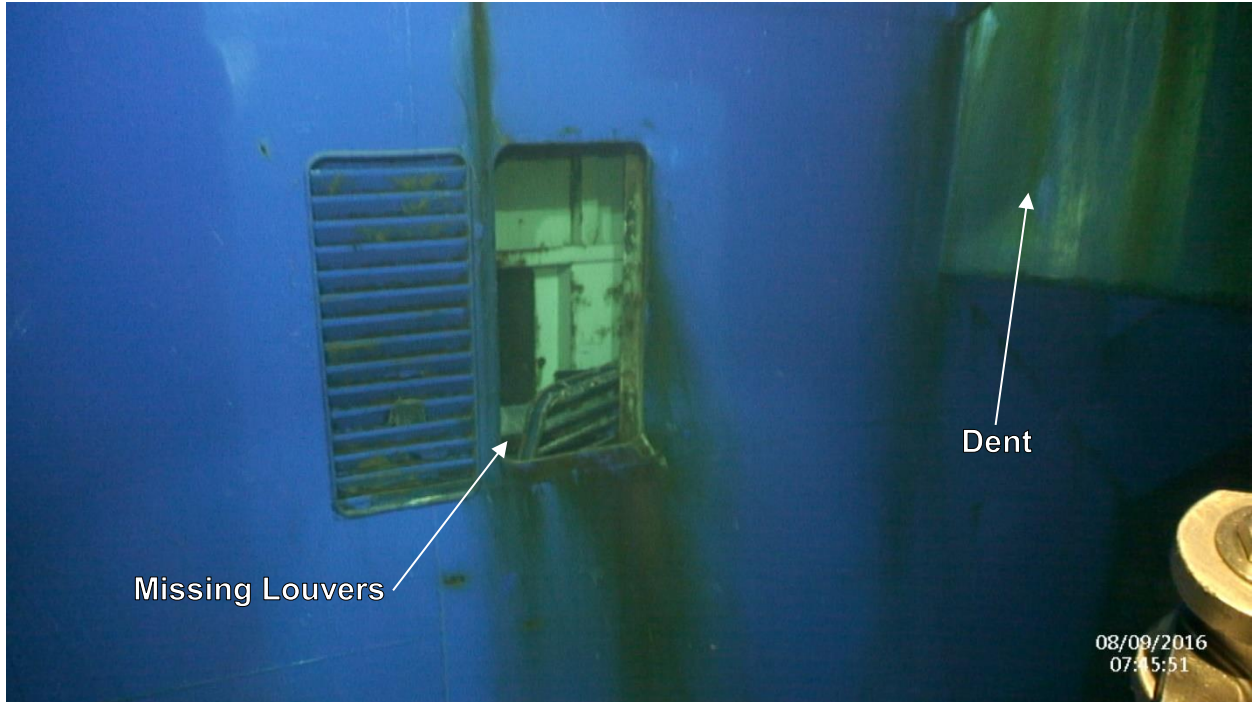
Figure 36. Region: Port – Frame 143. Source: Mission III Vehicle: CURV 21

Cargo hold exhaust vent with louvers missing in the approximate area just forward of frame 143. A dent is seen on forward face of blister for cargo hold supply vent at frame 143.

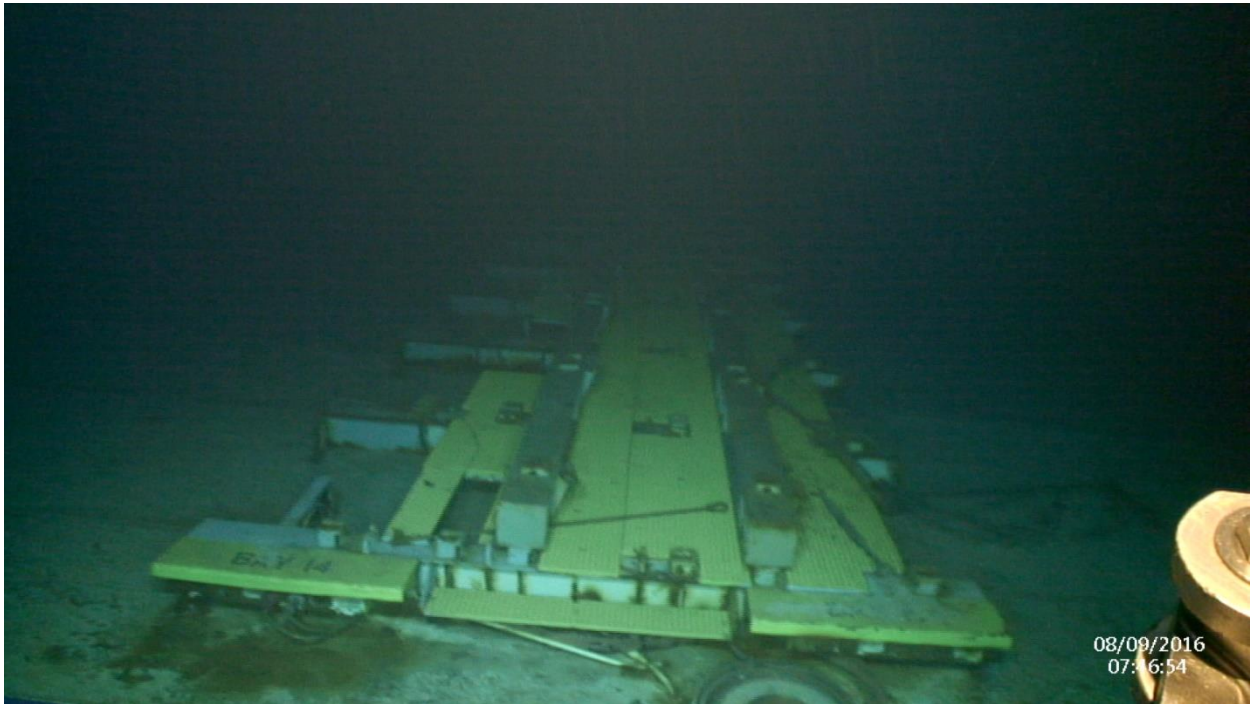
Figure 39. Region: Port – forward of house Source: Mission III Vehicle: CURV 21

An undamaged section of container supports and transfer beams. This is not typical of the other bays that were visible in other areas of the ship.

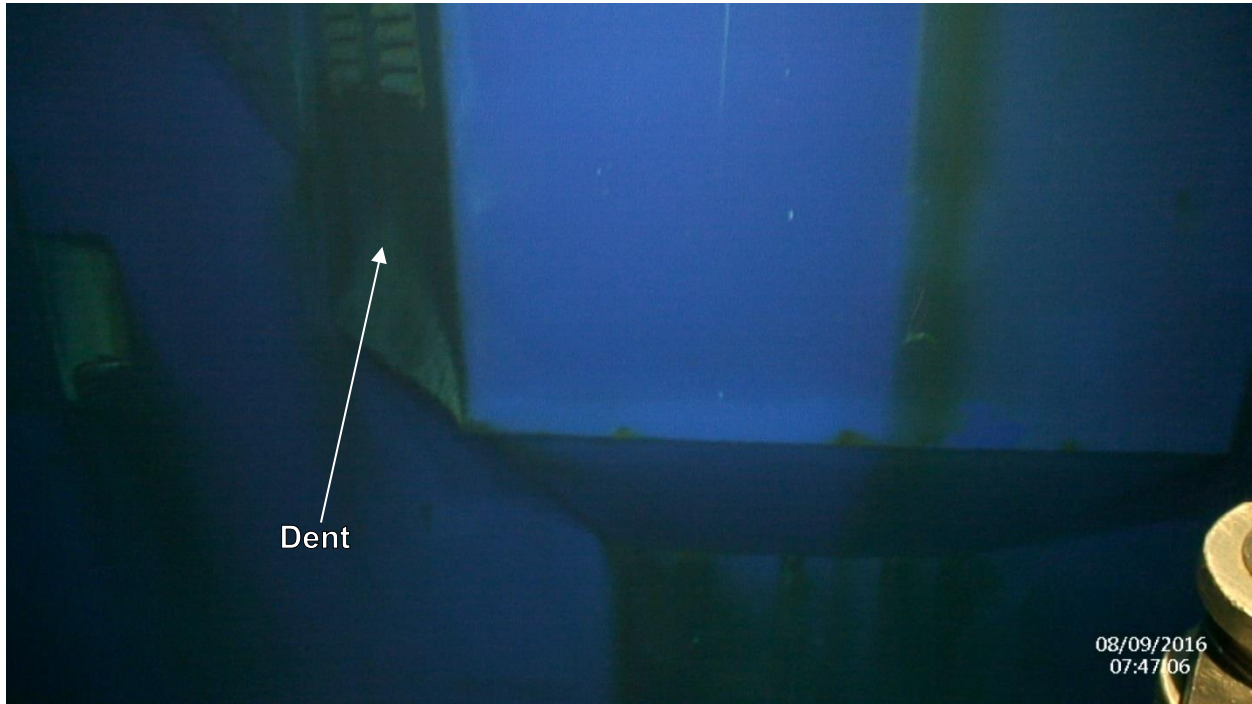
Figure 40. Region: Port – frame 143 Source: Mission III Vehicle: CURV 21

A dent is seen on forward face of blister/cargo hold supply vent at frame 143.

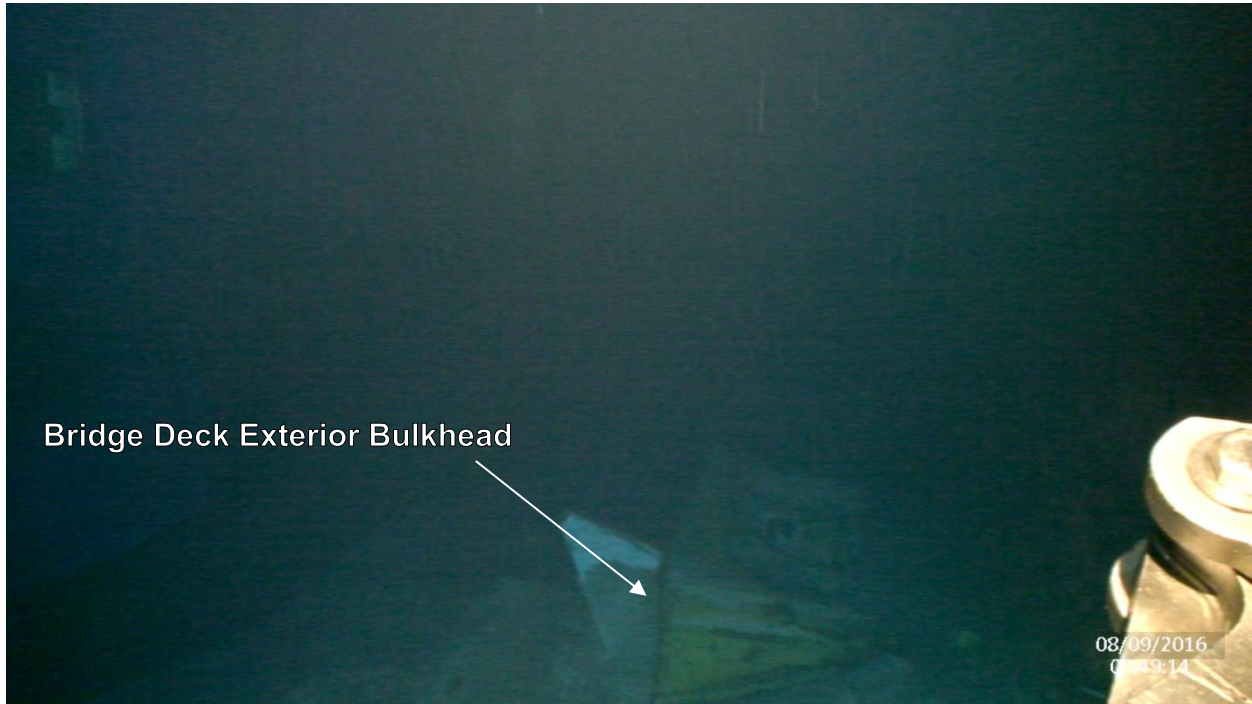
Figure 41. Region: Port – Abeam House Source: Mission III Vehicle: CURV 21

Section of lower navigation bridge deck exterior bulkhead with window on the seafloor, located abeam port side of the house, adjacent to the fueling station near frame 170.

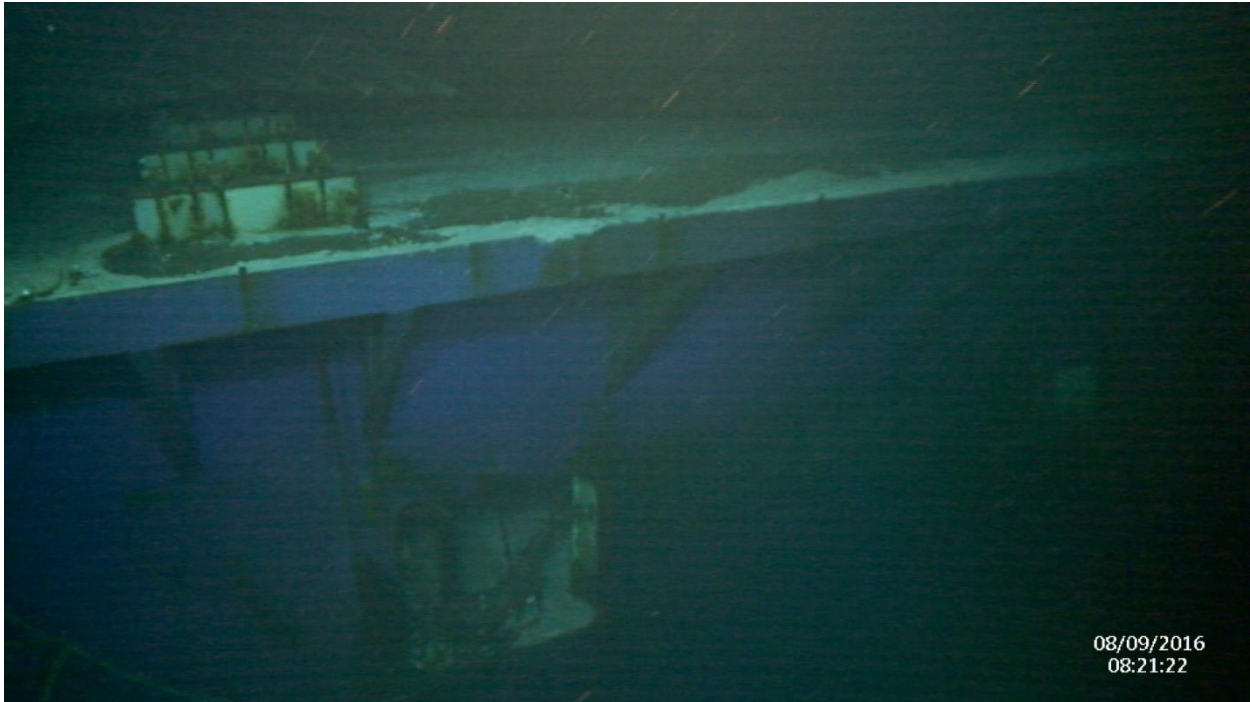
Figure 43. Region: Port – Frame 186 Source: Mission III Vehicle: CURV 21

Port main deck edge. Deck rail is absent.

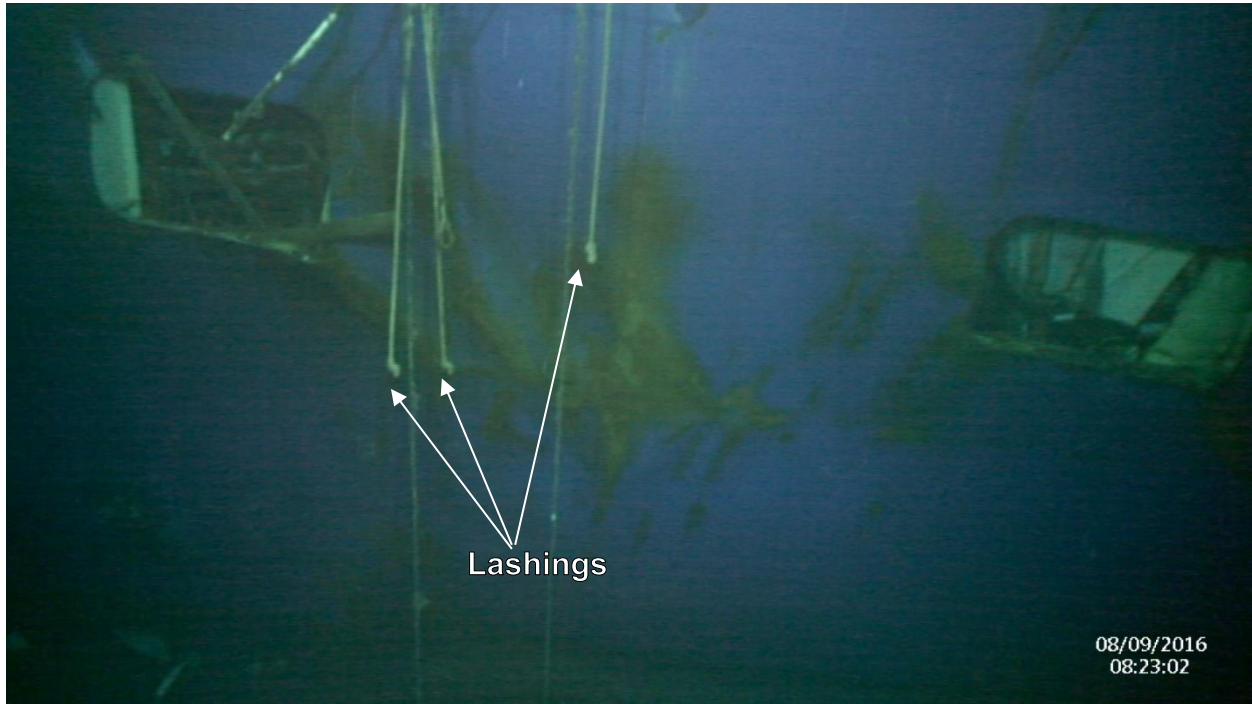
Figure 44. Region: Port – Frame 193 Source: Mission III Vehicle: CURV 21

Container lashings and other cordage hanging from main deck edge between 2nd deck openings at frame 198 and 193.

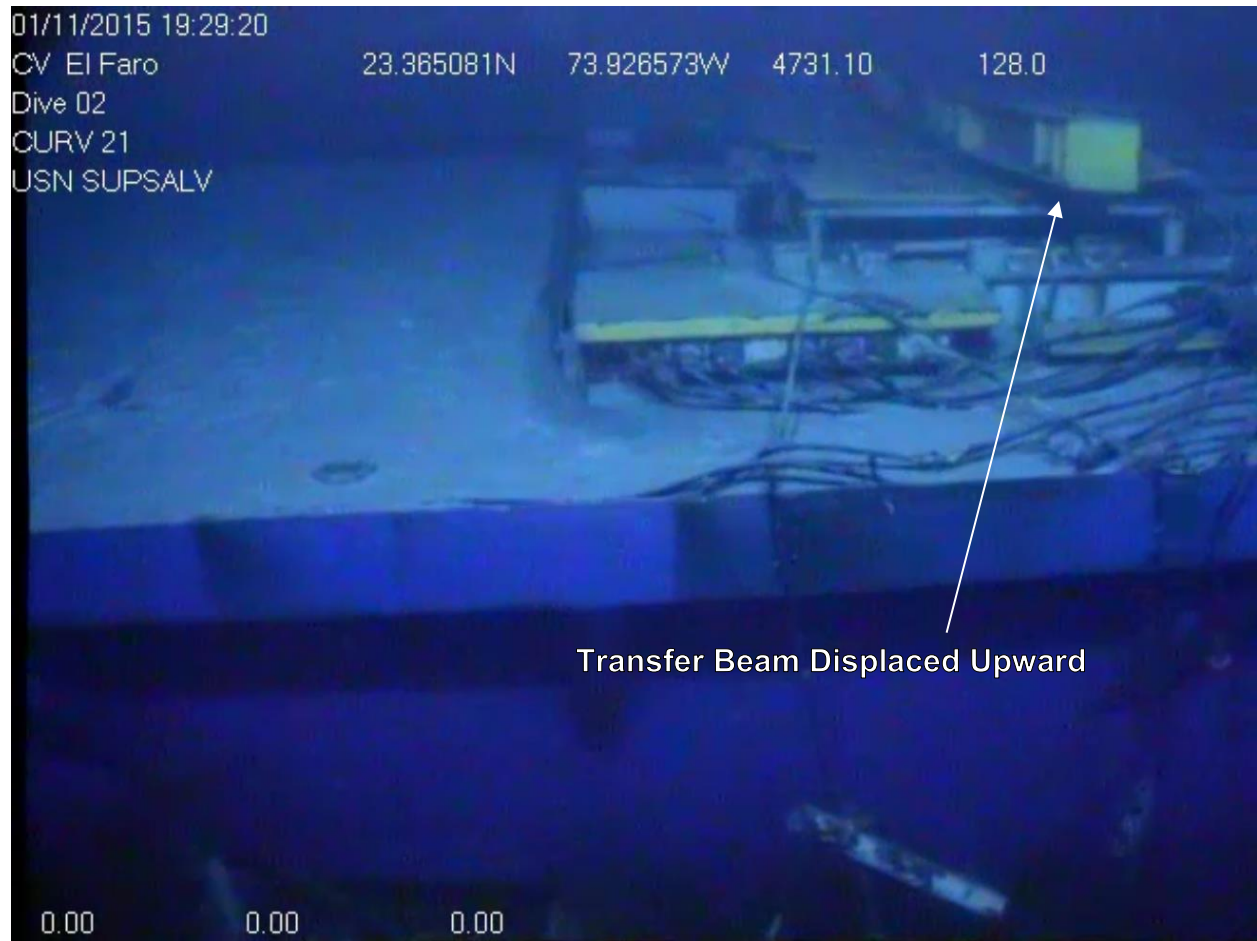
Figure 45. Region: Port – Bay 16 Frame 200 Source: Mission I Vehicle: CURV 21

Video was captured starting on the port side near bay 16 around frame 200. The transfer beam at frame 203 is visible and bent upward. The outboard portion of the transfer beam is displaced upward at least 12 inches.

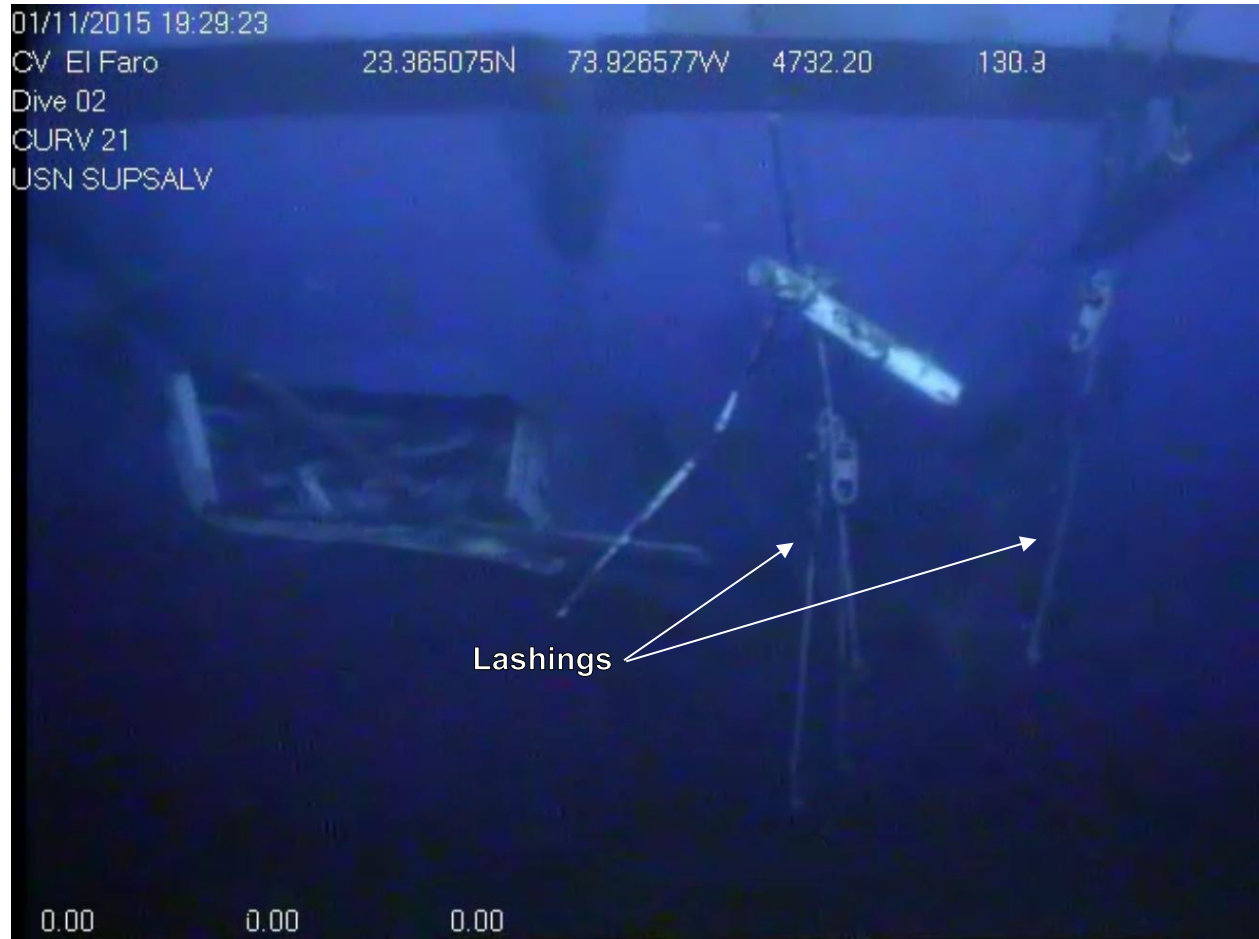
Figure 46. Region: Port – Frame 200 Source: Mission I Vehicle: CURV 21

Lashes hanging in the region of frame 200. A handrail station is entangled in the hanging lashings.

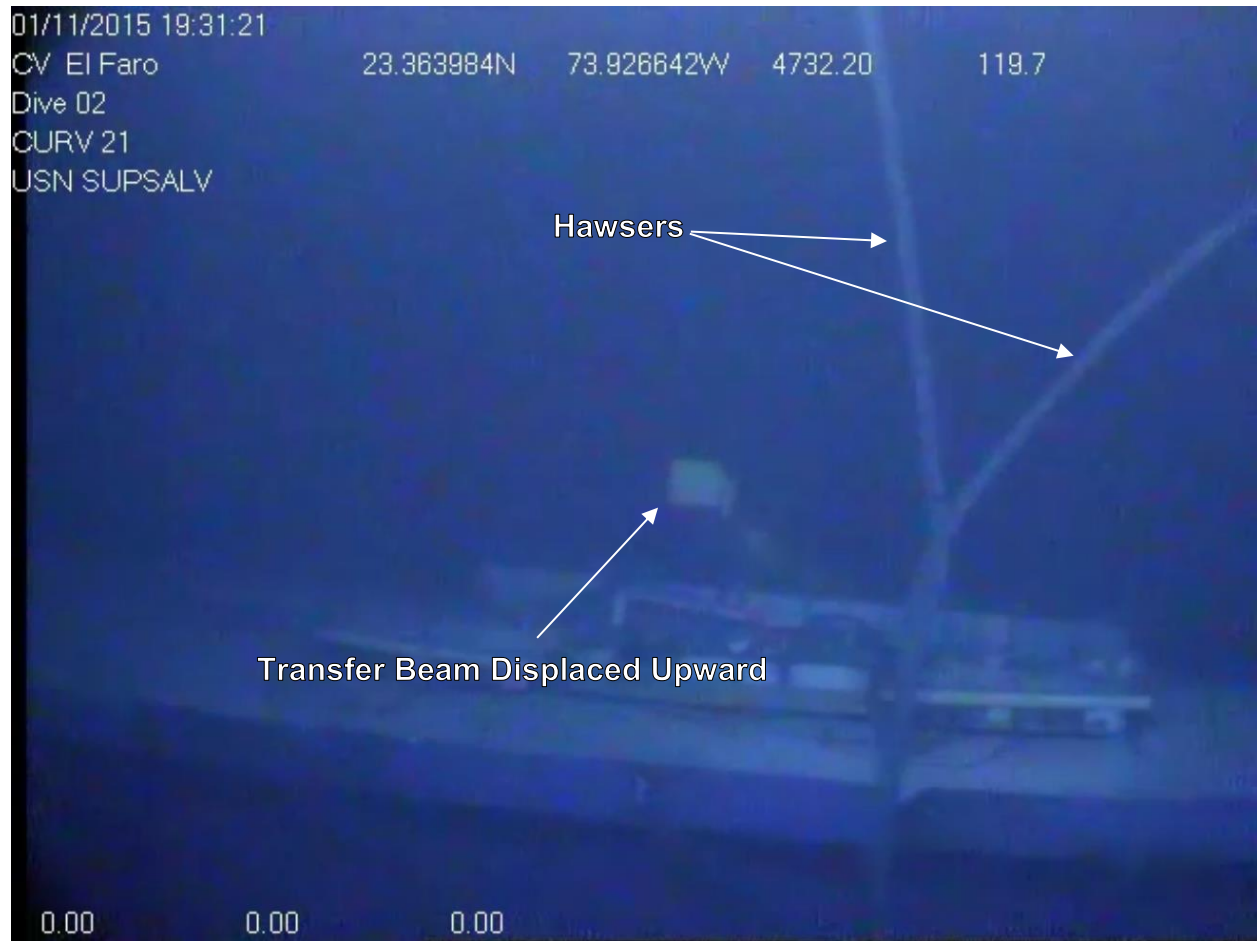
Figure 48. Region: Port – Bay 18 and 19 Source: Mission I Vehicle: CURV 21

A transfer beam is bent upward approximately four feet. A hawser is seen floating upward in the same area. The end of the mooring line was not seen.

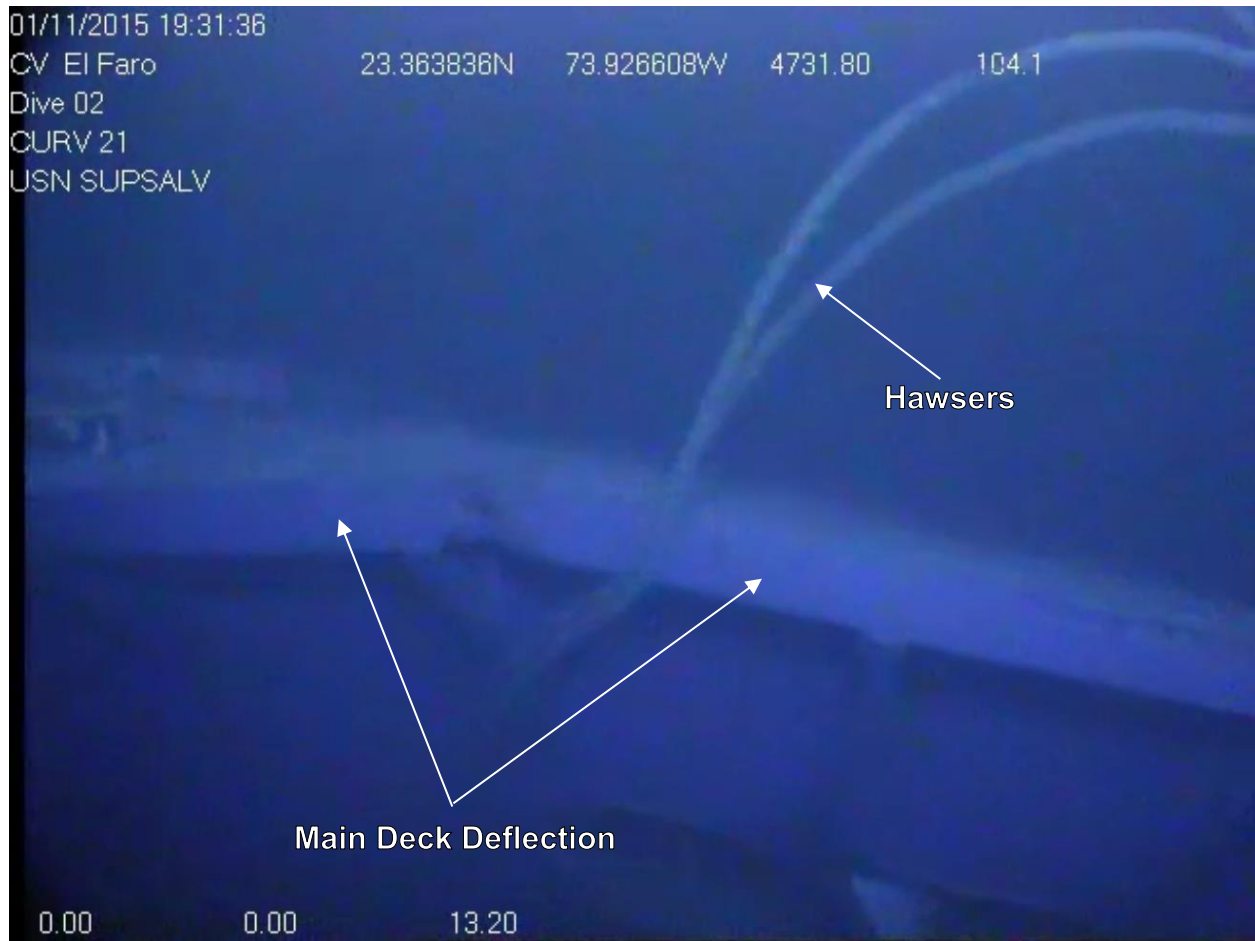
Figure 49. Region: Port – Frame 247 Source: Mission I Vehicle: CURV 21

Main deck is significantly displaced in the region of frame 247 on the port side. The angle of longitudinal deflection is estimated between 12 and 15 degrees.

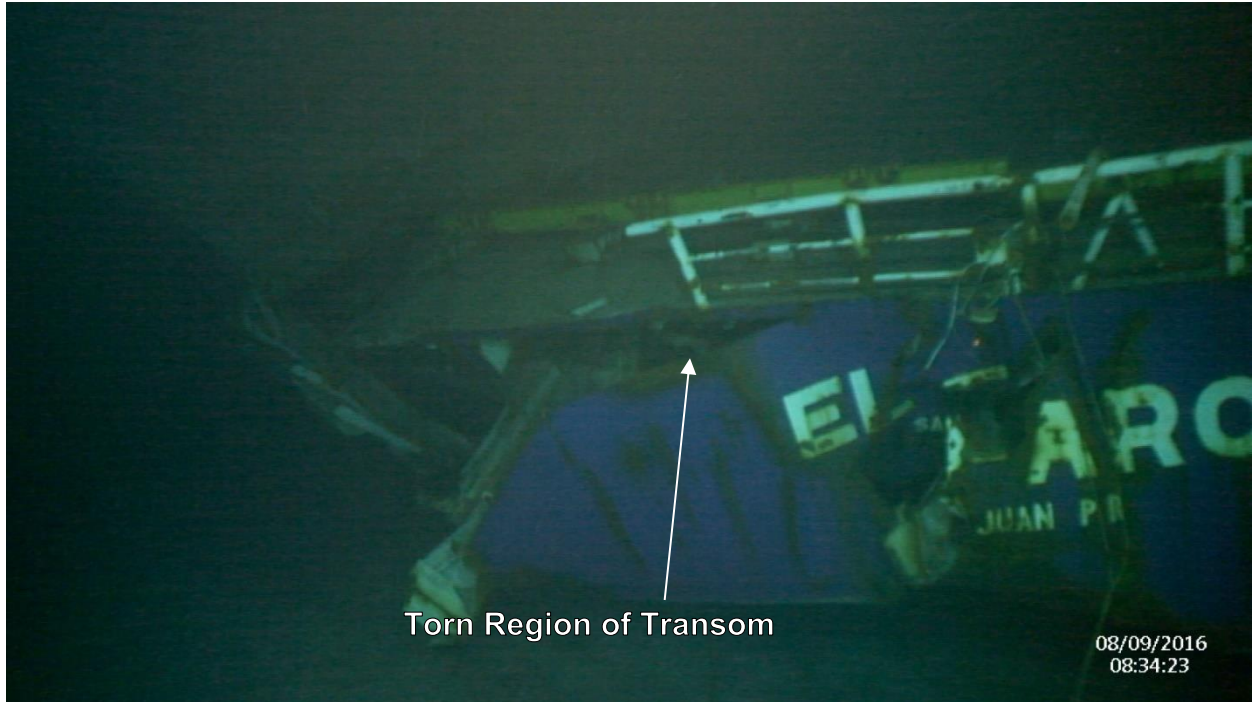
Figure 54. Region: Port – Stern Source: Mission III Vehicle: CURV 21

Greater detail of the tear in the ship's transom between centerline and 30 feet to port of centerline. The transom shell plating is separated from the main deck seam from the port corner to approximately 6 feet to port from the ship's centerline.
