**NATIONAL TRANSPORTATION SAFETY BOARD
Office of Research and Engineering
Vehicle Recorder Division
Washington, D.C. 20594**

GROUP CHAIRMAN'S FACTUAL REPORT OF INVESTIGATION

***S.S. El Faro* Wreckage Examination Report**

DCA16MM001

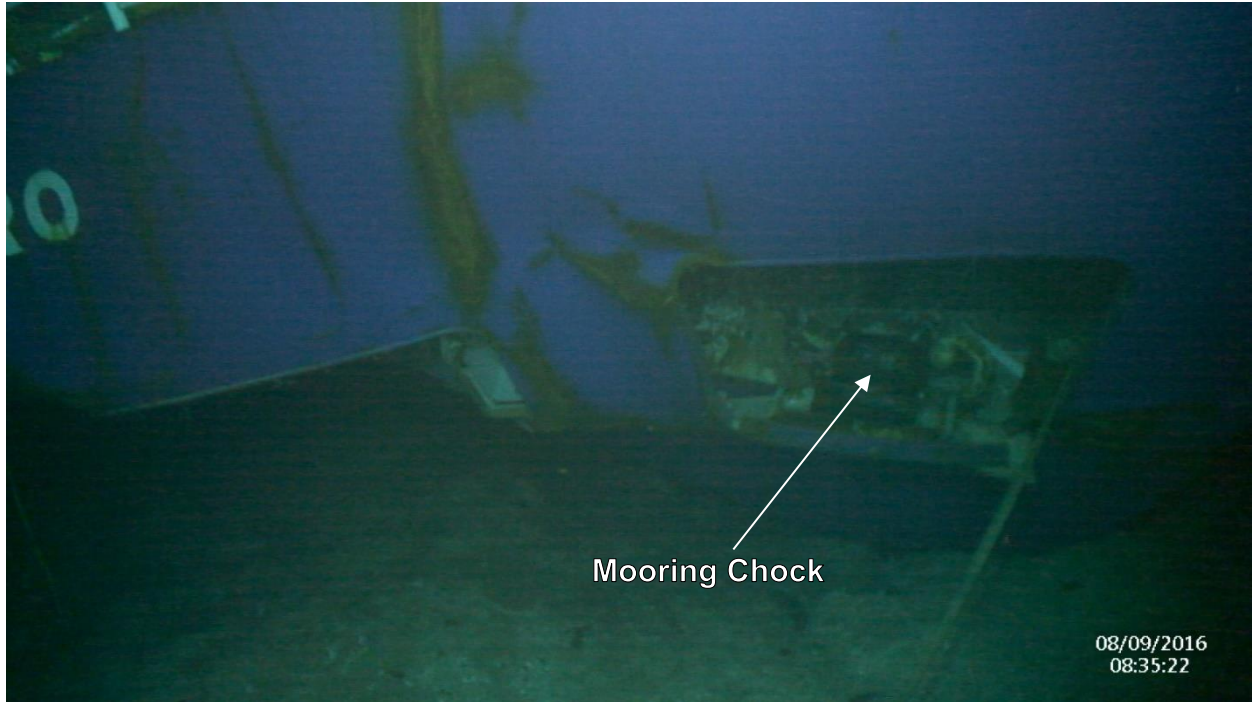
Figure 55. Region: Port – Stern Source: Mission III Vehicle: CURV 21

The transom starboard side bent aft (outwards) above second deck. Mooring chock on second deck visible approximately 8 feet forward of transom.

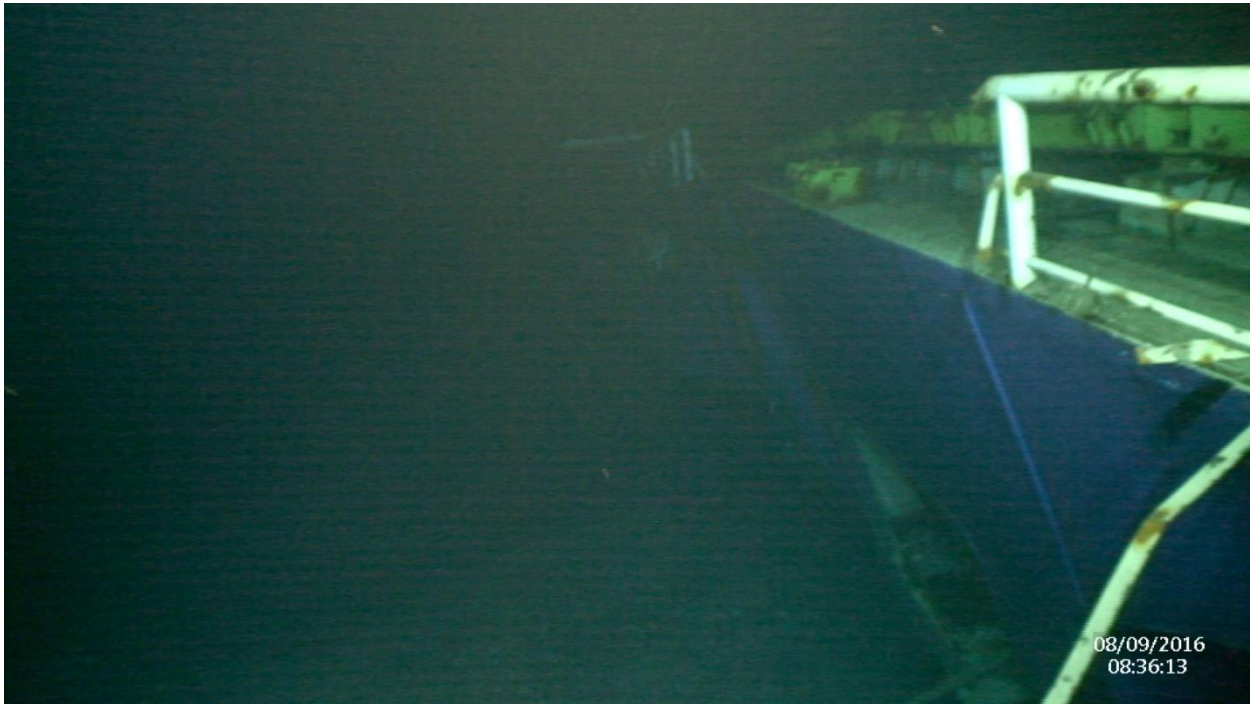
Figure 56. Region: Starboard – Stern Source: Mission III Vehicle: CURV 21

The image shows the stern of the ship as well as the ship's transom captured from the starboard stern quarter at main deck.

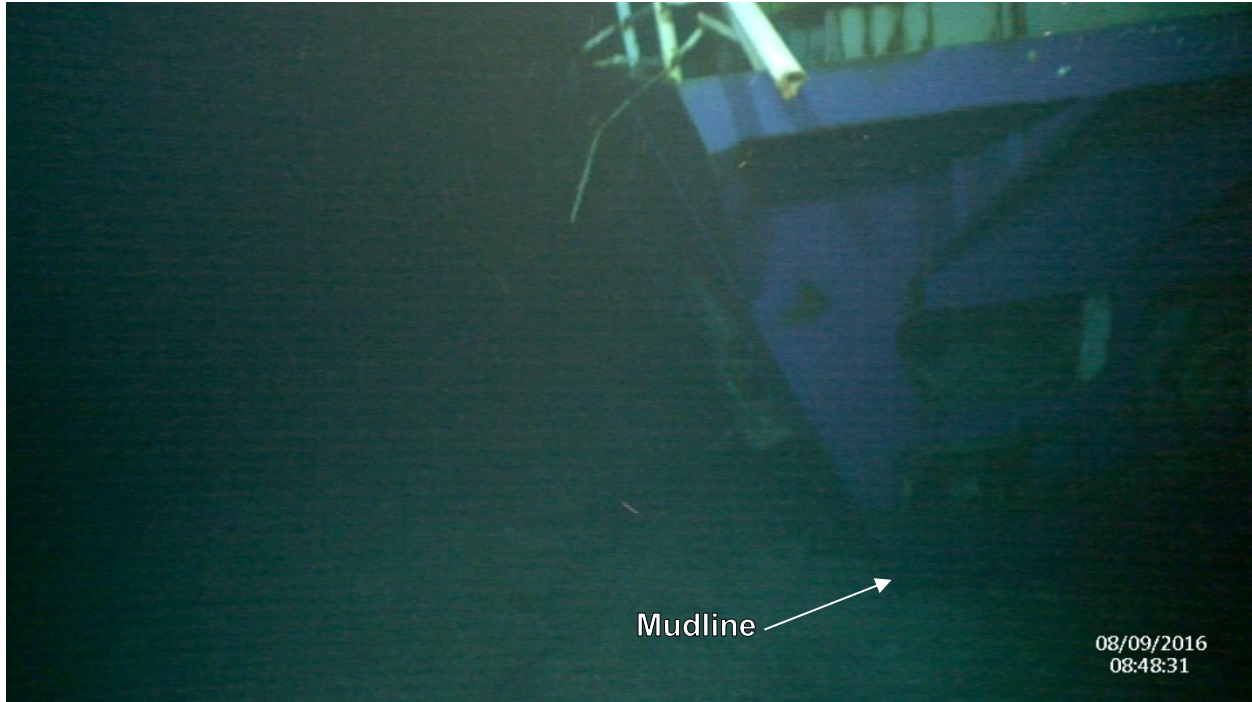
Figure 57. Region: Starboard – Stern Source: Mission III Vehicle: CURV 21

The mudline about three feet below the second deck at the starboard stern quarter.

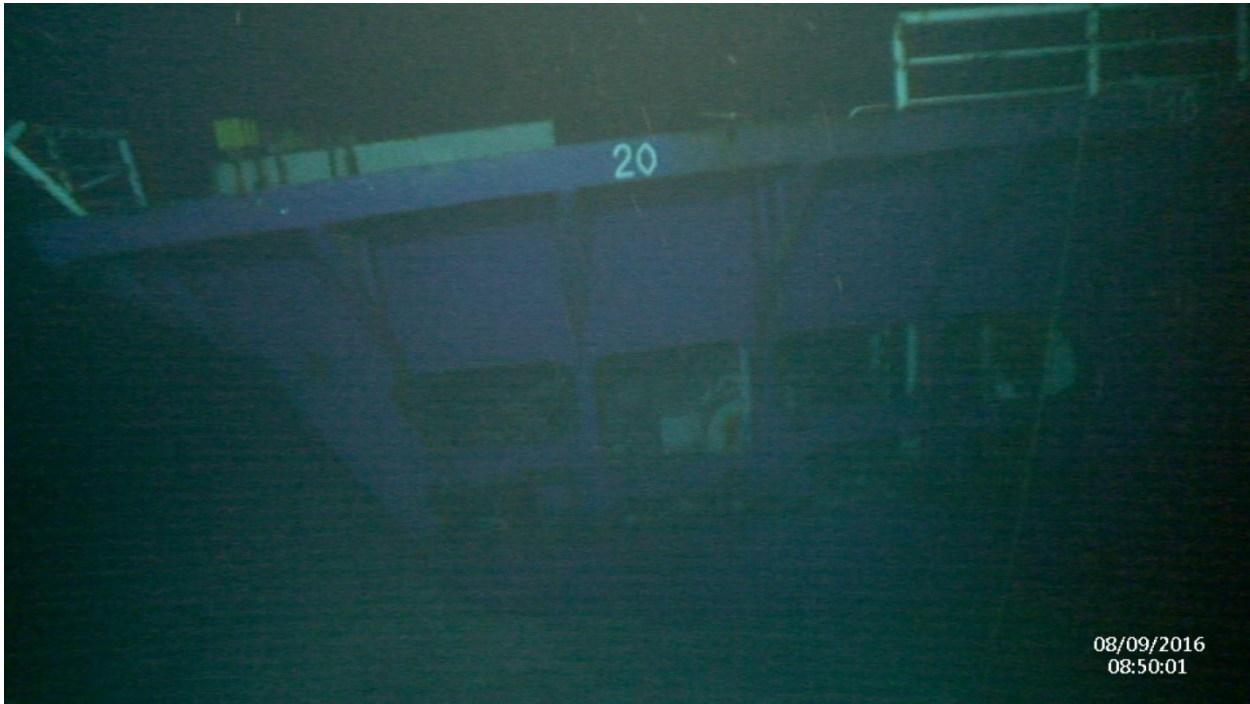
Figure 58. Region: Starboard – Frame 248 Source: Mission III Vehicle: CURV 21

The handrail is missing from frame 248 to the transom on the starboard side.

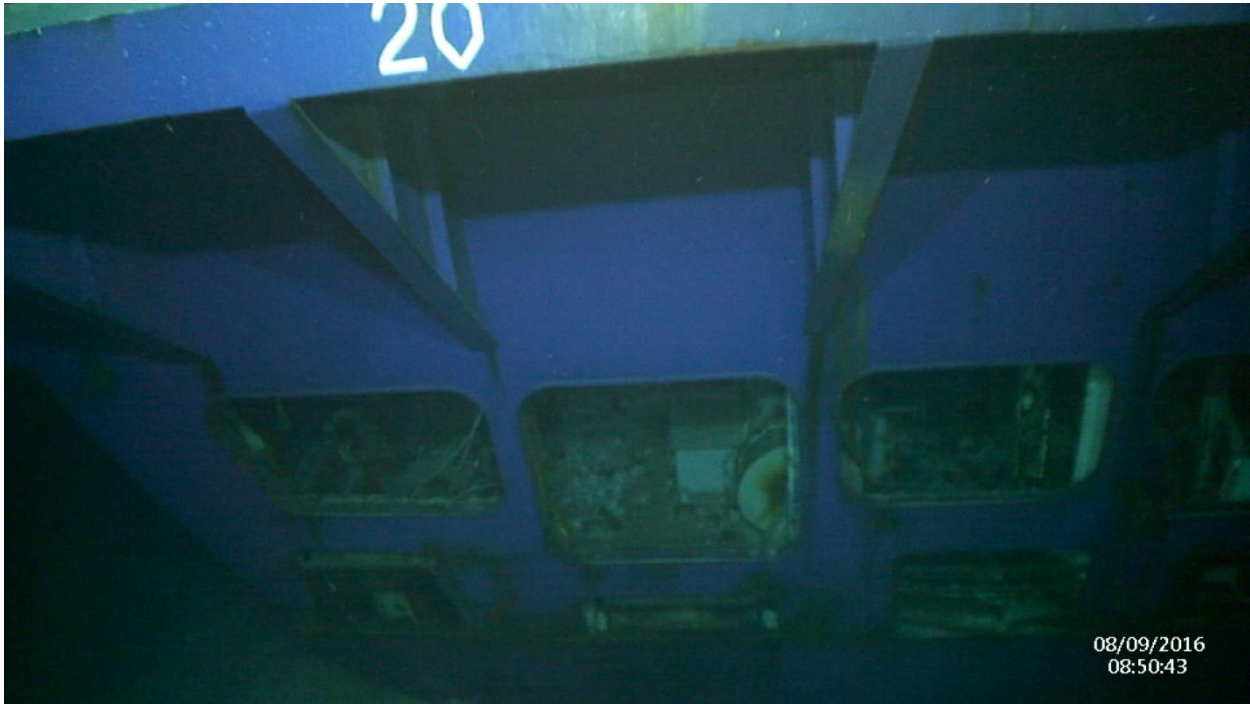
Figure 59. Region: Starboard – Frame 248 Source: Mission III Vehicle: CURV 21

View of the second deck mooring area on the starboard side of the ship.

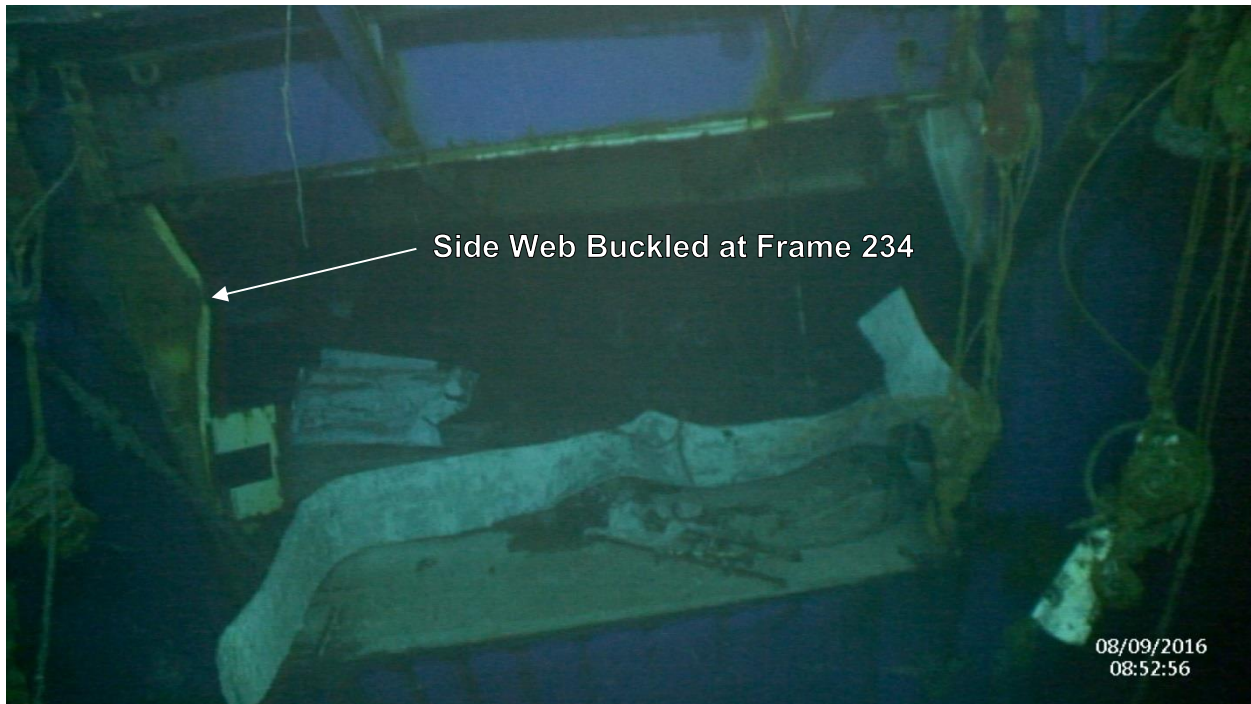
Figure 60. Region: Starboard – Frame 234 Source: Mission III Vehicle: CURV 21

Visible on the left (aft) side of the aft ramp opening, the side web at frame 234 is heavily buckled. Additionally, not clearly captured by the ROV, the handrail was present between bays 18 and 19.

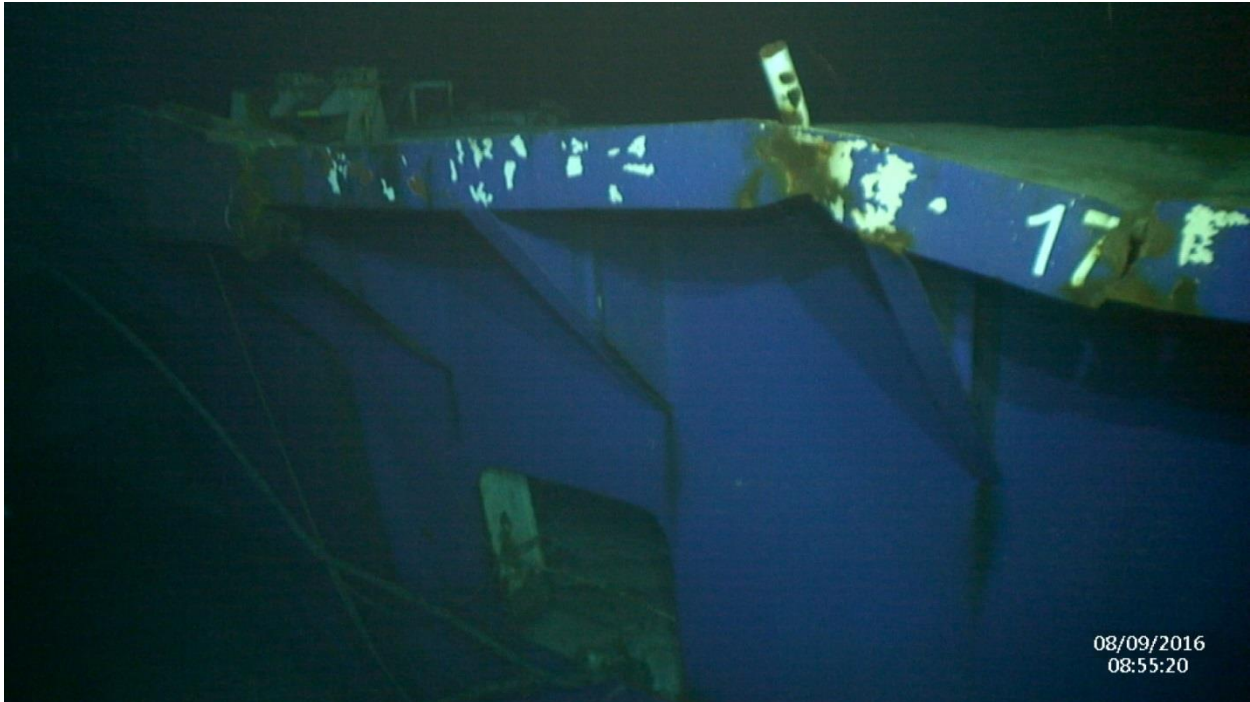
Figure 62. Region: Starboard – Frame 212 Source: Mission III Vehicle: CURV 21

Deformation in the region of bay 17 near frame 212 on main deck wing gunwale plate.

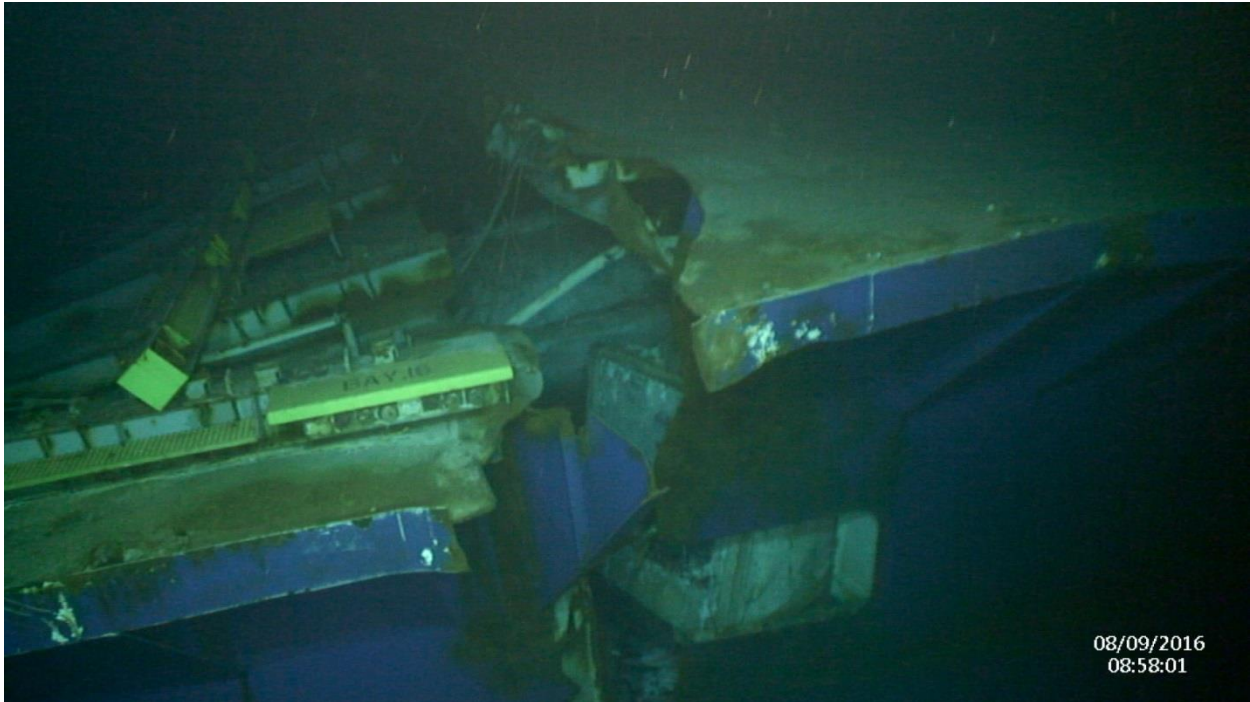
Figure 65. Region: Starboard – Frame 200 Source: Mission III Vehicle: CURV 21

A view of the crack just forward of frame 200. The view shows the crack extending transversely across the main deck toward the port side.

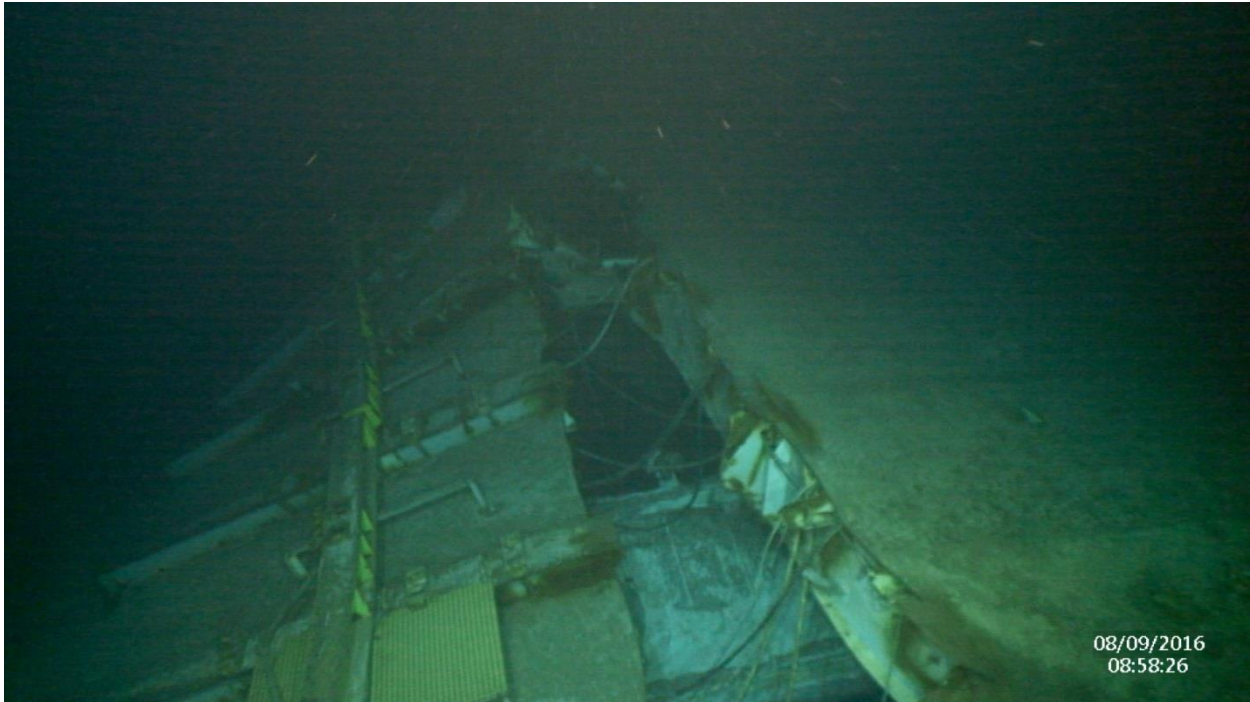
Figure 66. Region: Starboard – Frame 200 Source: Mission III Vehicle: CURV 21

Fly over of crack on the main deck looking transversely, starboard to port.

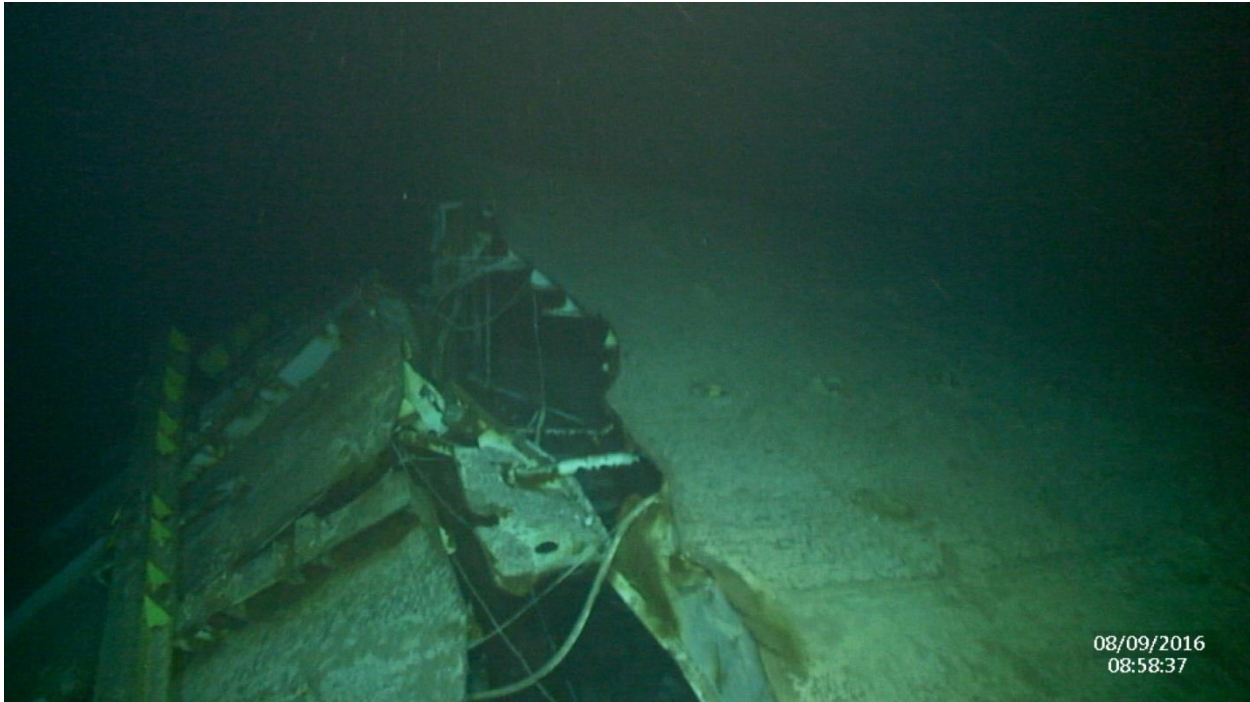
Figure 67. Region: Starboard – Frame 200 Source: Mission III Vehicle: CURV 21

View of crack along main deck approaching the port side of the ship viewed from starboard.

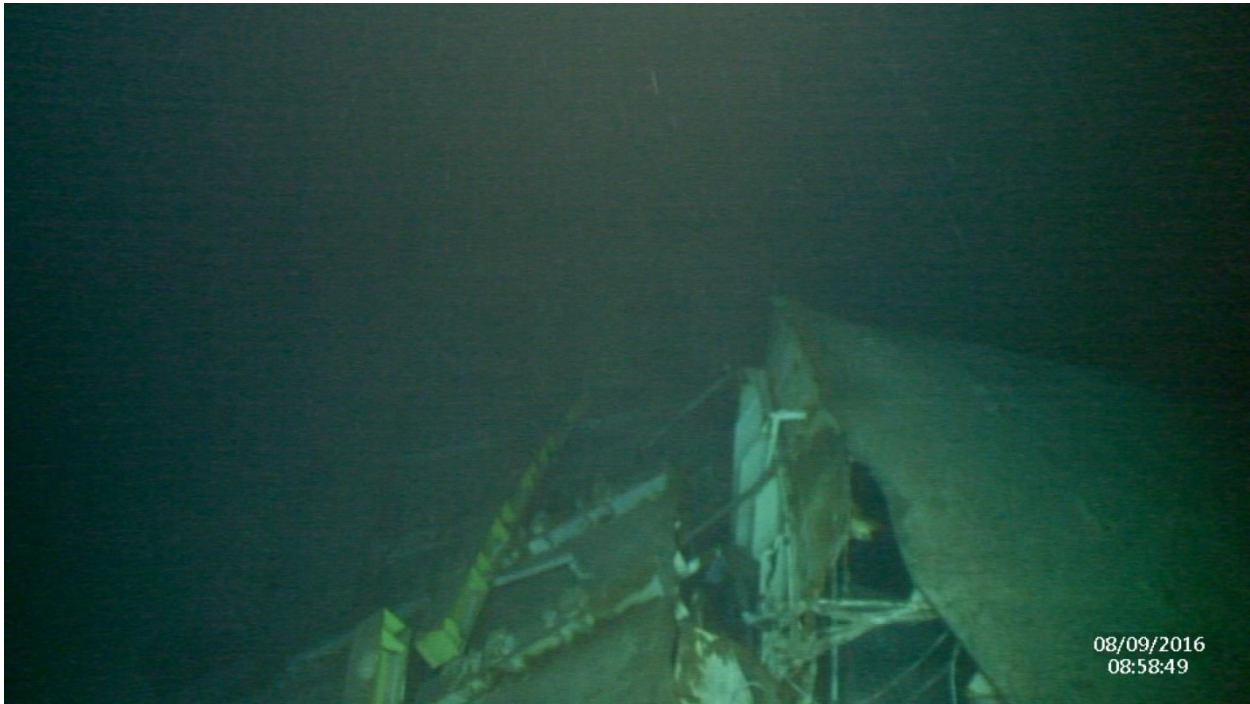
Figure 68. Region: Starboard - Main deck (aft) – Frame 200 Source: Mission III Vehicle: CURV 21

Substantial hull fracture (crack) at frame 200 shown along main deck nearing the port side of the ship as viewed from starboard.

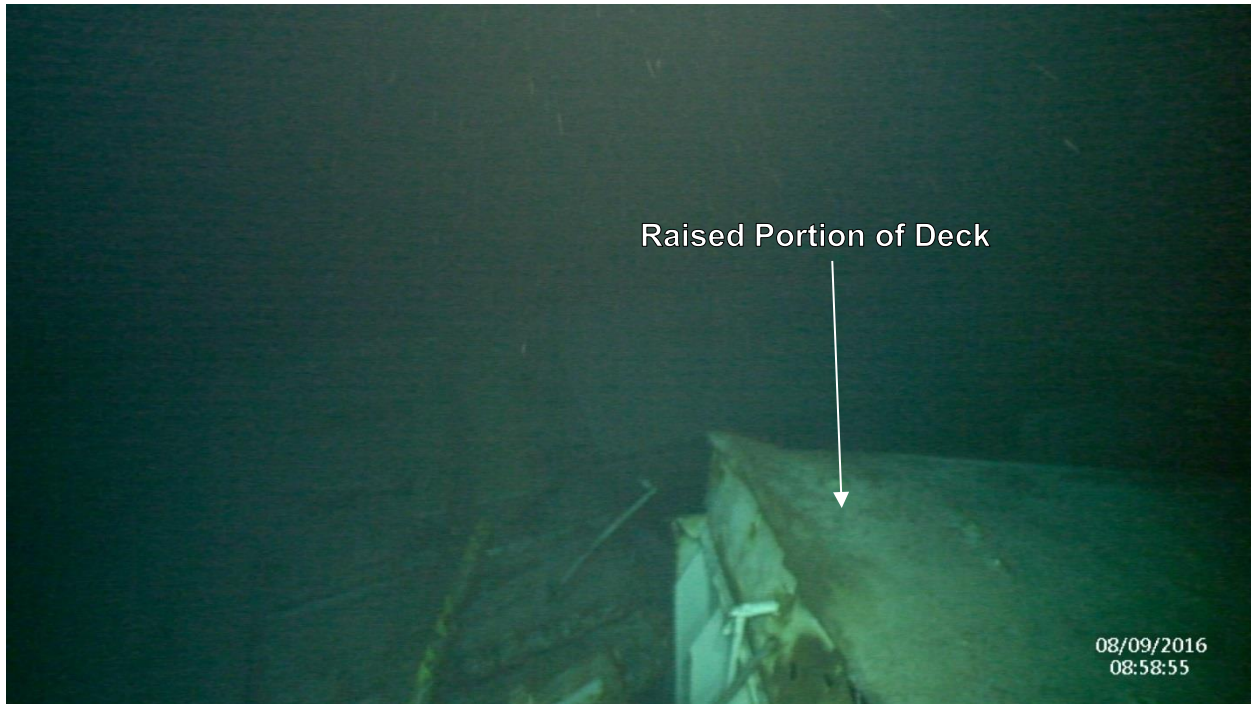
Figure 69. Region: Starboard - Main deck (aft) – Frame 200 Source: Mission III Vehicle: CURV 21

The main deck to port and aft of frame 200 is deflected downward relative to the main deck forward of frame 200 to starboard. The port side of the ship appears to have remained intact. The main deck is set down inboard of the side shell. The raised platform at lower right is the portion of the main deck above the port stanchion where the transverse bulkhead meets the main deck adjacent to the longitudinal ramp cut out.

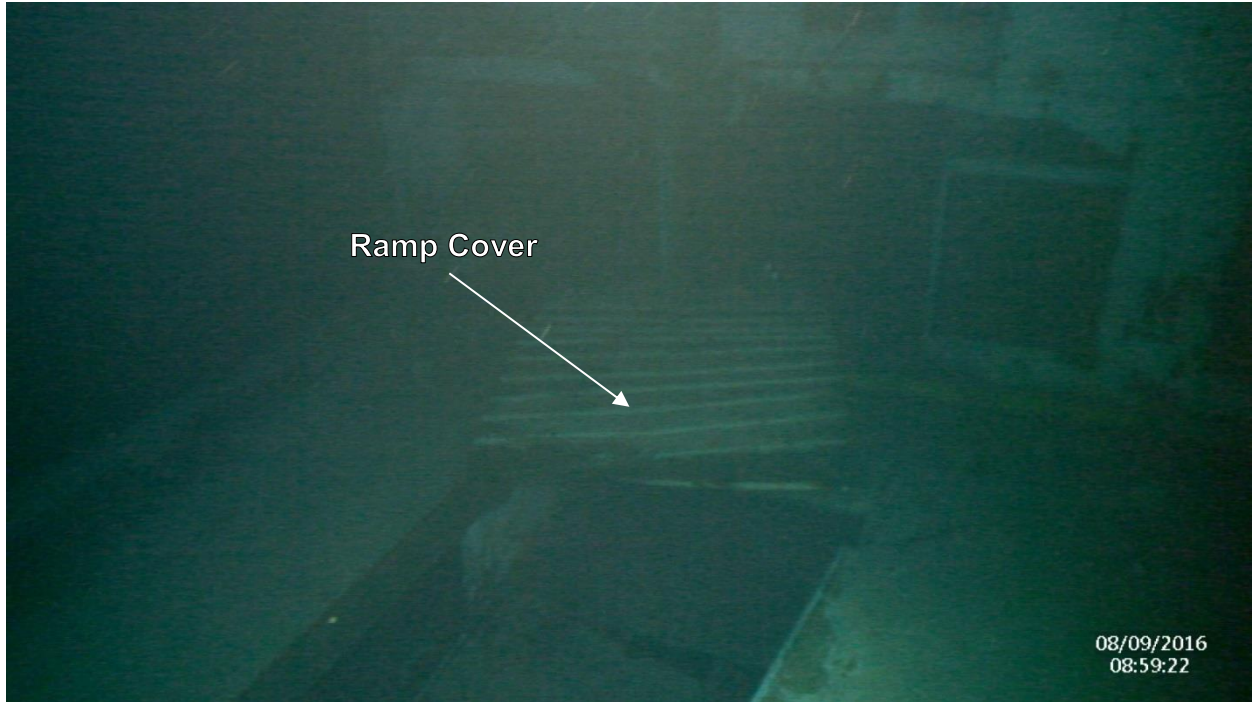
Figure 70. Region: Main deck (aft of house) – Frame 200 Source: Mission III Vehicle: CURV 21

Ramp cover (for obsolete ramp opening) is peeled back (toward the deck house) and slightly to port. The ramp cover is peeled up and forward. The ramp is inverted showing transverse stringers on top that were normally on the inside and underside of the plate.

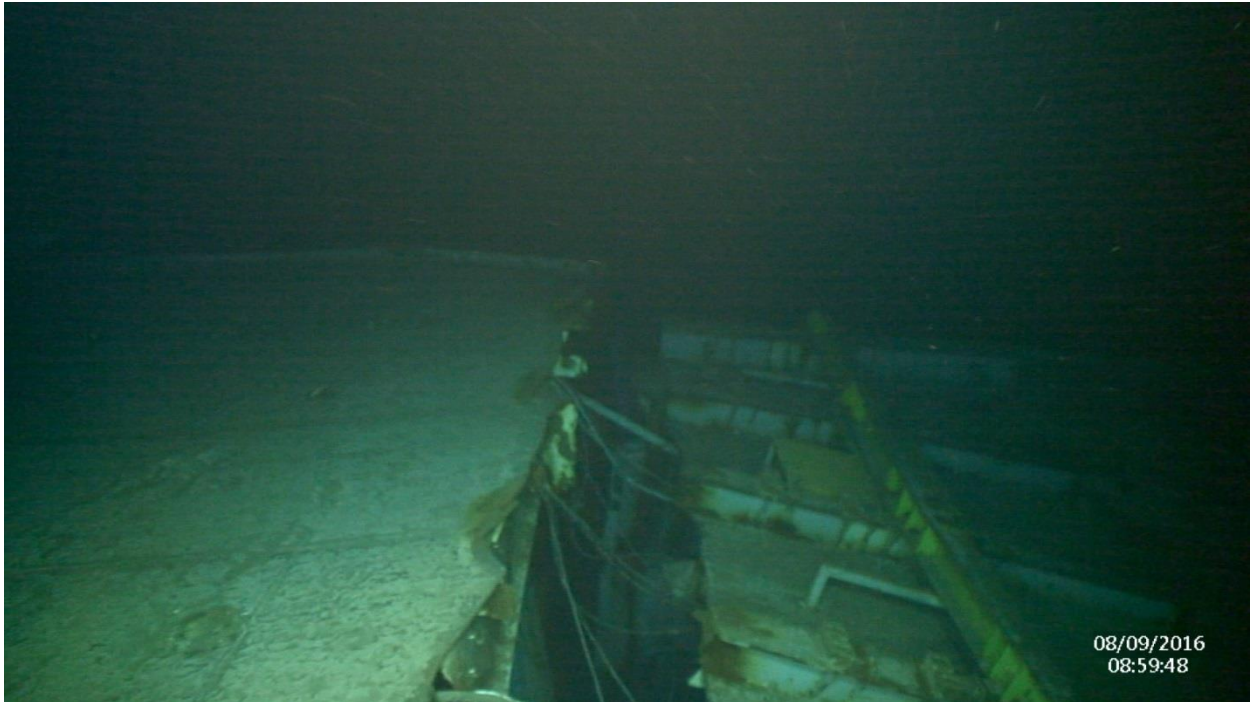
Figure 71. Region: Main deck (aft) – Frame 200 Source: Mission III Vehicle: CURV 21

Substantial crack on the main deck looking from port to starboard.

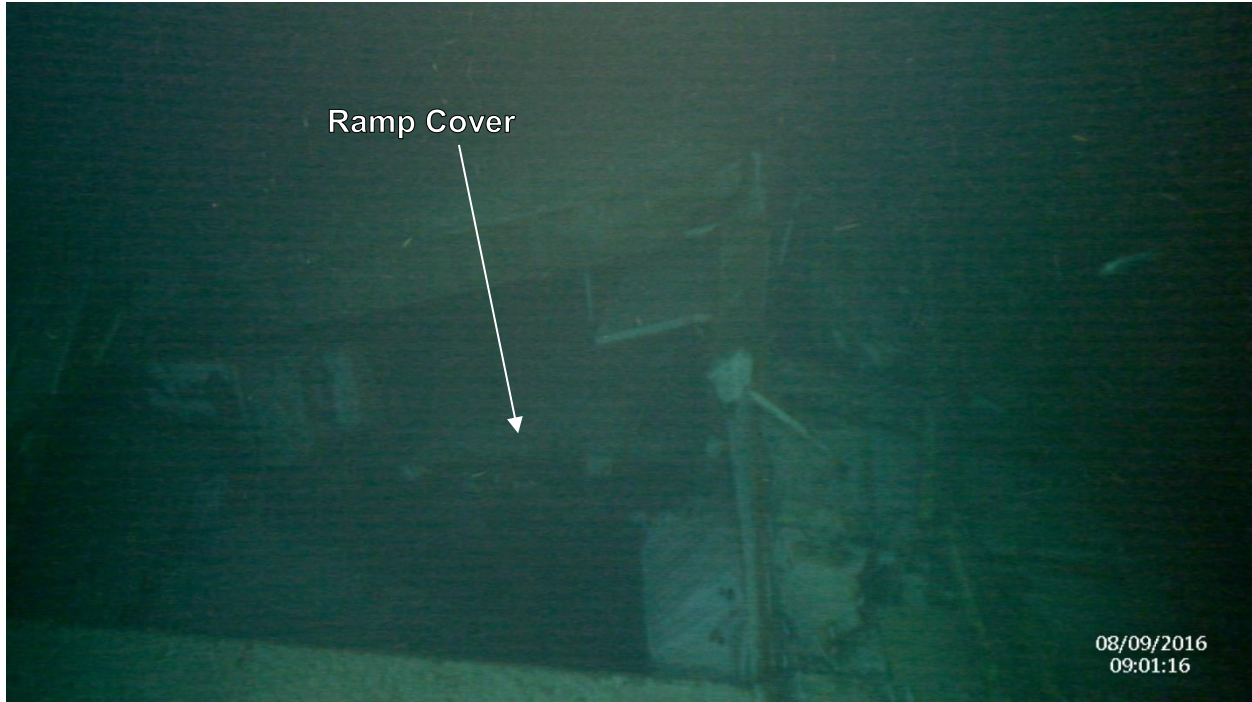
Figure 72. Region: Main deck (aft) – Frame 200 Source: Mission III Vehicle: CURV 21

Main deck looking from port to starboard into the obsolete ramp opening. The railing that surrounds the ramp opening on second deck is missing.

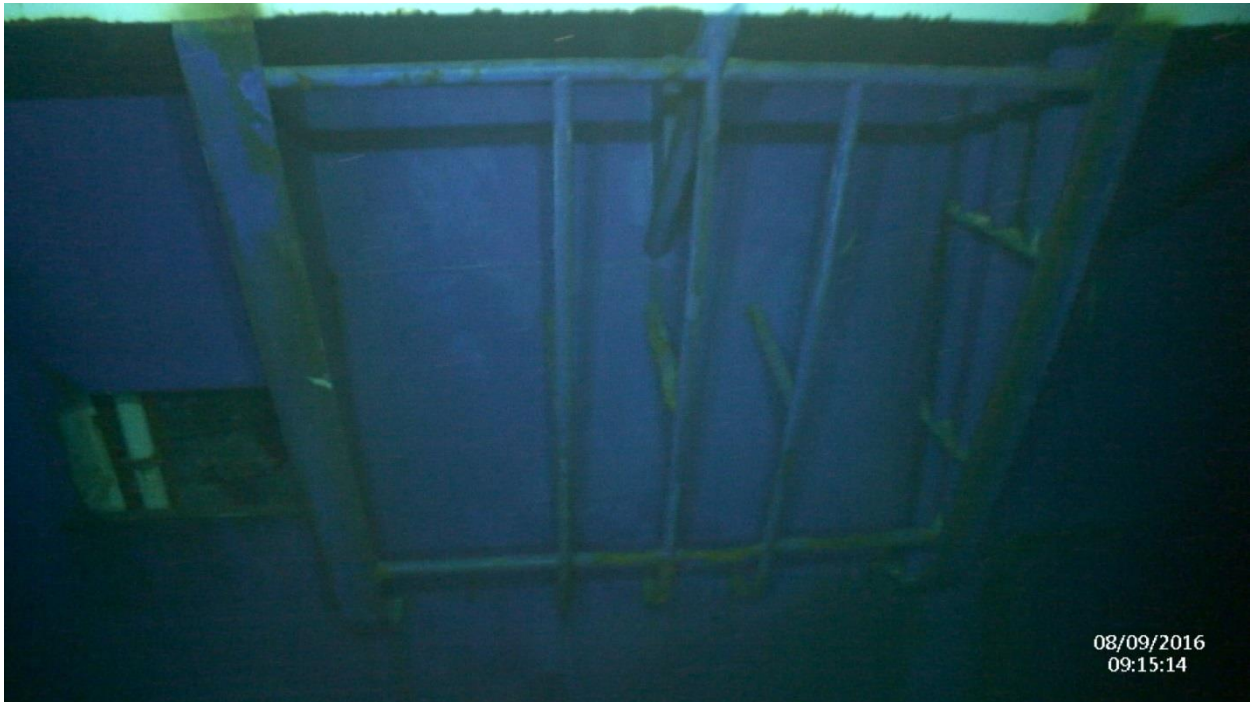
Figure 74. Region: Starboard – Life Boat Skid Source: Mission III Vehicle: CURV 21

View of starboard side life boat skid, undamaged.

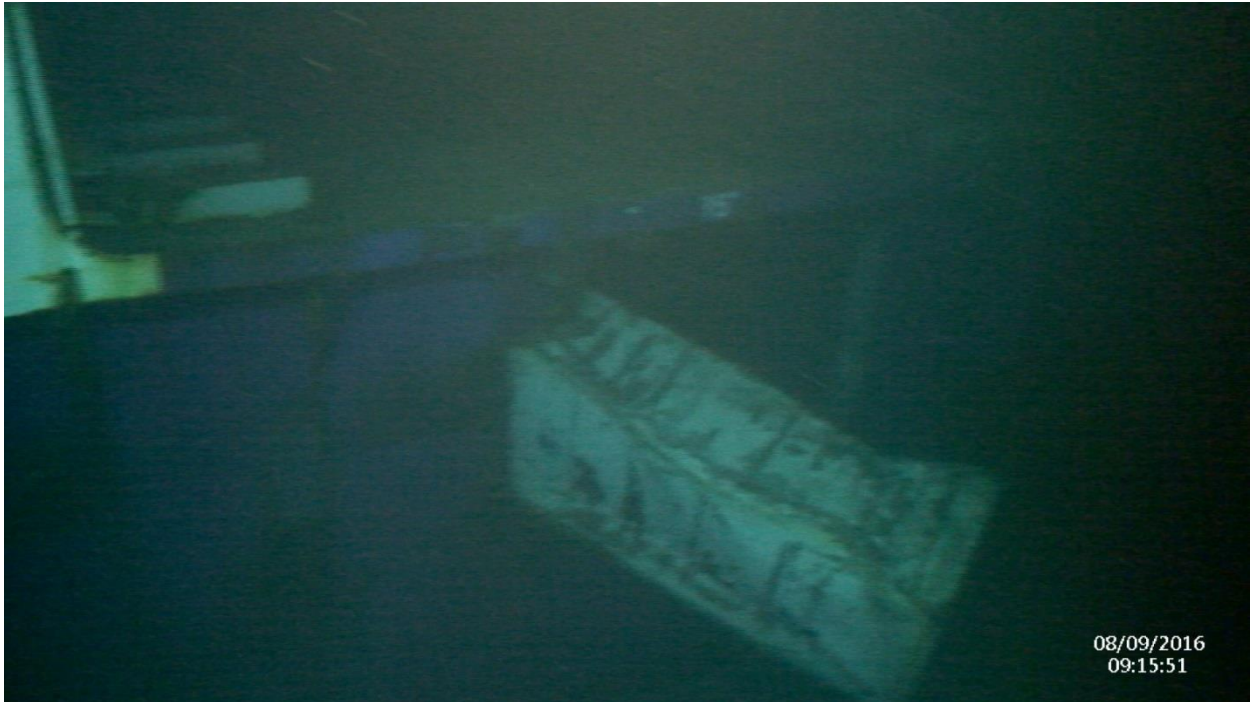
Figure 75. Region: Starboard –Bay 15 Frame 156 Source: Mission III Vehicle: CURV 21

Vehicle opening in the area of bay 15 near frame 156. A reefer container on chassis is sticking out through the starboard side vehicle opening. The container on chassis exhibits hydrostatic crush damage. Two breakwater panels that were mounted at the side shell in the opening are missing. Deck rail is missing from the house forward.

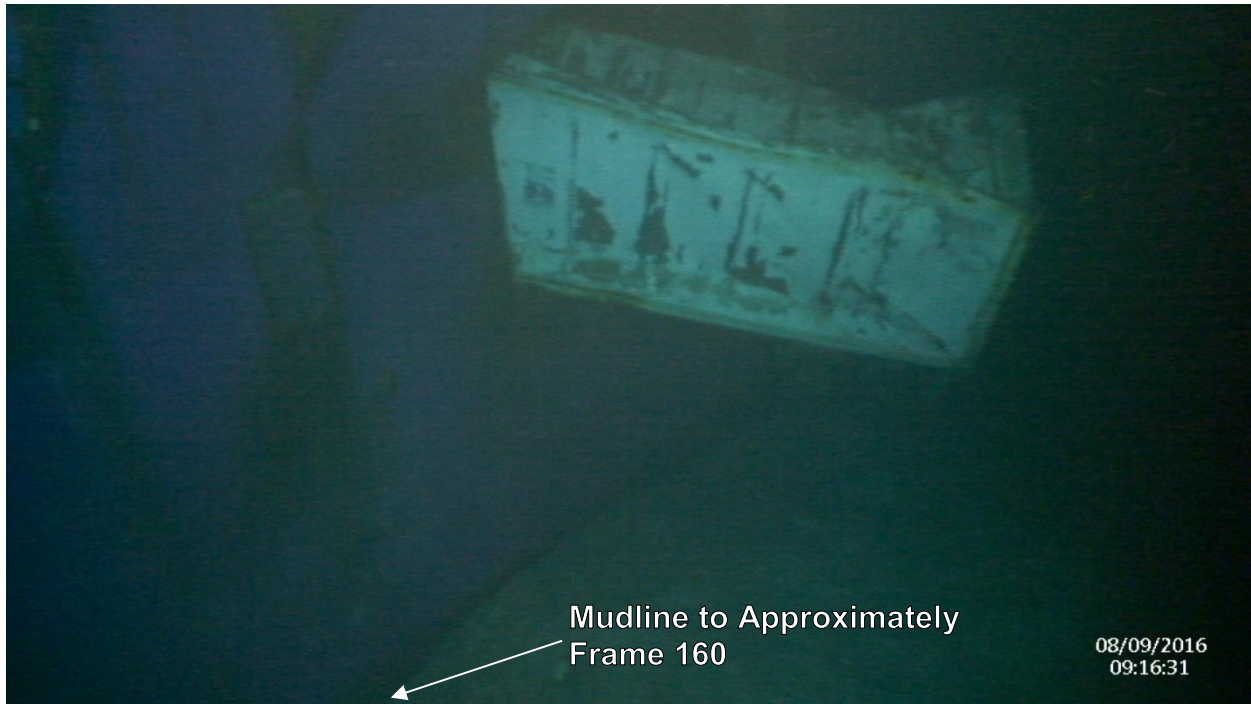
Figure 76. Region: Starboard –Bay 15 Frame 156 Source: Mission III Vehicle: CURV 21

Alternate view of reefer container on chassis sticking out of starboard side vehicle opening. The reefer container number is labeled “GESU 910338-6 45R1” in a later image. Also visible is the mudline to about frame 160. The mudline is above the loaded waterline in this area. The starboard side Emergency Fire Pump side shell penetration in Hold 3 above the Tank Top is located below the mudline.

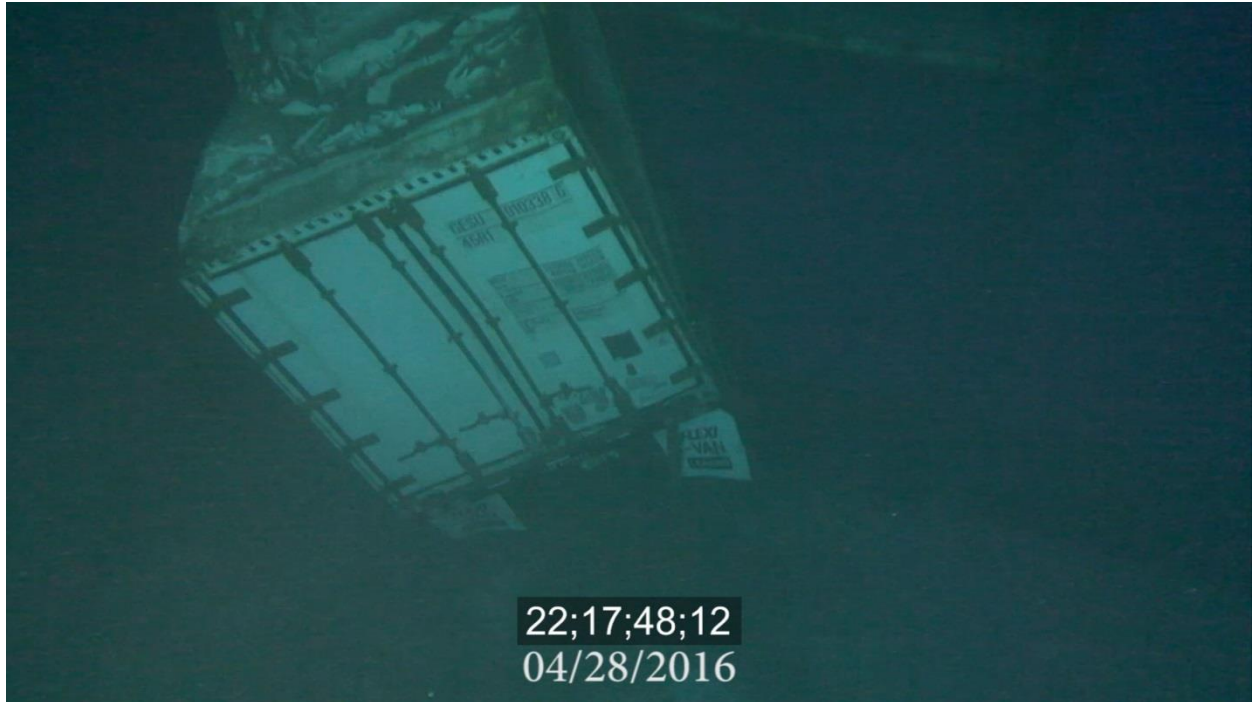
Figure 77. Region: Starboard –Bay 15 Frame 151 Source: Mission II Vehicle: AOV

The reefer container number is labeled “GESU 910338-6 45R1”.

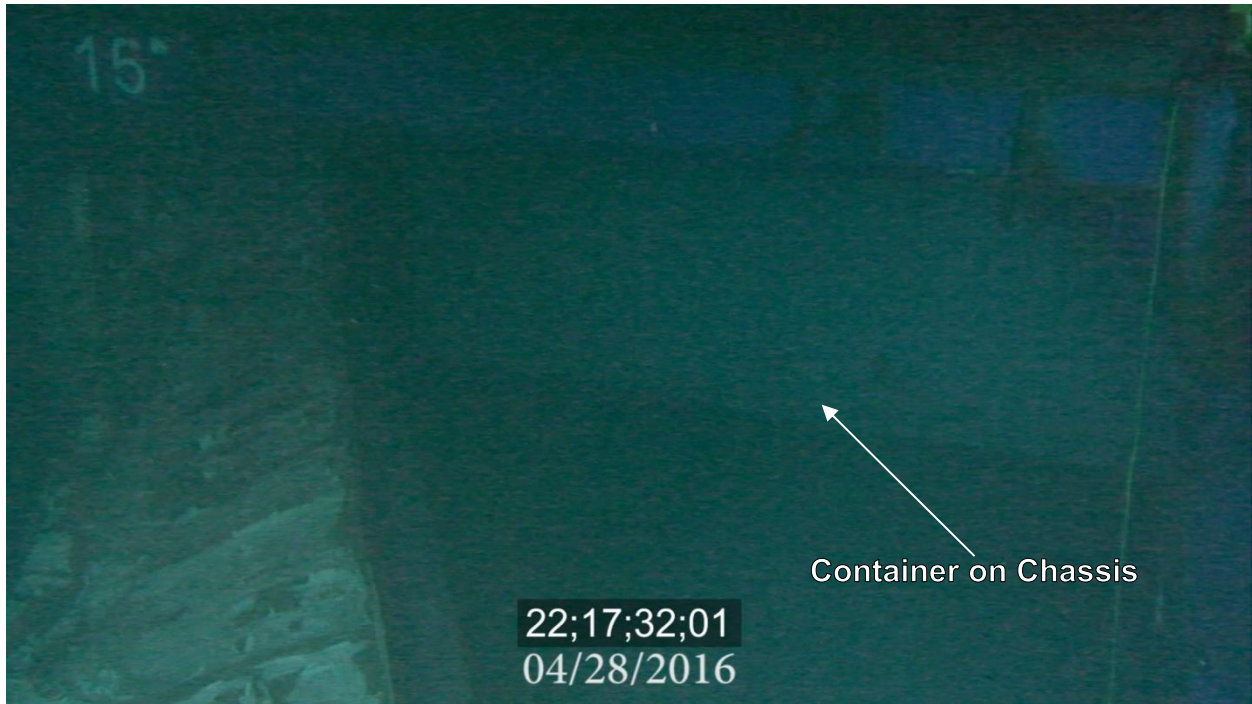
Figure 78. Region: Starboard –Bay 15 Frame 151 Source: Mission II Vehicle: AOV

A 40 plus foot white container on a chassis is seen inside the ship's hull in what appears to be an upright and a longitudinally stowed position.

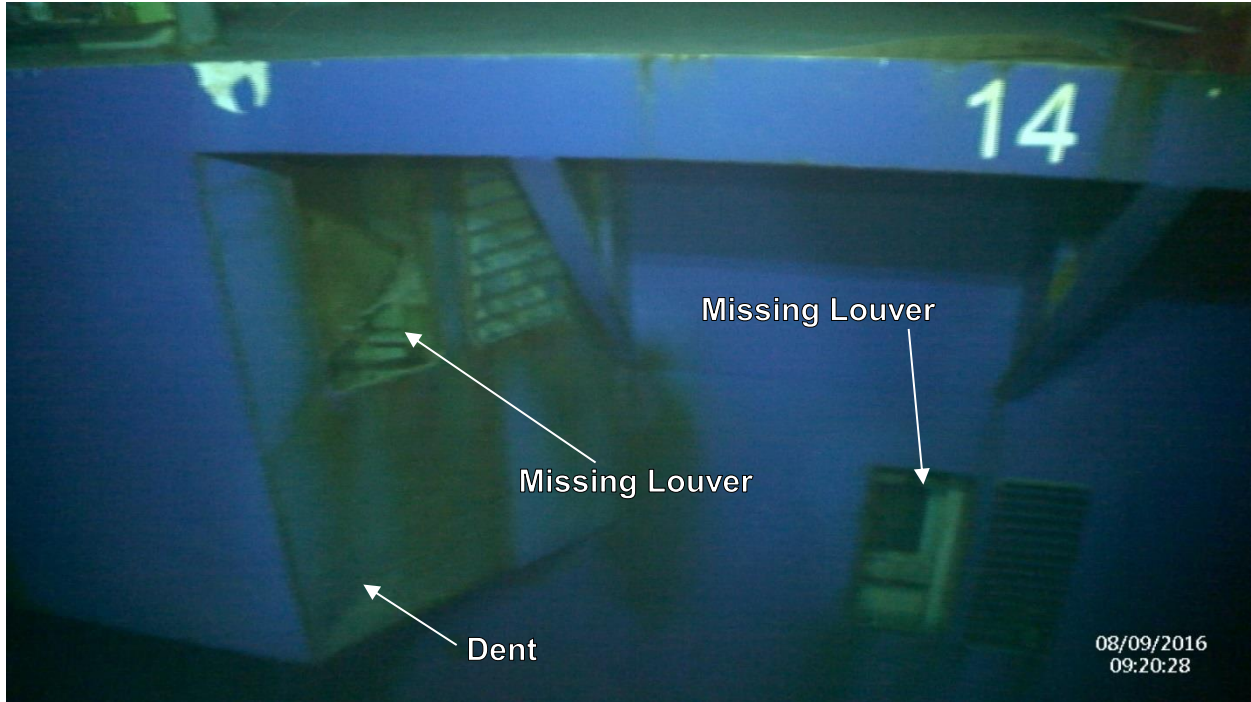
Figure 79. Region: Starboard – Bay 14 Source: Mission III Vehicle: CURV 21

A outboard louver for the cargo hold supply air intake at frame 142 is missing. A dent is on the forward face of the intake blister. A smaller louver associated with the cargo hold air exhaust vent located at frame 136 is also missing.

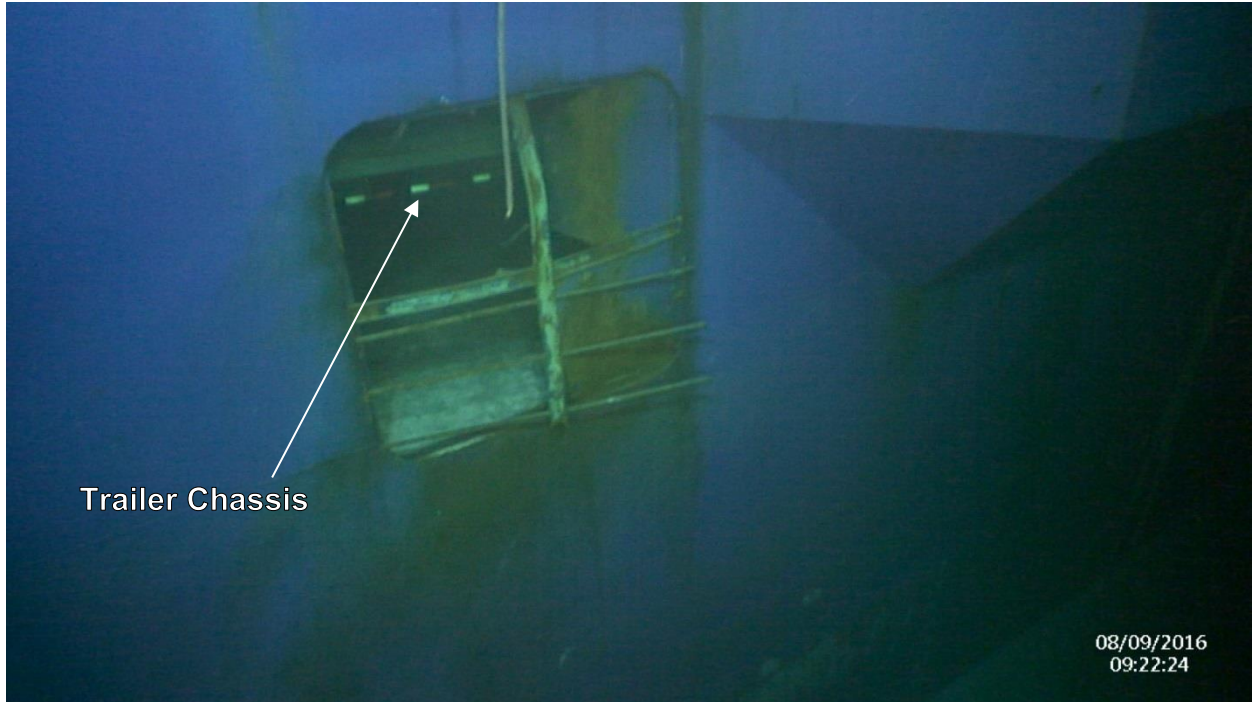
Figure 80. Region: Starboard – Frame 134/16 Source: Mission III Vehicle: CURV 21

Reflective tape associated with a trailer chassis is behind an open second deck access door in the vicinity of frame 134/16. The stanchions surrounding the second deck access door are pushed outward.

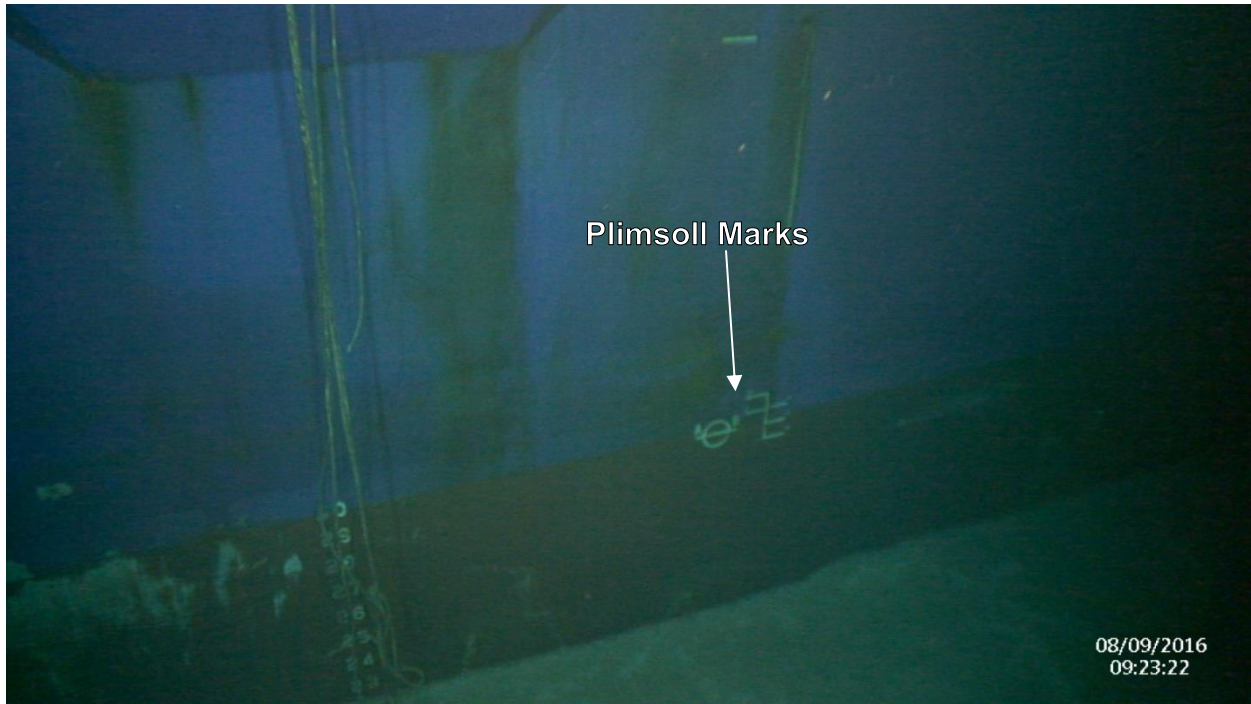
Figure 81. Region: Starboard – Midship Source: Mission III Vehicle: CURV 21

The plimsoll marks are visible. The draught marks are visible, showing a starboard midships mudline (draught) of 22.5 feet.

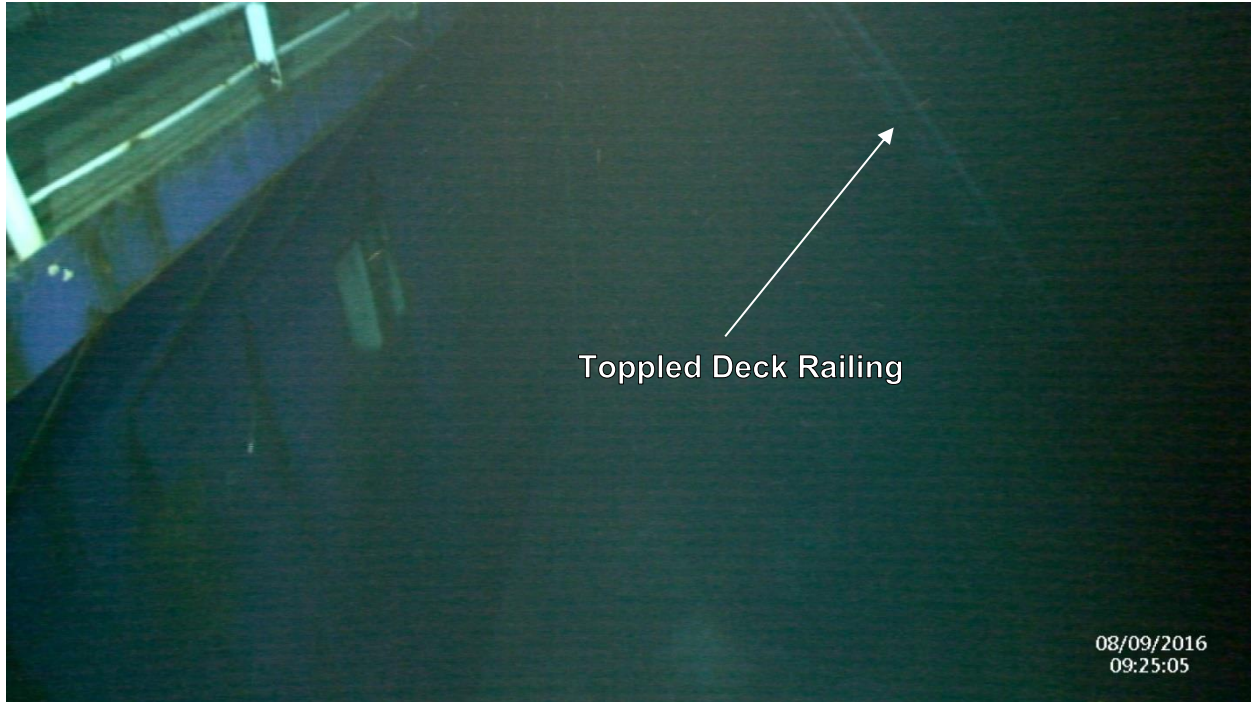
Figure 84. Region: Starboard – Frame 133 Source: Mission III Vehicle: CURV 21

Deck railing detached from deck and toppled onto seafloor. The deck rail is estimated to depart the deck around frame 115.
