**NATIONAL TRANSPORTATION SAFETY BOARD
Office of Research and Engineering
Vehicle Recorder Division
Washington, D.C. 20594**

GROUP CHAIRMAN'S FACTUAL REPORT OF INVESTIGATION

***S.S. El Faro* Wreckage Examination Report**

DCA16MM001

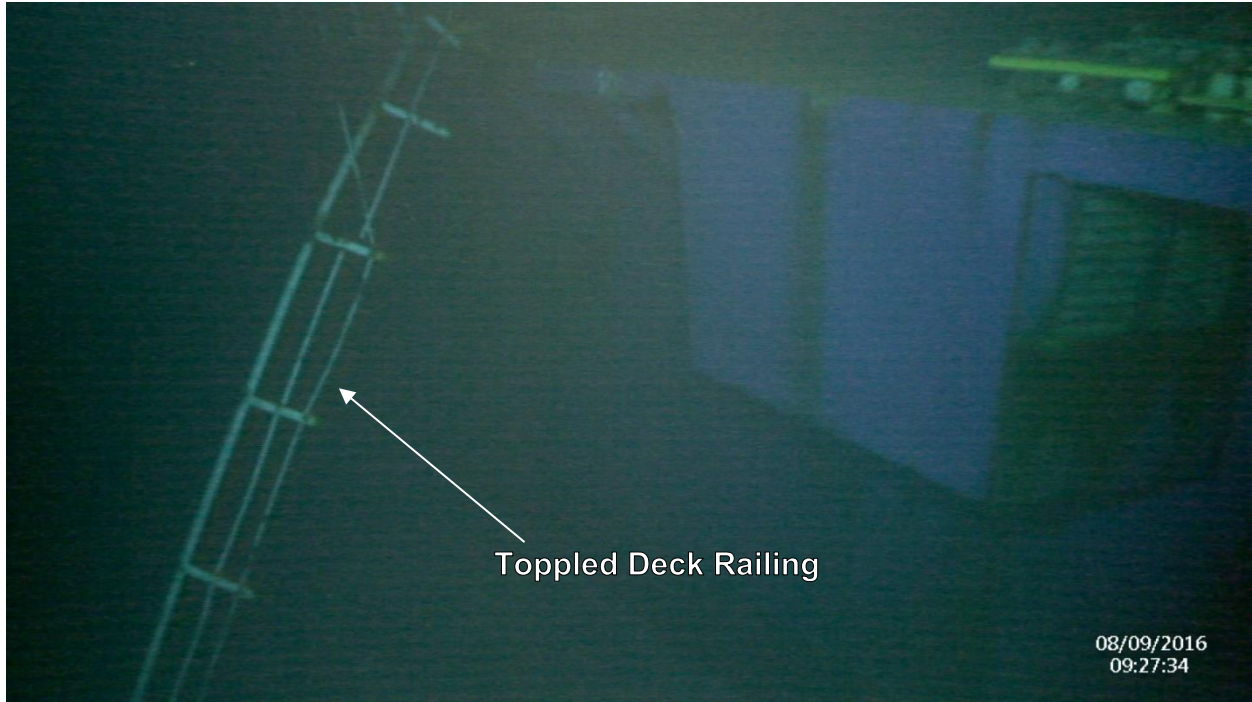
Figure 85. Region: Starboard – Frame 100 Source: Mission III Vehicle: CURV 21

Alternate view of deck rail detached from deck edge around frame 115.

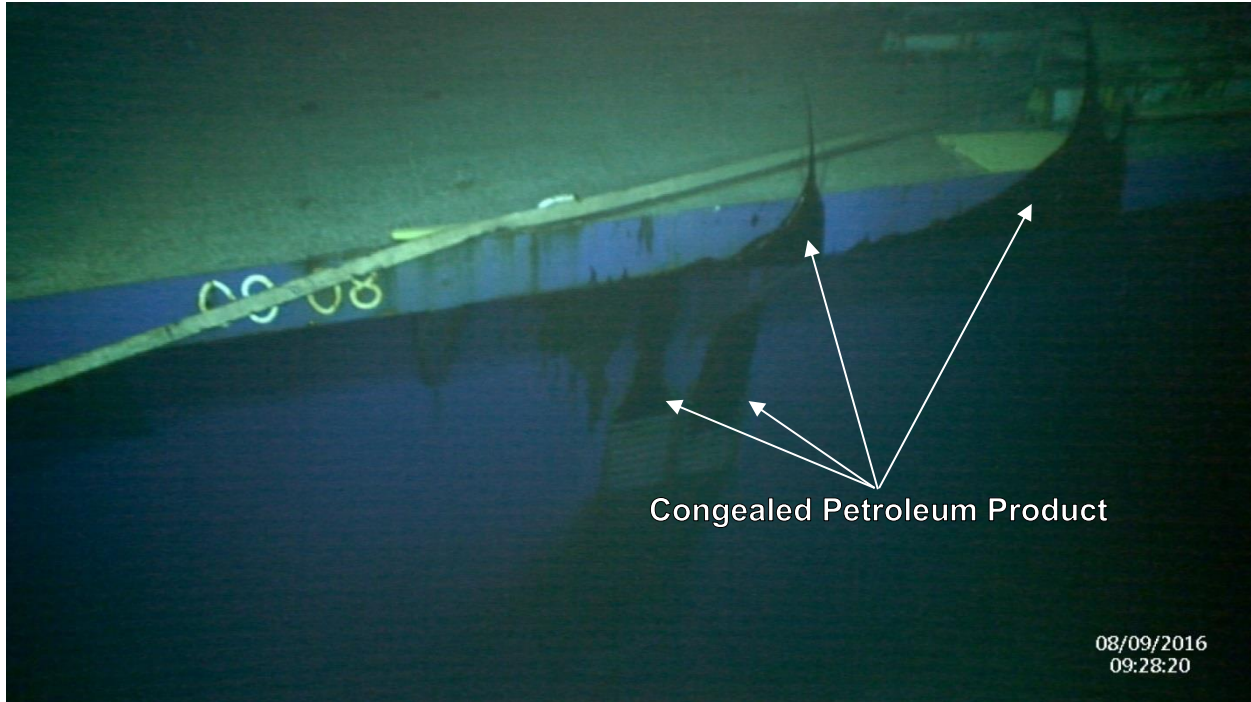
Figure 88. Region: Starboard – Frame 93 Source: Mission III Vehicle: CURV 21

Exhaust vent louvers from cargo hold no. 2 at frame 93 shows a congealed petroleum product streaming upward.

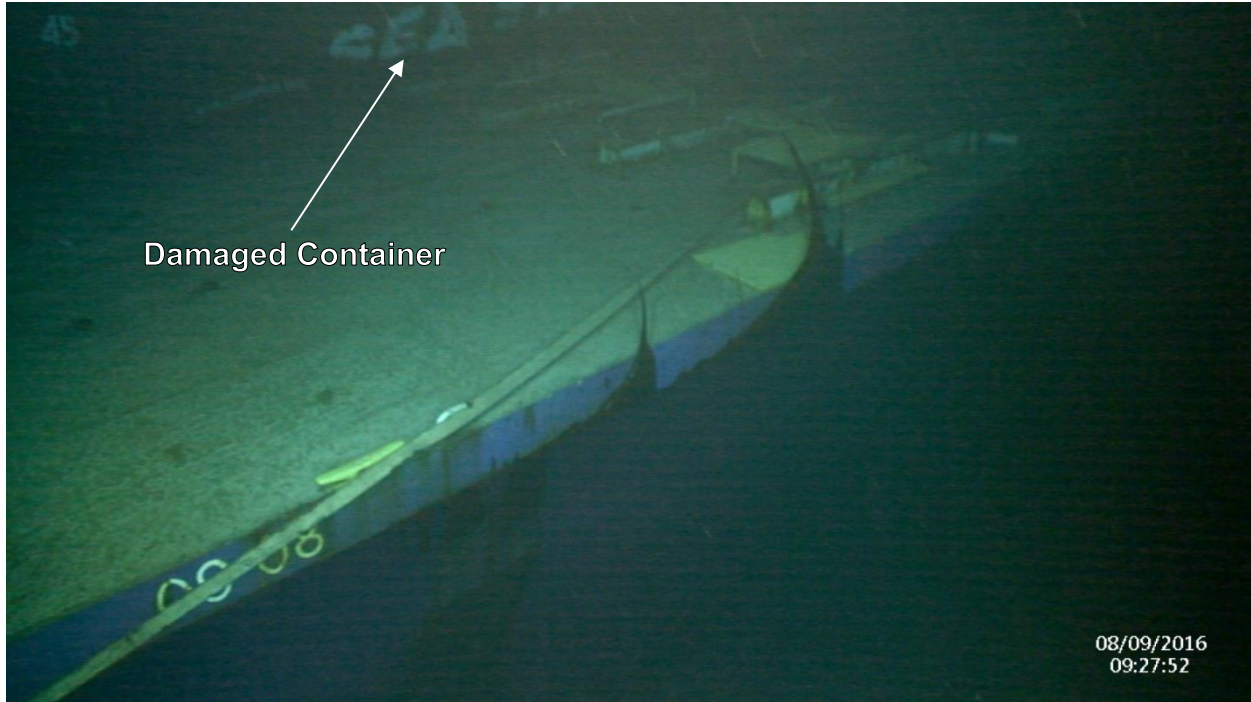
Figure 89. Region: Starboard – Frame 93 Source: Mission III Vehicle: CURV 21

A 45-foot dark red colored Sea Star container exhibiting crush or collision damage resting on main deck. The container is not in a secured position, as it is not resting on the deck sockets.

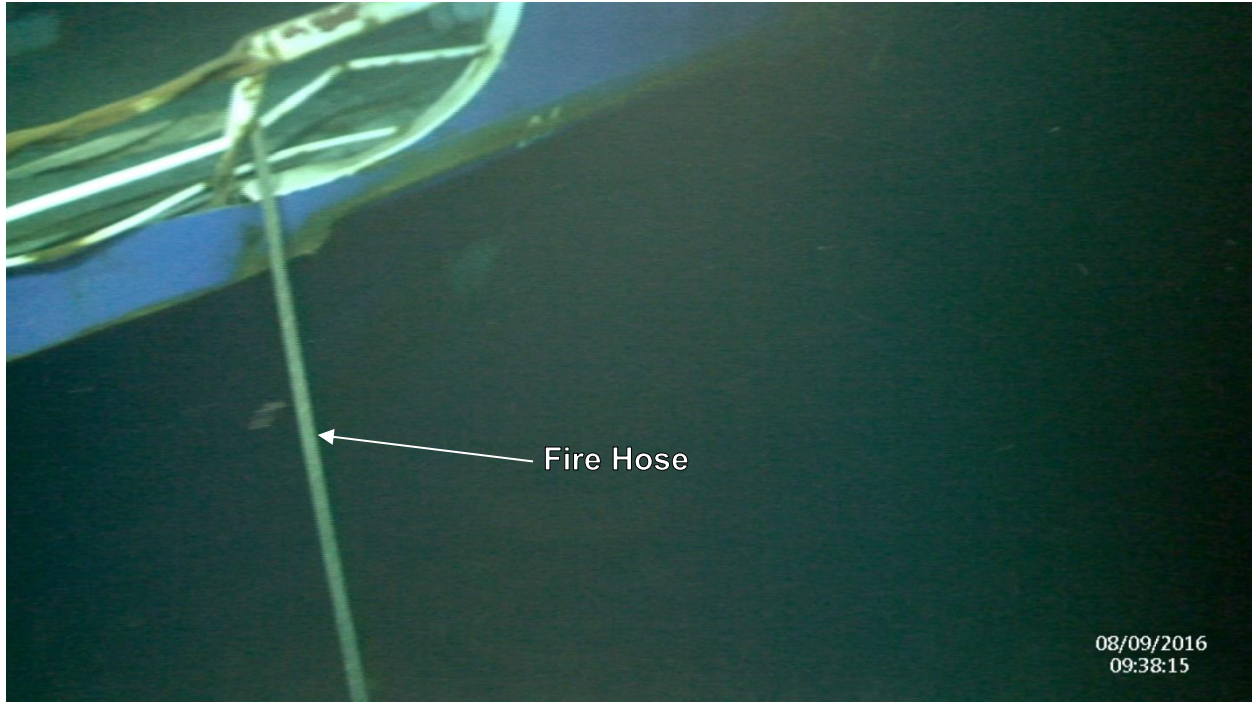
Figure 91. Region: Starboard – Frame 35 Source: Mission III Vehicle: CURV 21

Termination of firehose shown previously in figure 75, likely streaming from fire station no. 15. Deck rail twisted and showing signs of hydrostatic implosion damage.

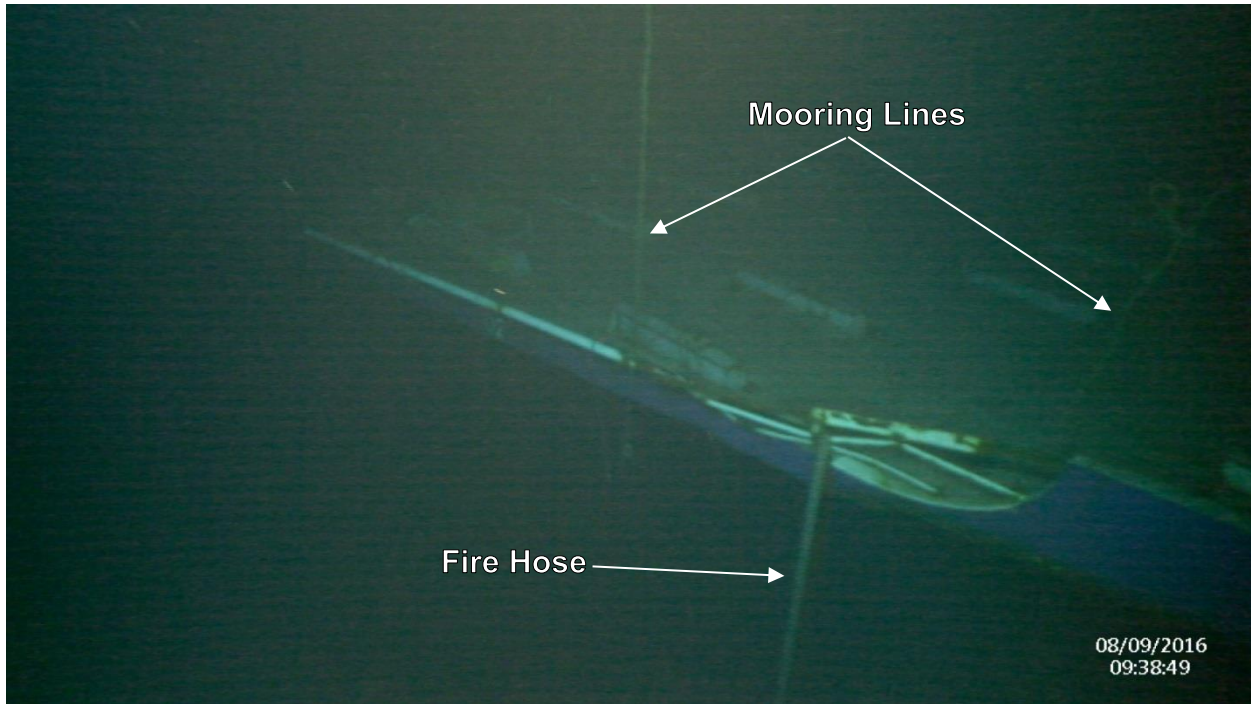
Figure 92. Region: Starboard – Frame 35 Source: Mission III Vehicle: CURV 21

View of two upward streaming mooring lines, one at approximately frame 38 and the other line at approximately frame 32. An alternate view of the termination of the streaming fire hose, likely streaming from fire station no. 15, is hanging downward near frame 35.

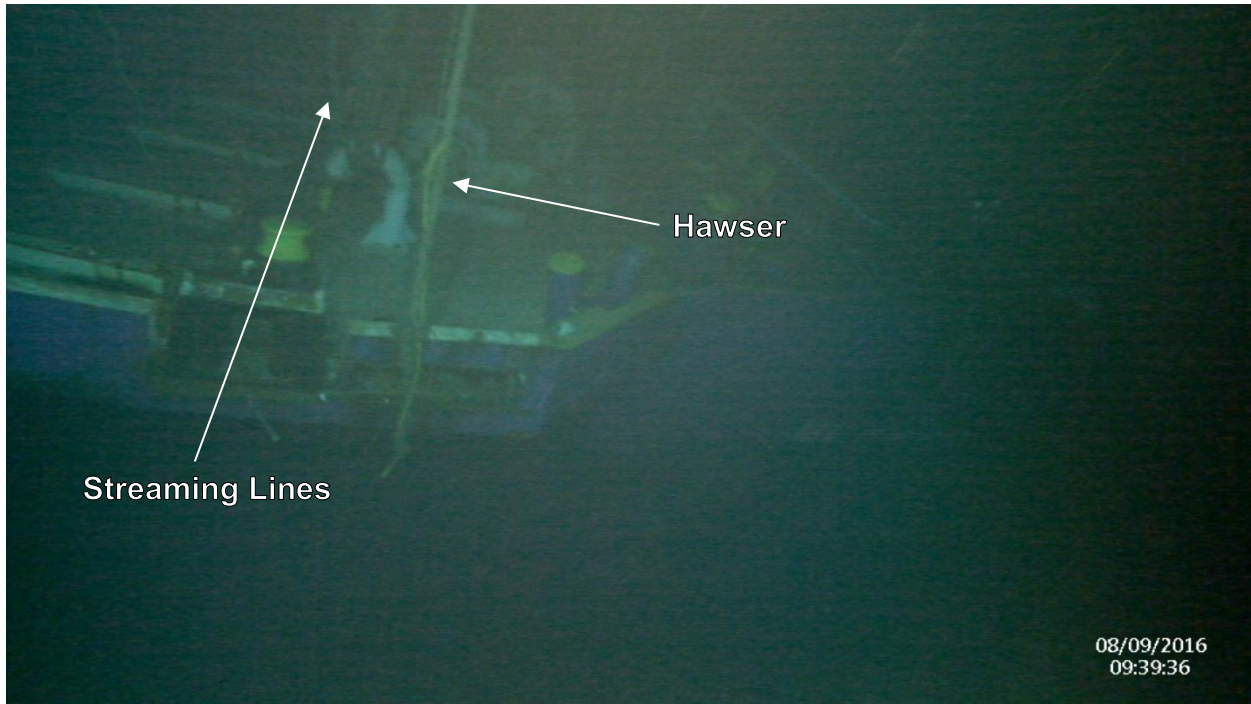
Figure 93. Region: Starboard – Frame 18 Source: Mission III Vehicle: CURV 21

A hawser at frame 18 threaded through a roller chock and streaming upward. Multiple lines are snagged and streaming upward from a vent at approximately frame 20.

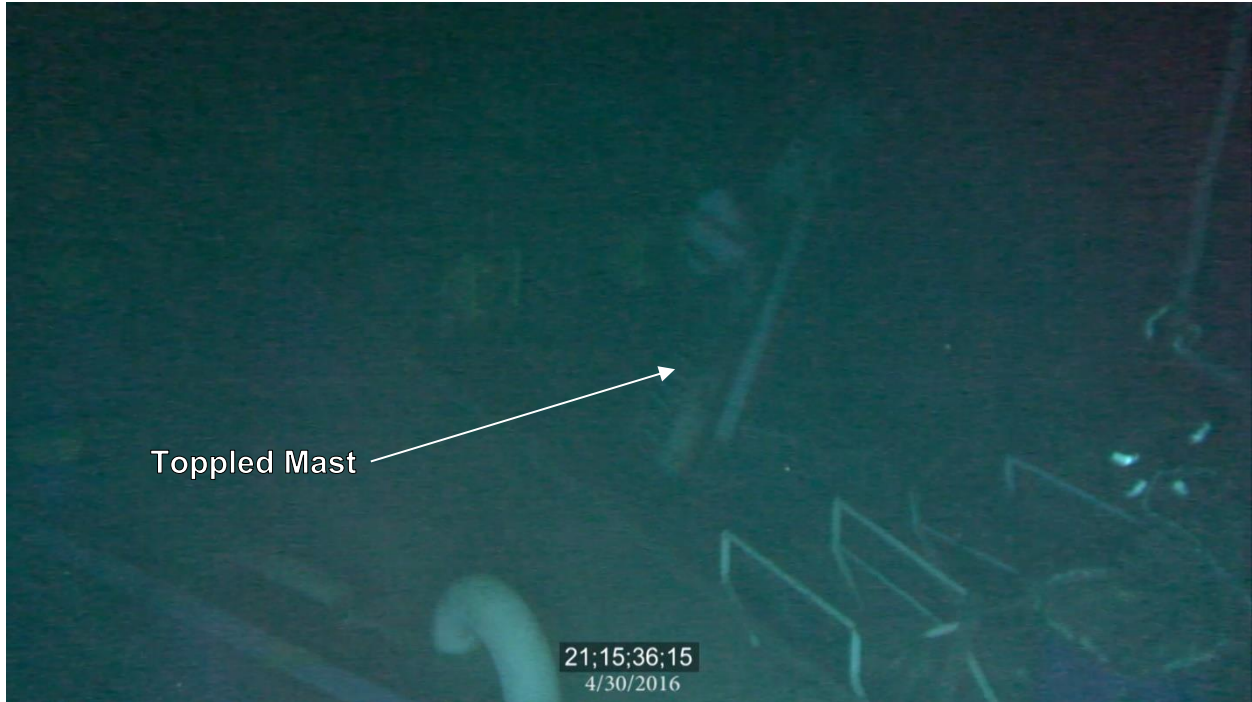
Figure 94. Region: Bow Source: Mission II Vehicle: AOV

Alternate view of toppled foremast laying from starboard to port, fore to aft.

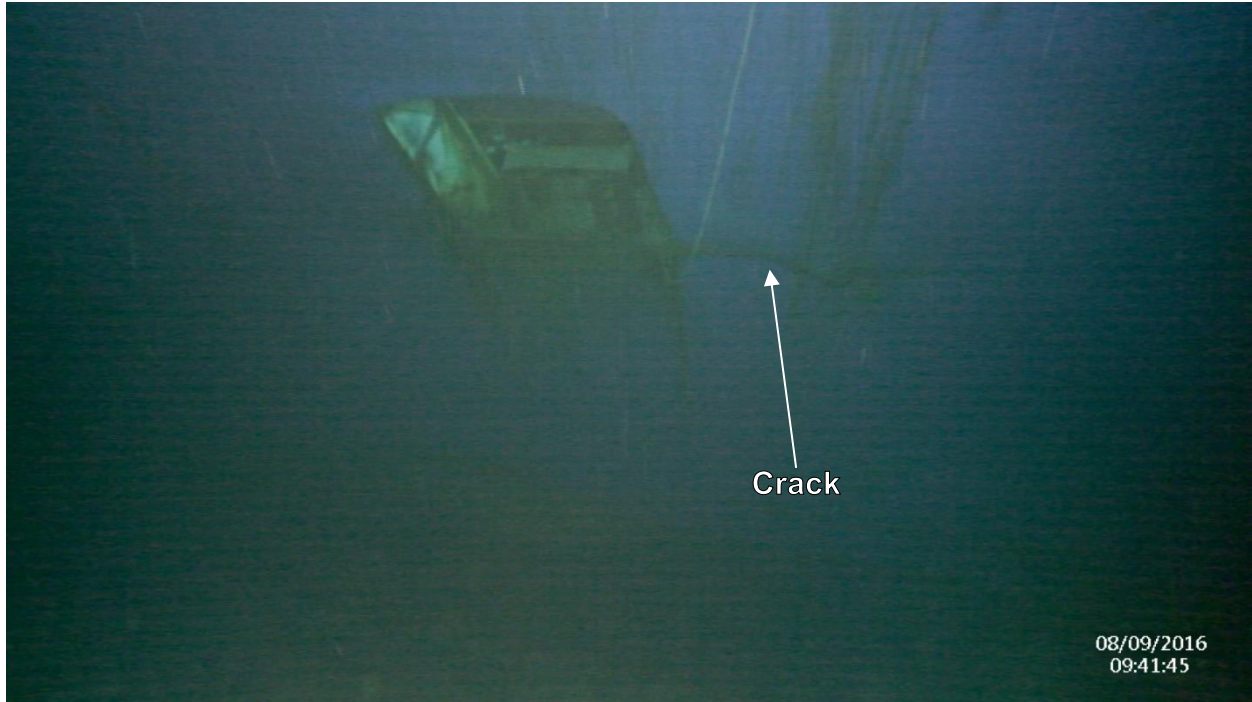
Figure 95. Region: Starboard – Frame 18 Source: Mission III Vehicle: CURV 21

Mooring vent opening at second deck, frame 26. Crack in main hull extending from lower forward corner of vent to approximately frame 20 (second deck). The crack length is estimated to be 12 feet. Rust marks are vertical along the hull.

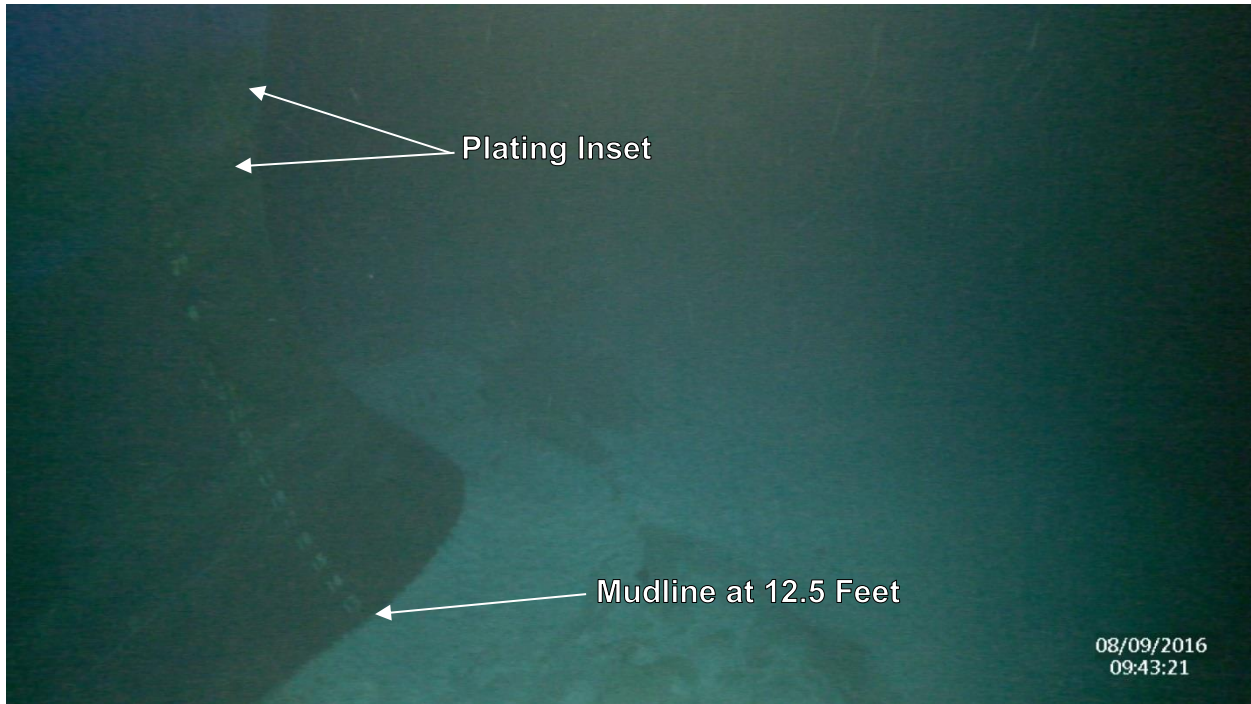
Figure 96. Region: Starboard – Bow Source: Mission III Vehicle: CURV 21

View of starboard bow region at mudline. Mudline is at 12.5-foot draught. Plating inset is in three areas beginning at 24-foot draught line and upwards.

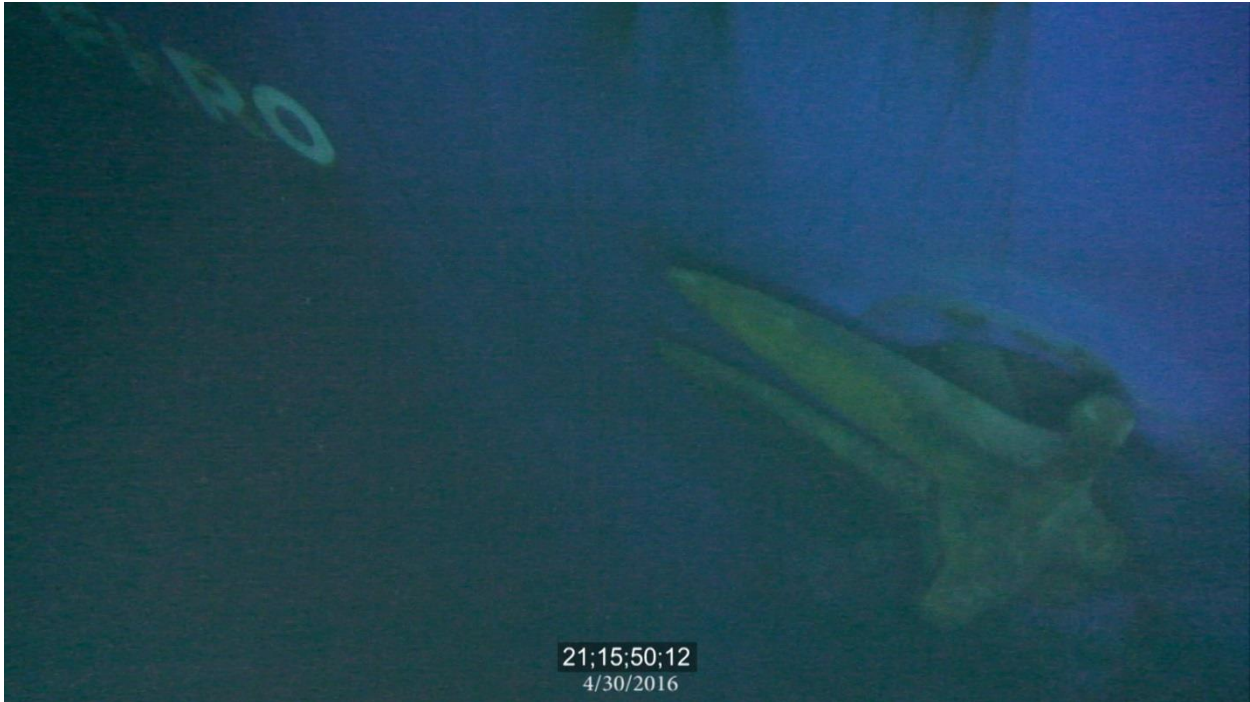
Figure 98. Region: Starboard – Bow Source: Mission II Vehicle: AOV

Starboard anchor is shown in place.

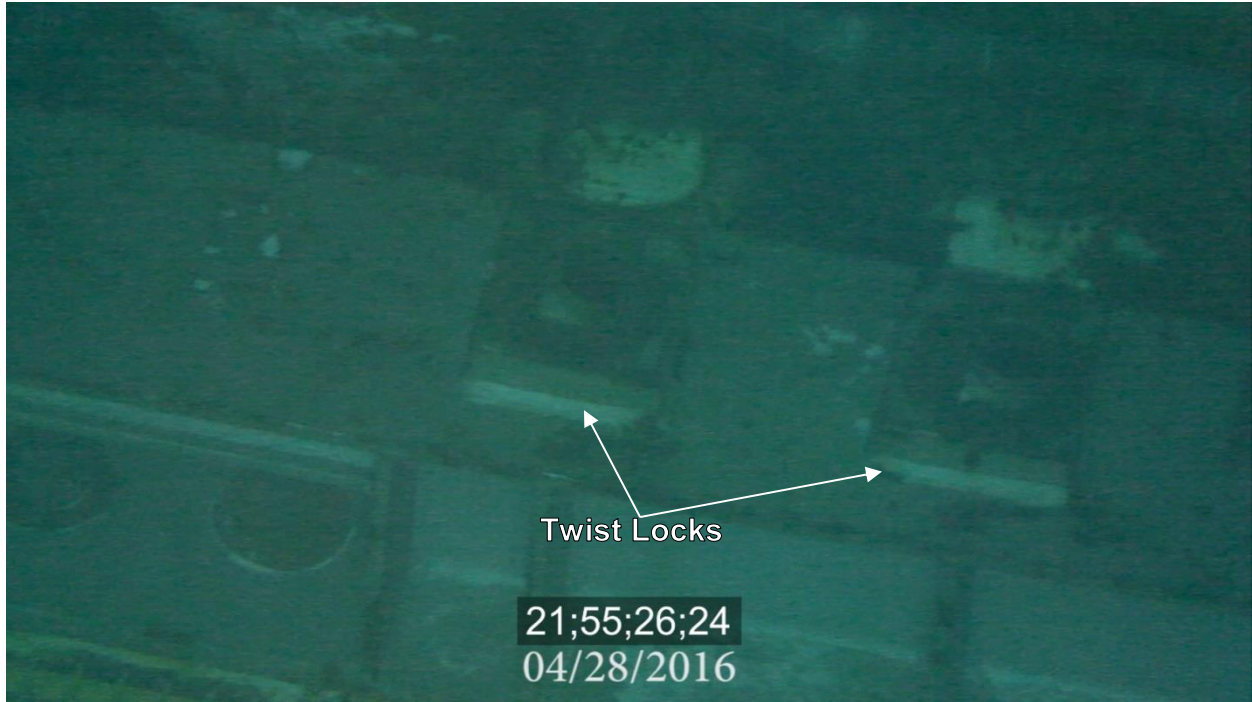
Figure 101. Region: Main Deck (forward) – Bay 14 Source: Mission II Vehicle: AOV

Failure region of deck sockets in vicinity of bay 14. Twist part of the lock is in place inside the bay socket. The bay socket appears to be intact. From the reviewed video, there does not appear to be bay socket failure or pad eye/D-ring failure.

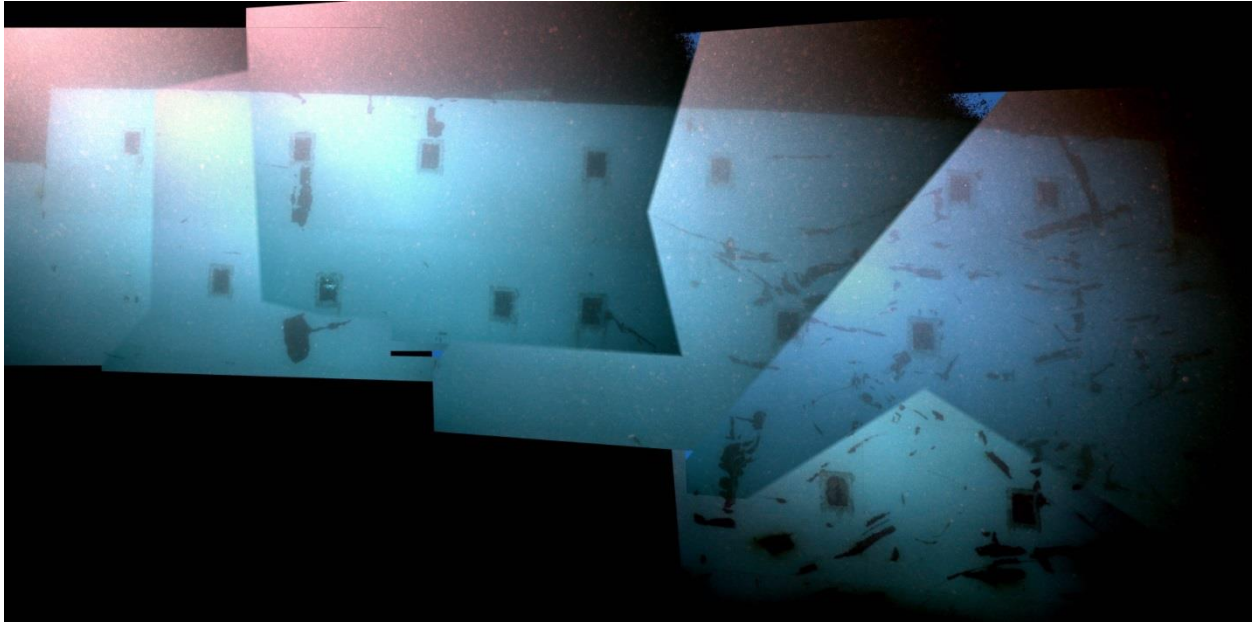
Figure 105. Region: Deck House – Fwd Source: Mission II Vehicle: AOV Mosaic Image

A mosaic image showing a portion of the front of the deckhouse. The boat deck level is shown at full width (uppermost row of windows), the next deck up is the lower navigation bridge deck, which is the uppermost existing deck. More scratching is on the port side of the forward face of the deck house. The structure associated with the top two decks of the deck house is absent from the photographed structure. The two missing decks are the lower navigation bridge deck and the navigation bridge deck. The structure for these decks appear to have completely separated from the house.

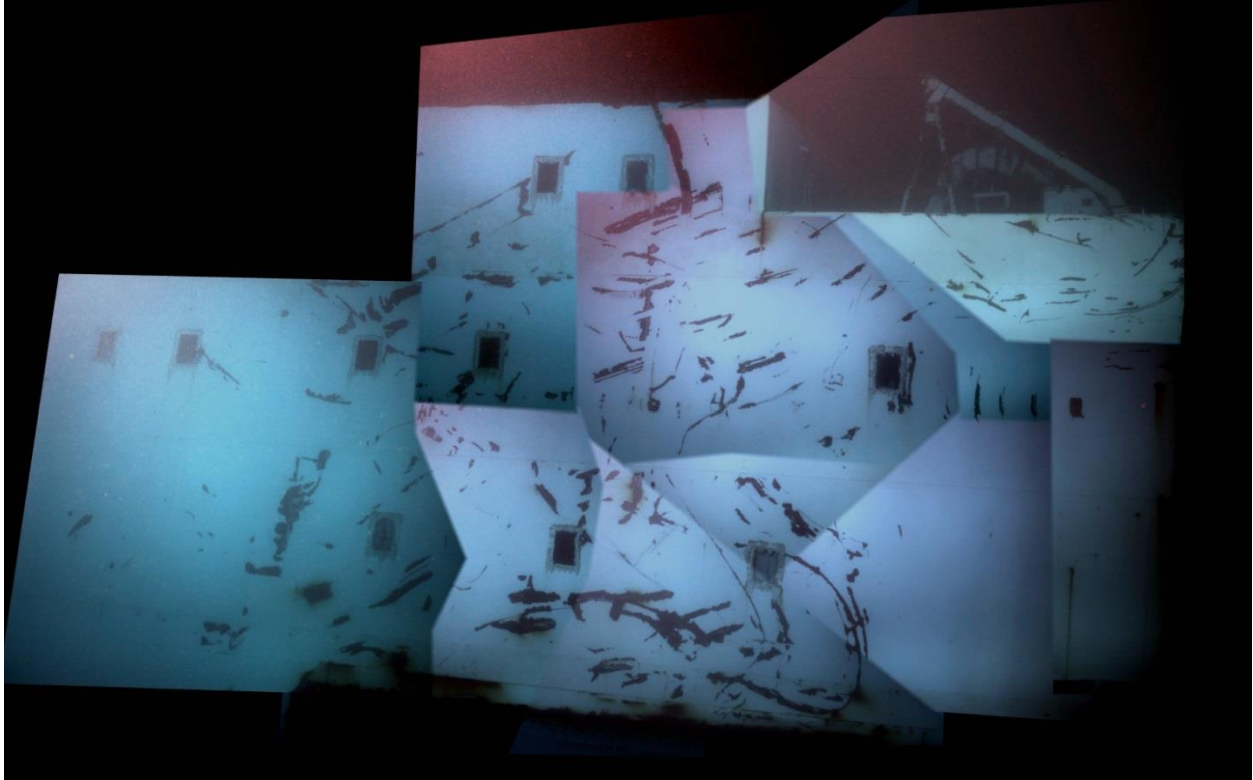
Figure 106. Region: Deck House – Fwd Source: Mission II Vehicle: AOV Mosaic Image

The forward upper port portion of the deck house is shown. The uppermost windows are on the boat deck. Scratching on the lower portion of the image is predominately side to side. Higher up on the deck house, the scratches are generally oriented to the port side.

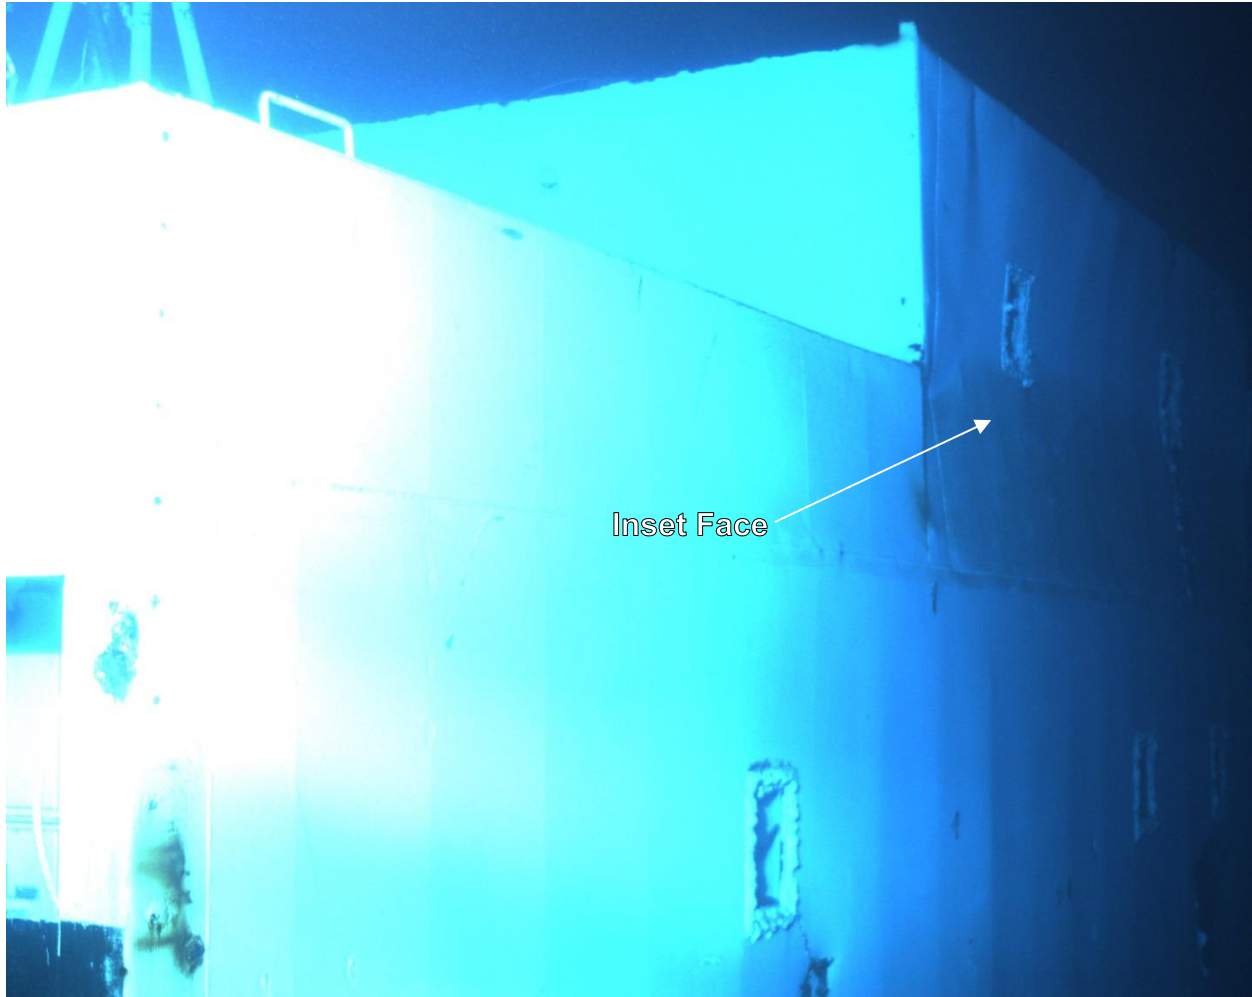
Figure 108. Region: Deck House – Fwd Source: Mission II Vehicle: AOV

The image shows the deck house front inset on the starboard side between the boat deck and the lower navigation bridge.

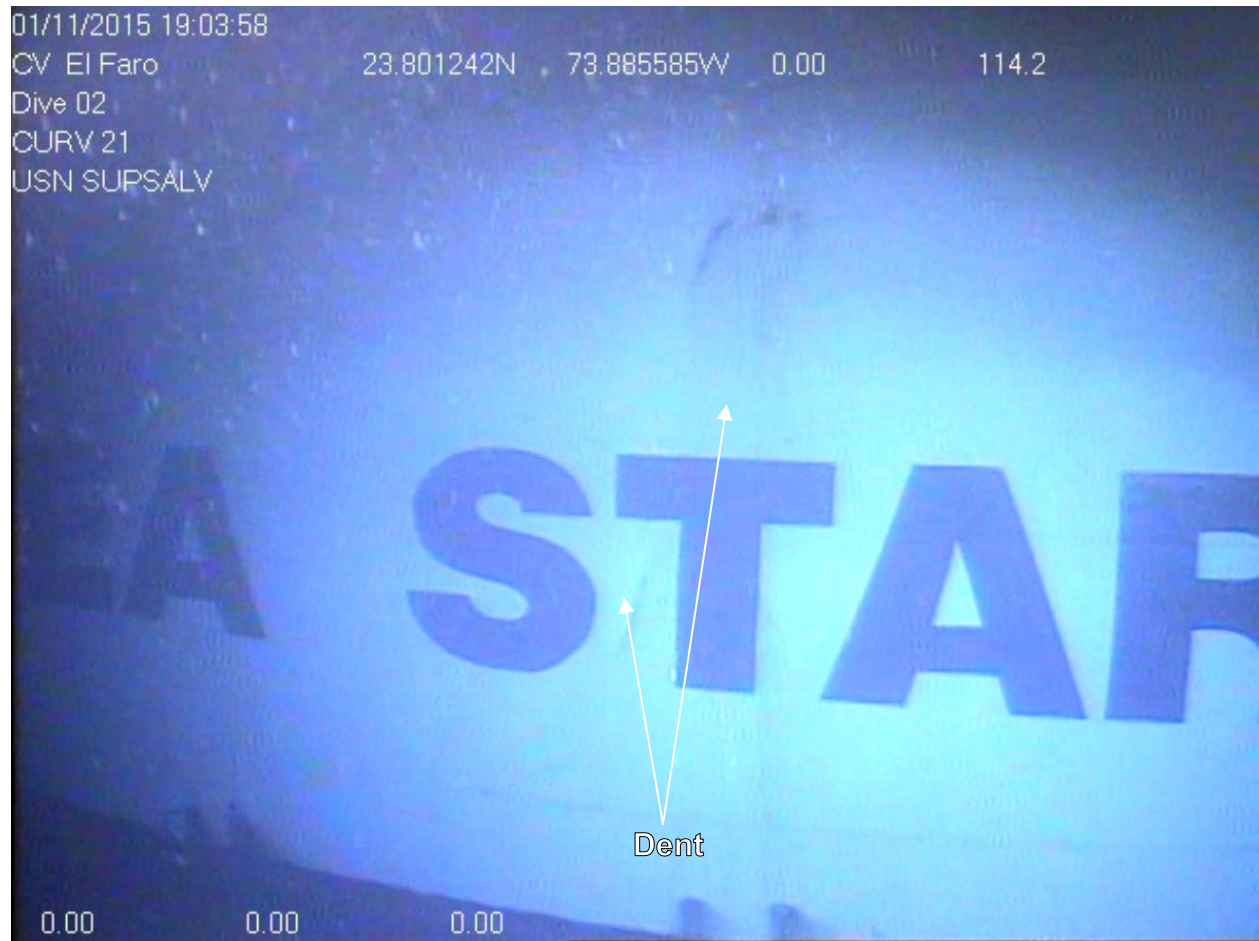
Figure 110. Region: Deck House – PORT Source: Mission I Vehicle: CURV 21

A dent between the “S” and “T” as well as above the “T” in “STAR.”

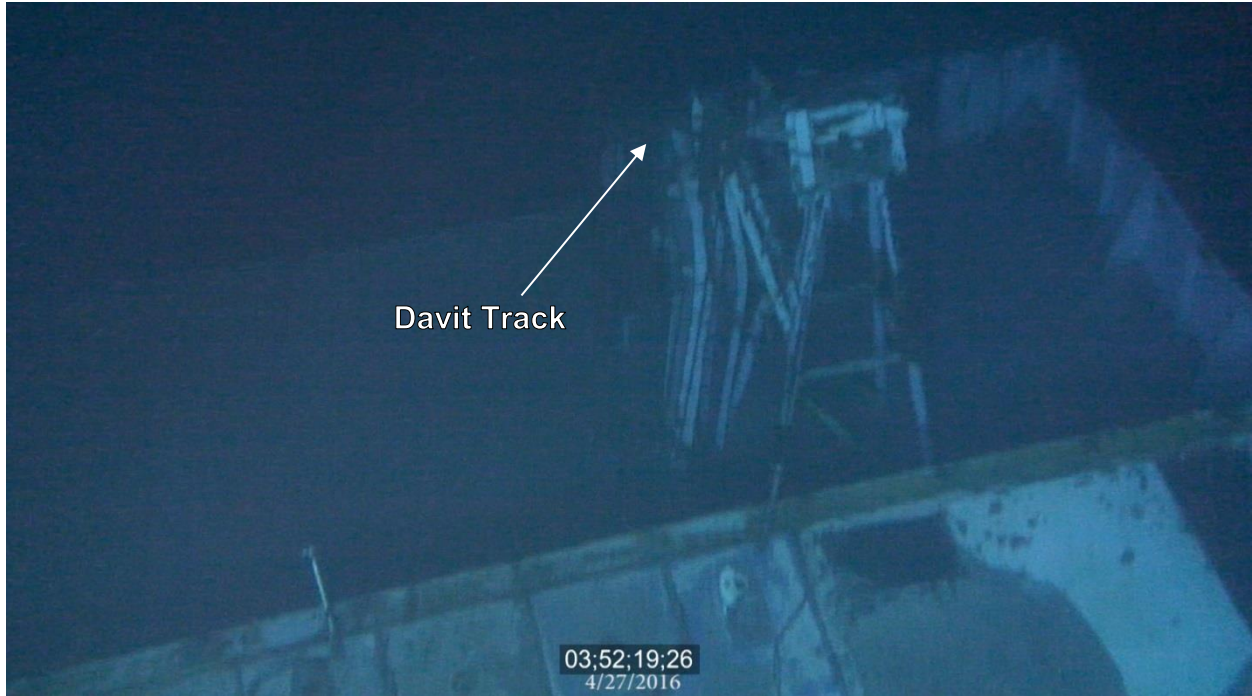
Figure 112. Region: Deck House – PORT Source: Mission II Vehicle: AOV

Alternate view of the port side forward davit track. The image is taken from above the deck house looking toward the port boat deck.

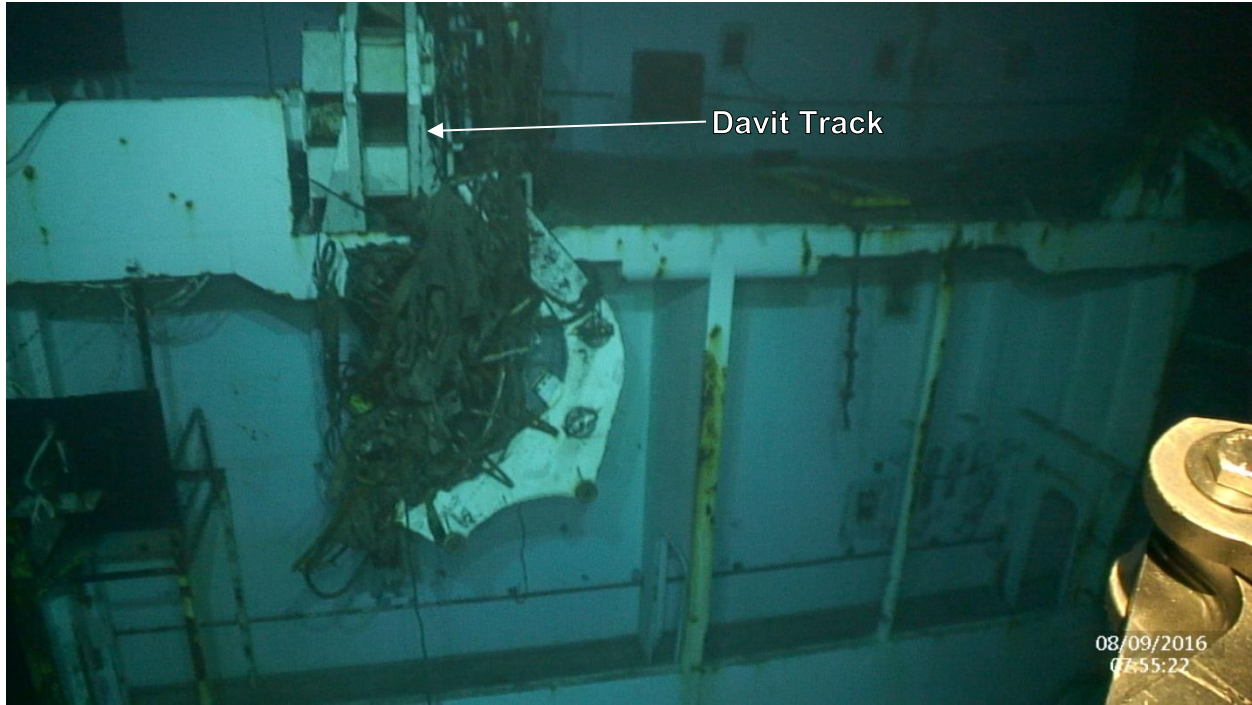
Figure 113. Region: Deck House – PORT Source: Mission III Vehicle: CURV 21

Alternate view of the port side forward lifeboat davit track.

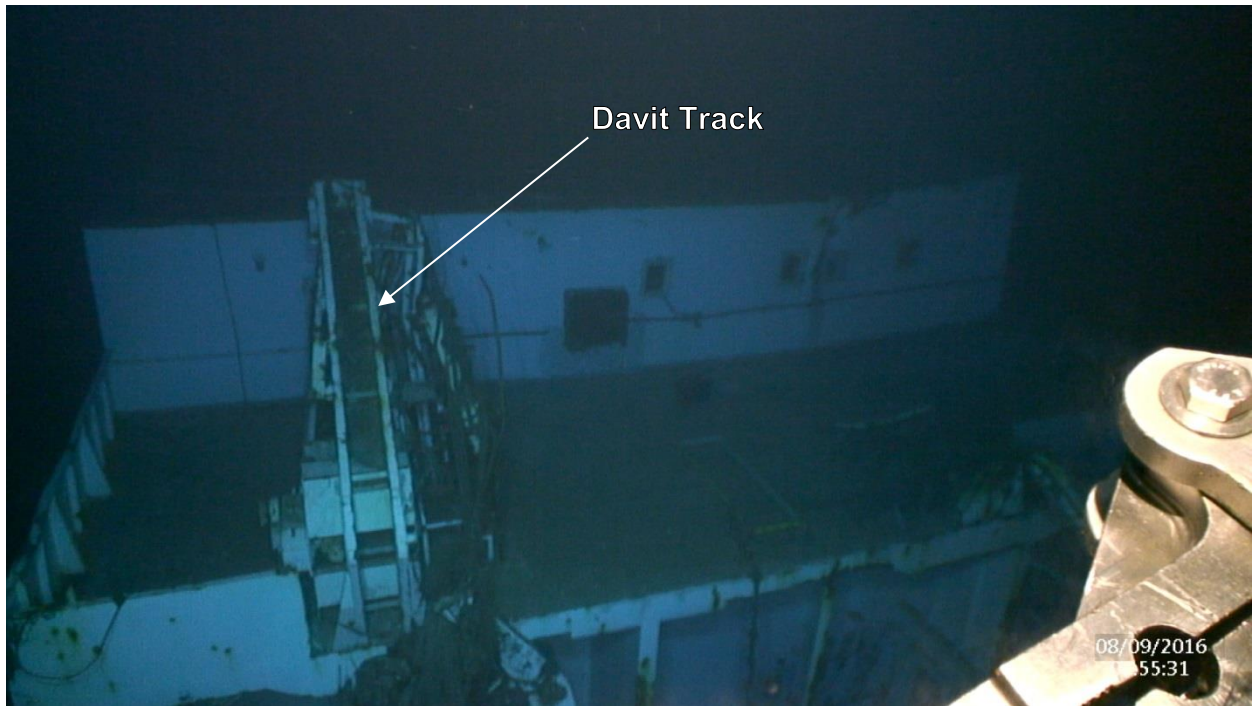
Figure 114. Region: Deck House – PORT Source: Mission III Vehicle: CURV 21

Alternate view of the port side forward davit track. There is evidence of a dent between the second and third window on the port side boat deck exterior bulkhead.

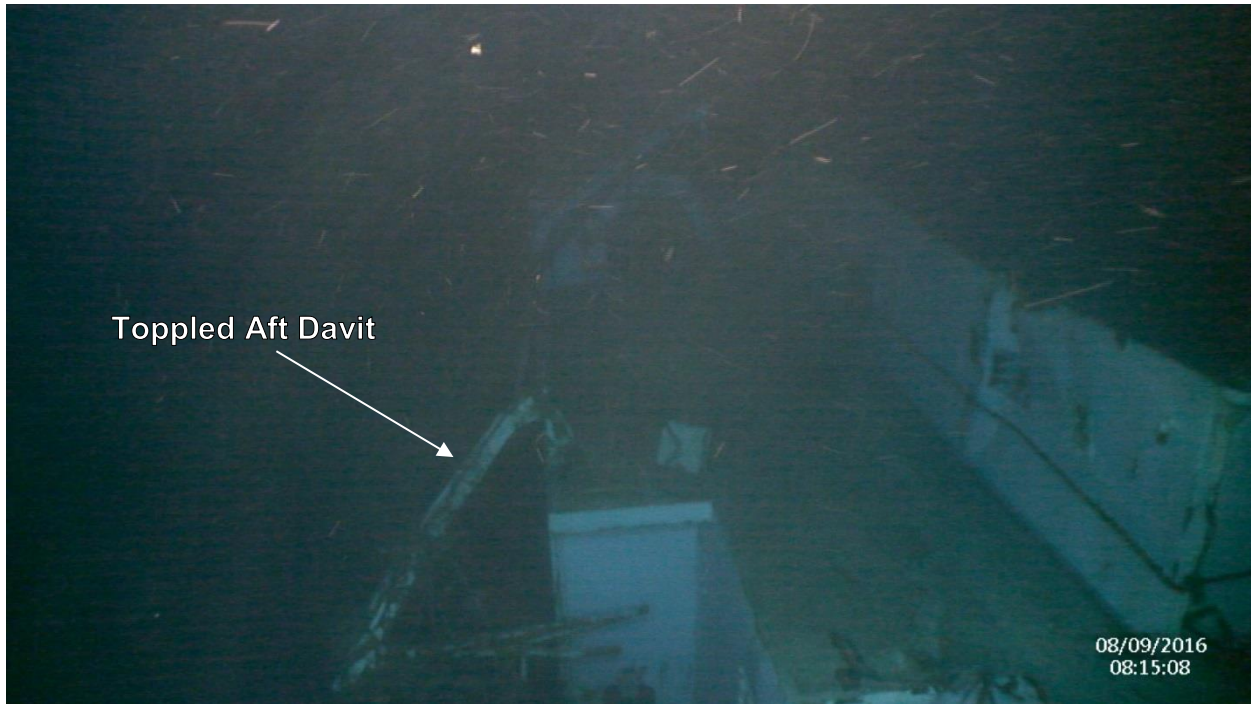
Figure 115. Region: Deck House – PORT Source: Mission III Vehicle: CURV 21

Looking forward, an alternate view of the port side aft davit track toppled over (center foreground) and dent on bulkhead of port side boat deck.

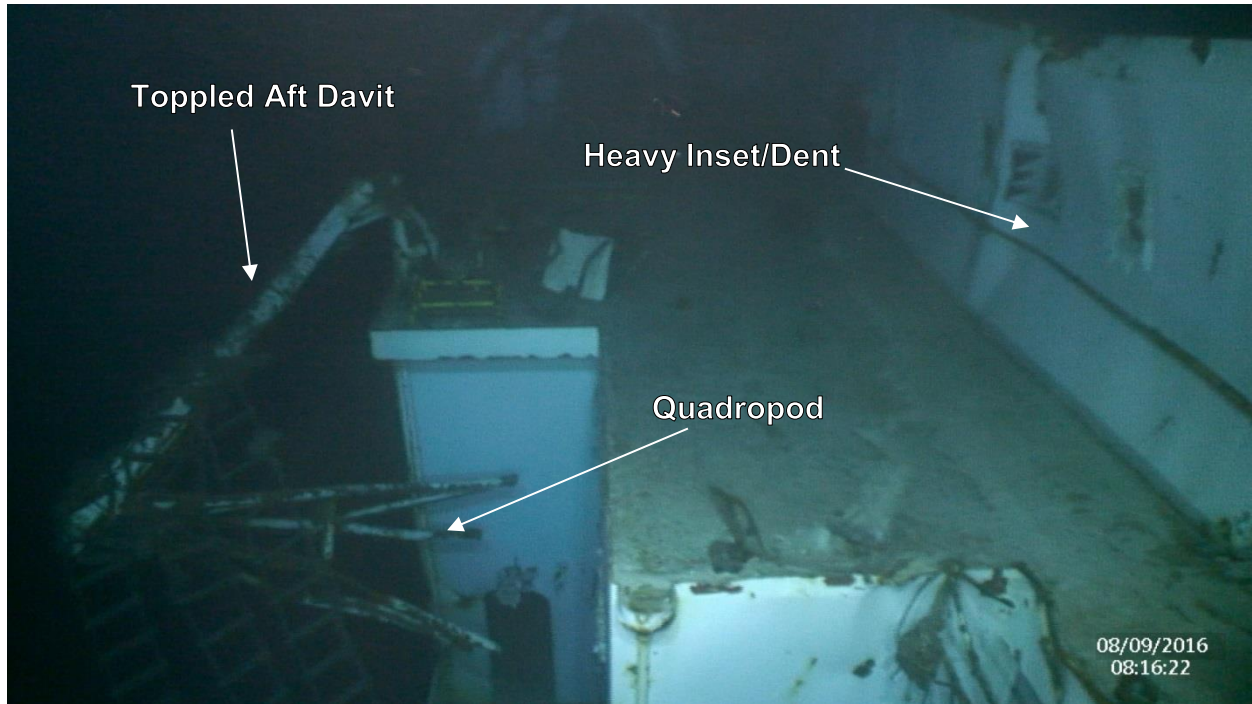
Figure 116. Region: Deck House – PORT Source: Mission III Vehicle: CURV 21

Looking forward, the port aft davit trackway is toppled and bent aft. The trackway quadropod is torn outboard, rotated 90 degrees and hanging over the port side. The deck house bulkhead on the port side boat deck is heavily set in and indented between frames 170 and 175.

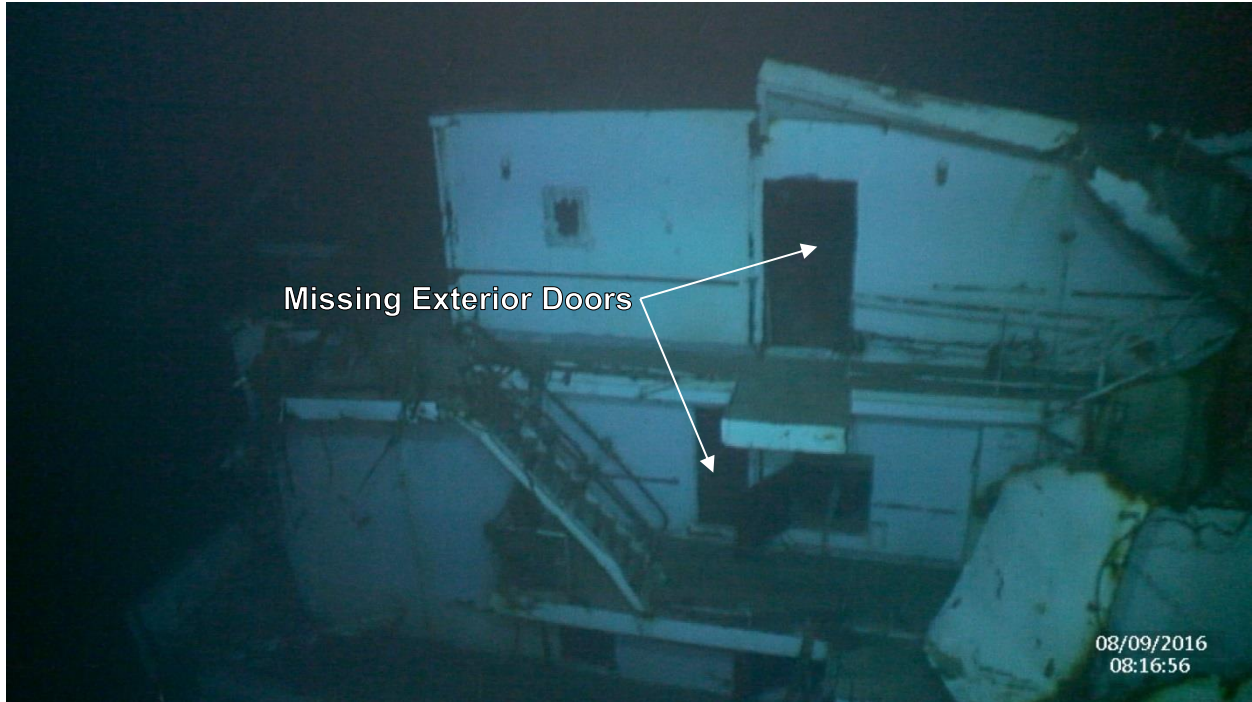
Figure 117. Region: Deck House – AFT Source: Mission III Vehicle: CURV 21

A view of the aft side of the deck house looking forward. The uppermost door is to the interior of the boat deck. The bent ladder on the left is from the boat deck to the cabin deck. The two exterior doors are missing, as is the majority of the handrails on the exterior ladder landings.

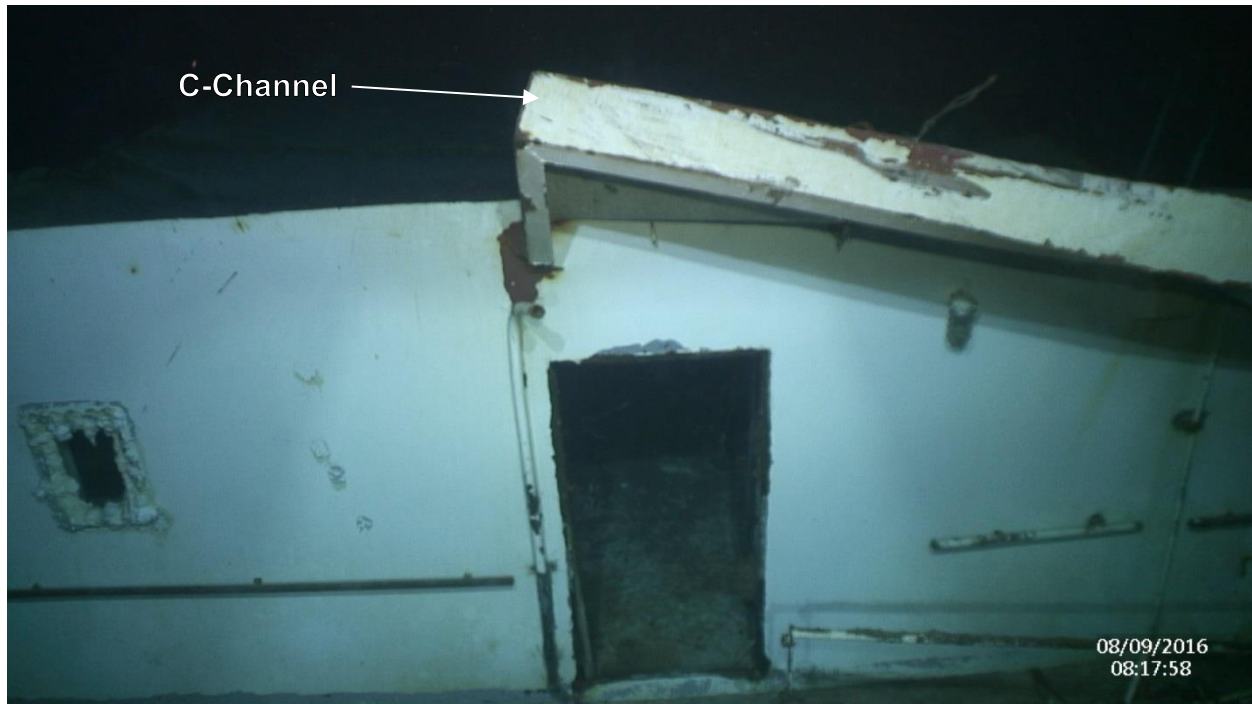
Figure 118. Region: Deck House – AFT Source: Mission III Vehicle: CURV 21

View through aft port side door on boat deck. Above the door, the lower navigation bridge deck supporting structural transverse channel is twisted upward with its C-channel face exhibiting deep scratches and denting. The deck of the lower navigation bridge deck is dished downward into the space of the boat deck.

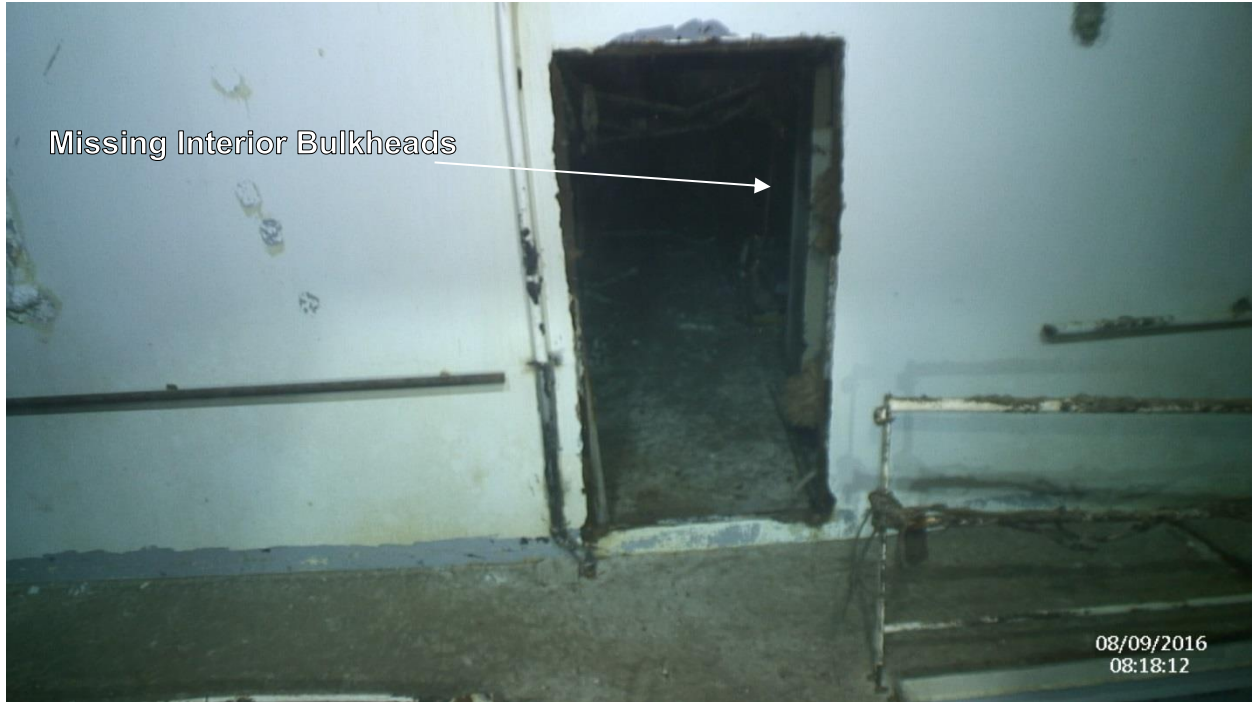
Figure 119. Region: Deck House – AFT Source: Mission III Vehicle: CURV 21

View through aft port side door on boat deck. Interior bulkheads that would normally be visible through this passageway appear to be missing.
