**NATIONAL TRANSPORTATION SAFETY BOARD
Office of Research and Engineering
Vehicle Recorder Division
Washington, D.C. 20594**

GROUP CHAIRMAN'S FACTUAL REPORT OF INVESTIGATION

***S.S. El Faro* Wreckage Examination Report**

DCA16MM001

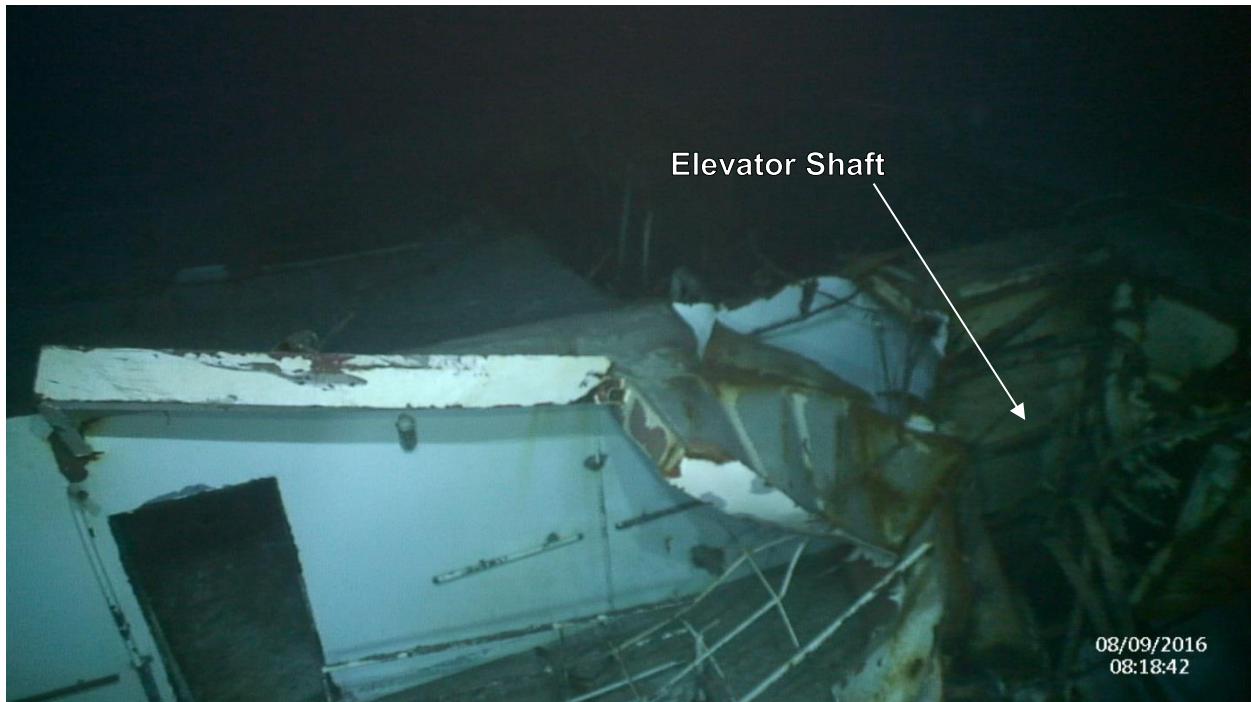
Figure 120. Region: Deck House – AFT Source: Mission III Vehicle: CURV 21

The elevator shaft terminating at the lower navigation bridge deck is on the right. Metal debris surrounding the elevator shaft is bent upward and aft. The image is looking forward and starboard.

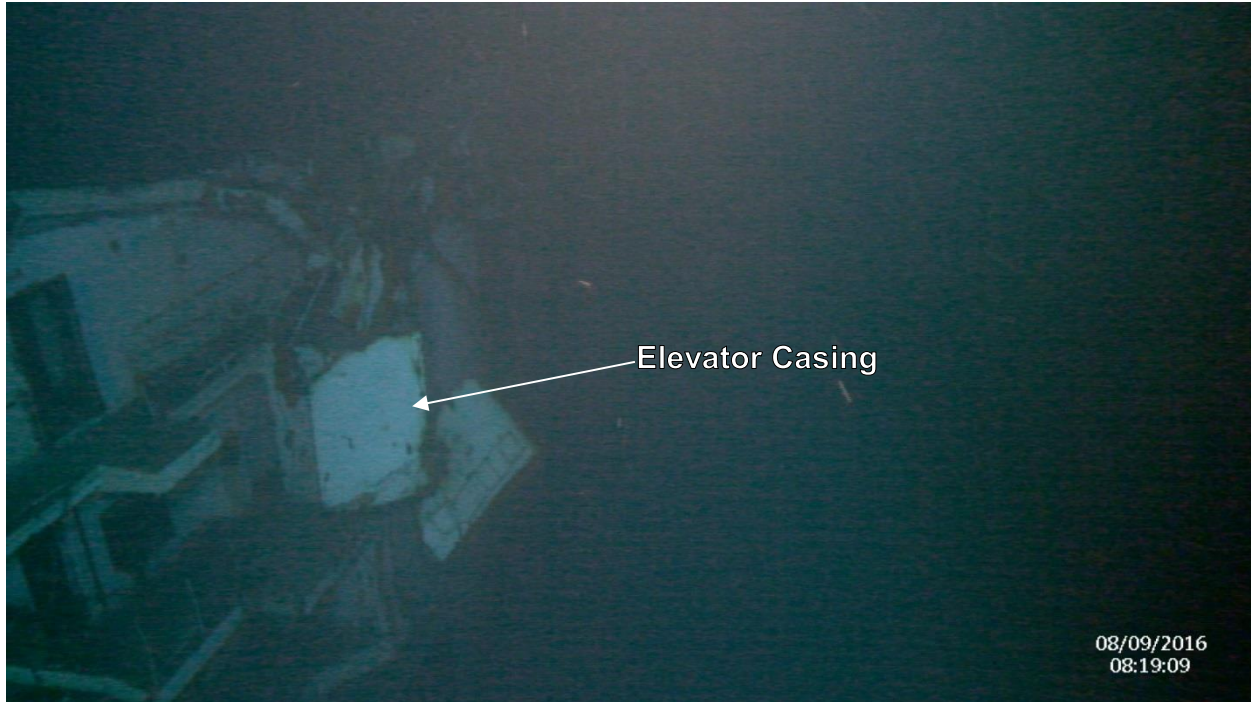
Figure 121. Region: Deck House – AFT Source: Mission III Vehicle: CURV 21

The lower navigation bridge deck port side of the elevator casing is torn off of the structure and bent aft. Image is looking port to starboard.

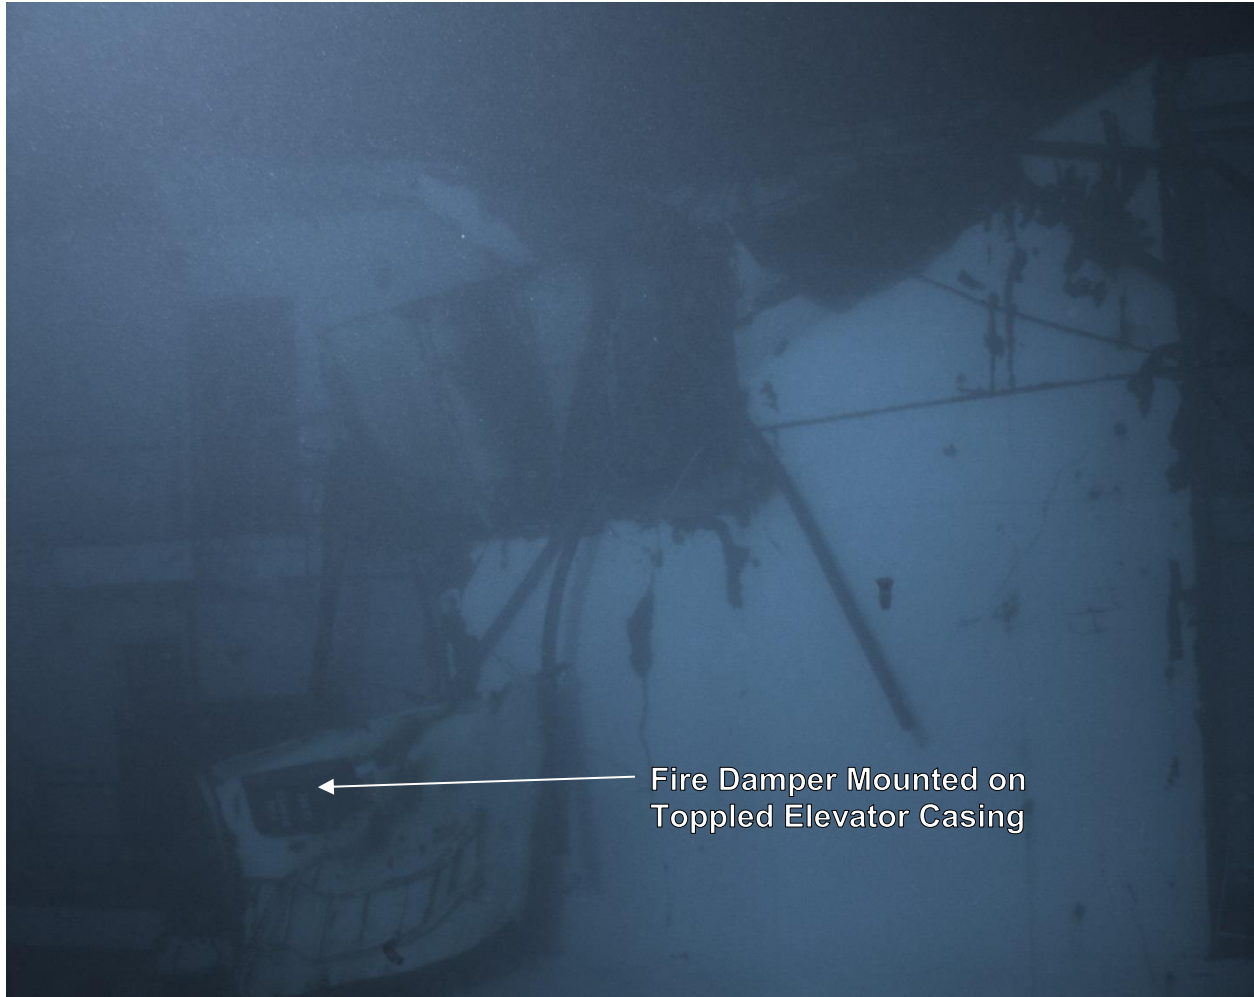
Figure 122. Region: Deck House – AFT Source: Mission III Vehicle: CURV 21

Alternate view of top of elevator casing. The elevator bulkhead which is hanging off the deck house structure has a dark box attached labeled "FIRE DAMPER." Good imagery was not captured of the lower aft port side of the deck house.

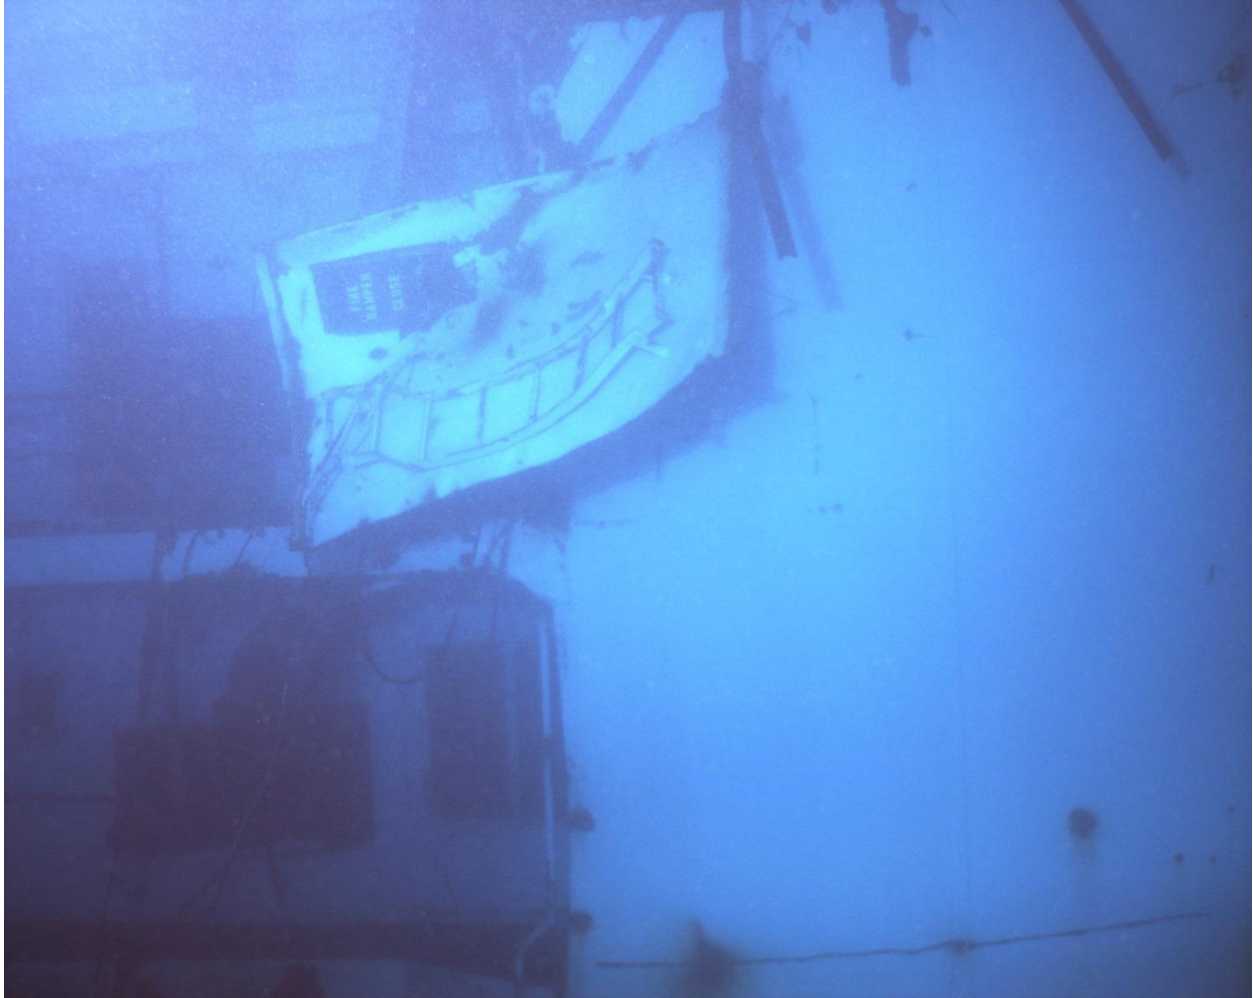
Figure 123. Region: Deck House – AFT Source: Mission III Vehicle: CURV 21

Lower view of figure 122.

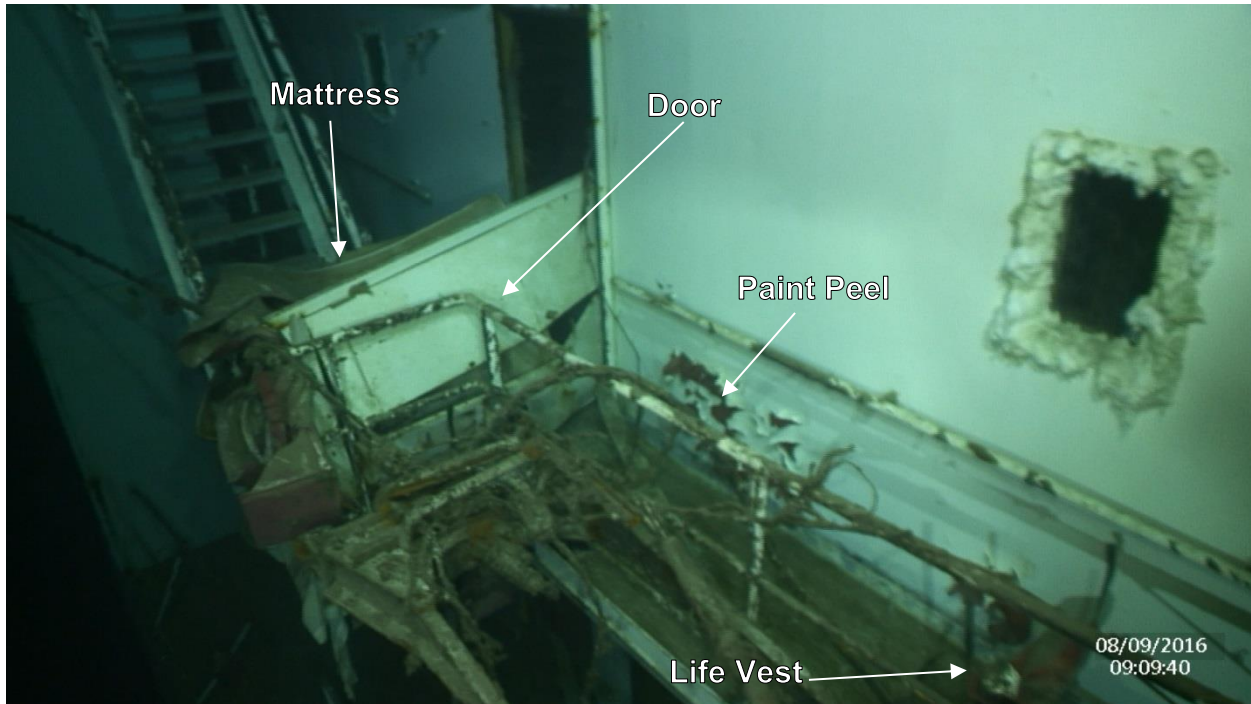
Figure 125. Region: Deck House – AFT Source: Mission III Vehicle: CURV 21

Starboard side of the aft deck house at the boat deck. This image shows a mattress and bi-fold joiner door displaced. There is an area of paint peel near the doorway. A tangled life vest with reflective tape is seen near the bottom right of the image.

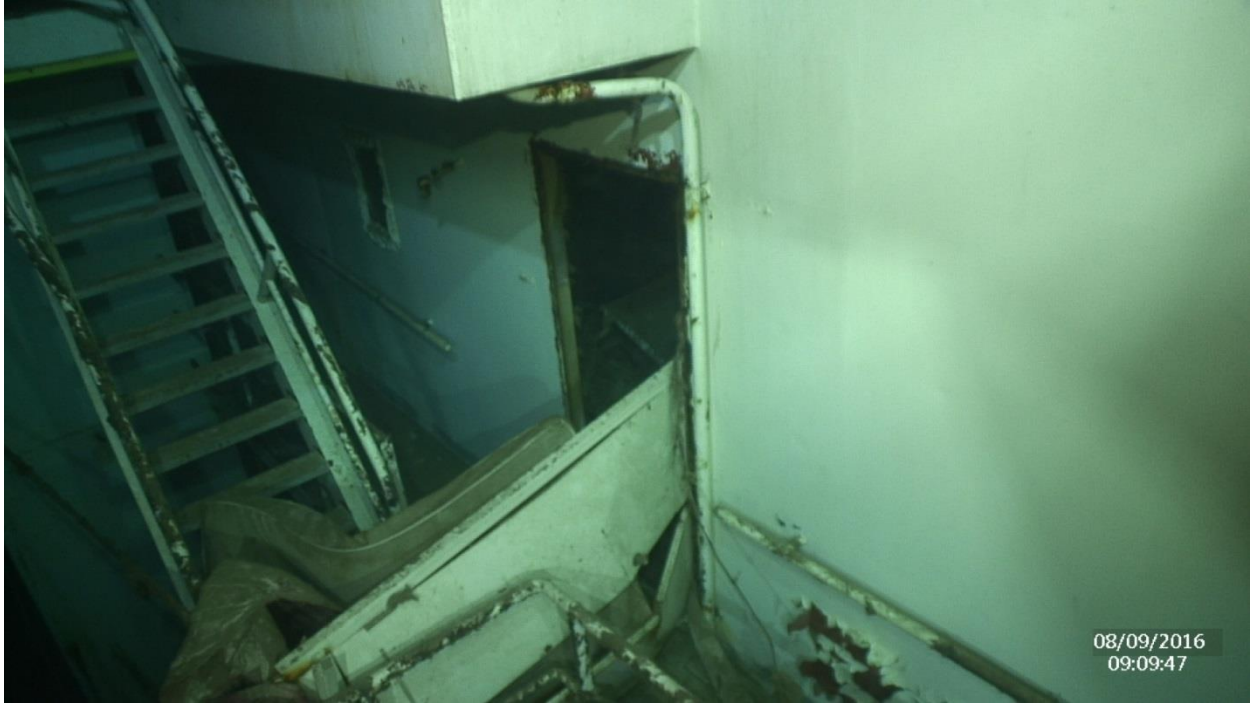
Figure 126. Region: Deck House – AFT Source: Mission III Vehicle: CURV 21

View into aft doorway from boat deck looking inside into the ship's treatment room. The bulkhead from the passageway to the treatment room is missing. Some debris appears toppled within the room.

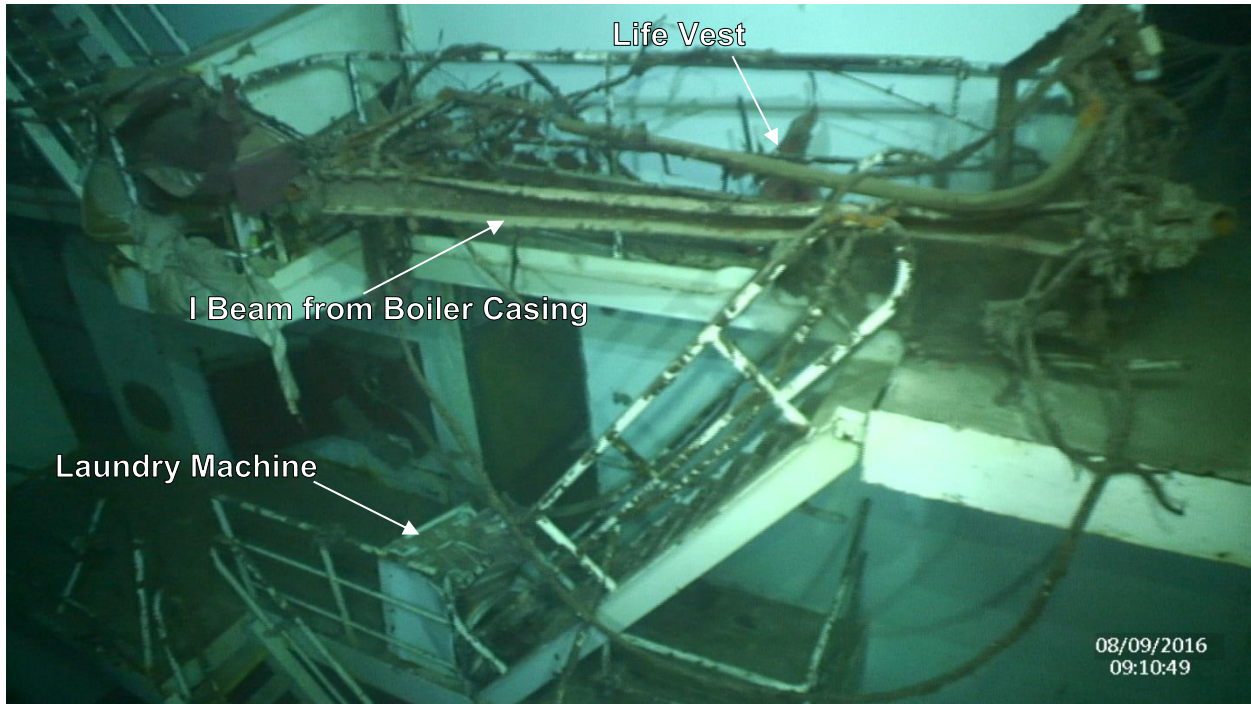
Figure 127. Region: Deck House – AFT Source: Mission III Vehicle: CURV 21

View of deck house aft starboard side boat deck (above) and cabin deck (below). A life jacket, or Personal Flotation Device (PFD) with reflective material is entangled on the boat deck walkway against the house forward of the top of the ladder down to the cabin deck. A laundry machine from the crew laundry room appears to be resting on the aft railing on the cabin deck. The brown athwartships structure appears to be an I-beam with associated piping from the boiler exhaust casing.

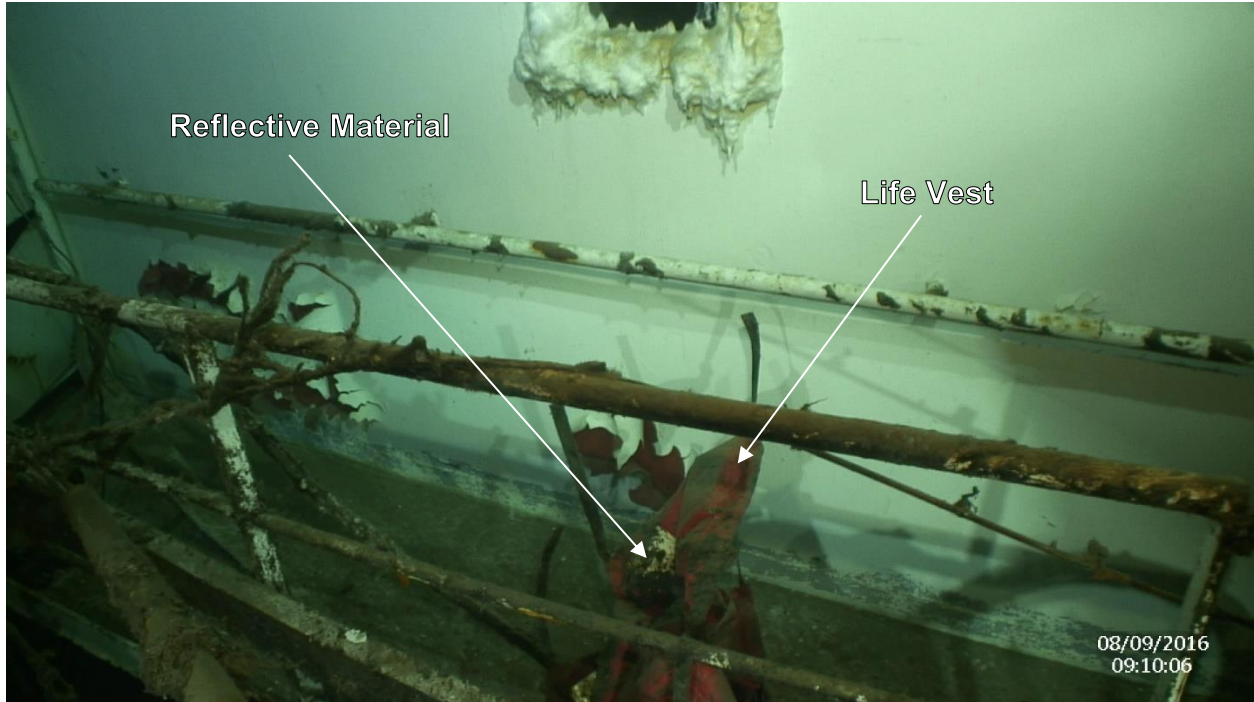
Figure 128. Region: Deck House – AFT Source: Mission III Vehicle: CURV 21

Closer view of PFD with reflective material entangled on the boat deck exterior landing (walkway).

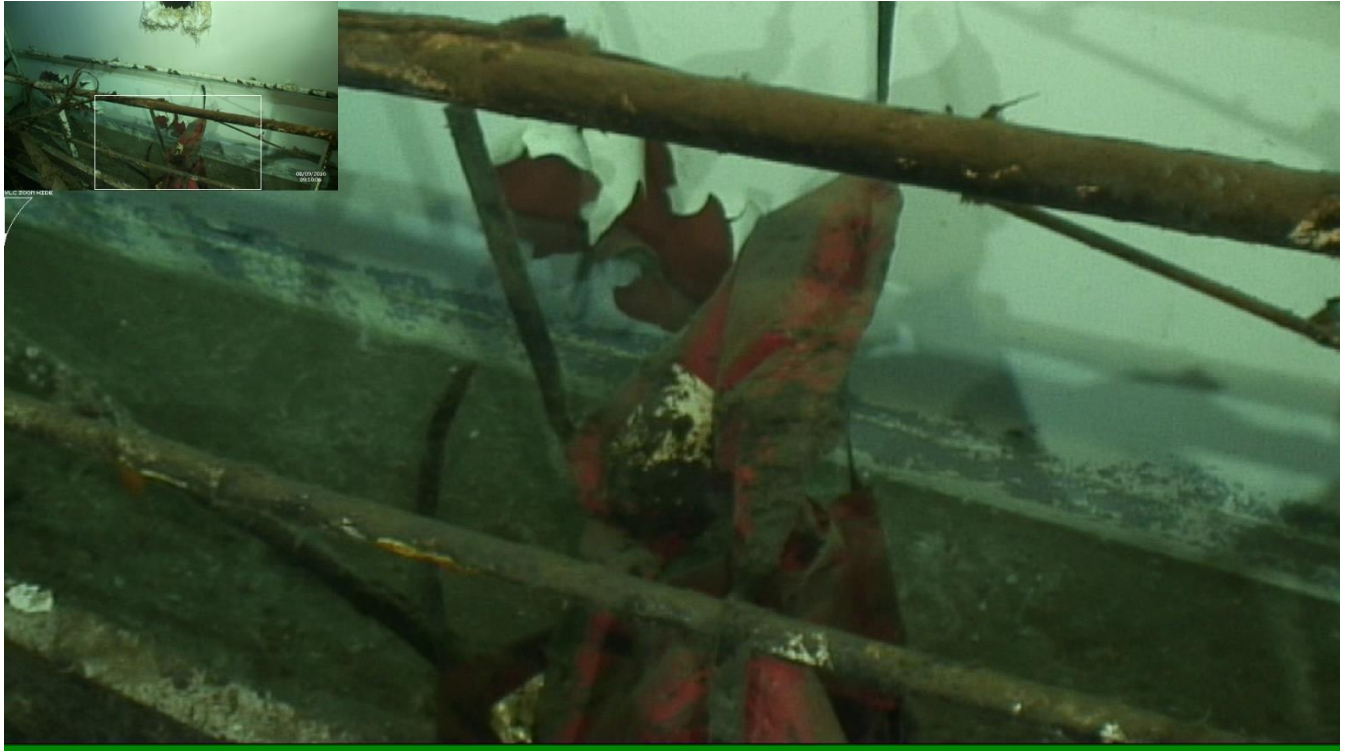
Figure 129. Region: Deck House – AFT Source: Mission III Vehicle: CURV 21

Close-up view from inset view of PFD with reflective material entangled on the boat deck walkway.

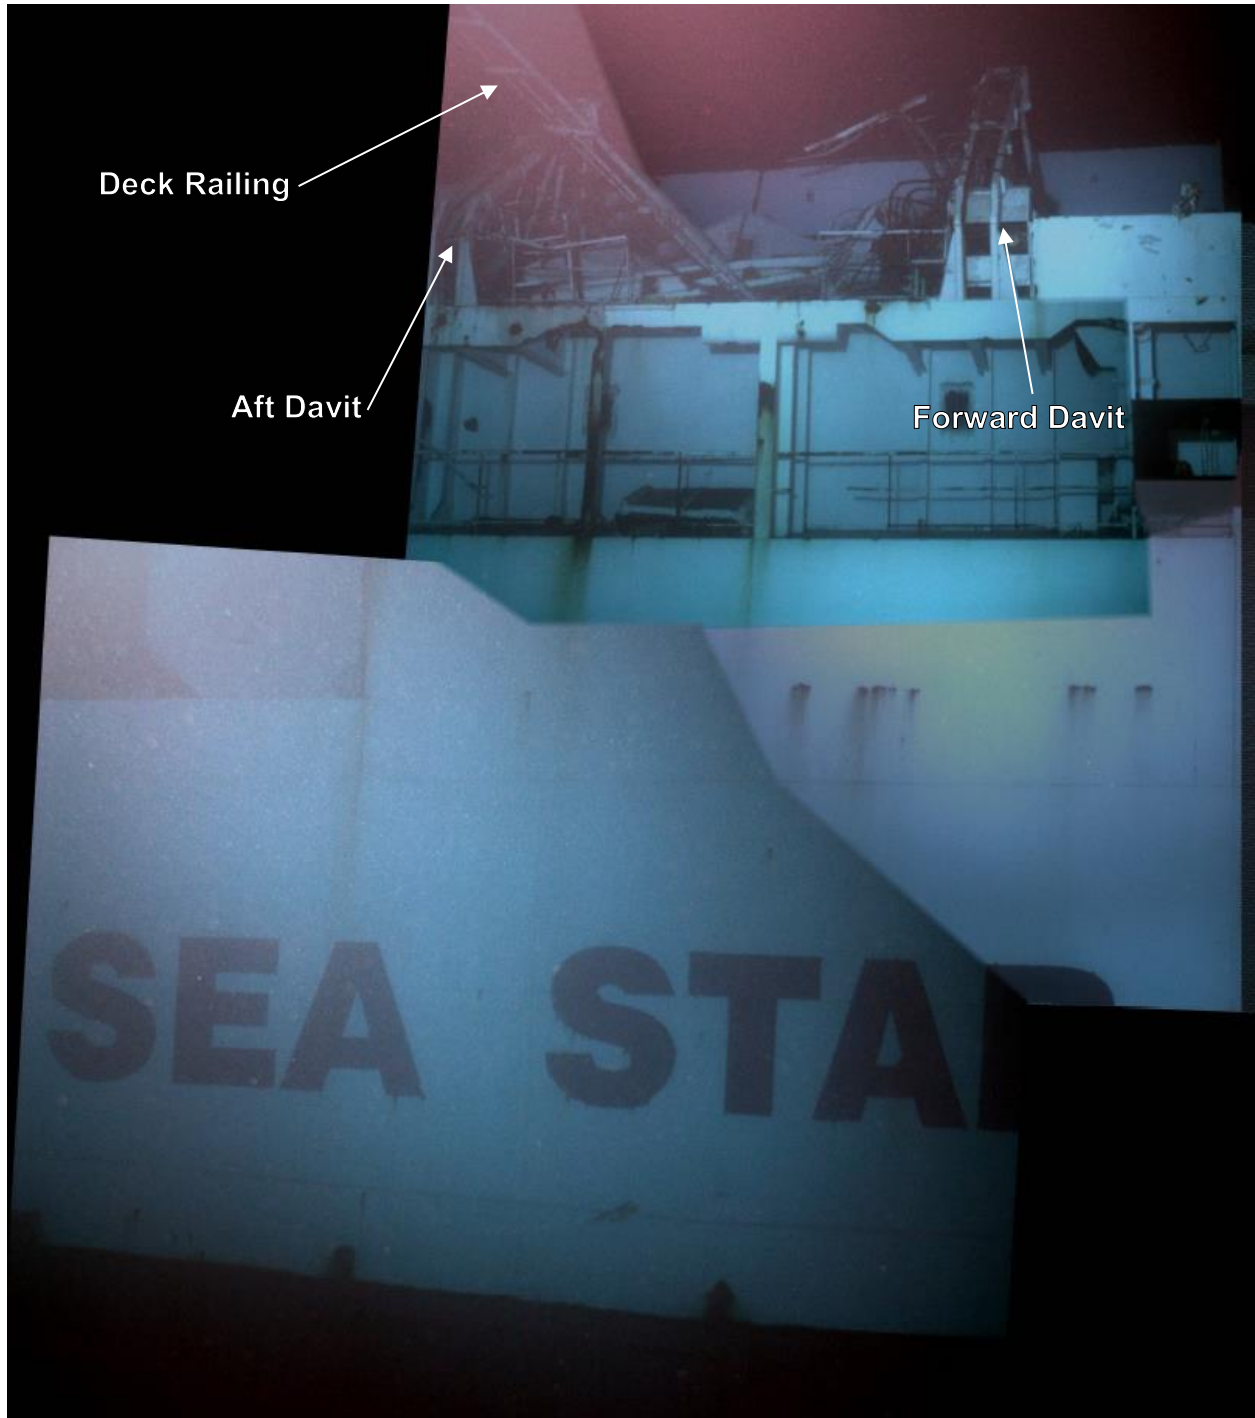
Figure 130. Region: Deck House – STBD Source: Mission II Vehicle: AOV Mosaic

A mosaic image of the starboard side of the deck house from the main deck to the lower navigation bridge deck. Both lifeboat davit tracks appear to be in place and intact. What appears to be main deck rail is resting on the boat deck, partially over the aft davit trackway assembly. The stern is to the left side of the image, and the bow to the right.

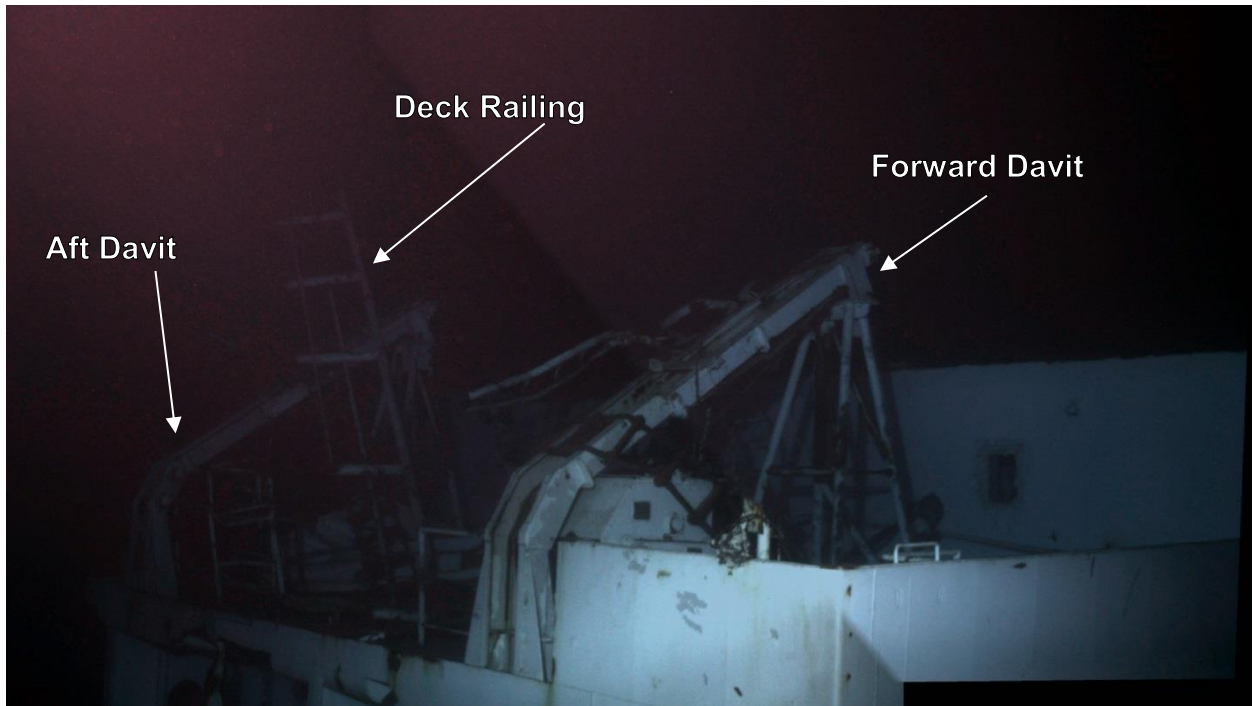
Figure 131. Region: Deck House – STBD Source: Mission II Vehicle: AOV Mosaic

Alternate view of starboard side boat deck taken from the forward starboard corner of the deck house looking aft. Forward davit is in foreground.

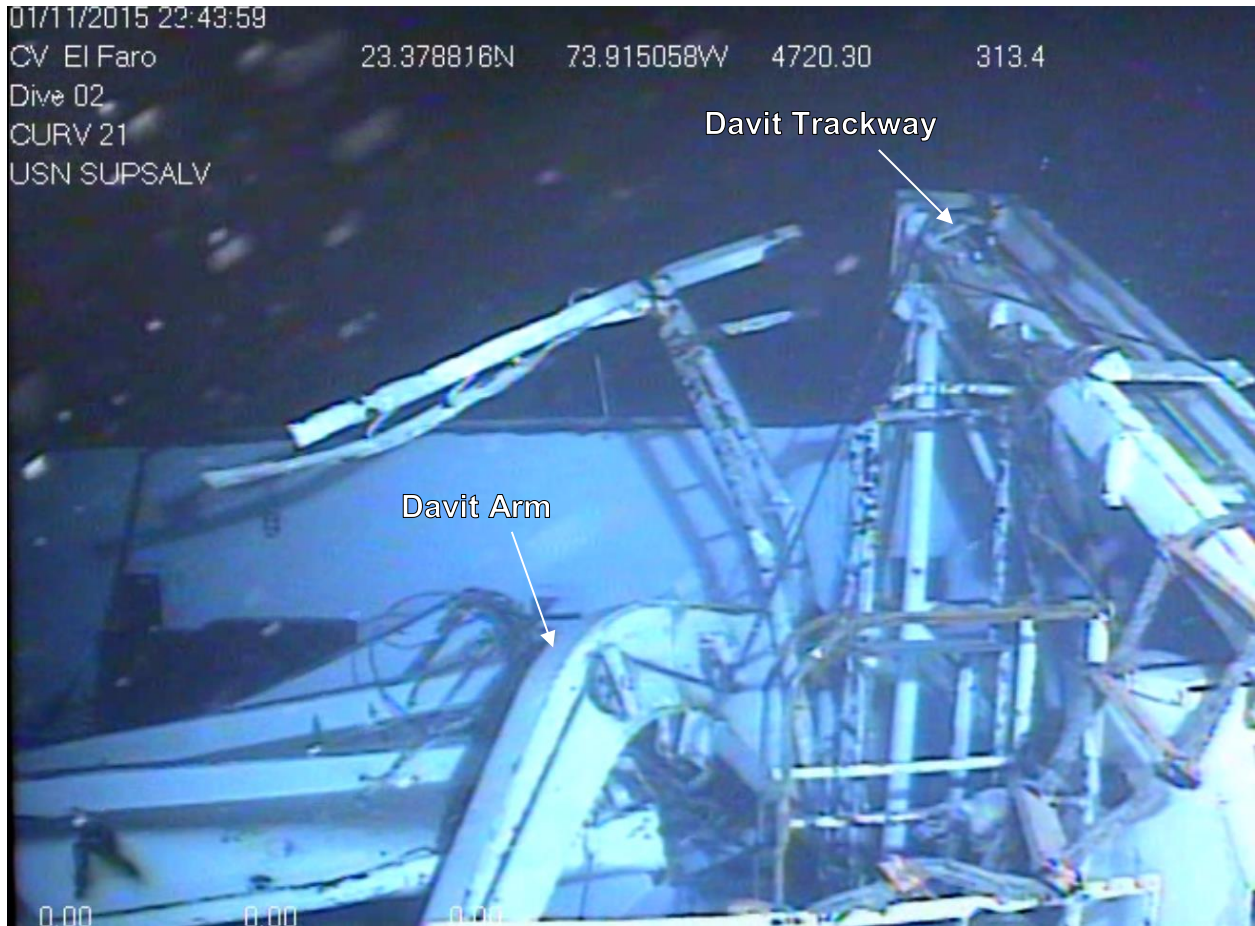
Figure 132. Region: Deck House – STBD Source: Mission I Vehicle: CURV 21

Close up view of the starboard forward davit and davit trackway assembly. The davit arm is displaced and resting on the deck. The davit arm cable is still attached to the forward davit trackway and davit arm. In the lower left side of the image, the underside of the navigation bridge deck's starboard bridge wing deck plate and structure is visible, resting upside down on the starboard boat deck.

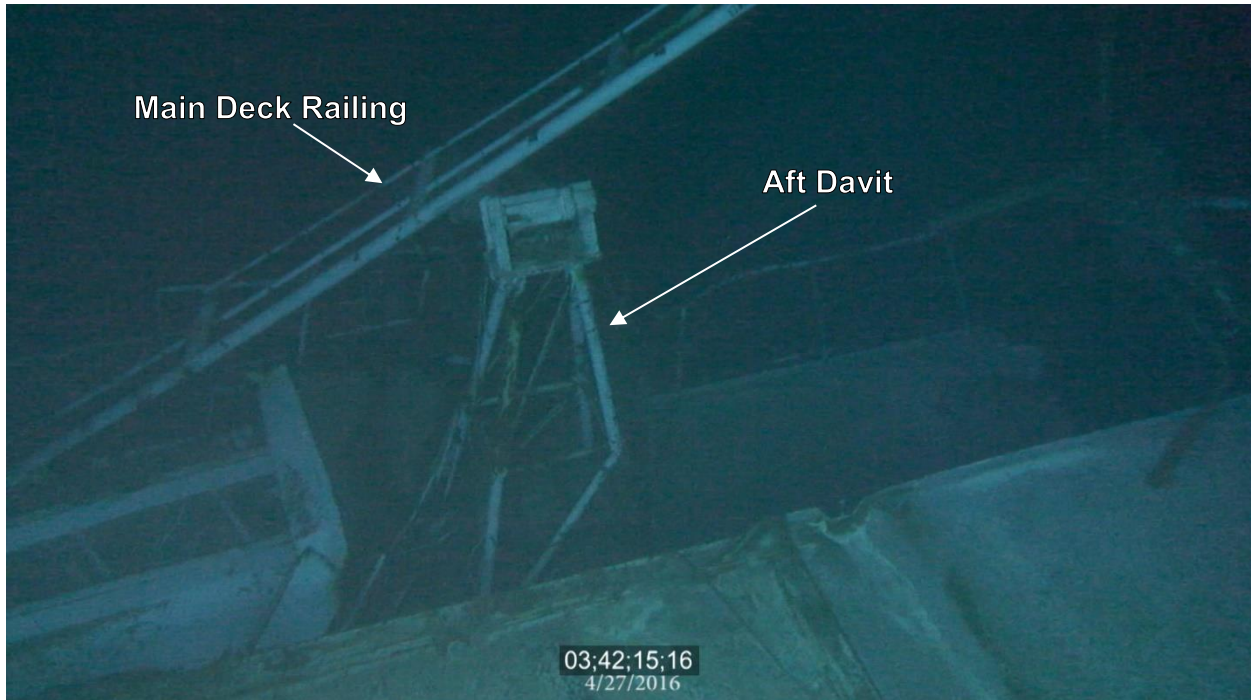
Figure 133. Region: Deck House – STBD Source: Mission I Vehicle: CURV 21.

An alternate view of the aft starboard davit assembly. The photograph is taken from over the top of the deck house (lower navigation deck) looking to starboard and slightly aft. A section of main deck hand rail is resting on top of the starboard aft boat deck assembly.

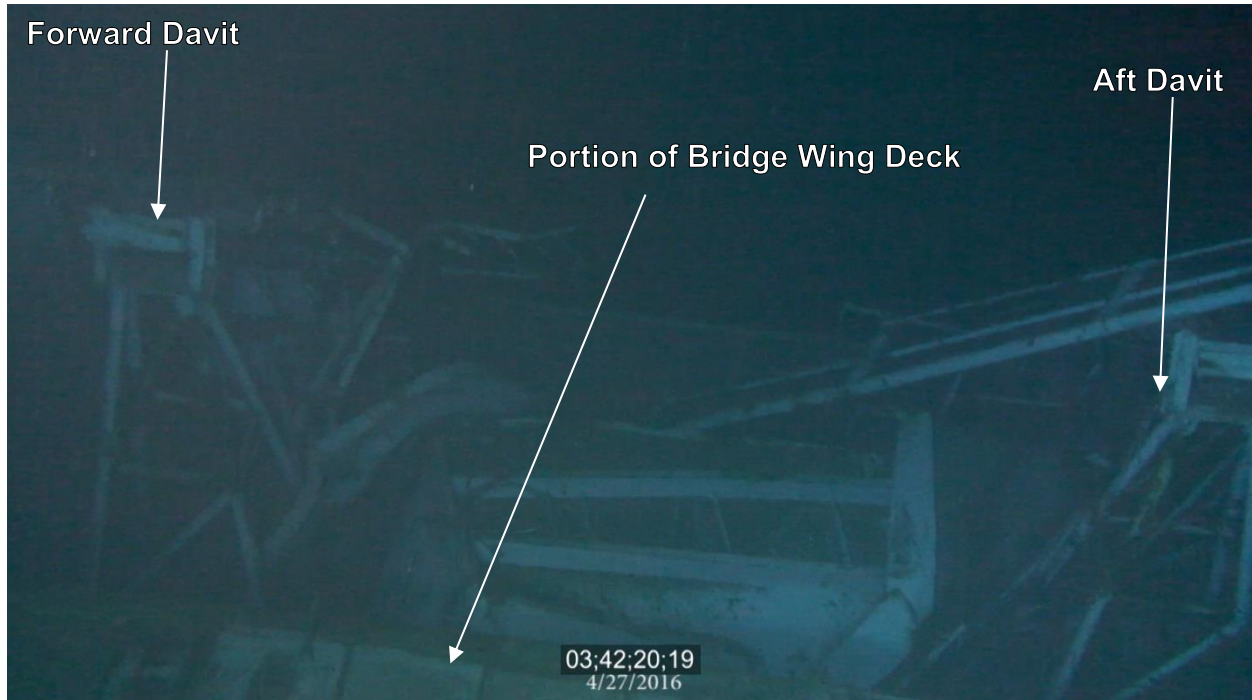
Figure 134. Region: Deck House – STBD Source: Mission I Vehicle: CURV 21.

An alternate view of the forward starboard davit assembly (on left) and aft davit assembly (right). The photograph is taken from over the top of the deck house (lower navigation deck) looking to starboard and slightly forward. A portion of the bridge wing deck is resting upside down between the two davit assemblies.

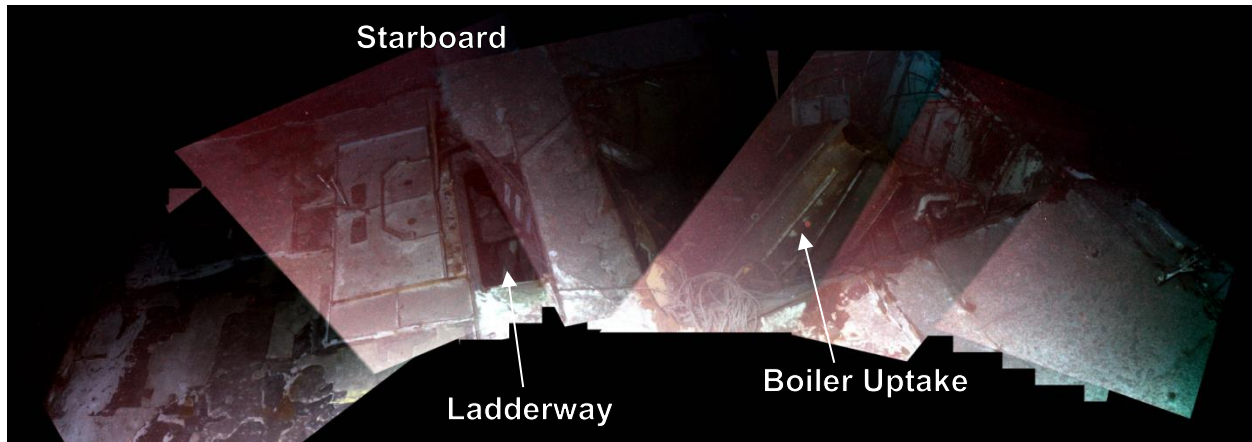
Figure 135. Region: Deck House – Top Source: Mission II Vehicle: AOV MOSAIC Image

A photographic mosaic image of the remaining surface of the lower navigation bridge deck. The orientation of the mosaic is looking toward starboard. The forward portion of the deck is located to the left of image. The boiler casing is visible to the right of the mosaic and the ladderway to the boat deck just left of center. The ladder within the ladderway appears to be missing. Toilet/shower unit flat bar perimeter outlines and some associated plumbing is just left of the ladderway. Flat bar associated with previously attached joiner bulkheads is visible throughout the deck. In general, the decks are heavily deformed.

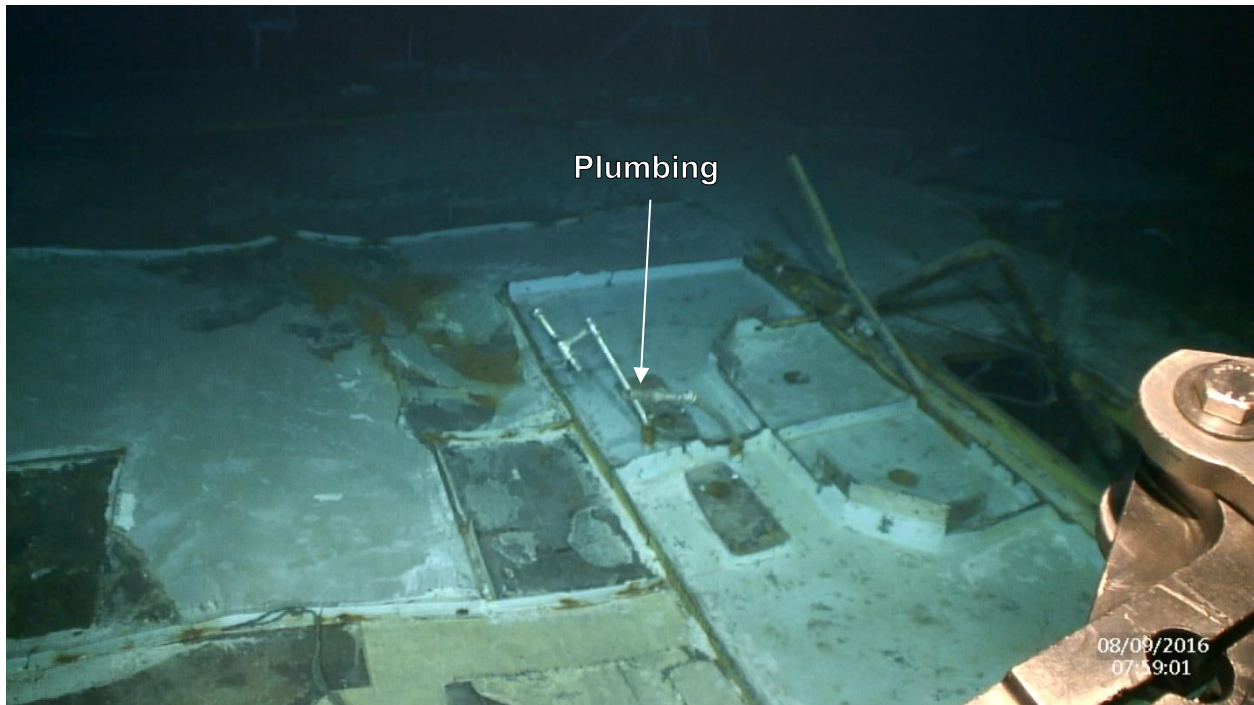
Figure 136. Region: Deck House – Top Source: Mission III Vehicle: CURV 21

A close up image of the lower navigation bridge deck. Some plumbing associated with toilet/shower units in staterooms is visible at frame 168 on centerline. Deformation of the deck is visible throughout.

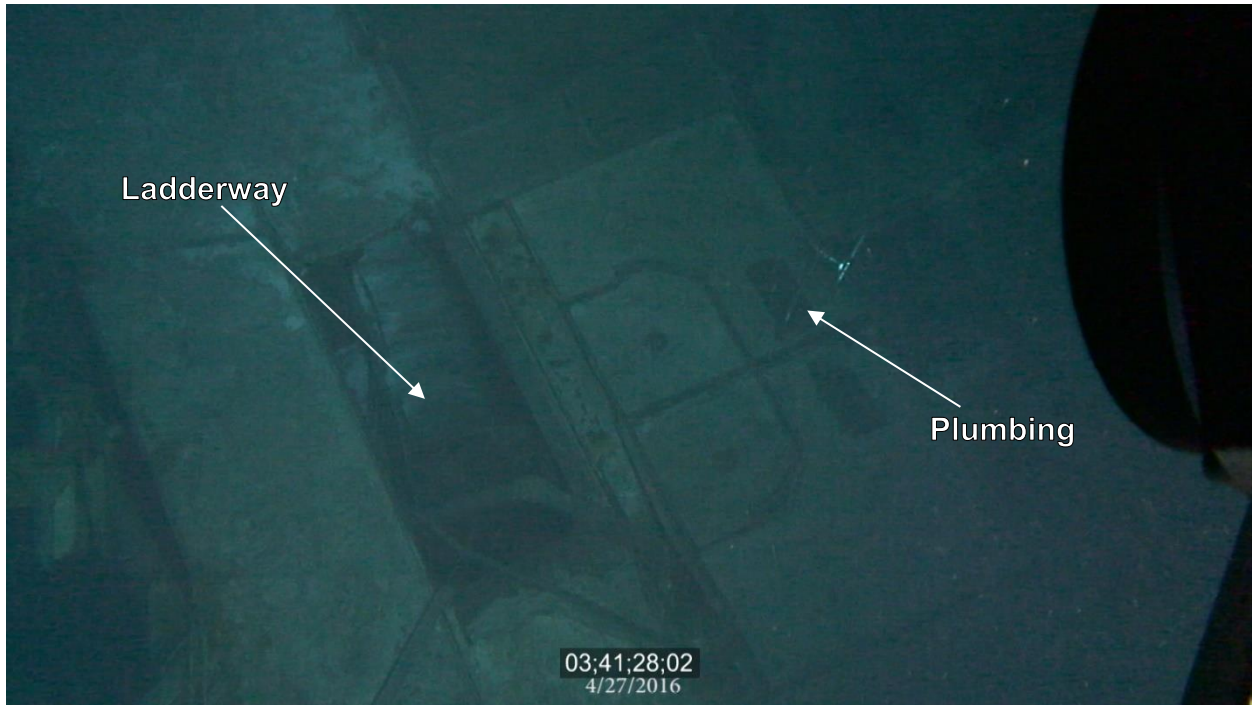
Figure 139. Region: Deck House – Top Source: Mission II Vehicle: AOV

The ladder associated with the ladderway to the lower navigation bridge deck is visible resting on the boat deck.

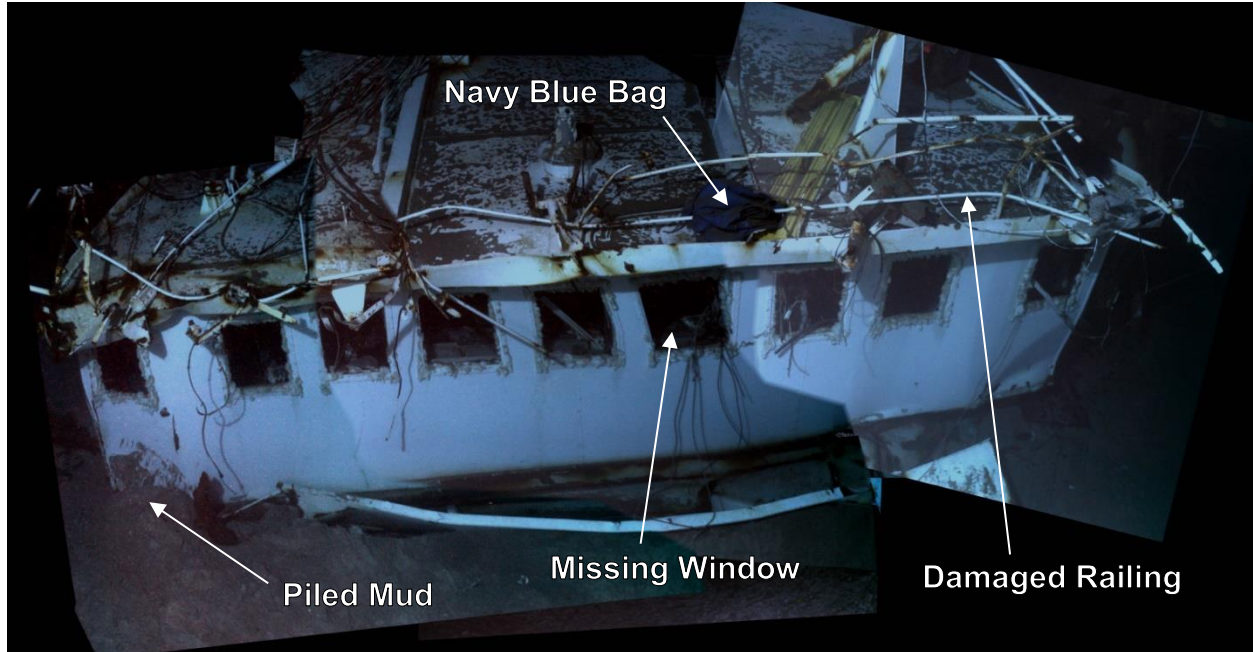
Figure 141. Region: Bridge Source: Mission II Vehicle: AOV Mosaic Image

The forward side of the wheelhouse and navigation bridge deck looking aft. All the windows are missing. The starboard forward corner (lower left side of image) is deeper into the seabed than other corners, and the seabed is mounded forward of the corner. The windscreen bulwark is bent inward at the deck level and has mud pushed forward of it. The main mast is missing and its three mast legs have been severed from the wheelhouse top. The railings around the perimeter of the wheelhouse top are missing or severely bent and broken. There is a navy-blue bag on the wheelhouse top at just forward of centerline.

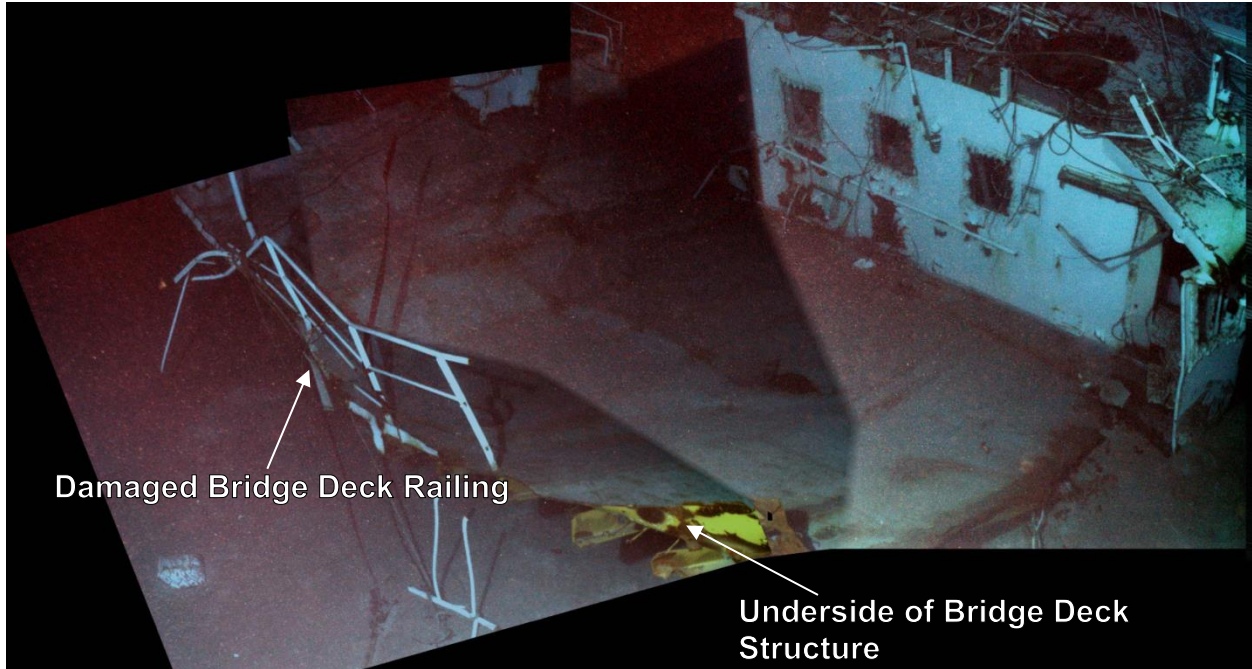
Figure 143. Region: Bridge Source: Mission II Vehicle: AOV Mosaic Image

The starboard corner of the navigation bridge deck looking down and aft. The bridge wing, which would extend to the left side of the exposed yellow structure, is missing. All exterior bulwarks that would have been beneath the navigation bridge deck are missing. The navigation bridge deck appears to be bent upward (curving) from the wheelhouse to the outboard deck edge. The railings around the perimeter of the navigation bridge deck are missing or severely bent and broken.

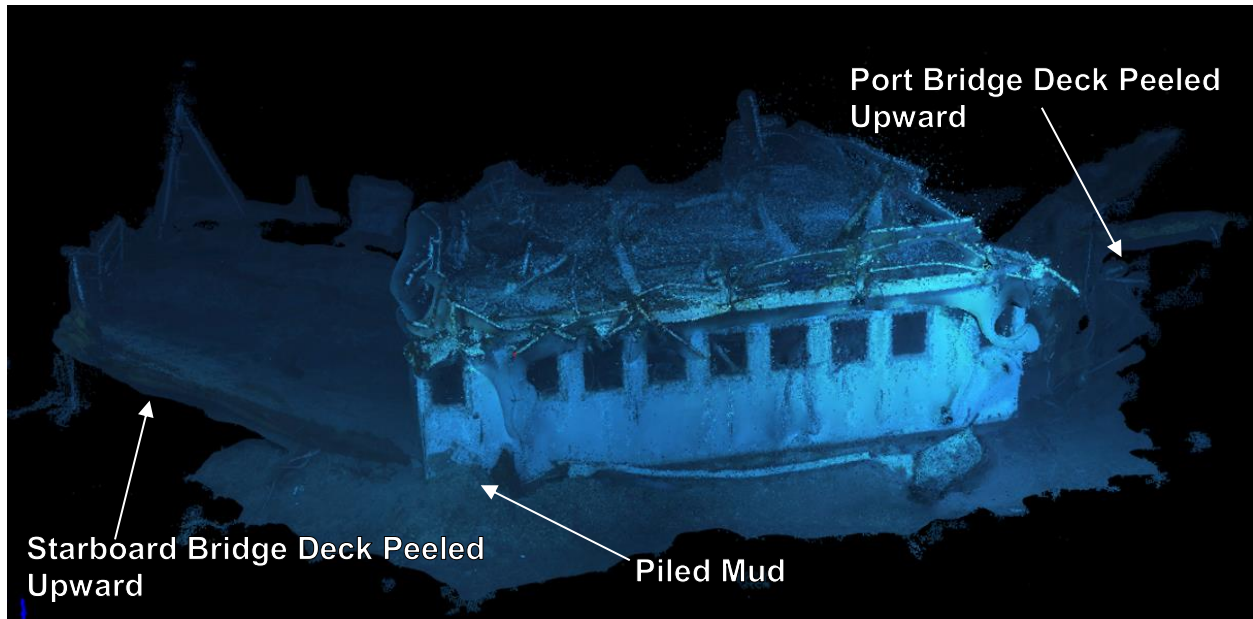
Figure 144. Region: Bridge Source: Mission II Vehicle: AOV- NTSB Point Cloud 3-D Model

The forward side of the wheelhouse and navigation bridge deck looking aft. The navigation bridge decks on both port and starboard sides are bent upward from the wheelhouse as they extend outboard. The bridge wings are missing. All exterior bulwarks that would have been beneath the navigation bridge deck are missing. Mud appears to be piled forward of the wheelhouse, and the starboard forward corner of the wheelhouse appears driven deepest into the seafloor.

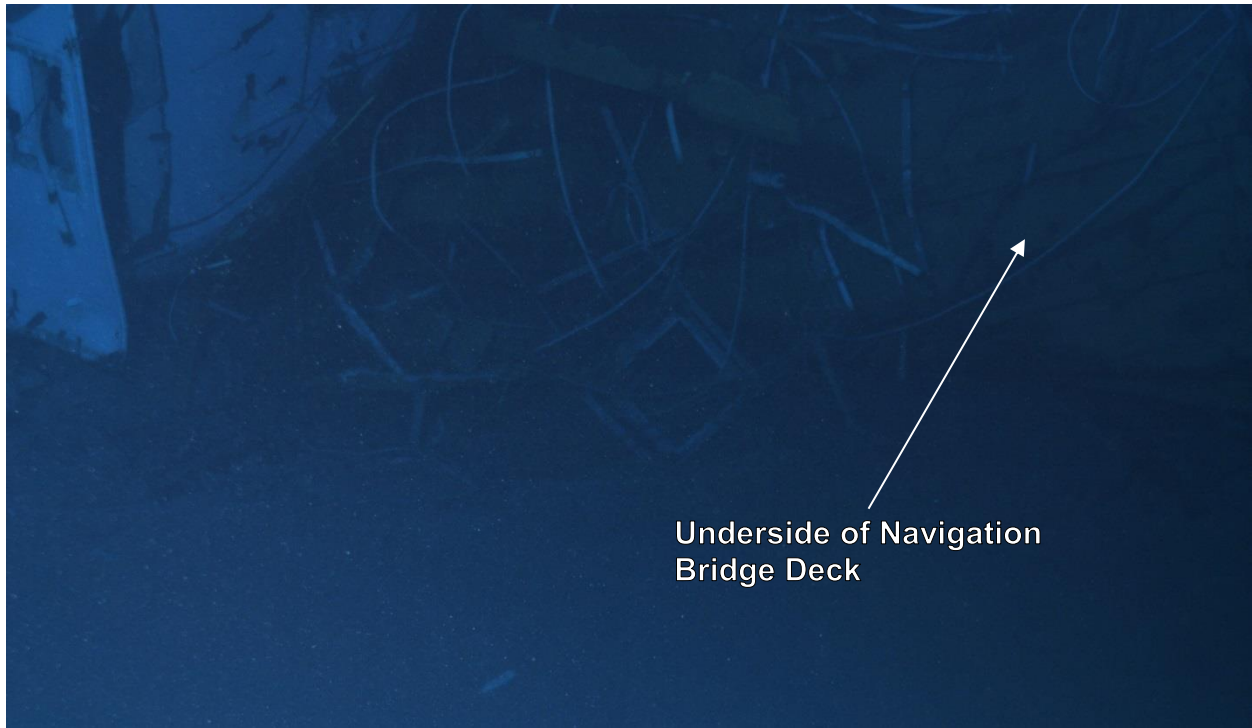
Figure 145. Region: Bridge Source: Mission II Vehicle: AOV

View of forward port corner of wheelhouse (upper left). Underside of the navigation bridge deck is curled upward and backward. Joiner work and wiring associated with the lower navigation bridge deck accommodations can be seen under the curled navigation bridge decking
