**NATIONAL TRANSPORTATION SAFETY BOARD
Office of Research and Engineering
Vehicle Recorder Division
Washington, D.C. 20594**

GROUP CHAIRMAN'S FACTUAL REPORT OF INVESTIGATION

***S.S. El Faro* Wreckage Examination Report**

DCA16MM001

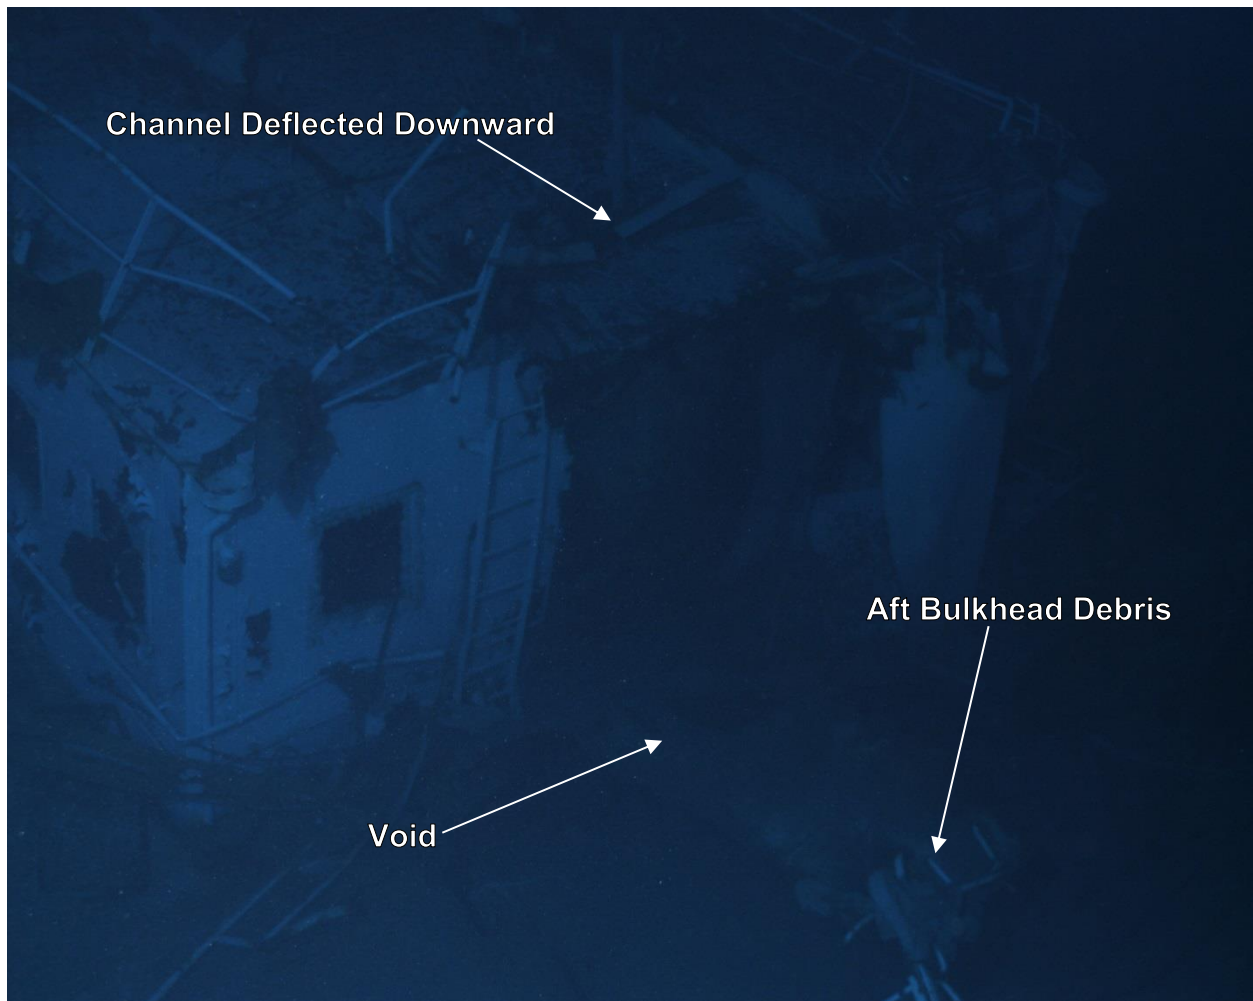
Figure 146. Region: Bridge Source: Mission II Vehicle: AOV

A view of the aft bulkhead of the wheelhouse taken from the aft port quarter. There is a void present between frame 170 and 172. Debris and the bulkhead from this area is removed from the house and bent aft. The channel is deflected downward where the rear mast leg was planted. The wheelhouse top also is deflected downward at centerline where the mast mounting channel is deflected most severely.

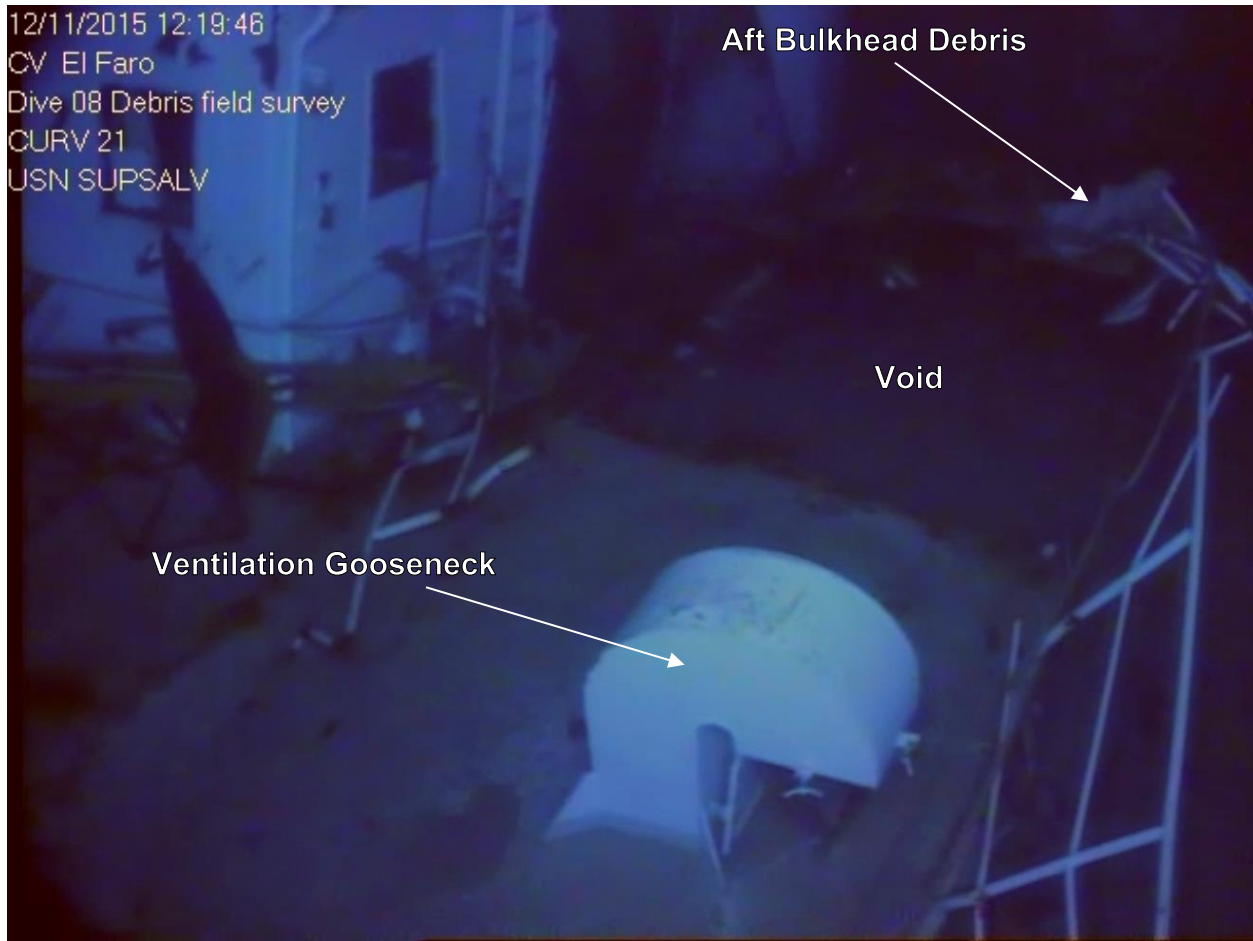
Figure 147. Region: Bridge Source: Mission I Vehicle: CURV 21

Alternate view of the aft bulkhead of the wheelhouse taken from the port quarter. Ventilation gooseneck at frame 174 is in position. Stack is separated from the house top, and is located nearby in the debris field.

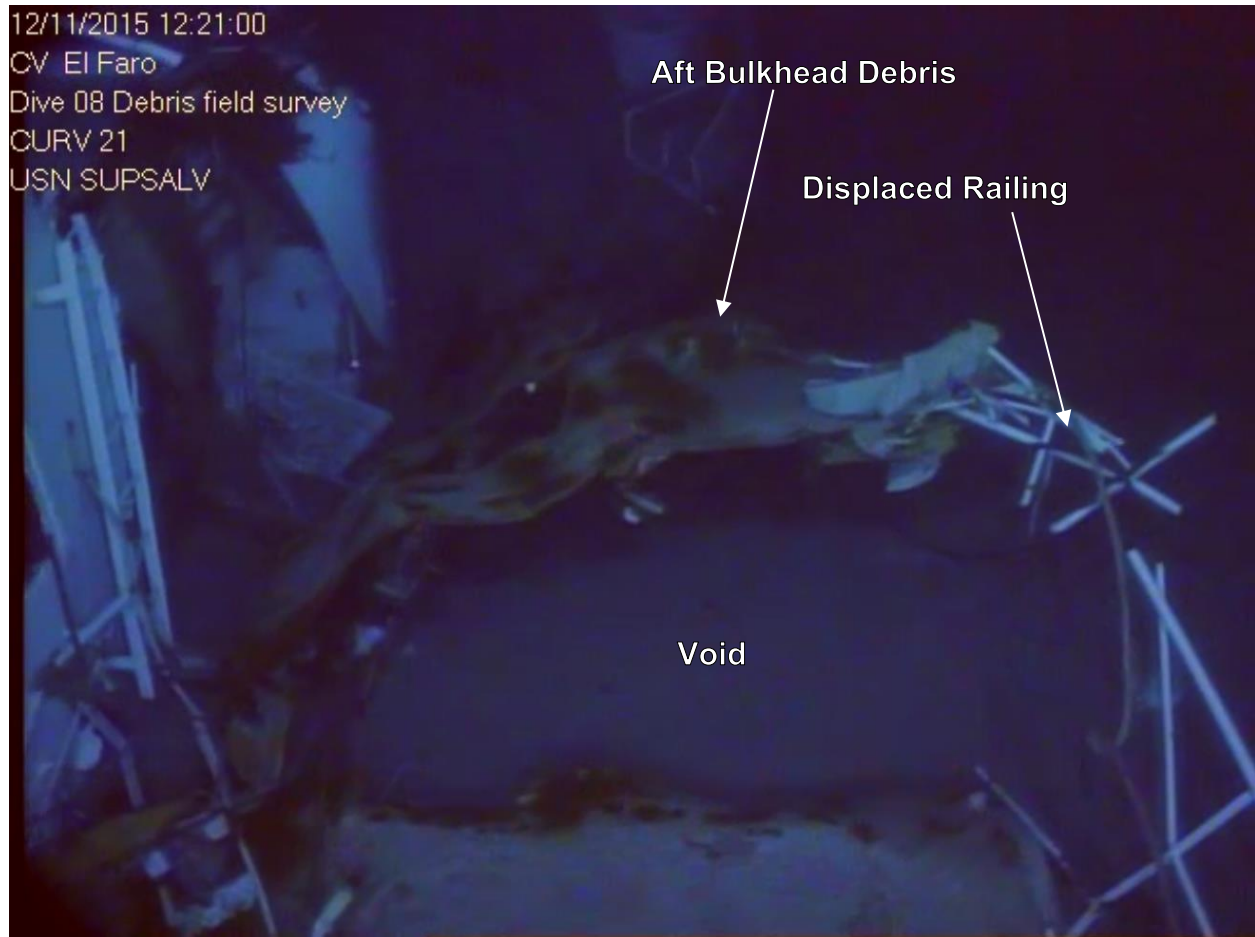
Figure 148. Region: Bridge Source: Mission I Vehicle: CURV 21

Alternate view of the displaced aft bulkhead between the wheelhouse and the ship's missing exhaust stack. Handrail at the top of the wheelhouse is still attached to the displaced section of bulkhead.

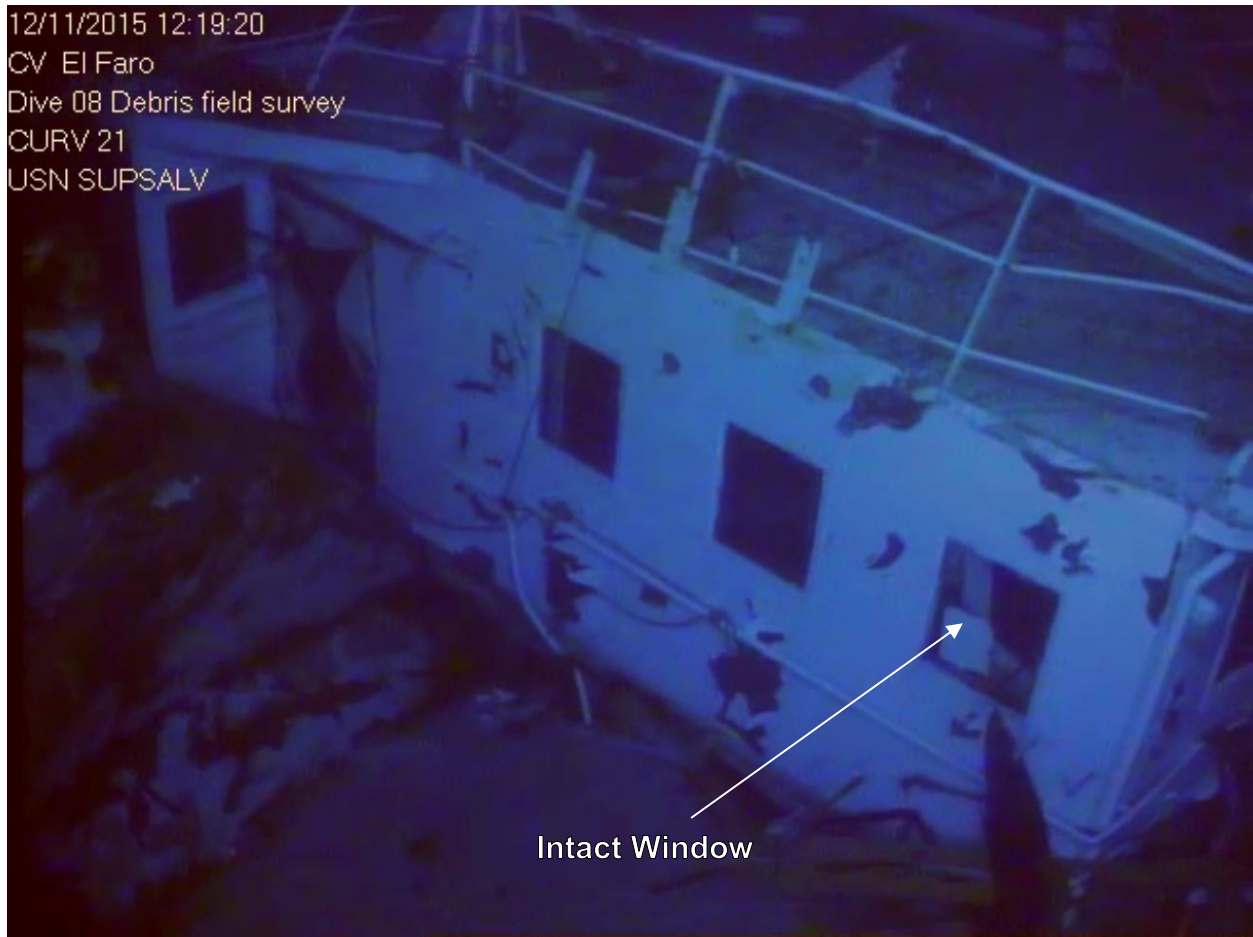
Figure 149. Region: Bridge Source: Mission I Vehicle: CURV 21

View from port side of wheelhouse. Windows are missing. Aft most window appears intact. A white object is resting against the aft most window.

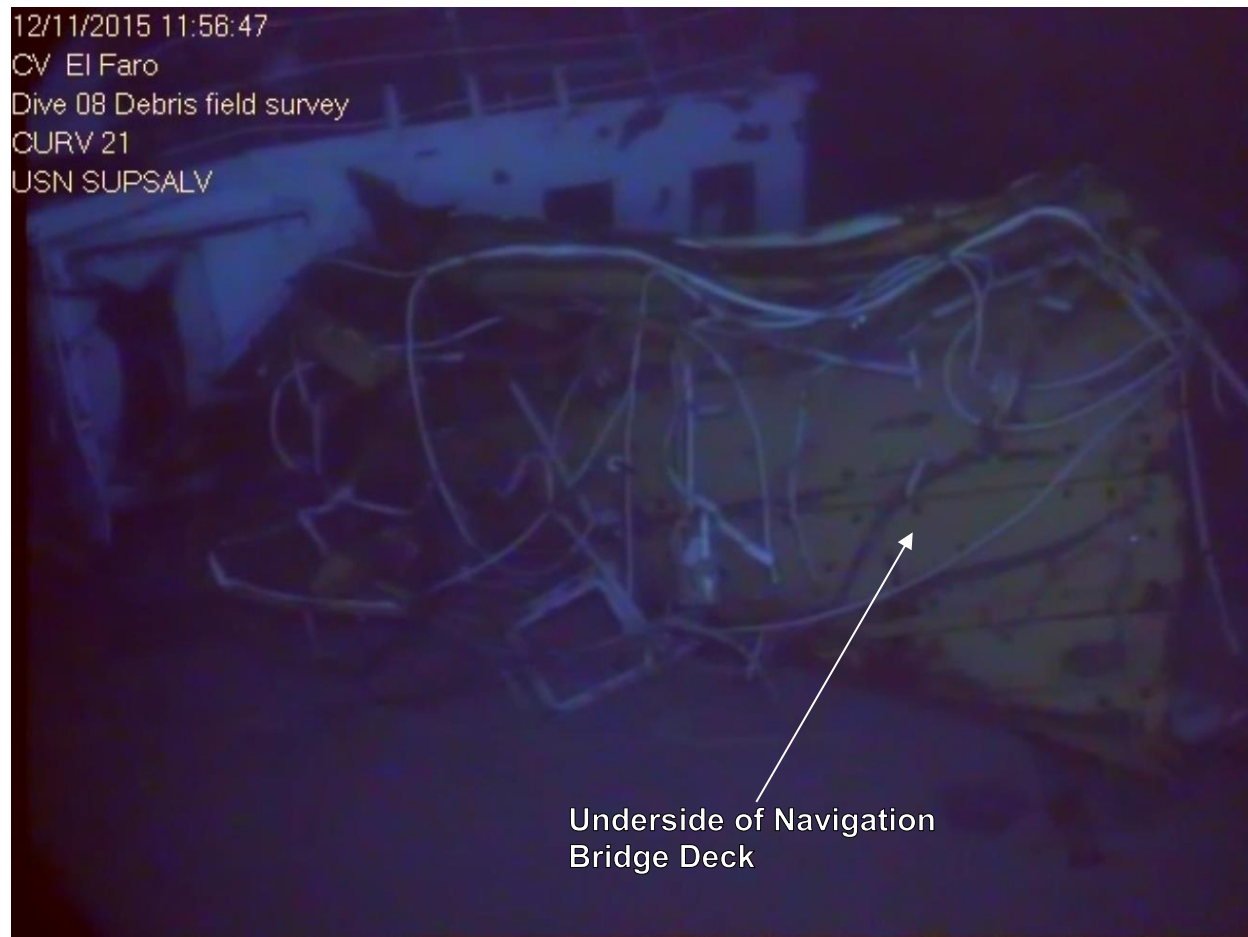
Figure 150. Region: Bridge Source: Mission I Vehicle: CURV 21

Additional view (see figure 143) of the underside of the port navigation bridge deck looking port to starboard. Deck is displaced upward, back and to starboard. No exterior vertical structural or bulkheads remain attached below the navigation bridge deck plating. Some associated joinerwork from spaces below remain attached.

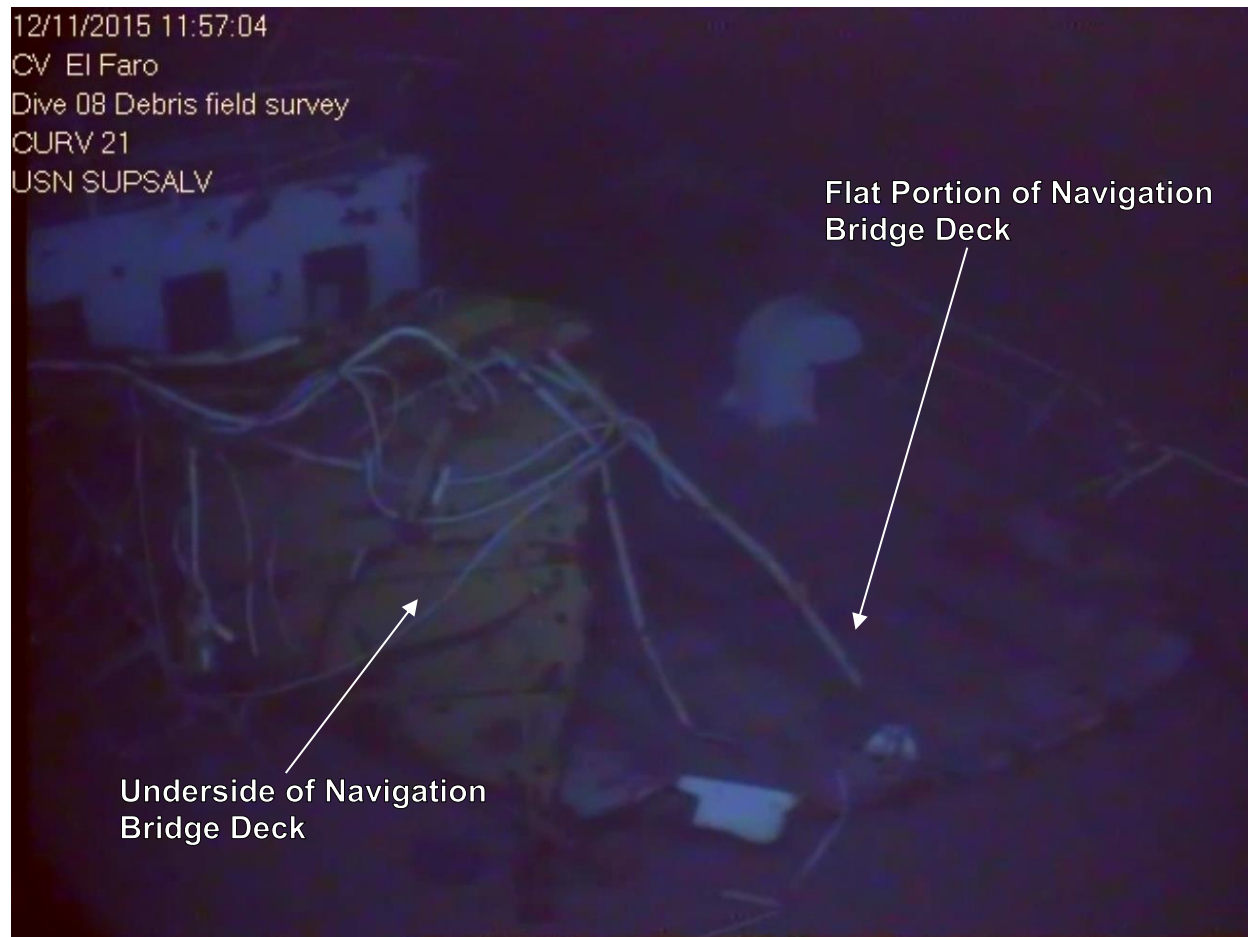
Figure 151. Region: Bridge Source: Mission I Vehicle: CURV 21

Another view of the underside of the port navigation bridge deck looking port and aft. Deck is displaced upward, back. After 2/3rd section of navigation bridge deck remains flat.

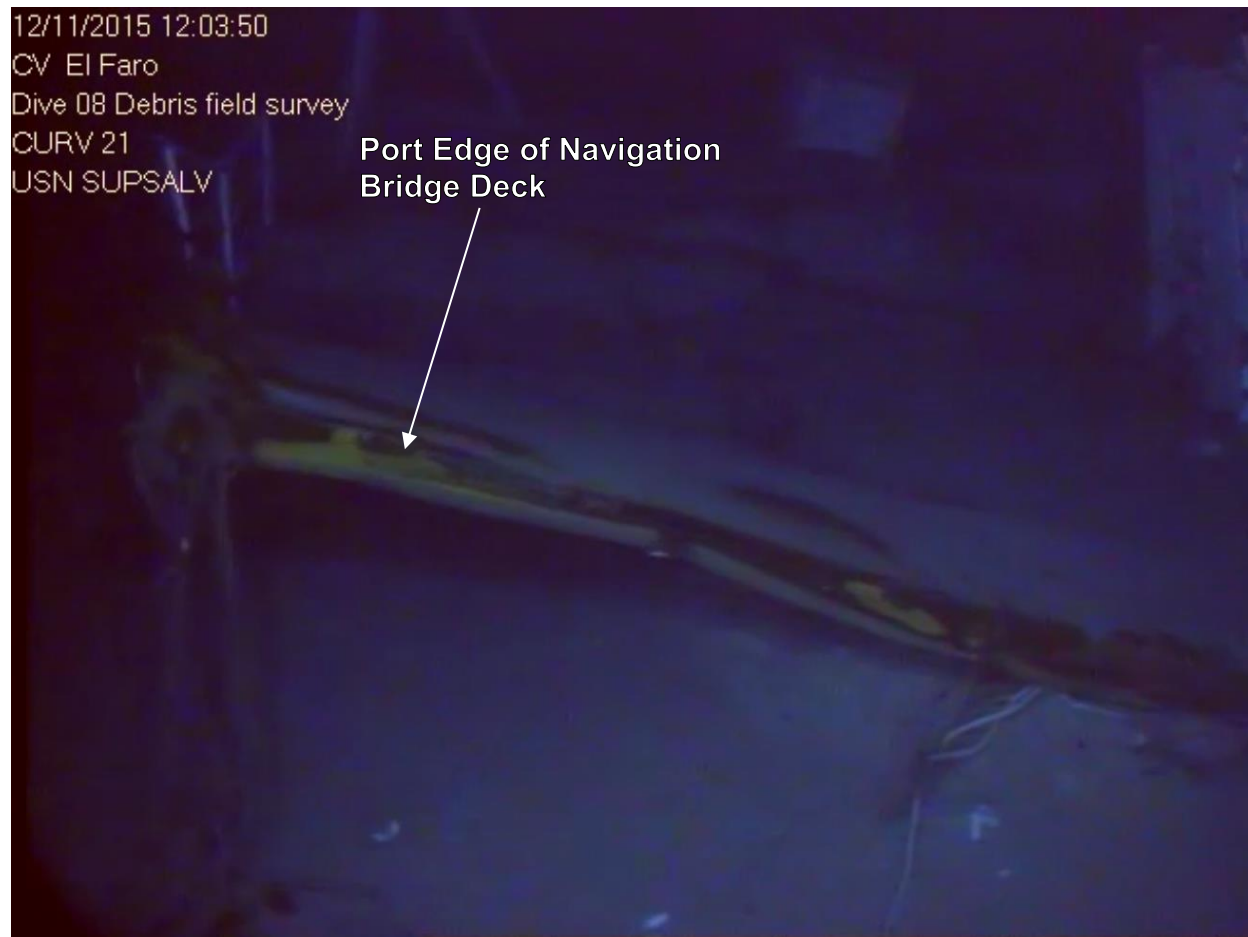
Figure 152. Region: Bridge Source: Mission I Vehicle: Curve 21

View of the port edge of the navigation bridge deck looking starboard.

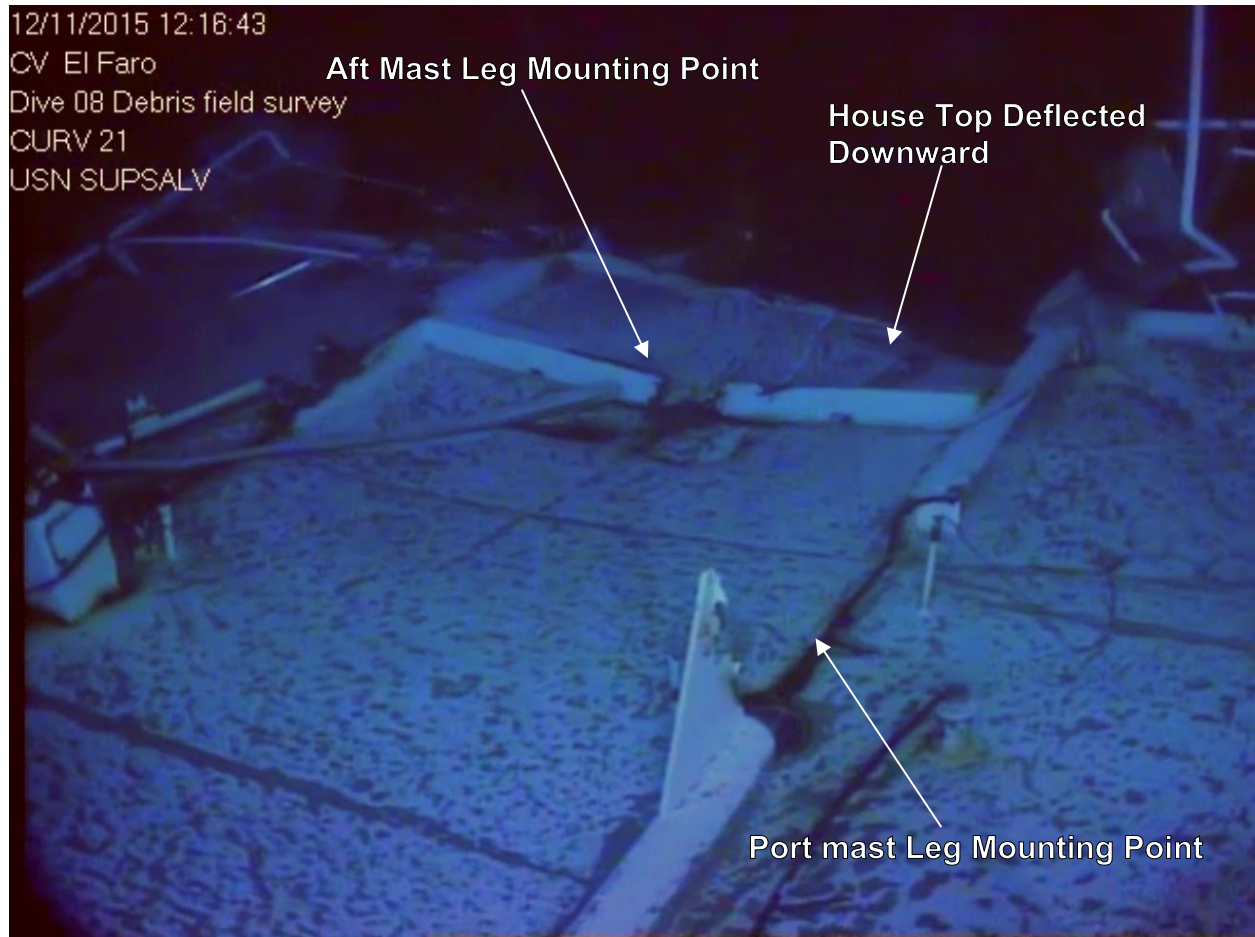
Figure 153. Region: Bridge Source: Mission I Vehicle: CURV 21

View of the wheelhouse top looking aft. Lower center of image shows main mast port leg mounting bracket is severed and both port and starboard mast longitudinal mounting channel sections are missing from house top. Aft mast leg transverse mounting channel is missing section at house top centerline, where aft mast leg was mounted. House top is deflected downward at centerline where aft mast leg landed.

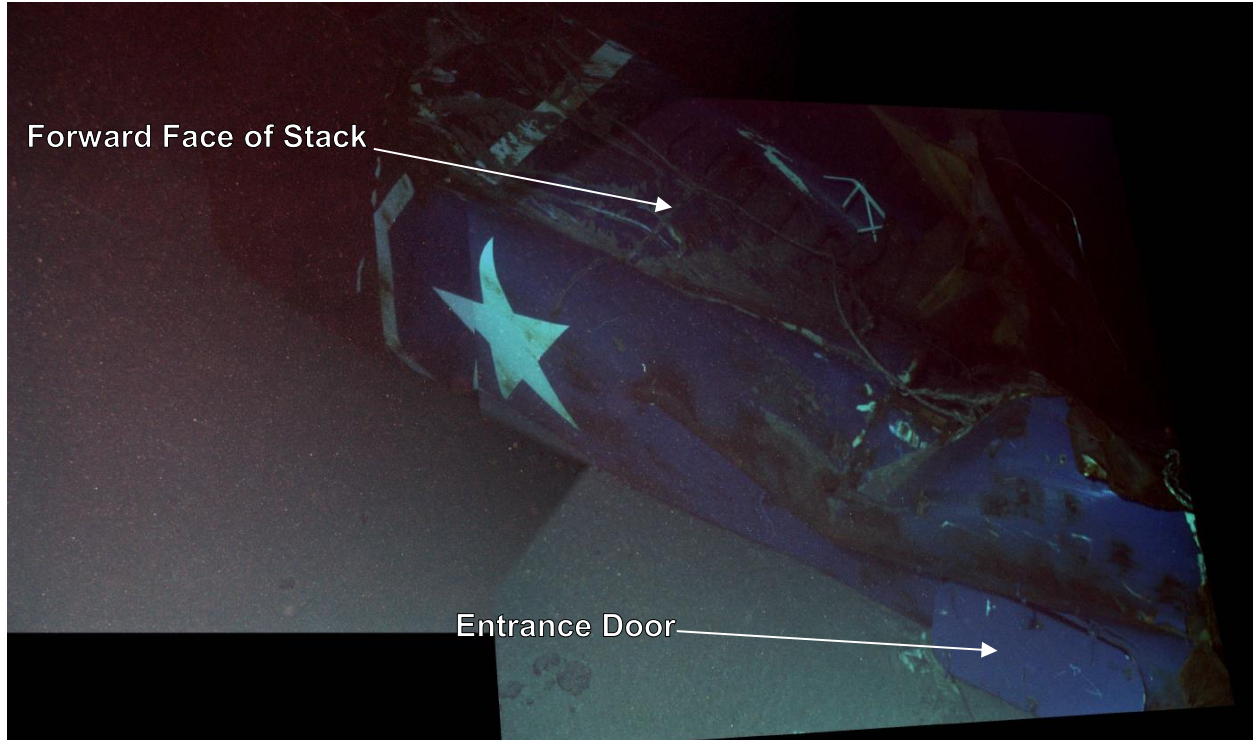
Figure 154. Region: Stack Source: Mission II Vehicle: AOV - Mosaic Image

View of the stack on the seafloor. The forward face of the stack is facing up and missing steel plating. The forward face is scratched, dented and deflected inward (aft) over its length. The stack is largely intact, with its 6-dog entrance door attached, but open (lower left side of image). The boiler uptake funnel is missing from the top of the stack.

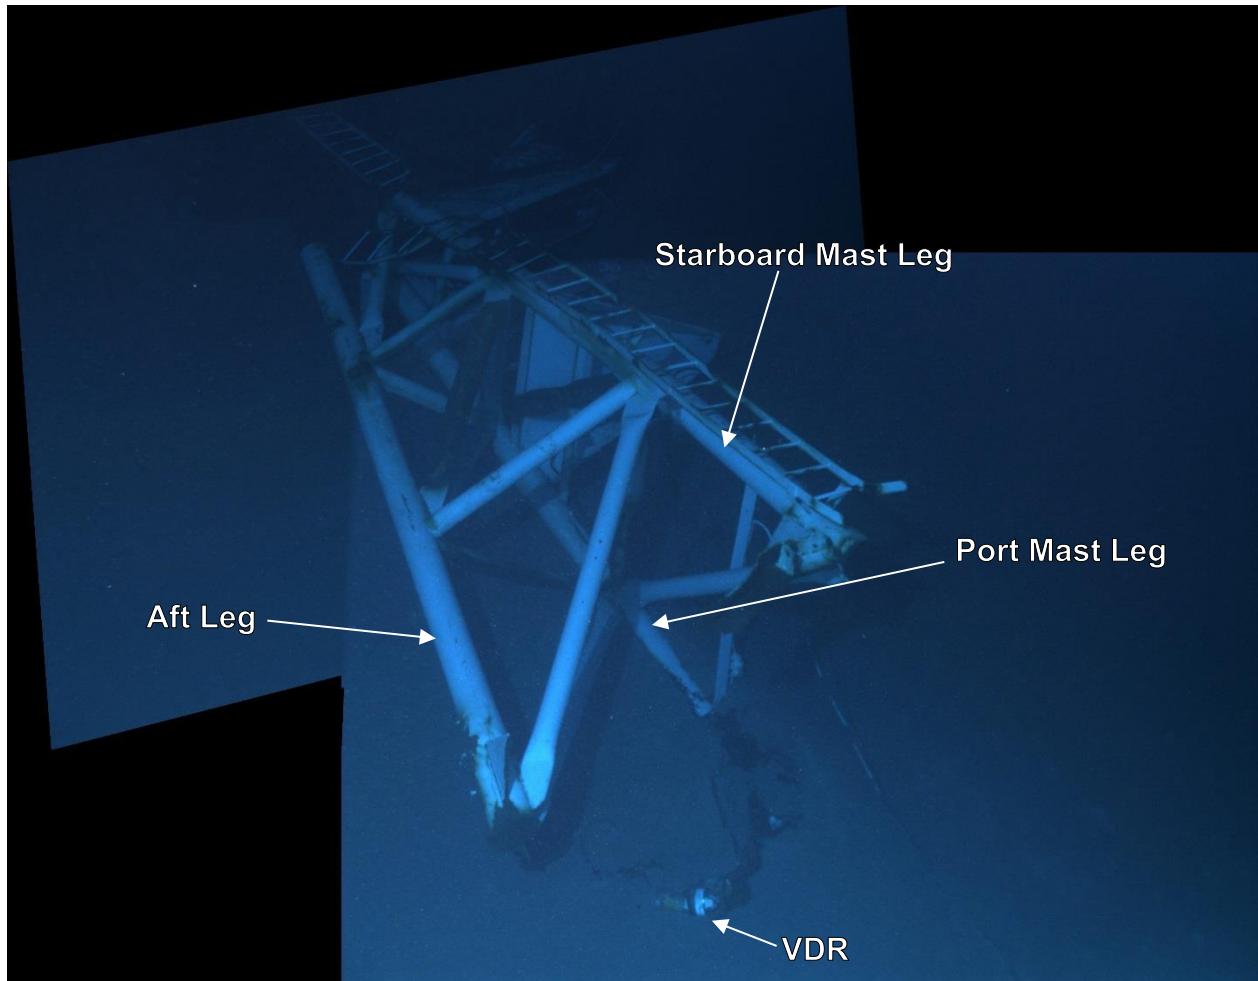
Figure 155. Region: Mast Source: Mission II Vehicle: AOV Mosaic Image

View of the mast and VDR capsule on the seafloor. The three mast legs are in the foreground. The starboard leg of the mast is upward, the aft leg is in the left foreground and the port leg with attached VDR is in the mud below the starboard leg.

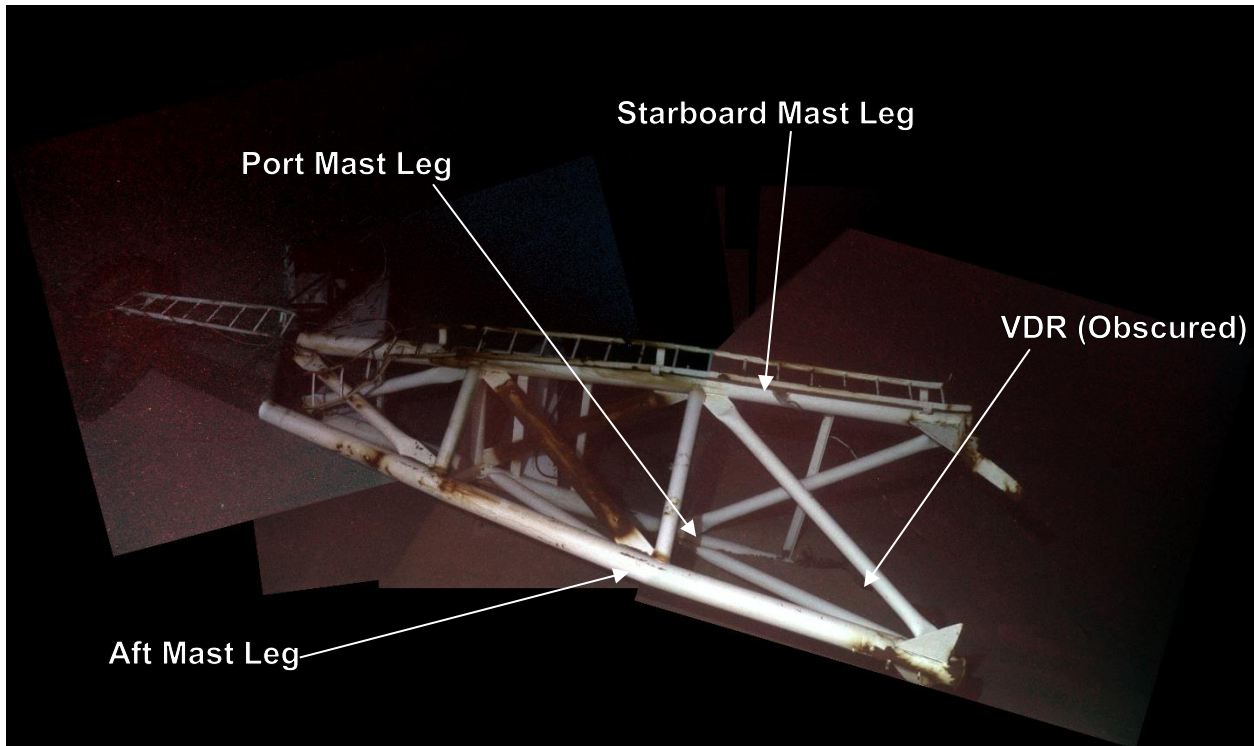
Figure 156. Region: Mast Source: Mission II Vehicle: AOV Mosaic Image

Side view of the mast and VDR capsule on the seafloor. The tripod mast's large structural members are intact. The starboard mast leg is up, the port foot with VDR is in the mud, and the aft foot is in the foreground.

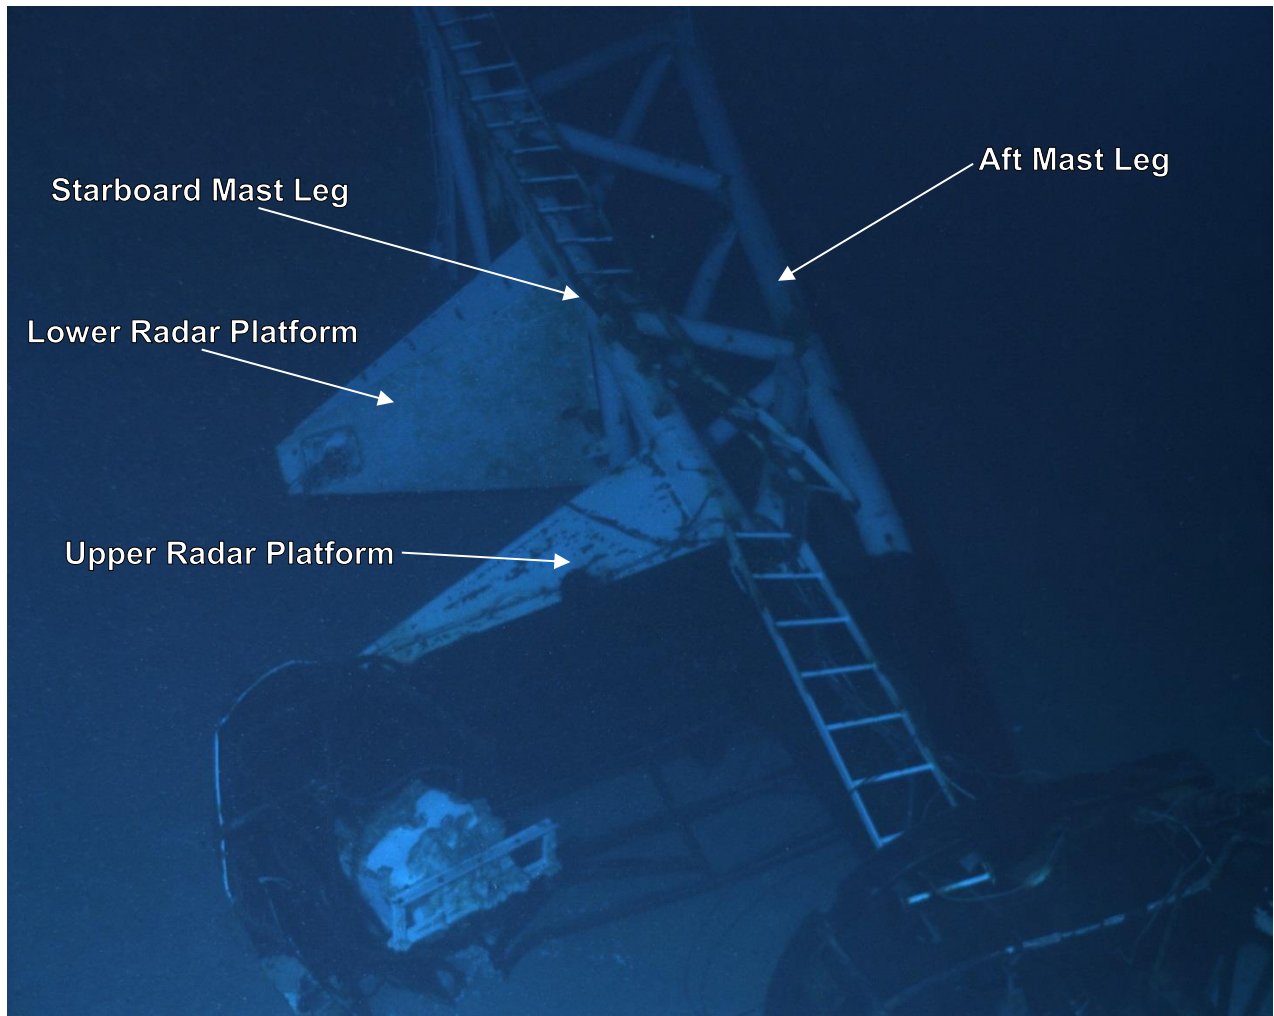
Figure 157. Region: Mast Source: Mission II Vehicle: AOV

Mast pictured from above with mast top in foreground. Ladder is on the starboard mast leg, aft leg of tripod mast is to the starboard side of image. Two radar platforms are attached to the forward side of the mast tripod structure. The lower-mounted and smaller (triangular white plate) platform, and an upper and larger (black rectangle with triangular white support bracket) platform are visible from above. The overall tripod structure has an aft-ward bend as it transitions toward its top.

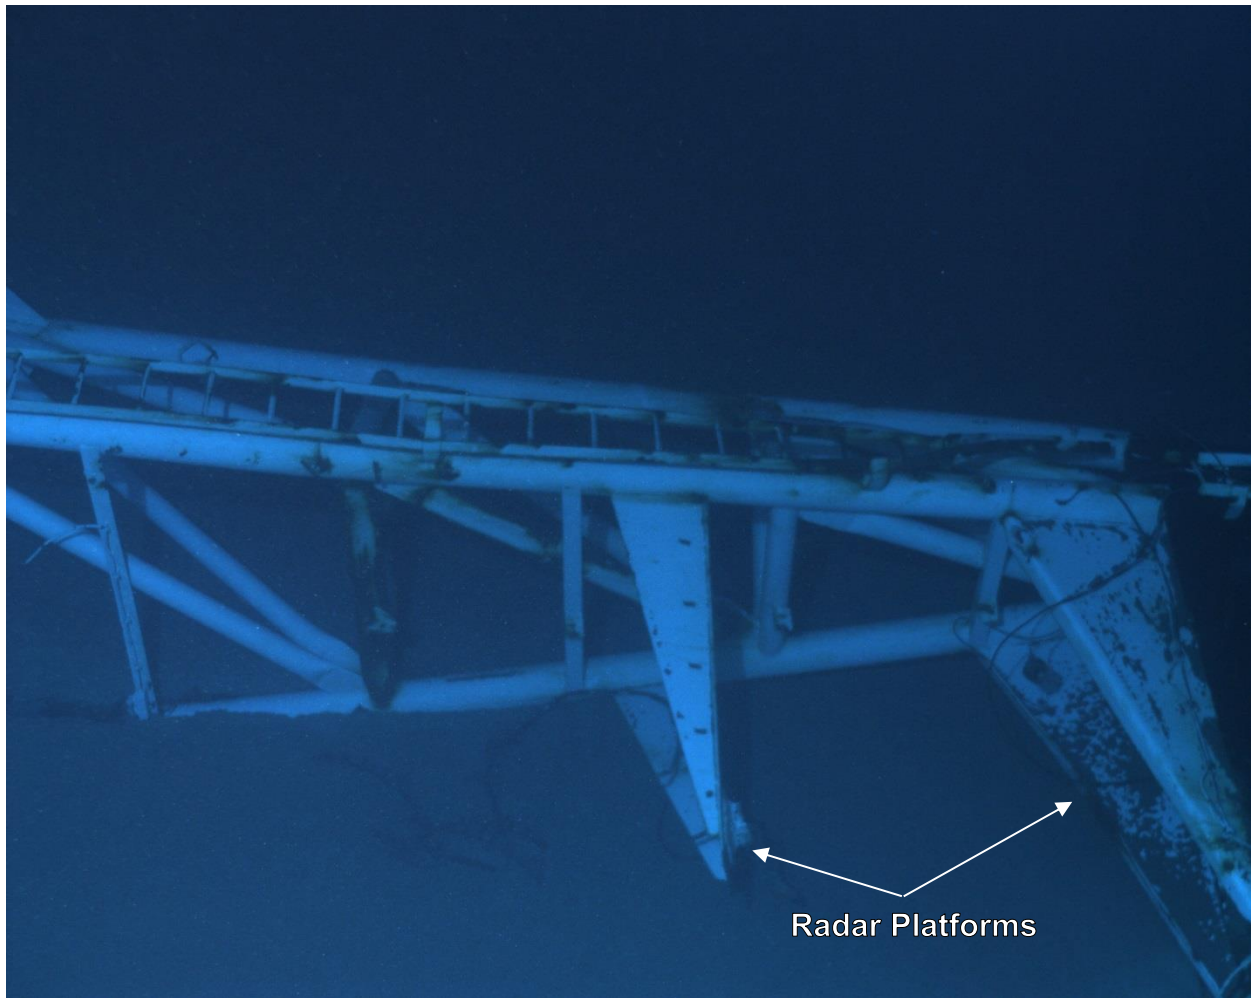
Figure 158. Region: Mast Source: Mission II Vehicle: AOV

Mast pictured facing forward side of mast structure. Ladder is on the starboard mast leg. Both upper and lower platforms are attached to the forward side (port and starboard mast leg stanchions) of the mast and all four triangular plate support brackets are attached. The overall mast structure has a pronounced aft-ward bend as it transitions toward its top.

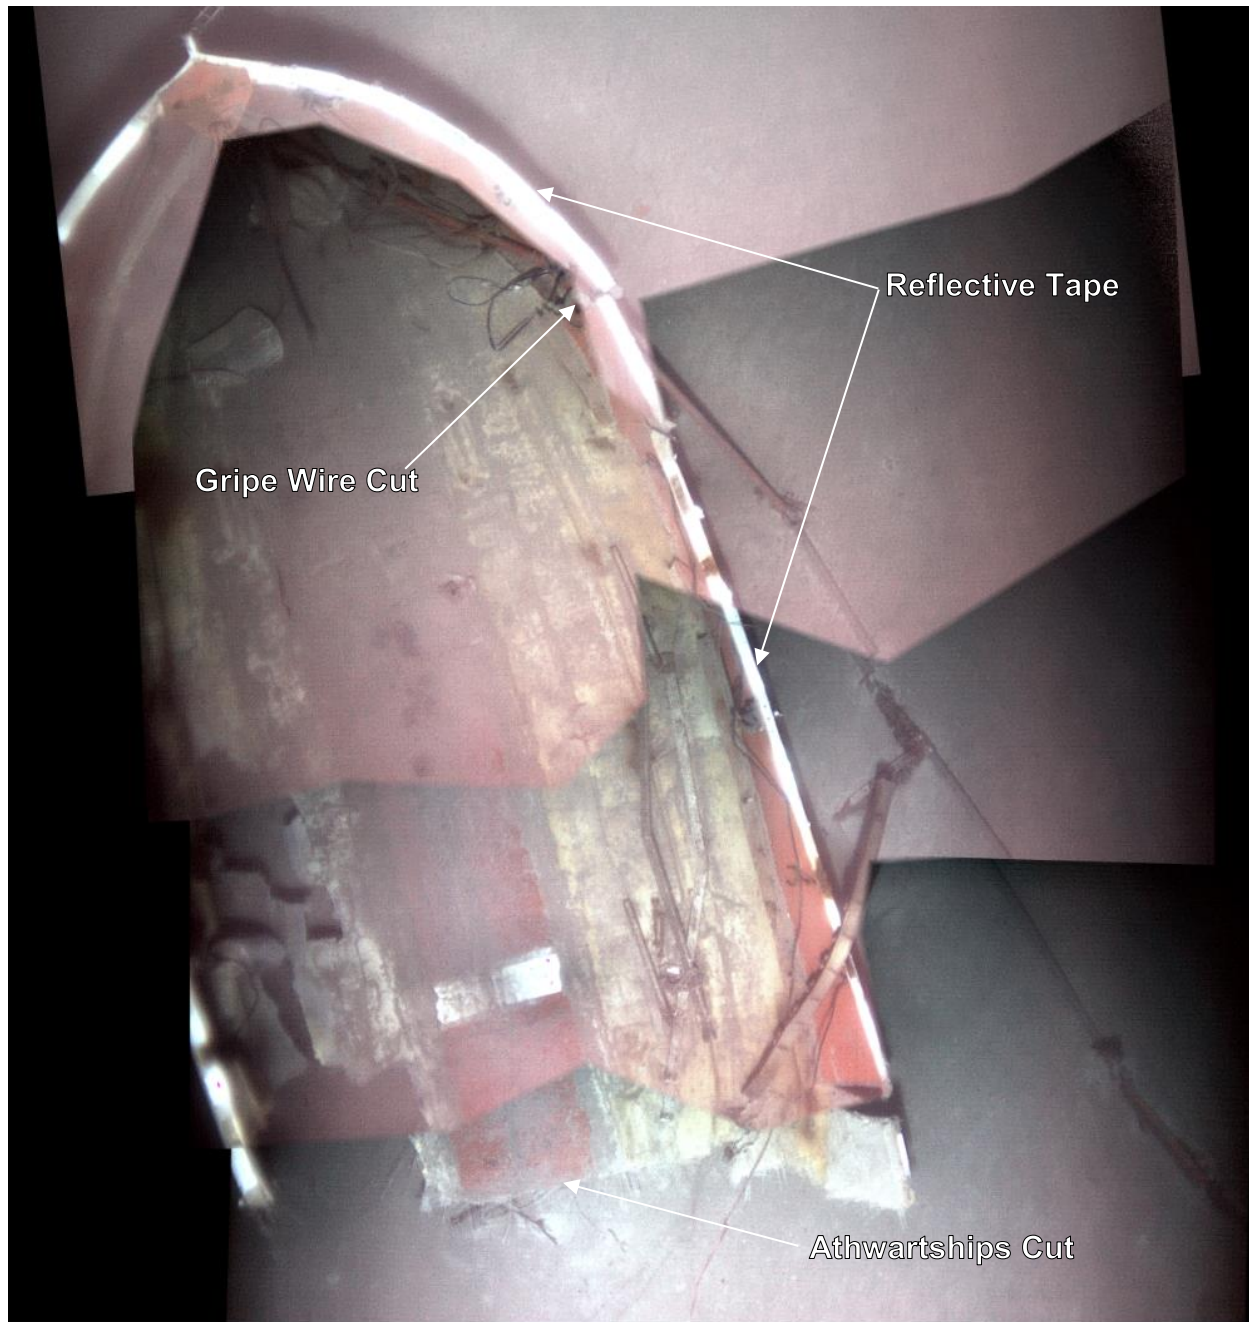
Figure 159. Region: Lifeboat Source: Mission II Vehicle: AOV Mosaic Image

Top view of lifeboat on seafloor. Boat cut completely athwartships where gripe wire would have been when boat was stored (bottom of image). Boat fiberglass hull partially cut by other gripe wire (top center of image). Bench seats and other internals missing. Reflective tape on topside of gunwales illuminated.

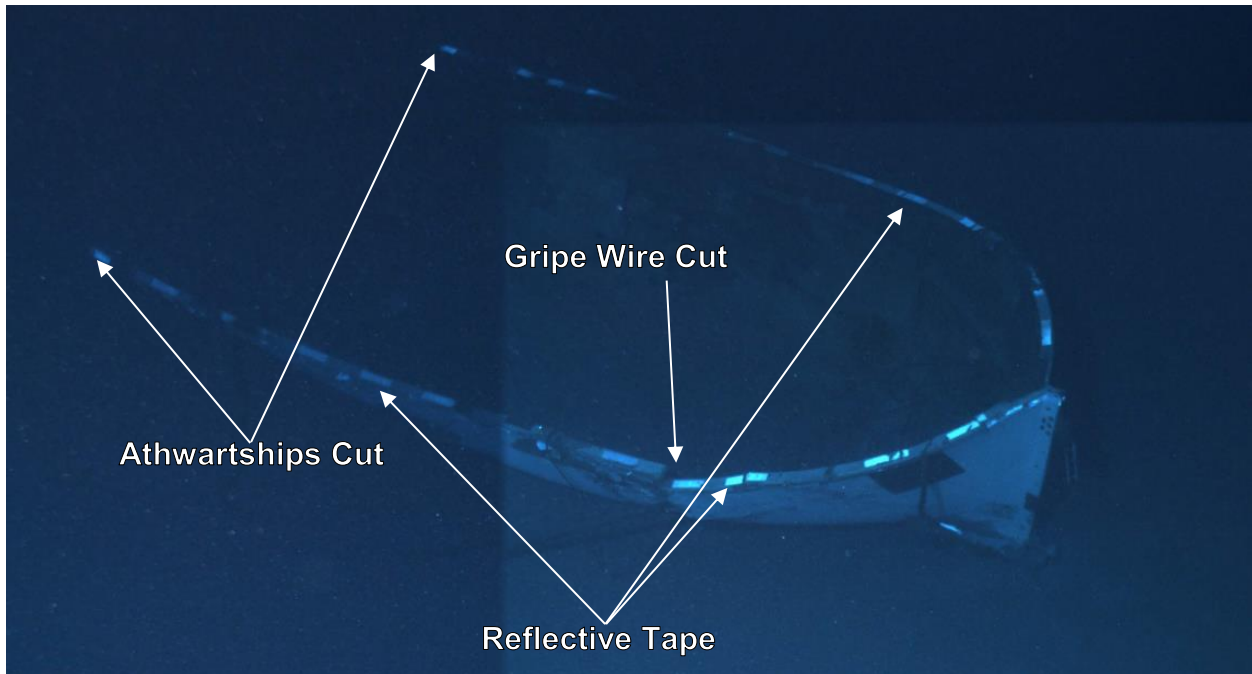
Figure 160. Region: Lifeboat Source: Mission II Vehicle: AOV Mosaic Image

Alternate view of lifeboat on seafloor. Reflective tape on topside of gunwales illuminated. Hull fiberglass partially cut where gripes would have been located (lower right side of image). Hull is cut away where reflective tape ends (upper left of image).
