# National Transportation Safety Board

## Group Chairman's Factual Report

*Seastreak Wall Street*

DCA-13-MM-005

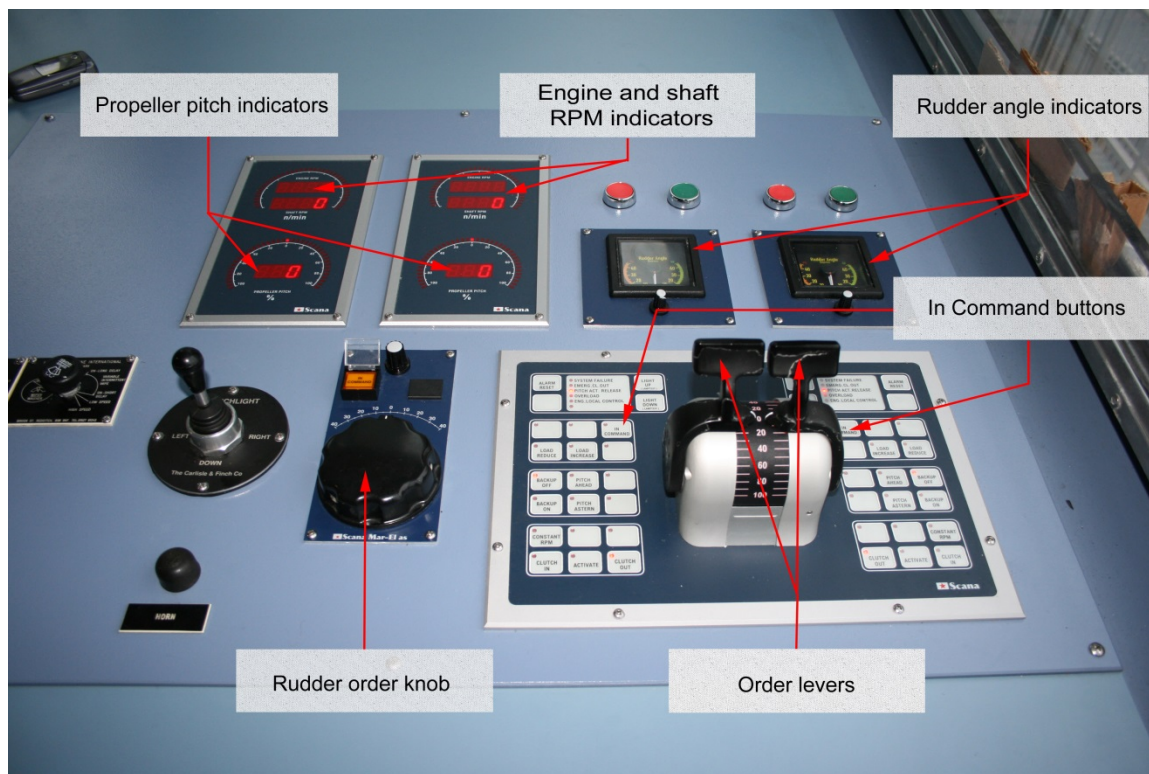
Figure 5. Starboard side propulsion and steering control station. See figure 6 for more detailed view of pushbuttons.

**power failure** – loss of supply voltage (24 VDC) to the control system. At the time of the accident, the “power failure” LED was functional but it was not labeled to indicate its function.
