# National Transportation Safety Board

## Group Chairman's Factual Report

Naval Architecture Group

*SS El Faro*

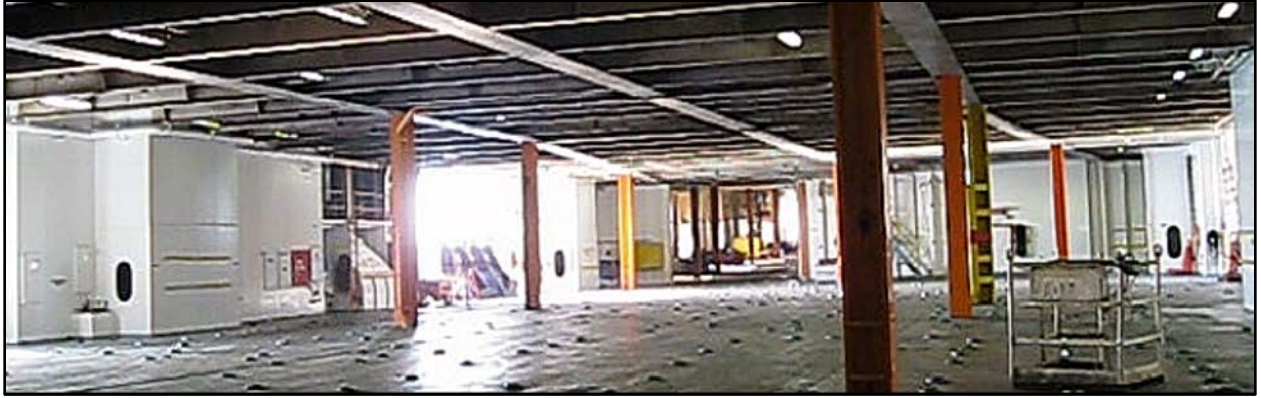
2 The VDR transcript indicates that the vertical-access scuttle on the starboard side of the  
3 second deck that led to hold 3 was open for a time during the accident. Investigators reviewed  
4 drawings and photographs and interviewed previous *El Faro* crewmembers to ascertain the type  
5 and dimensions of that scuttle. General arrangement drawings (**figure 8**) show that the second deck  
6 had two RWTHs (raised watertight hatches) through the second deck to hold 3, at frame 163 on  
7 the starboard side and at frame 138.5 on the port side. Hold 2A also had two such accesses. **Figure**  
8 **9** is a photo of the second deck forward of the house.

1  
2 **Figure 9.** *El Faro* second deck looking aft from frame 134/8. (Screen capture from video by former  
3 *El Faro* second mate, September 2008<sup>251</sup>)

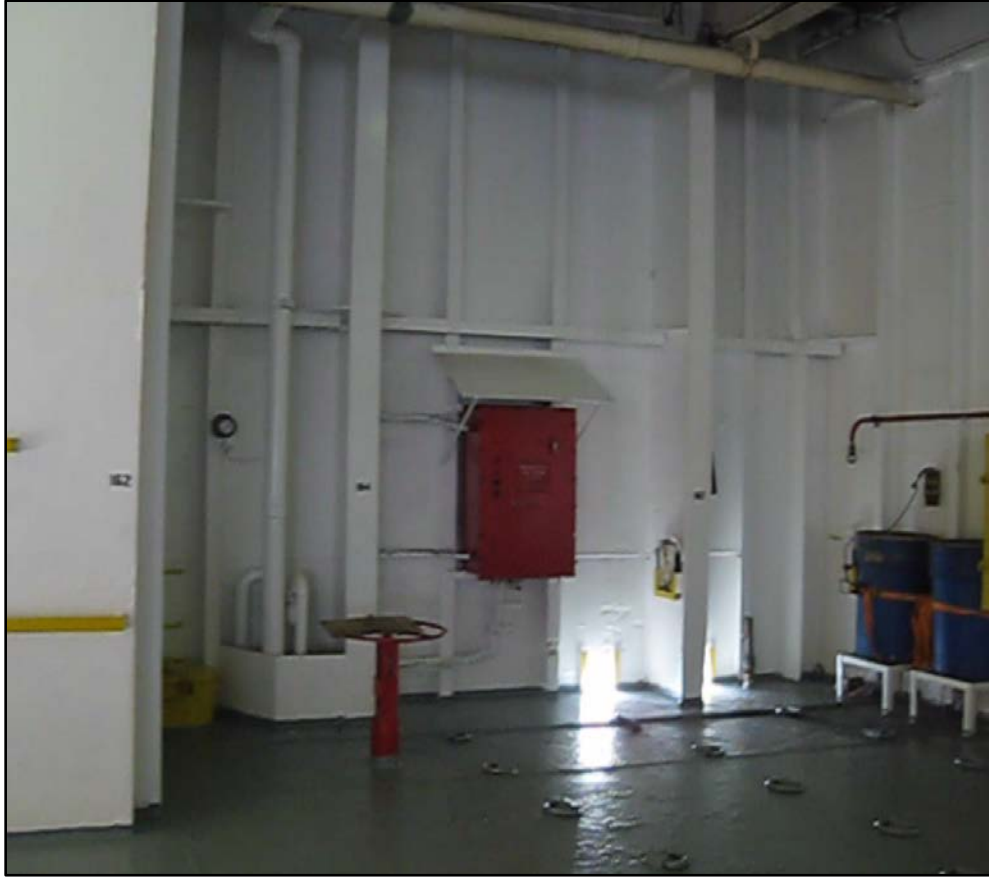
4           A previous chief engineer recalled that the *El Faro* scuttles were “supposed to be” secured  
5 for heavy weather, but that securing was the responsibility of the deck department.<sup>252</sup> The only  
6 available ABS form LL11<sup>253</sup> for *El Faro* recorded second deck transverse-hinged, R.M.H. (round  
7 manhole) oval escapes at frames 122 and 163. The form noted that the escapes had four evenly  
8 spaced dogs, with a hatchway dimension of 22.75 inches by 14.75 inches and a coaming height of  
9 12 inches. Images of the scuttles to holds 3 and 2A on the starboard side of *El Faro*’s second deck  
10 are shown in **figures 10, 11, and 12.**

2 **Figure 10.** *El Faro* second deck starboard side, frames 162–170; reach rod handwheel to  
3 emergency fire pump and scuttle in left background. (Screen capture from video by former *El Faro*  
4 second mate, September 2008<sup>254</sup>)

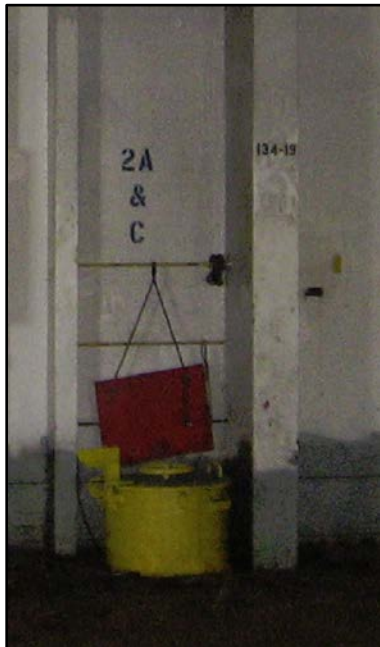
4  
 5 **Figure 12.** *El Faro* second deck scuttle to hold 2A, port side at frame 134-19.5. Scuttle type similar  
 6 to hold 3 scuttle in Figure 11. (HEC photo, July 2015)

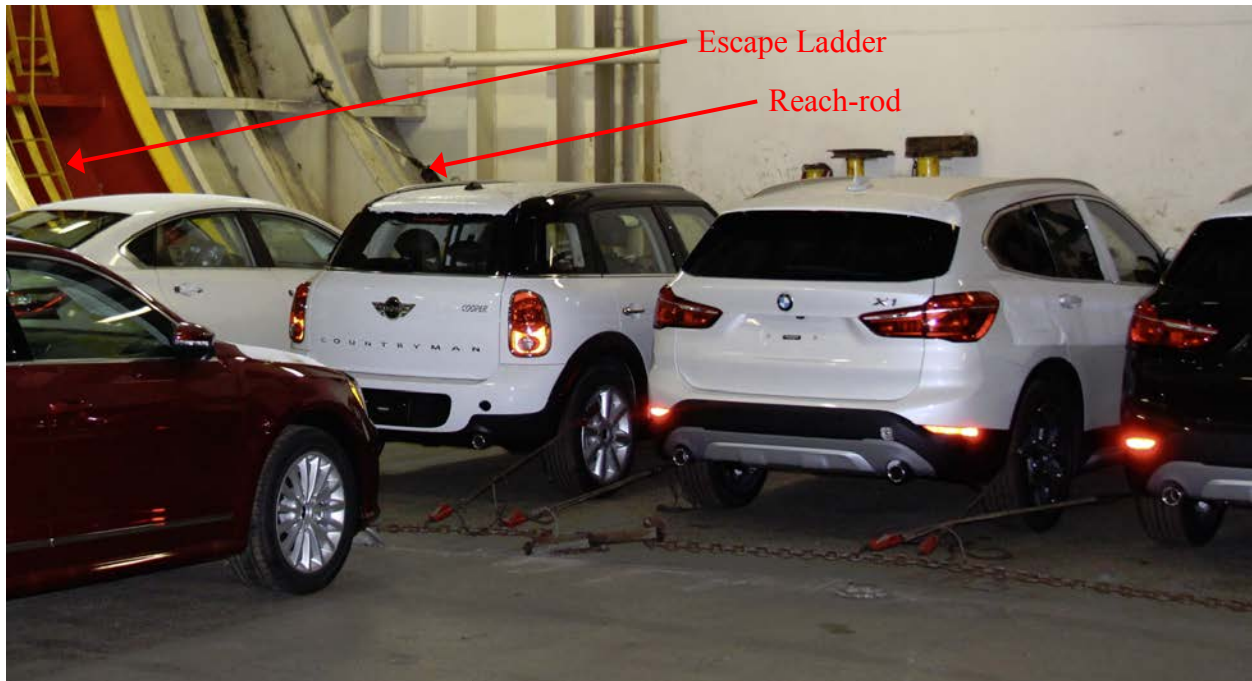
11 Nautical Operations group investigators asked the NCB to comment on the lashing  
 12 arrangement of automobiles photographed on *El Yunque* in December 2015 on the tanktop in hold  
 13 3, on the tanktop (**figure 14**). The NCB report stated that photographs showing car lashings secured

1  
2 **Figure 14.** Cars lashed on *El Yunque* during loading in hold 3, tanktop, looking aft and to port.  
3 Escape ladder and emergency fire pump reach-rod in left background. (Photo from December  
4 2015)

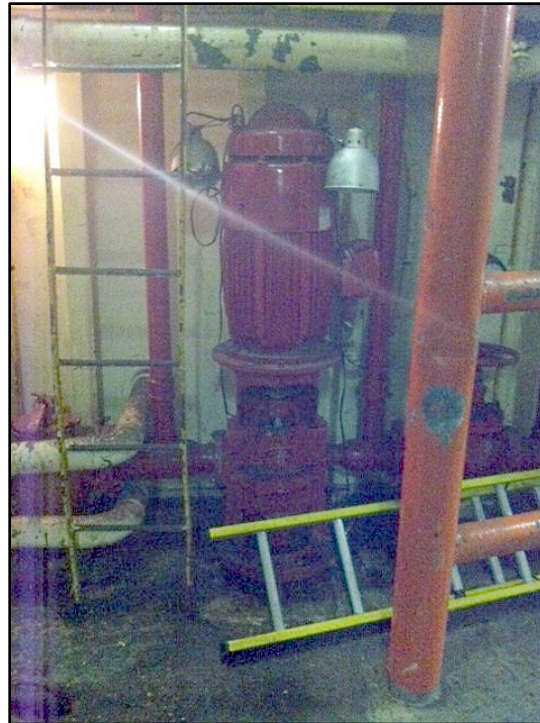
1 at sea, whereas the suction valve was closed at sea.<sup>270</sup> Another chief engineer who had served on  
2 *El Faro* said that the “emergency fire pump discharge valve was kept open at sea, suction valve  
3 was kept closed at sea.”<sup>271</sup> He also said that “both the main and emergency fire pump were able to  
4 charge the fire main. “Investigators could not locate a detailed piping drawing of the emergency  
5 fire pump installation on *El Faro*, but obtained a single photograph (**figure 15**).

6  
7 **Figure 15.** *El Faro* emergency fire pump, located at starboard frame 164, viewed from tanktop  
8 deck looking aft. (Photo by Maine Maritime Academy cadet, 2015)

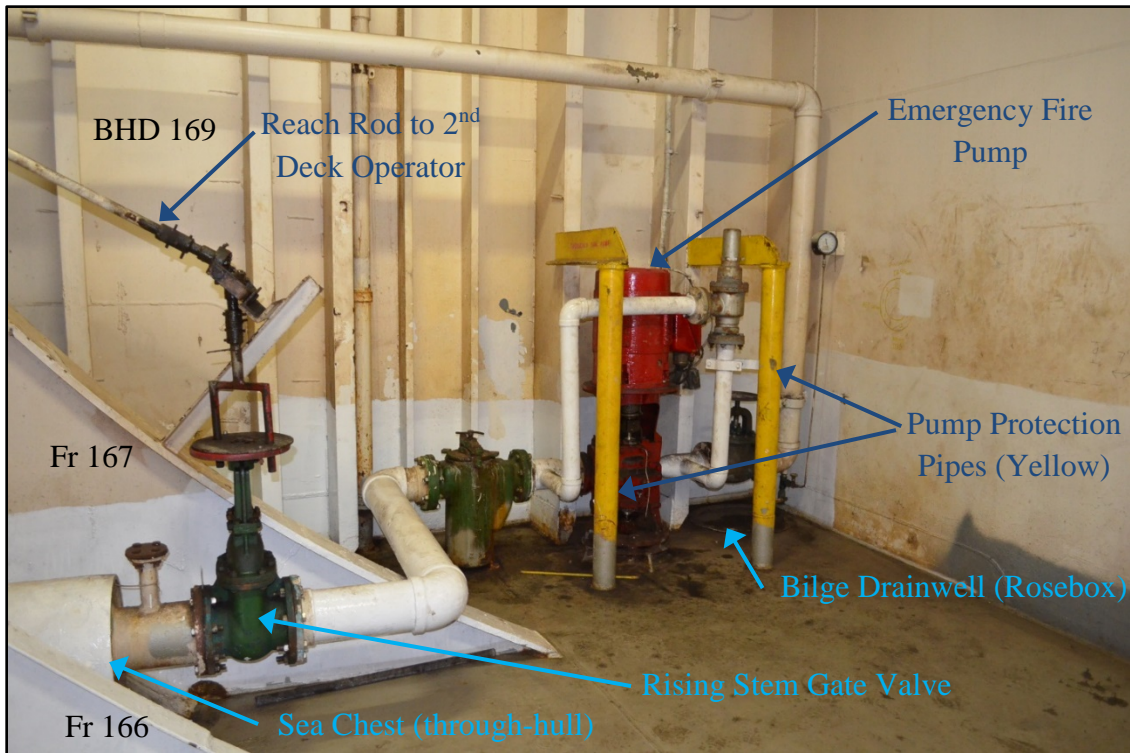
1 the arrangement and found the vertical access hatch in hold 3 centered at frame 163.5, the sea chest  
2 penetration centered at frame 166.5, and the emergency fire pump at frame 168.5 (just forward of  
3 the aft bulkhead at frame 169 in hold 3). Investigators noted that the bulkhead configuration of *El*  
4 *Yunque* was not the same as that of *El Faro* in this area. The *El Faro* drawings show a void space  
5 from frames 164 to 169, whereas *El Yunque* had a continuation of hold 3.

6  
7 **Figure 16.** *El Yunque* emergency fire pump (December 2015).

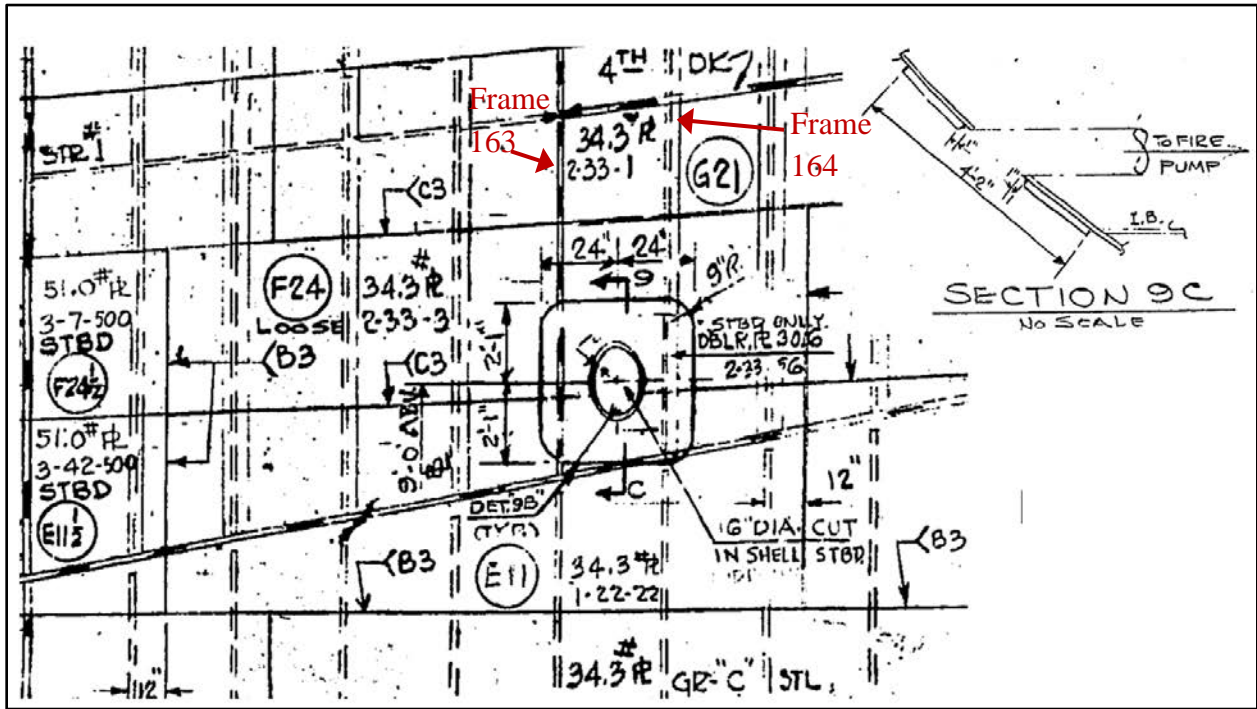
6 Ship plans indicate that the sea chest for the emergency fire pump consisted of a 6-inch  
7 pipe directly penetrating the hull 9 feet, 0 inches above the baseline at frame 163.5 (**figures 17**  
8 **and 18**).<sup>272 273</sup> Shell drawings show plate E11 as the steel plate in way of the penetration as 34.3#,  
9 or 0.841 inch (about 27/32 inch). An exterior 30.6#, or 3/4-inch steel doubler-plate with  
10 dimensions of 50 inches (vertical) by 48 inches (longitudinal) was centered around the hull  
11 penetration.

5  
 6 **Figure 17.** Portion of shell expansion drawing at emergency fire pump sea chest.<sup>277</sup>

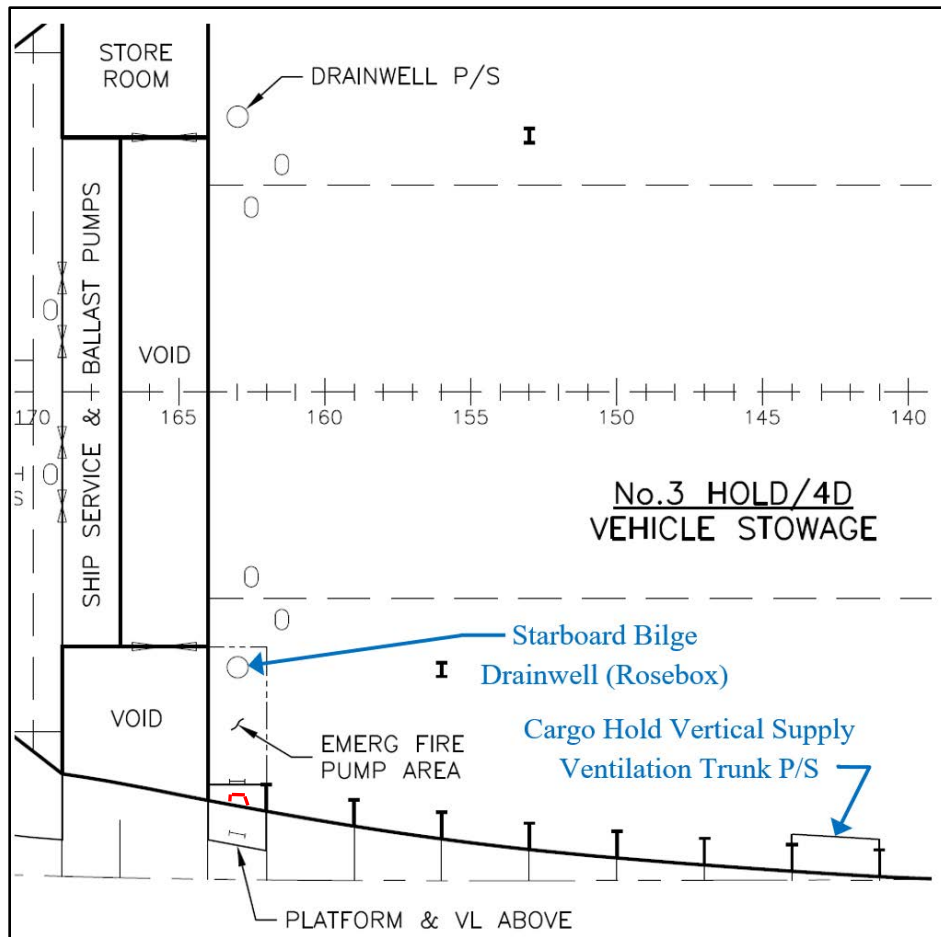
9         Investigators reviewed drawings and photographs and interviewed former *El Faro*  
10 crewmembers to determine the arrangement and operation of the bilge pumping system and bilge  
11 alarm system in the cargo holds. Water in the cargo holds collected in the port and starboard bilge  
12 drainwells (bilgewells, roseboxes), located against the aft bulkhead and outboard in each cargo  
13 hold on the tanktop (**figure 19**). Photographs showing details of the drainwells on *El Faro* could  
14 not be found.

**Figure 19.** *El Faro* hold 3 at tanktop deck, with starboard bilge rosebox and supply ventilation vertical trunk indicated. The red semi-circle at frame 163.5 indicates approximate location of the seachest to the emergency fire pump inlet piping.<sup>283</sup>

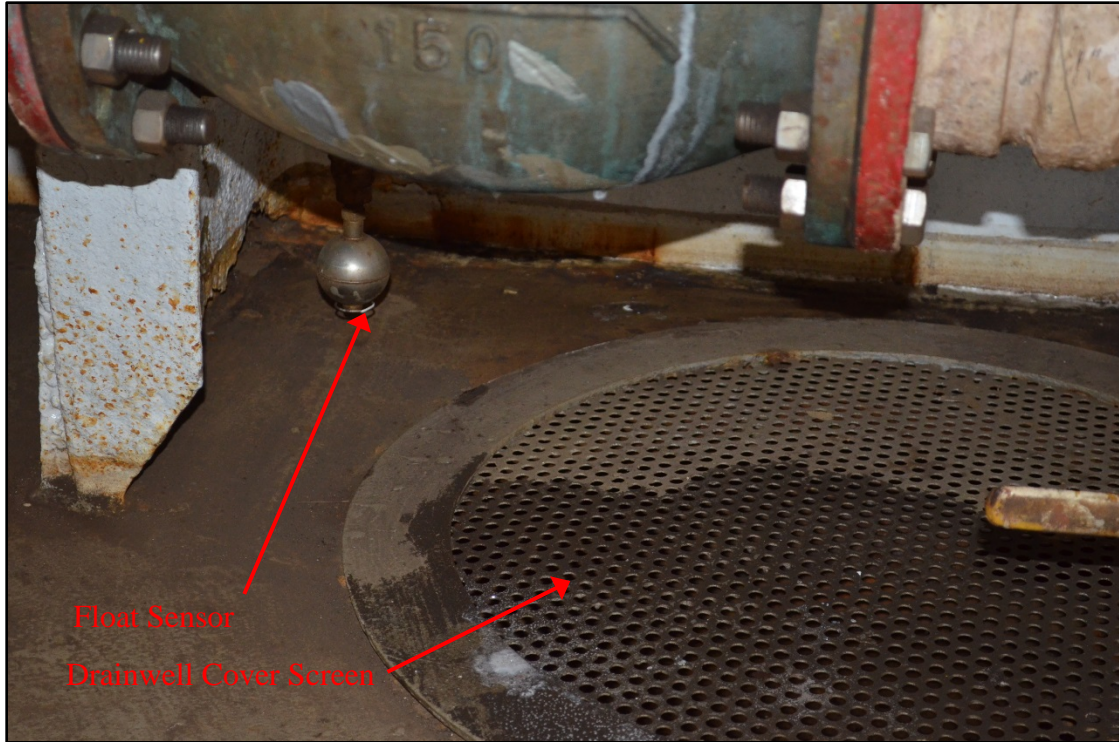
15         Investigators visited the sister ship *El Yunque* to ascertain the grating type, bilge well size,  
16 and suction pipe location (**figures 20 and 21**). The floats for the bilge alarm sensors on *El Faro*  
17 were like those on *El Yunque*.<sup>282</sup>

2 **Figure 20.** *El Yunque* hold 3 tanktop, starboard-side bilge well alarm float. (Photo from December  
3 2015)

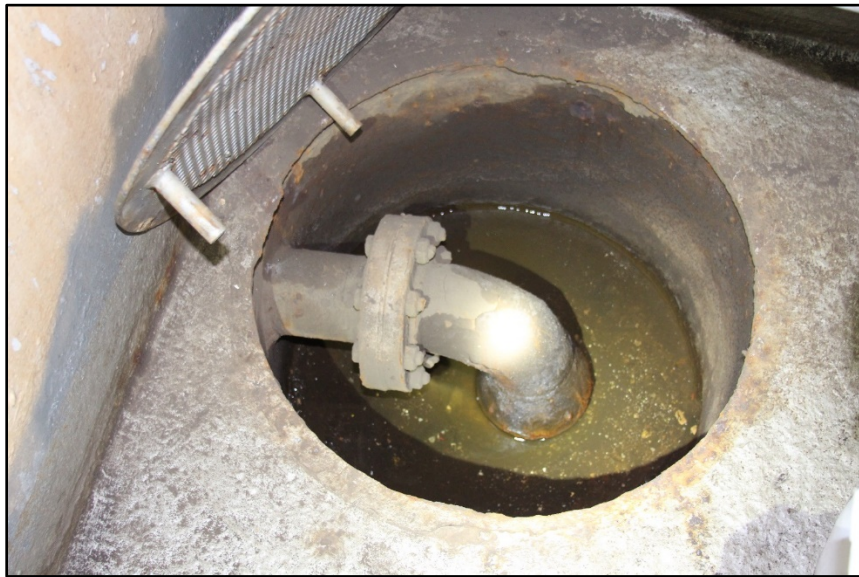
5 **Figure 21.** *El Yunque* hold 3 tanktop, portside bilge drainwell (rosebox) with cover screen lifted.  
6 (Photo from December 2015)

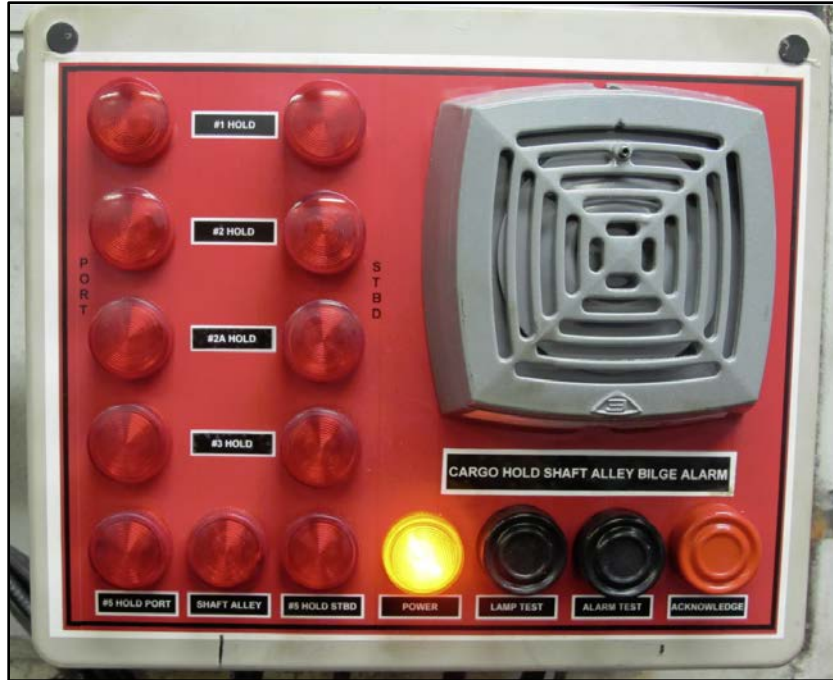
6 The contractor described the system alarm panel as located near the engine room control  
7 flat (area) (**figure 22**), and a previous chief said it was on the starboard side of the main console.<sup>298</sup>  
8 He said that if a float was raised for 5 seconds, a high bilge alarm would activate both an engine-  
9 room-wide audible alarm (horn) and a flashing indicator (dedicated to each specific rosebox) on  
10 the panel. Once the operator pushed a button to acknowledge the alarm, the horn would stop and  
11 the light would change from flashing to steady. After the alarm condition was cleared, the light  
12 would go off and the system would rearm. He stated that there was no bilge alarm repeater on the  
13 bridge, and the power was from the “IC battery system.” He did not recall taking a service call on  
14 the system and thought it reliable.

1  
2 **Figure 22.** *El Yunque* bilge alarm panel on engine room control flat. (Photo from September 2016)

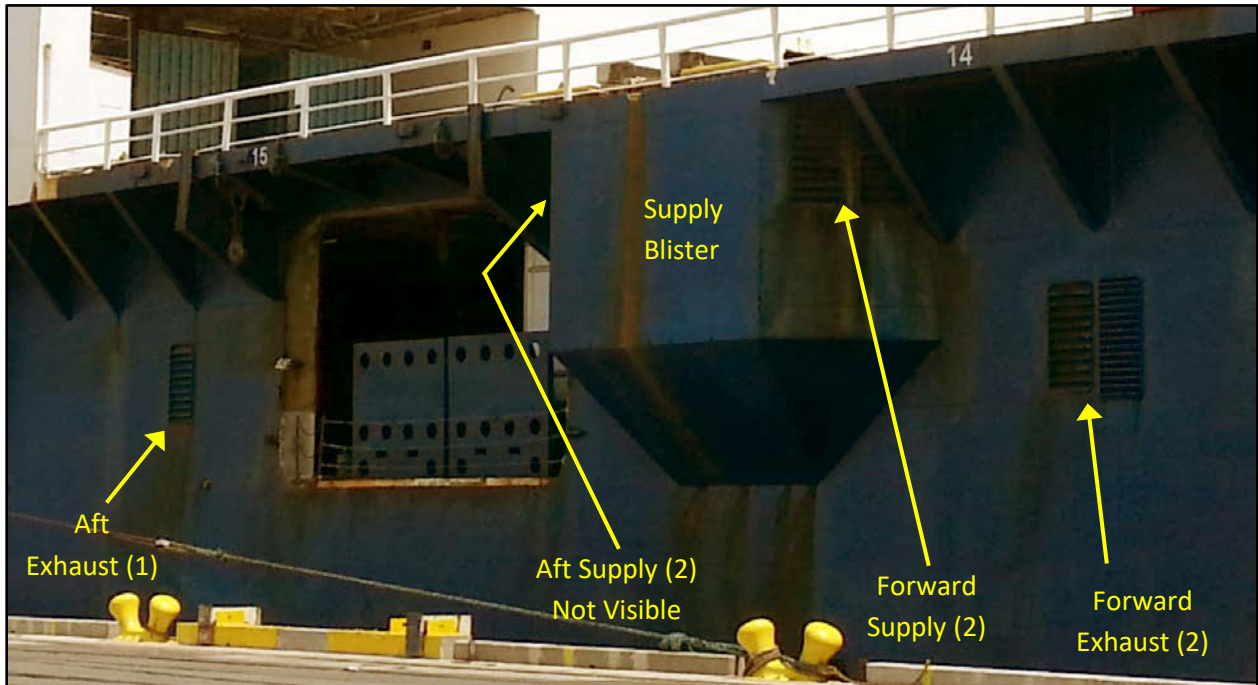
11 Each cargo hold had two electrically driven supply fans mounted port and starboard  
12 (directly opposed) on the semi-enclosed second deck. The supply fans were in “blisters” that  
13 bulged out from the hull below the overhung main deck (**figure 23**). The individual supply fans  
14 pulled air through four sets of rectangular louvers mounted on the forward and aft sides of the  
15 three-sided blister shell plate, then drew it into the fan bell mouth. The fan pushed supply air  
16 through a manually activated fire damper (designated watertight in drawings<sup>307</sup>) into a single trunk  
17 that passed through the tween holds and into the lower holds at the tanktop. Here the trunk split  
18 into horizontal runs mounted longitudinally against the sides of the hold.

9  
10 **Figure 23.** *El Faro* starboard-side supply and exhaust louvered ventilation openings to cargo  
11 hold 3. (HEC photo, July 2015)

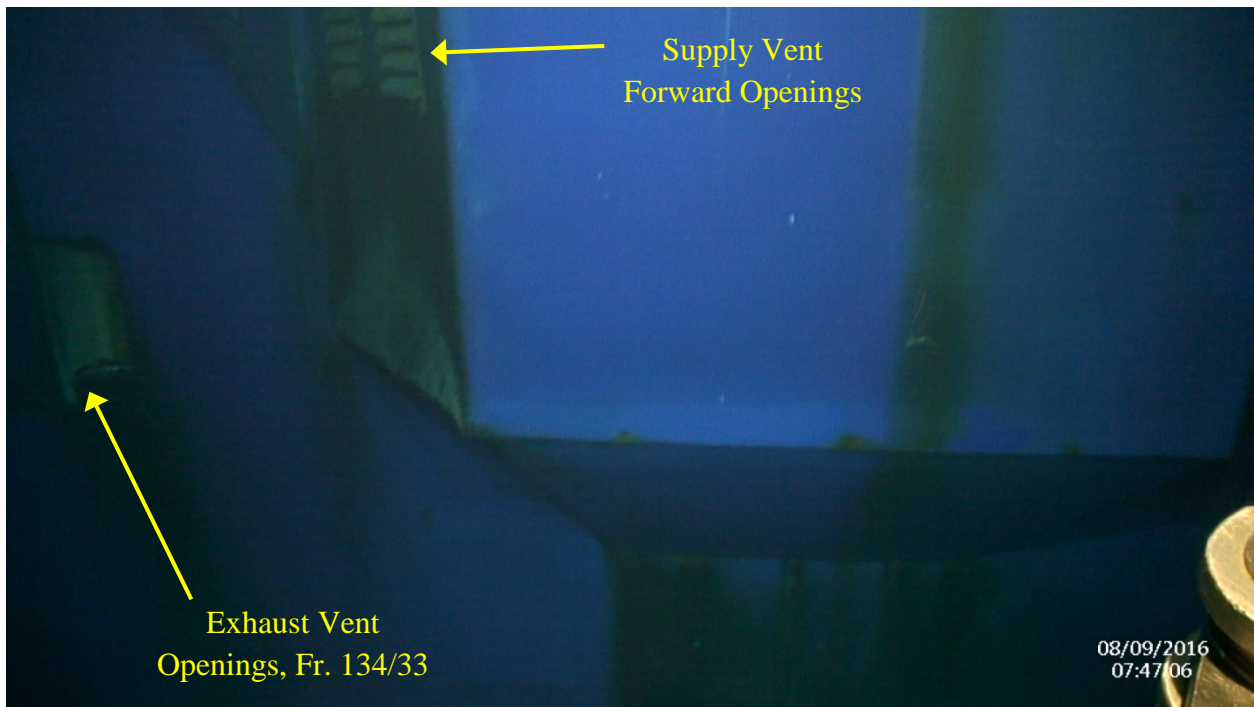
1           The ventilation air was distributed into the hold through numerous louvered registers in the  
2 horizontal trunk. Positive pressure from the supply fan would exhaust the air back up through the  
3 perforations in the tween deck and enter a set of three rectangular screened openings to exhaust  
4 trunks mounted on both the port and starboard sides (directly opposed) of the tween hold deck.  
5 The air would exhaust up the trunk through the second deck and pass a through a weathertight (not  
6 watertight) fire damper into a trunk with baffles on the second deck. The air would push over the  
7 baffles and then out through louvered rectangular openings in the vessel's sideshell (**figures 24**  
8 **and 25**).

6 **Figure 25.** *El Faro* wreckage, port side, hold 3 supply ventilation blister with forward louvered  
 7 openings at frame 139. (Photo from August 2016)

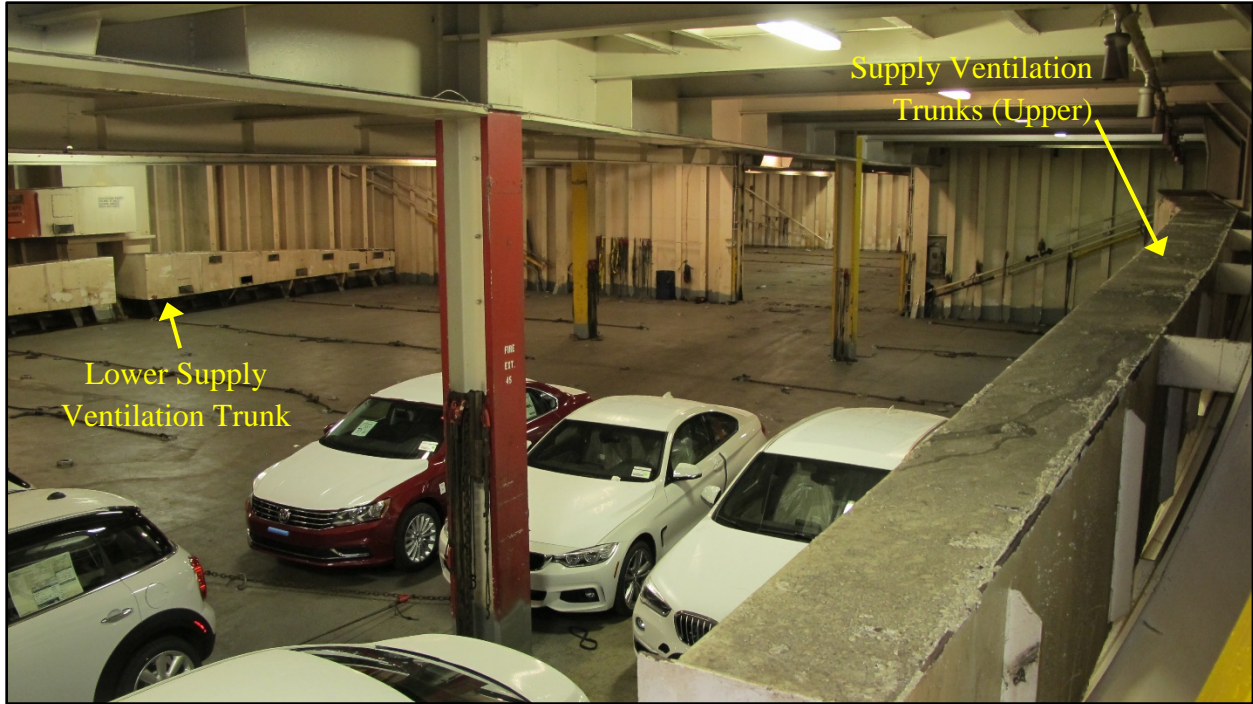
1  
2 **Figure 28.** *El Yunque*, view of hold 3 from vertical ladder at frame 163.5, looking forward. (Photo  
3 from December 2015)

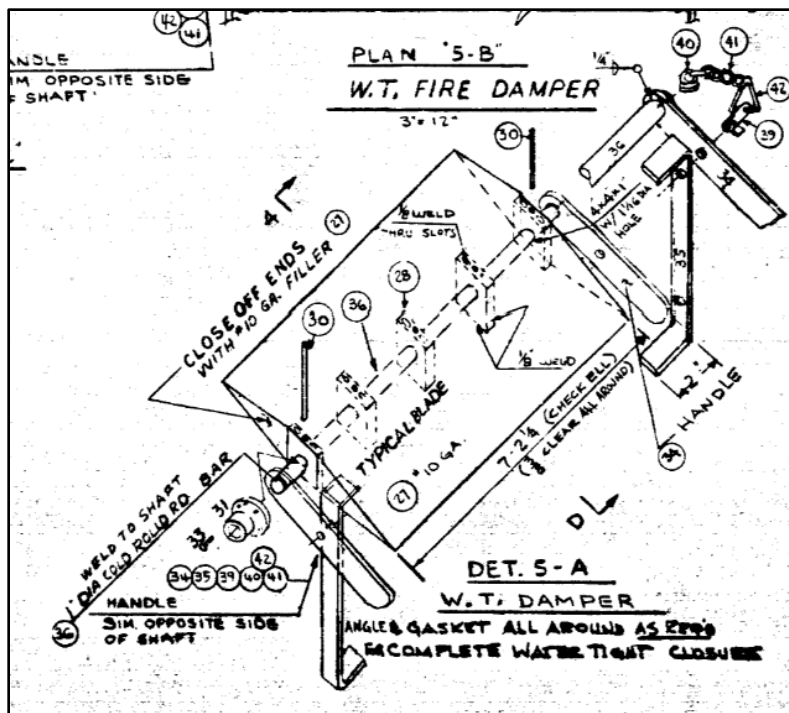
4           The closing appliances on the supply trunk were listed as watertight in the *Northern*  
5 *Lights/El Faro* conversion drawings for the ventilation system.<sup>310</sup> The detail of the supply damper  
6 shown in **figure 30** stated: “GASKET ALL AROUND AS REQ’D FOR COMPLETE WATER  
7 TIGHT CLOSURE.” Investigators examined the starboard damper in hold 2A of *El Yunque*  
8 (**figure 31**) and found it similar to the supply damper and supply inlet configuration in the *El Faro*  
9 drawings.

1  
2 **Figure 30.** *El Faro* cargo hold ventilation supply, W.T. (watertight) fire damper detail 5-A.<sup>311</sup>

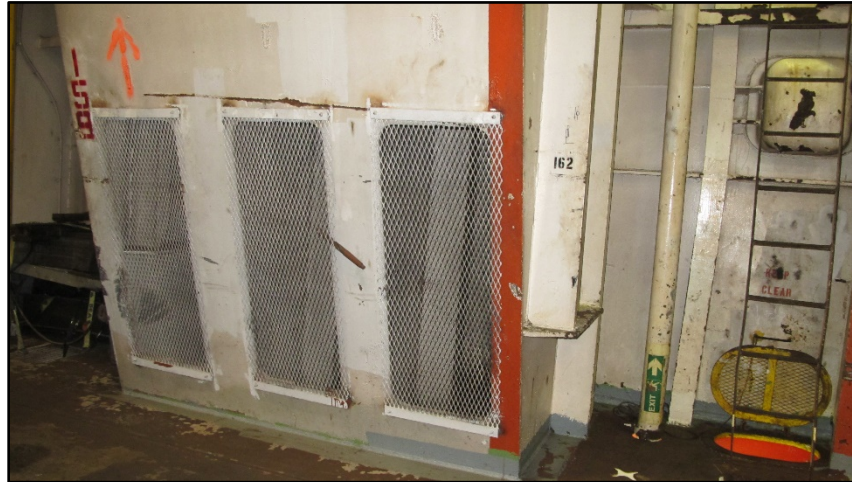
1           The tanktop decks of the cargo holds were naturally exhausted up through the permeable  
2 (non-watertight or airtight) tween deck, and then into exhaust ventilation trunk intakes with three  
3 screens at the tween deck (**figure 32**).

4  
5 **Figure 32.** *El Yunque*, cargo hold 3, natural exhaust ventilation inlets, tween deck frames 158-  
6 162. (Photo from December 2015)

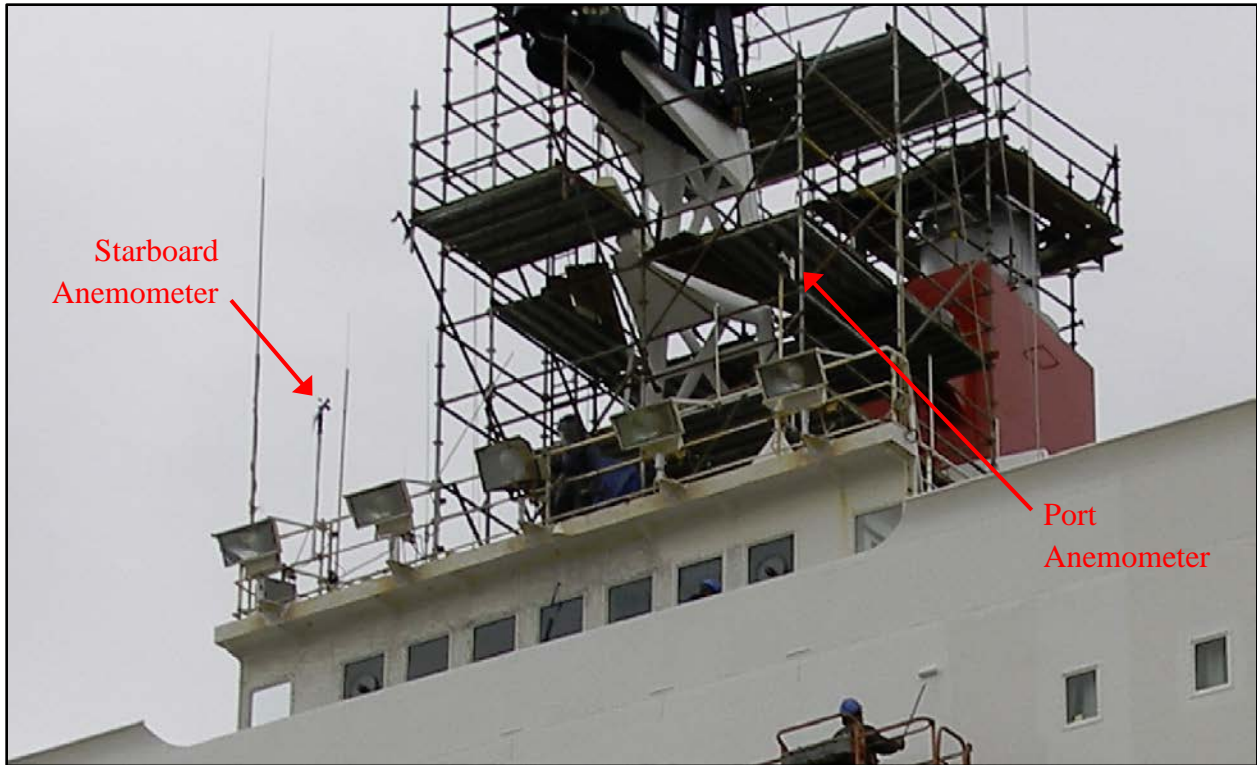
13 A photograph from 2009 of *El Faro*<sup>345</sup> shows two anemometers (Young Wind Monitors,  
14 model 05106<sup>346</sup>). The vertical positions of the anemometers were estimated from a shipyard photo  
15 (**figure 38**) to be double the rail height on the housetop, or 7 feet. With a departure draft of 29.6  
16 feet amidships, the anemometers would have been about 100.5 feet above the static waterline on  
17 the accident voyage.

2 **Figure 38.** Anemometers on *El Faro* during shipyard period in January 2011. (TOTE photo)

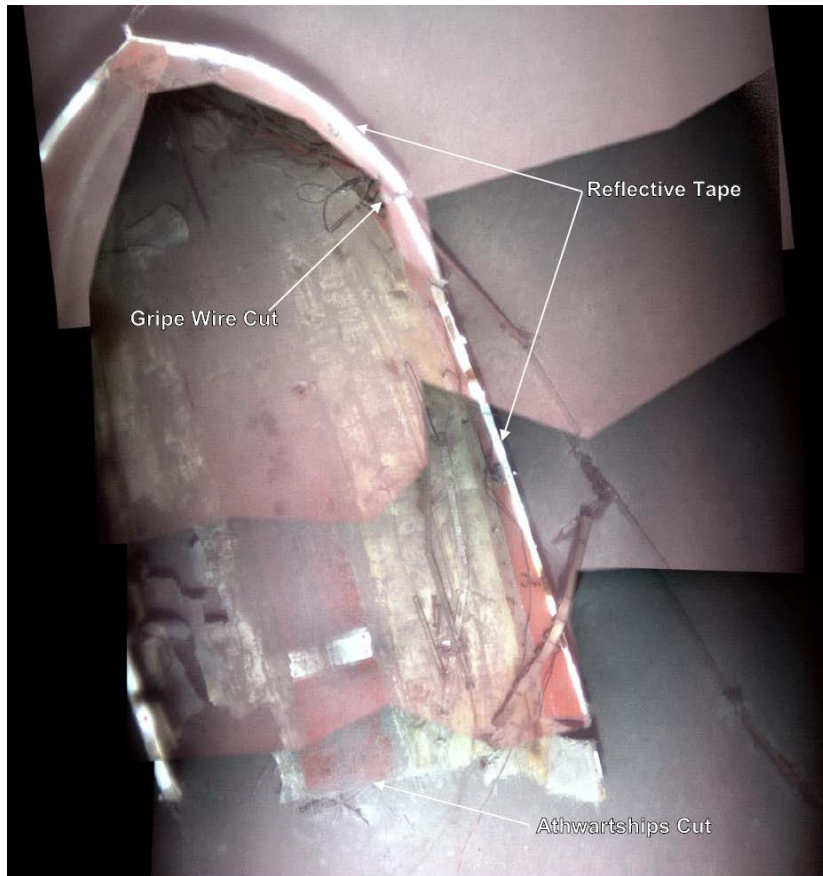
18 During the second mission, *El Faro*'s port lifeboat was discovered north of the bridge, at a  
19 depth of 15,364 feet (see **figure 43**). The lifeboat was about 754 feet (0.12 nautical mile) north-  
20 northeast of the bridge wreckage and about 0.68 nautical mile (4,101 feet) north-northeast of the  
21 center of *El Faro*'s hull. The stern of the lifeboat was missing and was not discovered elsewhere.

2 **Figure 43.** Photomosaic of *El Faro's* port lifeboat from images taken by AUV during second  
3 search mission. Bench seats and other internals are missing. Reflective tape on top of gunwales  
4 is illuminated.

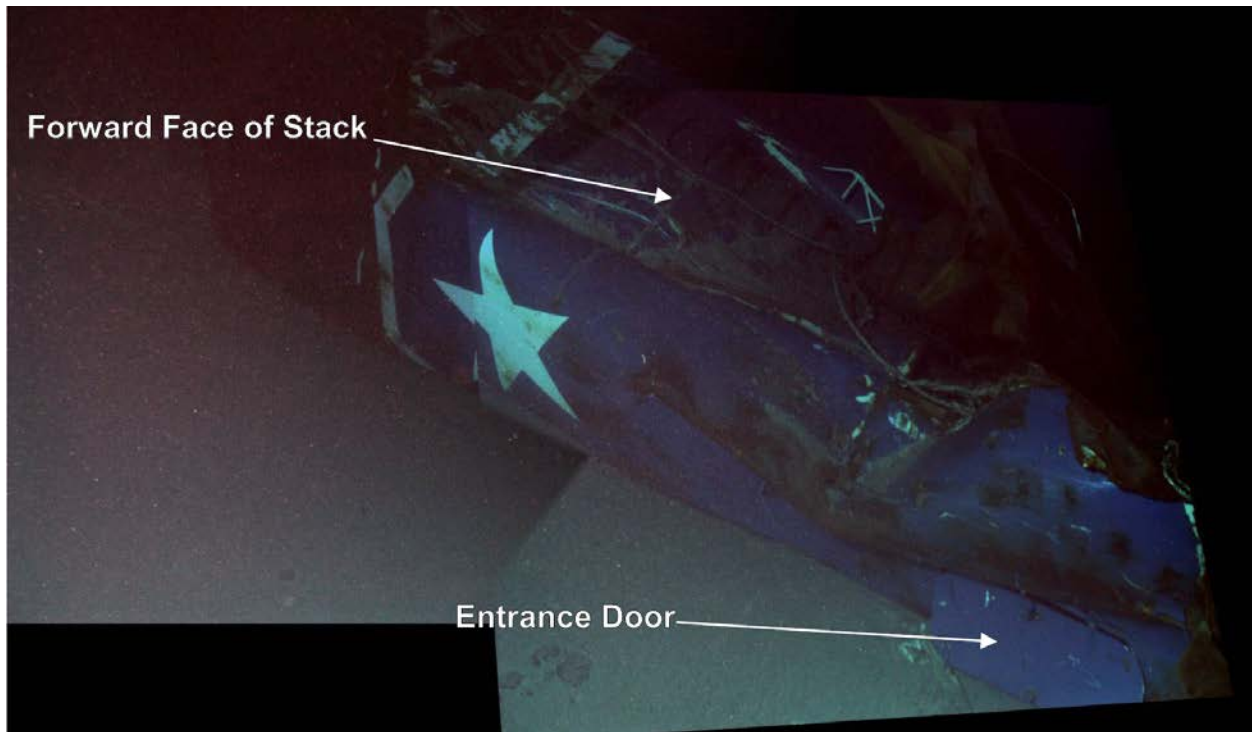
5 *El Faro's* exhaust stack was discovered during the second mission about 2,625 feet (0.43  
6 nautical miles) north of the main hull (**figure 44**). The forward face was missing its steel plating  
7 and the stack was scratched, dented, and deflected inward, but it was largely intact. The boiler  
8 uptake funnel was missing from the top.

**Figure 44.** Exhaust stack lying on seafloor, Sea Star (company) symbol clearly visible (photomosaic image from mission 2).

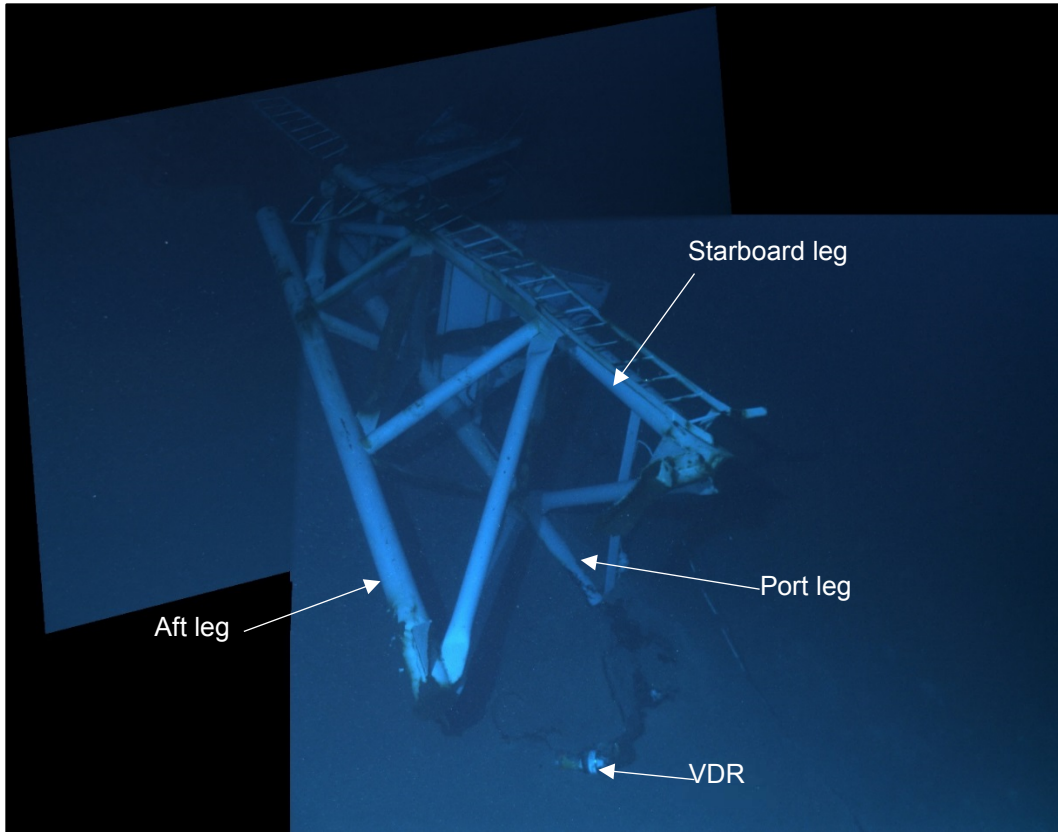
The tripod mast and VDR capsule were discovered on the seafloor about 1,640 feet (0.28 nautical miles) north of the main hull (**figure 45**). The main structural members were intact, though the overall structure was bent aft. The VDR was attached to the port leg and buried in mud.

**Figure 45.** Mast and VDR capsule on seafloor (photomosaic image from mission 2).

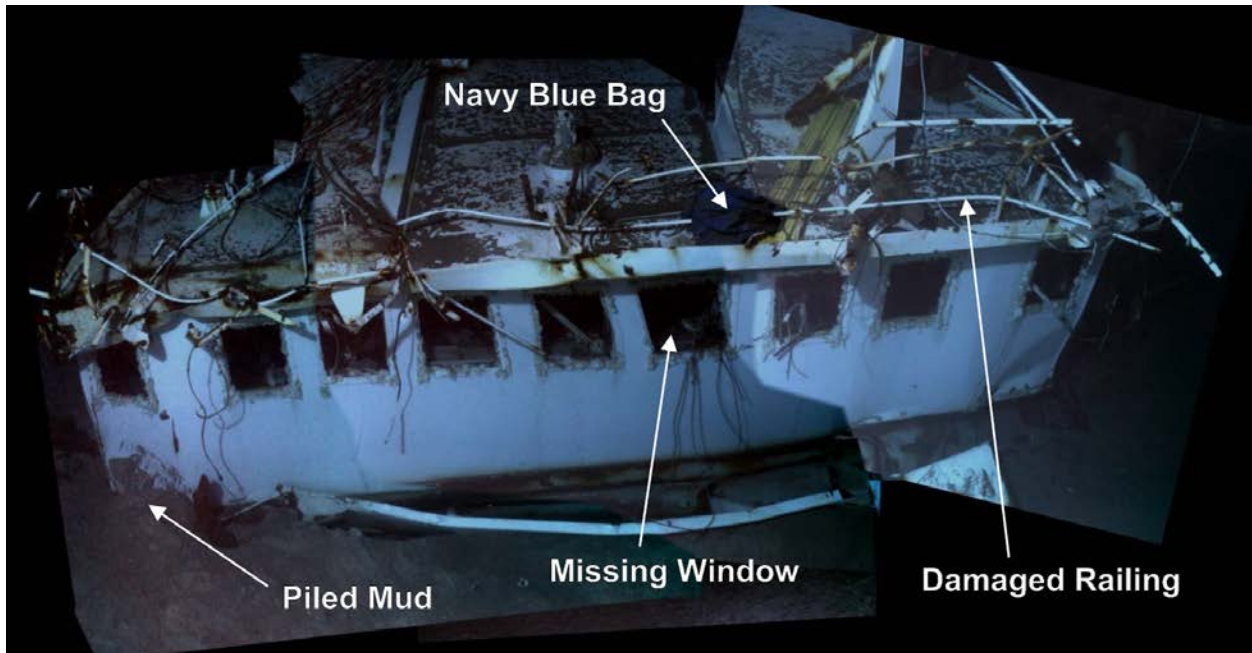
The navigation bridge and bridge deck that had been discovered during the first mission were further explored during mission 2. The photomosaic image in **figure 46** shows that the main mast was missing, all windows on the forward side of the bridge were missing, that the windscreen bulwark was bent forward, with mud piled in front of it, and that the top railings were missing, severely bent, or broken. The starboard forward corner of the wreckage was deeper into the seabed than the other corners. A blue bag was noted on top of the bridge.

**Figure 46.** Bridge and bridge deck, looking aft (photomosaic image from mission 2).

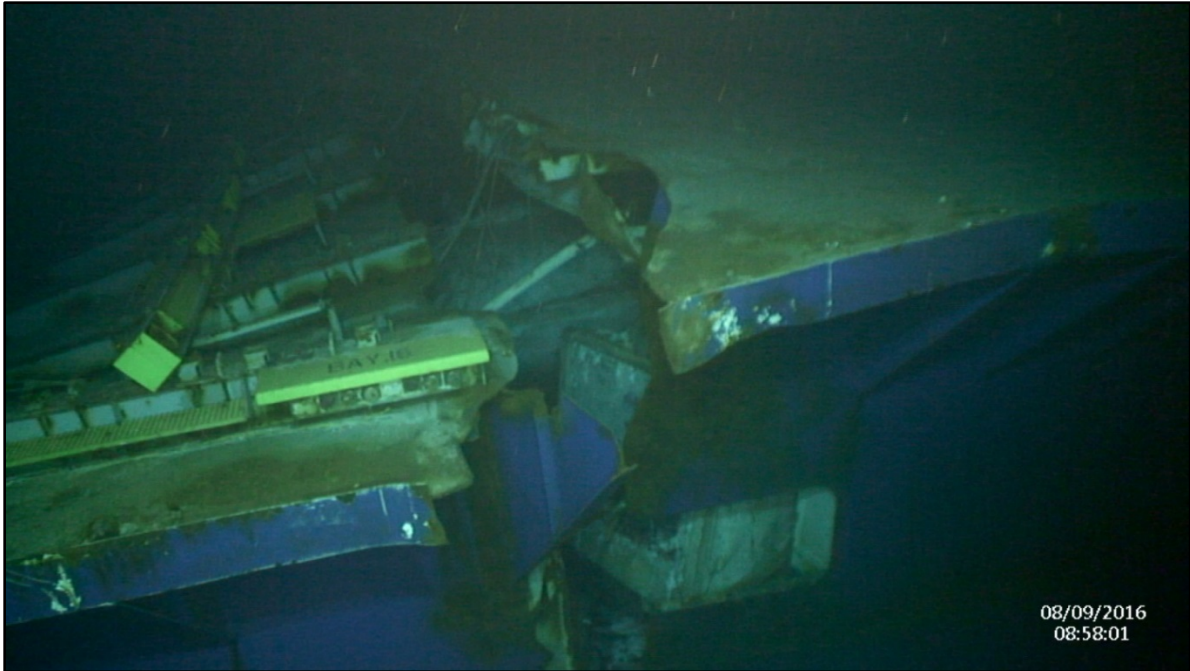
As documented during all three missions, the port side of the ship was intact, though dents on the forward side of the supply vent blisters were observed. The starboard side was intact forward of Bay 16. At Bay 16, major hull damage included a large vertical fracture on the starboard side, estimated to be 3 feet wide at the main deck and extending across the deck to the port side ramp opening (**figure 47**). Major damage and fractures were also observed at the stern, including a hull longitudinal fracture extending about 20 feet forward of the transom, which was torn open down to the second deck (**figure 48**). The main deck on the starboard side was severely buckled and inset about 8 feet from the deck edge at frame 234. A gunwale plate on the main deck wing near bay 17 was also deformed.

**Figure 47.** Hull fracture in starboard side shell and across main deck at container bay 16, just forward of frame 200 (mission 3 image).

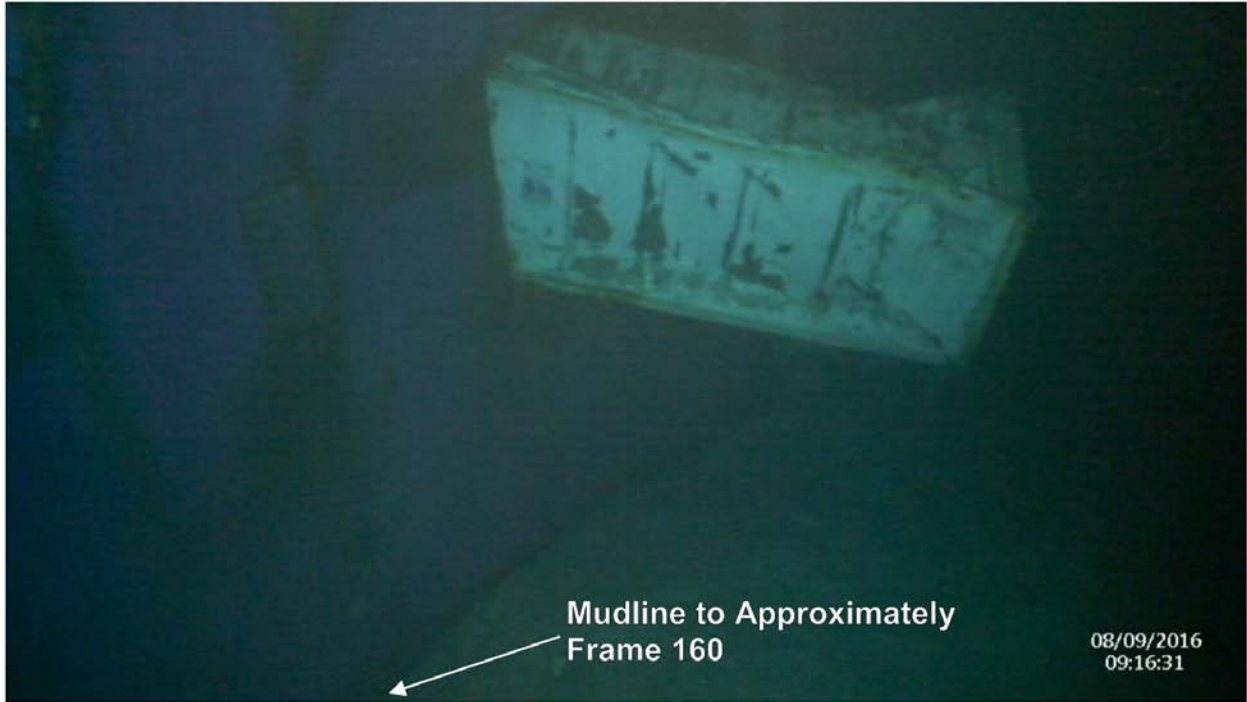
7 The state of the cargo remaining on the ship was observed. A refrigerated container  
8 exhibiting hydrostatic crush damage (damage caused by water pressure) protruded from the  
9 vehicle opening near bay 15 on the starboard side (**figure 50**). In bay 2, a 20-foot tank container  
10 was crushed but still mounted to its stowage location, with a trailer chassis inboard of it (**figure**  
11 **51**). Metal flashing hanging over the deck on the port side was determined to be part of the cargo,  
12 while fire hose and broken railing sections were hanging over portions of the starboard side.

**Figure 50.** Refrigerated container protruding through vehicle opening at frame 156, starboard side (mission 3 image).

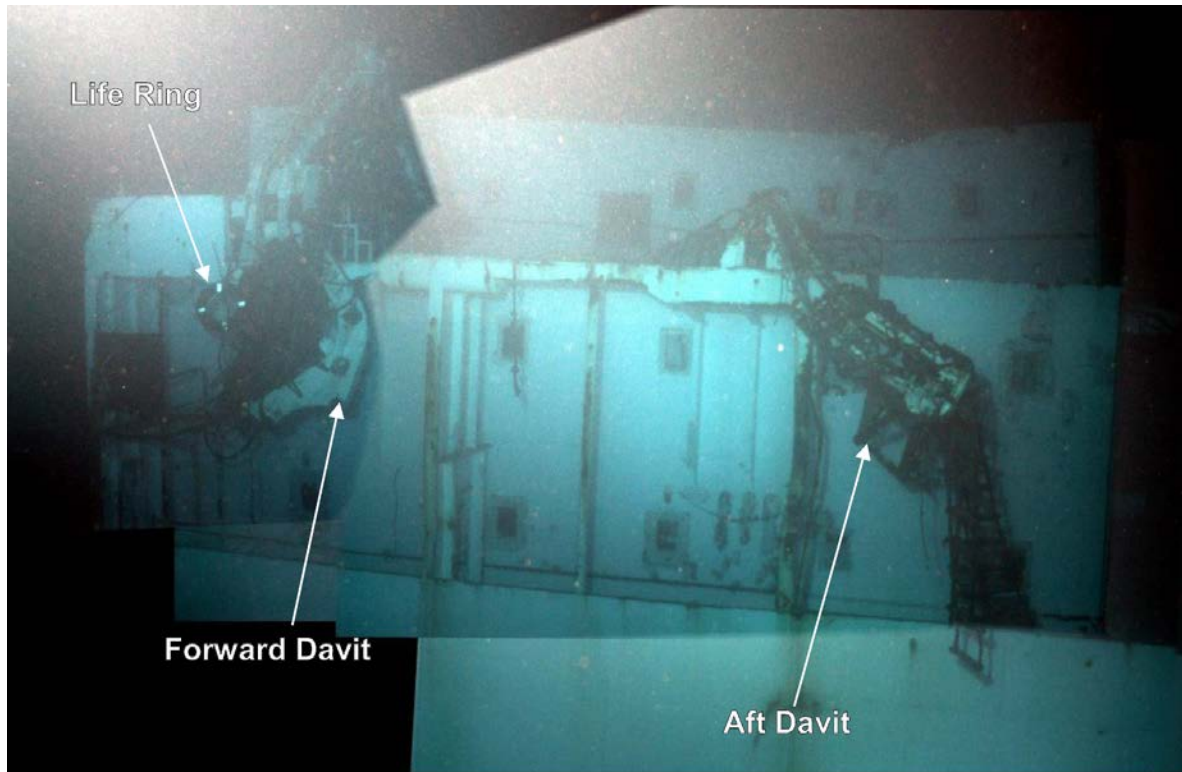
1           The gravity davits for the starboard lifeboat were generally intact (**figure 56**). The arm for  
2 the forward davit was displaced and resting on the deck, but the arm's cable was still attached to  
3 the track. The gravity davits for the port lifeboat had greater damage, with the aft track and davit  
4 broken and the forward davit hanging (**figure 57**).

2 **Figure 56.** Portside gravity davits showing forward davit track in place but davit damaged. Aft  
3 davit track and davit are broken loose and hanging aft (mission 2 AOV mosaic image).
