NATIONAL TRANSPORTATION SAFETY BOARD

Group Chairman's Factual Report

AIR TRAFFIC CONTROL

DCA13MA133

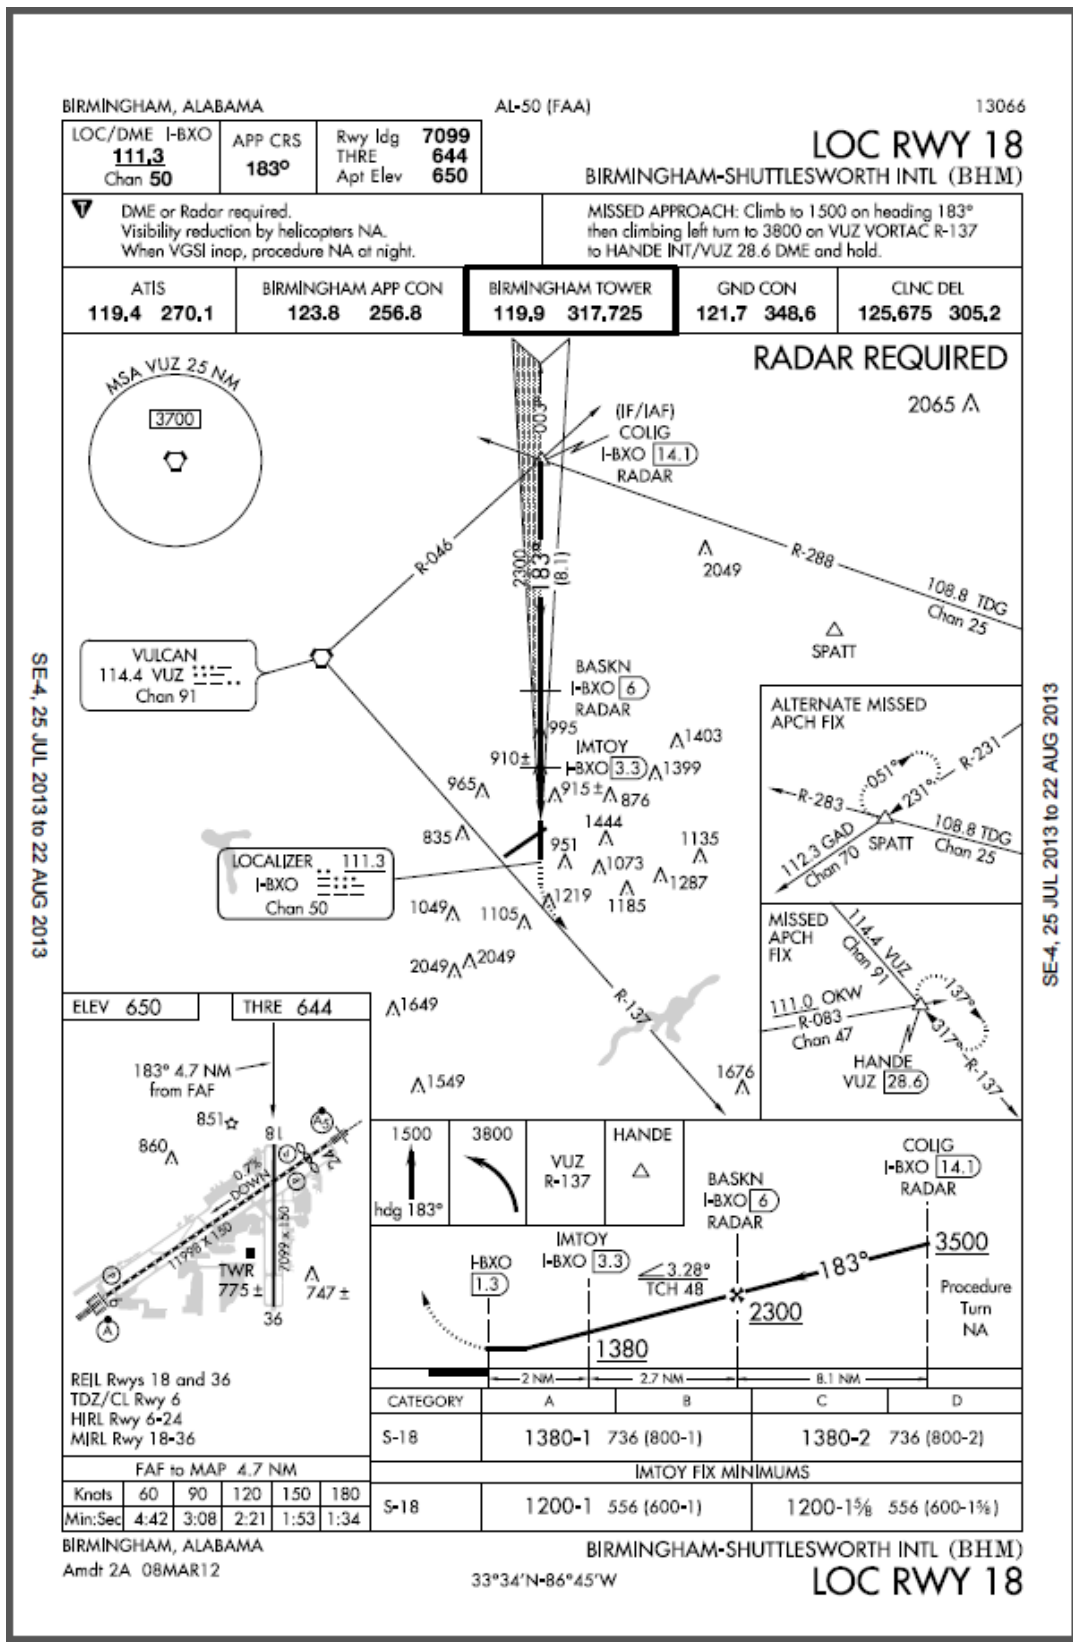
Figure 3 – Localizer Runway 18 Approach Procedure to BHM

The pilot of Skylab 301 said that he flew into and out of BHM on a routine basis. On the night of the accident, the pilot had departed BHM en route to Nashville and returned, arriving at BHM at 0417. The pilot said that he had flown the localizer runway 18 approach and was able to see the airport from the BASKN fix at 2300 feet msl.

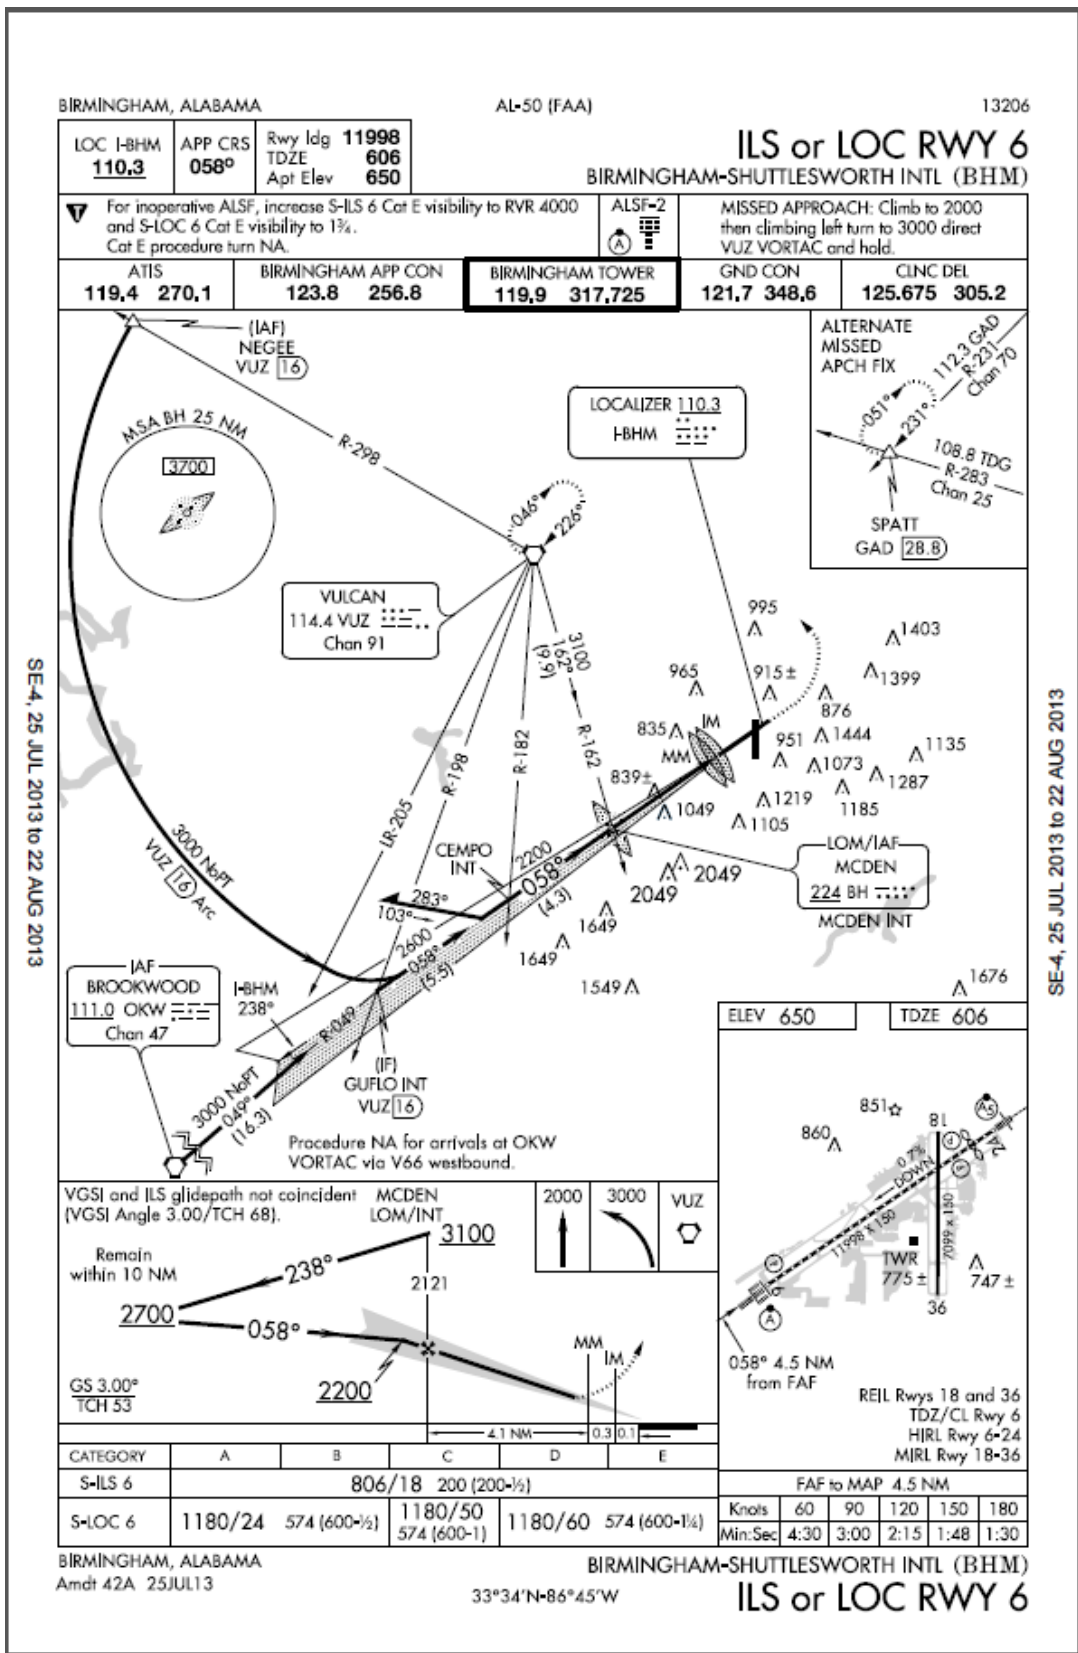
Figure 4 – ILS Runway 6 Approach Procedure to BHM

The pilot of MTN8375 said that he had flown from Memphis to BHM and used the instrument landing system (ILS) approach to runway 6, landing at approximately 0334 CDT. The pilot recalled responding to a request from the BHM ATCT for a PIREP² and reported the cloud base at the MCDEN fix as 1700 feet agl / 2300 feet above mean sea level (msl). (See figure 4.) The pilot reported that when he departed BHM runway 18 approximately 45 minutes later, the weather conditions had significantly improved.

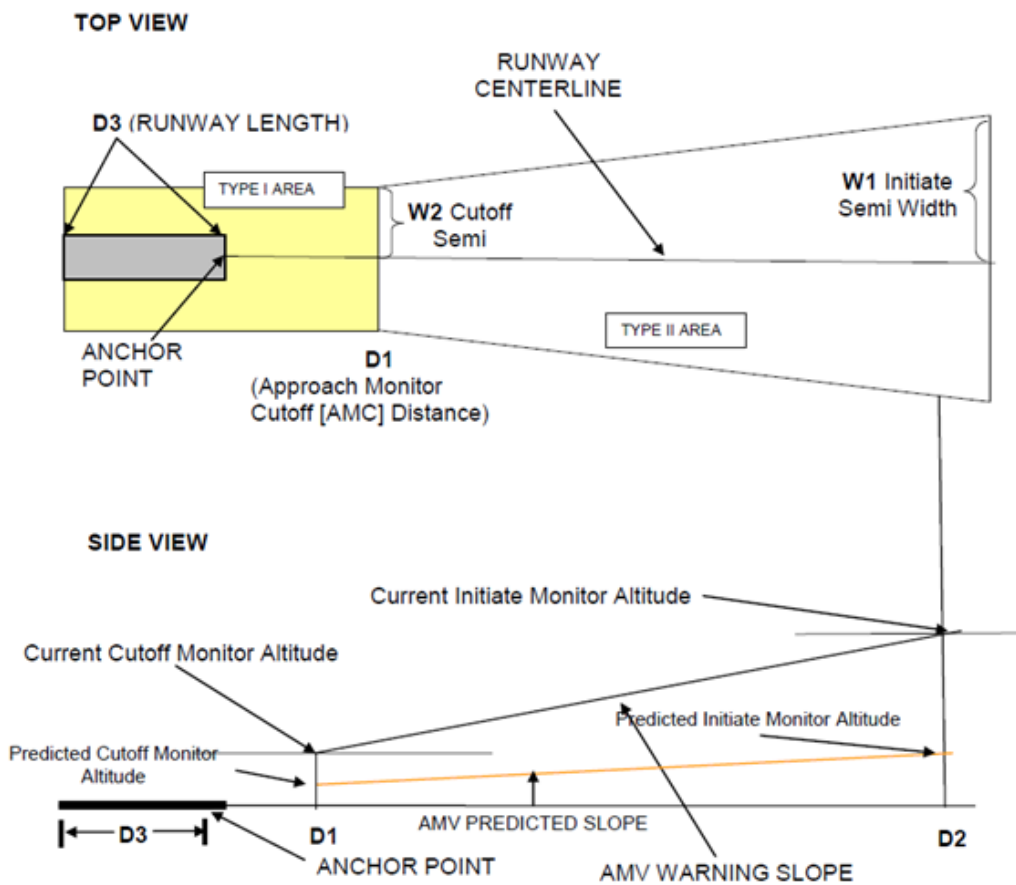
Figure 8 - MSAW Top and Side View Example

unique and configured according to various parameters such as topography, nuisance alert mitigation, etc. (See figure 8.)

MSAW Vertical: The MSAW current initiate monitor altitude, also referred to as the warning slope, begins where the type I and type II areas intersect at an altitude based on the airfield elevation plus 500 feet plus the distance from the runway end to the beginning of the warning slope in nautical miles time 100 feet. The predicted initiate monitor altitude, also known as the predicted slope, is nominally set 100 feet below the warning slope. If the slope created by this equation exceeds 100 feet per NM, the current initiate altitude may be lowered to obtain any slope of at least 100 feet per NM. All obstacles and terrain must be at least 200 feet below the adapted current warning slope generated by the beginning and ending of the current warning slope settings.
