Pilot/Race 177, *The Galloping Ghost*
North American P-51D, N79111
Reno, Nevada
September 16, 2011

Accident Brief

NTSB/AAB-12/01
PB2012-916203

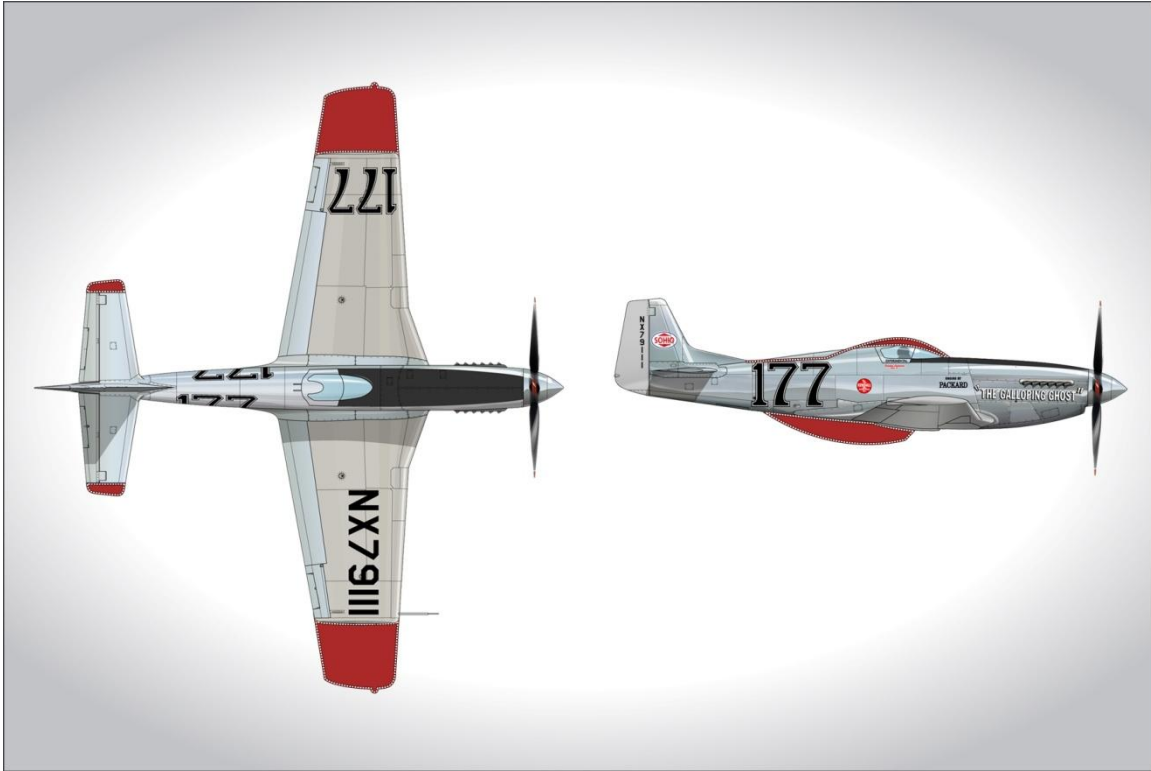
Figure 2. Illustration of the accident airplane with stock P-51D dimensions shown in red.

The outboard section of each wing was removed, and a new wingtip with an end plate was installed. The airplane's modified wingspan was about 28 feet 10 inches (compared to the stock wingspan of 37 feet 5/16 inch), which was the shortest wingspan of any modified P-51D racing in 2011. Each aileron was shortened to about 3 feet (from a stock length of about 7 feet) and had two hinges (a stock aileron has three). The right aileron trim tab was removed, and the trim for the left aileron was run by an electric trim motor installed at the wing root (as opposed to the stock manual trim system). The horizontal stabilizer and elevators were equipped with modified flat end caps that reduced the horizontal stabilizer span to about 12 feet 1 inch (from a stock span of 13 feet 2 1/8 inches). (See figure 2.)

Modifications to the elevator counterweights, upper rudder counterweight, vertical stabilizer incidence, horizontal stabilizer incidence, and rudder were discovered during the postaccident wreckage examination. The horizontal stabilizer, elevators, and trim tabs were of all-metal construction but were modified with up to 1/8 inch of filler material on the upper and lower skins that smoothed the surfaces. The left elevator counterweight weighed 26 pounds, and the right elevator counterweight (with some of the elevator structure and outboard hinge assembly still attached) weighed 27.5 pounds. Available documentation for the stock elevator counterweight specified a maximum total weight of 13.75 pounds. The vertical stabilizer's leading edge was offset to the right of the airplane's longitudinal axis by means of a tapered shim installed between the vertical stabilizer rear spar and the empennage structure (the stock P-51D's vertical stabilizer is offset to the left of the airplane's longitudinal axis). The rudder was modified to remove the stock trim tab and its associated control cables and to cover the trim-tab cutout with fabric. The modified upper rudder counterweight weighed 25 pounds. Available documentation for the stock upper rudder counterweight specified a maximum total weight of 16.6 pounds. The horizontal stabilizer incidence was increased from the stock value of 0.5° leading edge up to 0.91° leading edge up through the installation of a shim between the forward attach points and the fuselage.

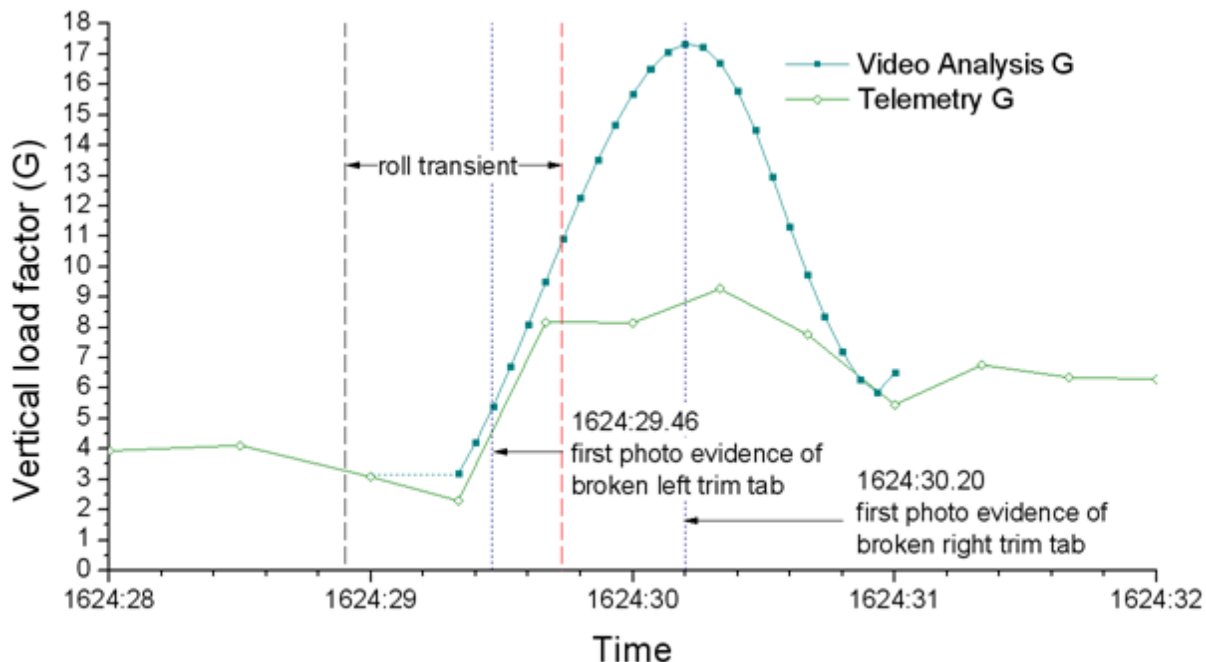
Figure 11. Airplane’s vertical acceleration during upset over time. Times that correspond with specific photographs are noted.

Telemetry data were time-correlated with the results of the video study calculations that determined the airplane's roll, pitch, and heading angles and vertical load factors throughout the upset event. During the roll upset and the onset of the pitch-up maneuver, the airplane's onboard accelerometer recorded a greater than 5-G jump in vertical acceleration within about 0.3 second. The video study established that, during the pitch-up maneuver, the maximum vertical load factor reached about 17.3 G about 0.47 second after the airplane reached its maximum left bank angle. Figure 11 shows the vertical acceleration leading up to, during, and after the roll upset as

determined through the video study calculations and the telemetry data (the telemetry data were subject to the accelerometer’s limitations).³⁴
