NATIONAL TRANSPORTATION SAFETY BOARD

ACCIDENT SITE EXAMINATION

WPR16FA131

Location: Coeur d'Alene, Idaho
Date: June 25, 2016
Aircraft: Cessna A185F N4585F,
Serial 1851092
NTSB IIC: Albert Nixon

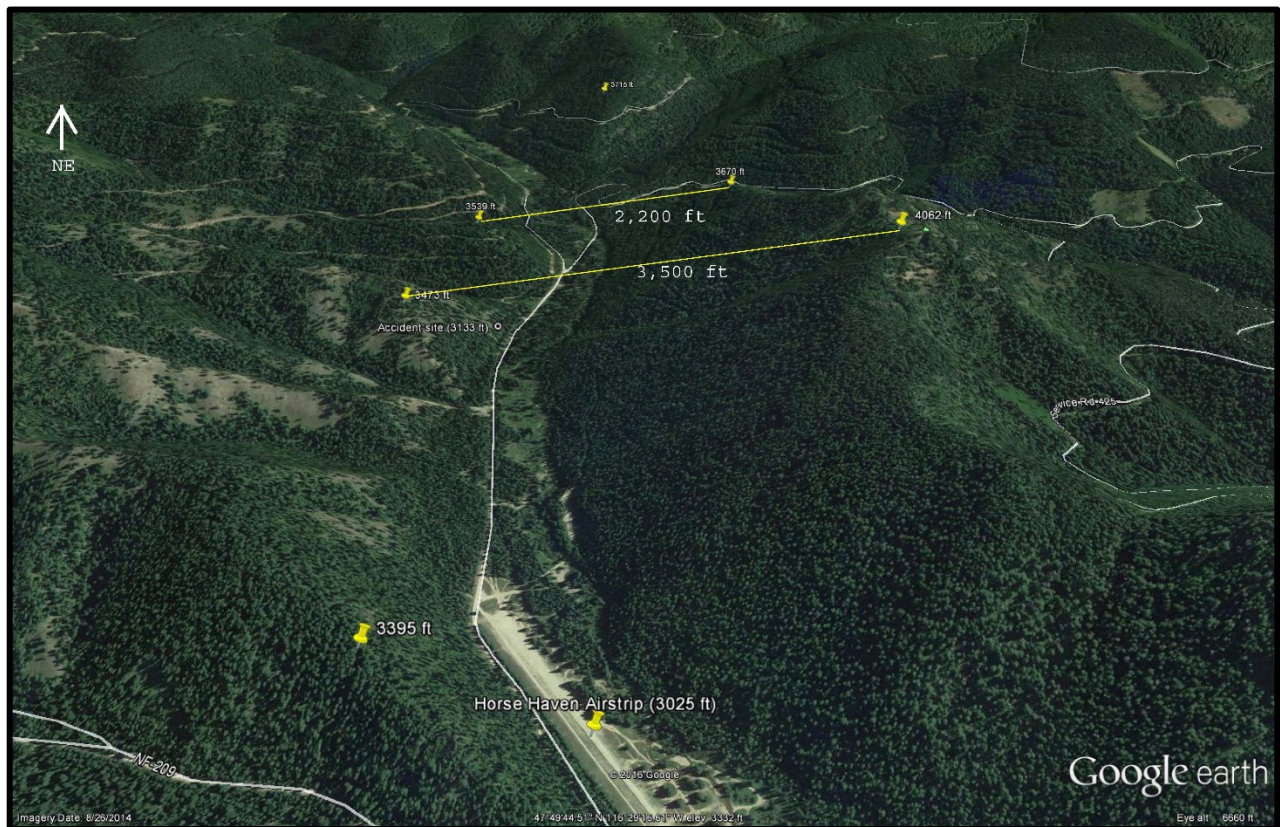
Examination of the accident site by investigators from the National Transportation Safety Board (NTSB), Continental Motors, and Textron Aviation, revealed that the airplane impacted heavy wooded terrain on a canyon hillside at an elevation of about 3,133 ft. The wreckage came to rest inverted on a hillside, with a slope of about 45°, about 1-mile northeast of the Horse Haven airstrip. The area surrounding the impact site consisted of a canyon valley surrounded by mountainous terrain with approximately 3,500 ft in distance between the closest ridgelines surrounding the accident site. The canyon ridgelines were about several hundred ft above the accident site elevation. The canyon narrowed ahead, with the distance between ridgelines decreasing to about 2,200 ft in distance, about a 1/3 of a mile northeast of the accident site, and the canyon valley elevation increased by several hundred ft. Further, the canyon continues to narrow a couple miles further ahead, with the canyon base floor elevation increasing by several hundred ft, and the ridgeline's high terrain about 1,500 ft higher in elevation than the accident site.

Figure 1: Horse Haven Airstrip and Canyon Valley (Courtesy Google Earth).
