NATIONAL TRANSPORTATION SAFETY BOARD

ACCIDENT SITE EXAMINATION SUMMARY

WPR17FA085

Location: Harrisburg, OR
Date: April 7, 2017
Aircraft: Piper PA-46-310P, N123SB
NTSB Investigator-in-Charge: Maja Smith

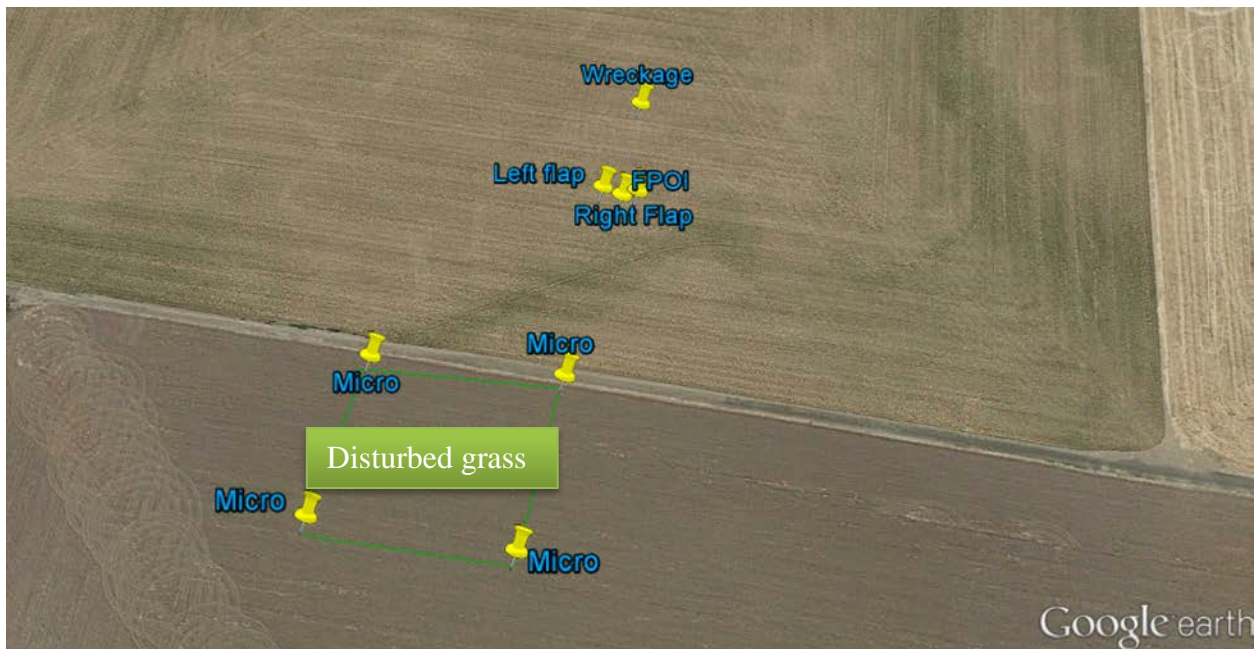
Image 1-Satellite View

Initial Impact: 44°17'40.63"N, 123°10'59.99"W– Elevation: 276 feet
Main Wreckage: 44°17'41.53"N, 123°10'59.95"W– Elevation: 276 feet

The accident site was located on the grass field near Harrisburg, Oregon. The nearest airport, and the intended destination was Mahlon Sweet Field Airport (EUG), Eugene, Oregon. EUG was located about 12 miles south from the accident site at about 188 degrees bearing from.
