DOCKET NO. **SA-510**

**NATIONAL TRANSPORTATION SAFETY BOARD**

## **737 Rudder PCU Input Rod Summary**

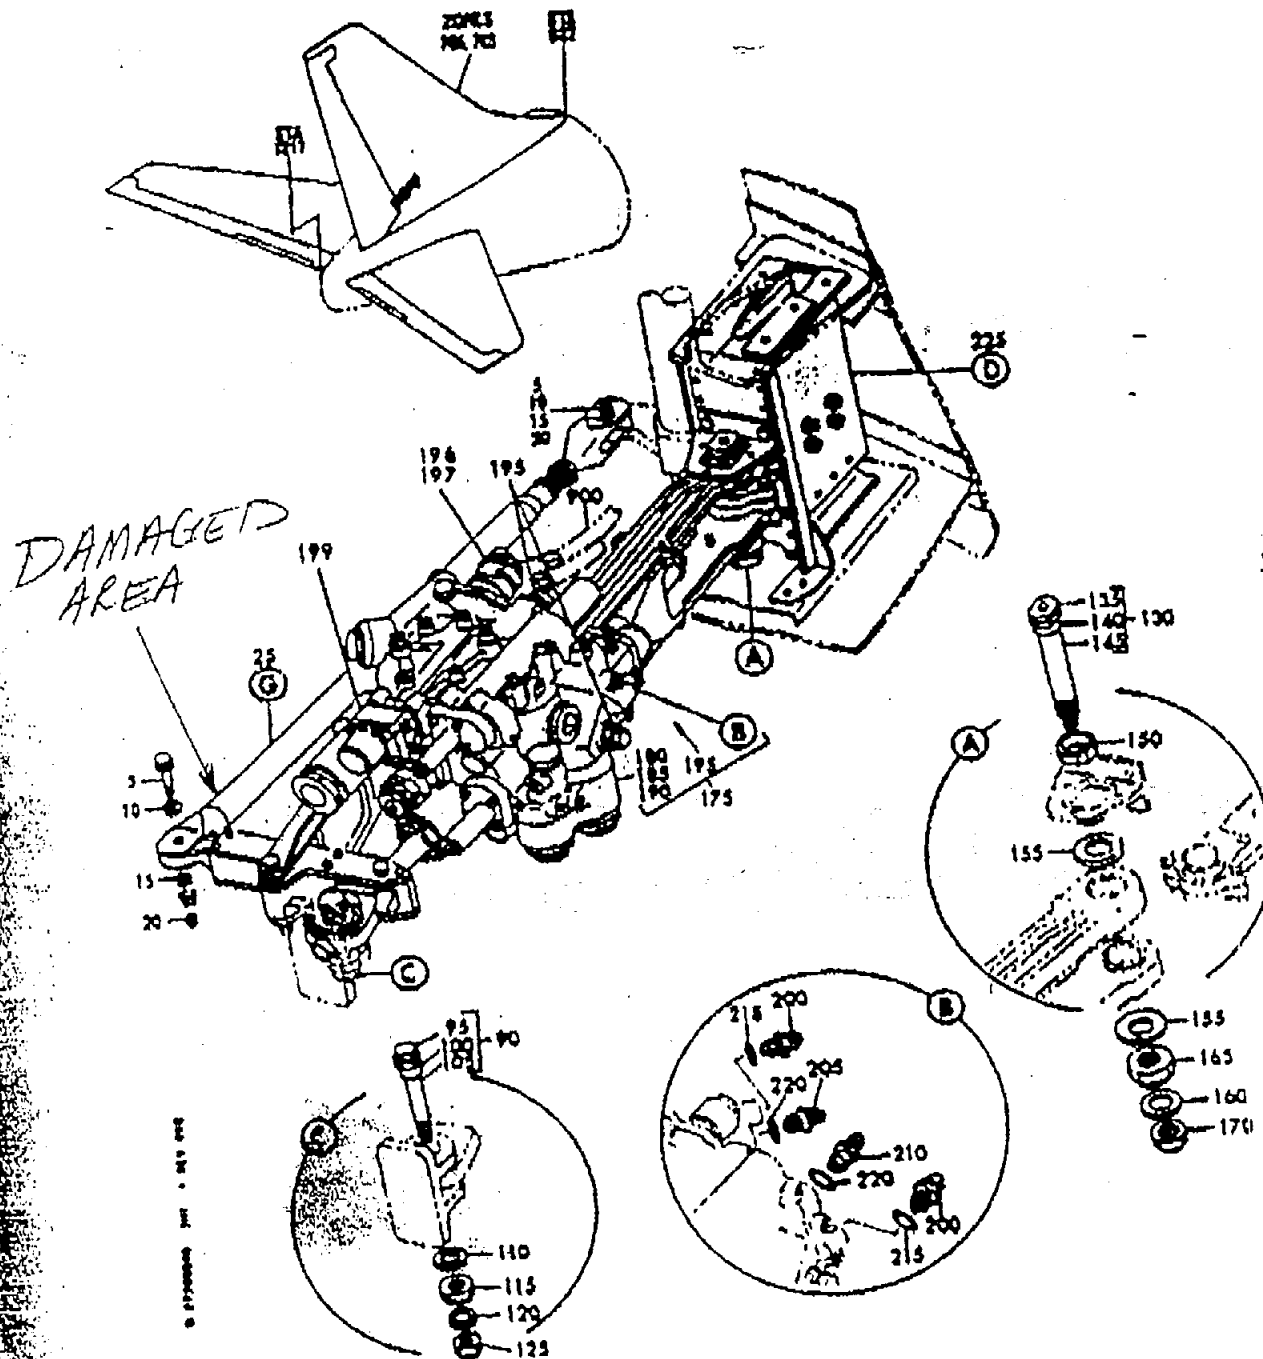
Ref PEM.DHN.94065TR

THE OUTER ROD P/N 69-37291-2 WAS DENTED  
WHEN THE RUDDER ACTUATOR WAS ACCIDENTALLY OPERATED  
WHILE THE RUDDER WAS REMOVED FOR BALANCING.  
THE ROD WAS FORCED AGAINST AN ADJACENT STRUCTURE  
WHICH CAUSED A SMALL DENT AND A CRACK (Ref FIG 1)

IN THE REF /A/ FAX PEMCO REPORTED THE THAT OUTER RUDDER PCU INPUT ROD P/N 69-37291-2 BECAME DENTED WHEN THE RUDDER PCU WAS INADVERTENTLY OPERATED WHILE THE RUDDER WAS REMOVED FOR BALANCING. THE ROD WAS FORCED AGAINST AN ADJACENT STRUCTURE WHICH CAUSED A SMALL DENT. PEMCO ASKED WHETHER THE DAMAGED AREA IS REPAIRABLE OR THE ROD MUST BE REPLACED.

THE ROD IS STRUCTURALLY ACCEPTABLE IF REPAIRED PER THE FOLLOWING INSTRUCTIONS.

1/ BLEND-OUT THE DAMAGED AREA. THE MAXIMUM ALLOWABLE DEPTH OF MATERIAL REMOVAL IS 0.018 INCHES. MINIMUM RADIUS OF BLEND-OUT IS 0.25 INCHES.

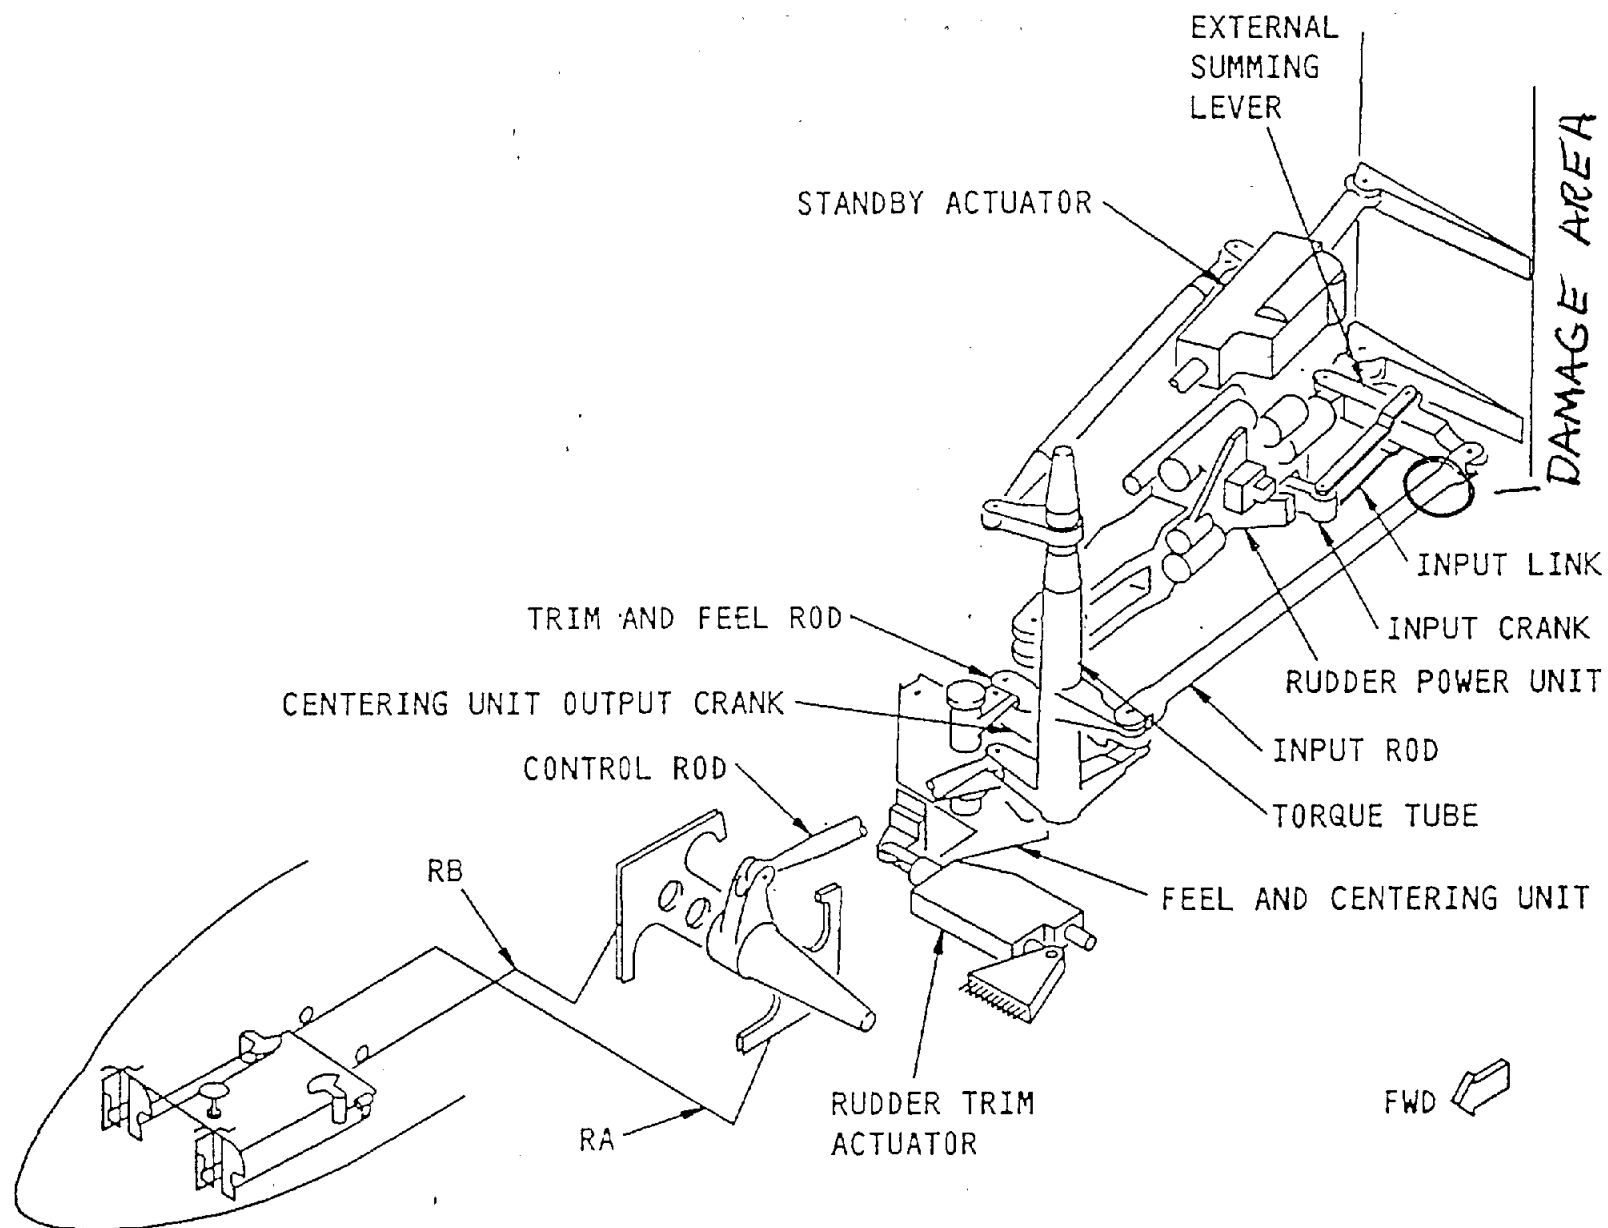
DELTA (DAL) REPORT (DAL-ATL-95-0114TR)

DURING THE PRESENT HMV OF THE DATA AIRPLANE, A DAMAGED INPUT ROD TO THE RUDDER PCU WAS DISCOVERED. DAMAGE HAS OCCURRED AT THE AFT END OF THE ROD WHERE THE ROD HAS BEEN STIKING THE LEFT AFT VERTICAL FRAME STRUCTURE OF THE STABILIZER. UPON NOTIFICATION, PICTURES WERE TAKE WITH ALL COMPONENTS IN PLACE. THE PICTURES HAVE BEEN SENT BY AIRBORNE EXPRESS AIRBILL 8770295332. THIS OFFICE HAS ASKED FOR THE INPUT ROD AND THAT THE RUDDER PCU BE MADE AVAILABLE IF BOEING REQUESTS. THE REF /B/ SKETCH SHOWS DAMAGE LOCATION. THE DENT IN THE INPUT ROD IS APPROXIMATELY 1/4 INCH DEEP AND IS SCRAPED REARWARD ABOUT 1 INCH. THERE IS A MINOR INDICATION OF SCRAPING ON THE VERTICAL RUDDER STRUCTURAL ELEMENT.
