RE: LAX08PA259, Weaverville, CA helicopter accident

## ***Synopsis of Pertinent Facts in the Crash of N612AZ***

**LAX08PA259**

## Comparison of four sets of FCU-PRV Particle Contamination

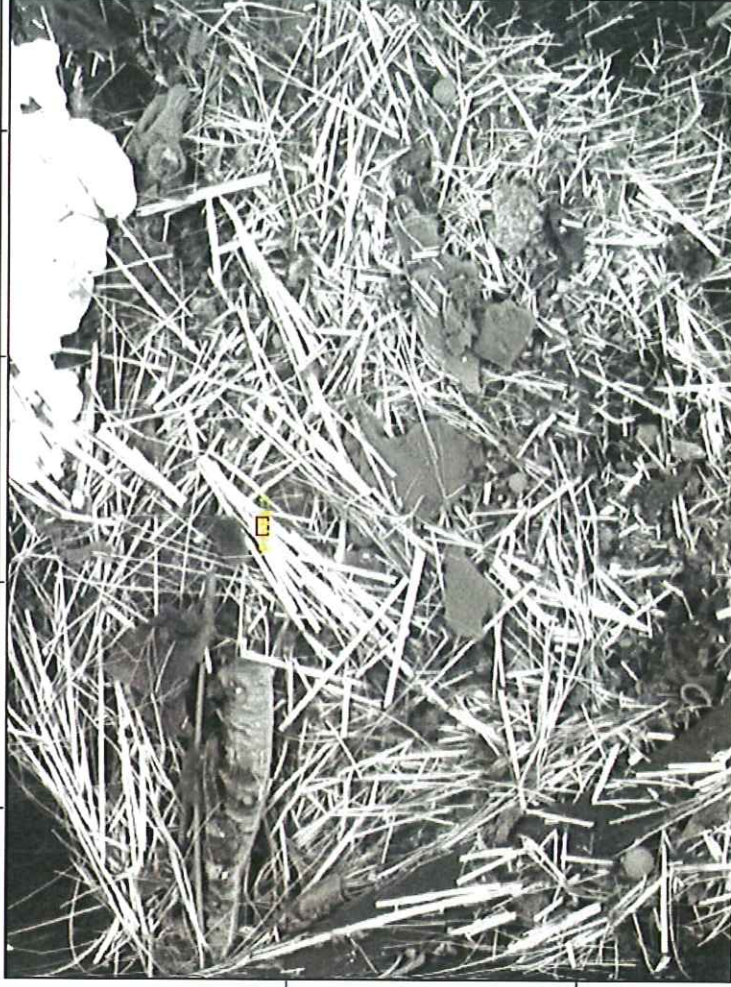
N612AZ #2 PRV

S/N 39989 Cartridge - Probe 1 - 1000X

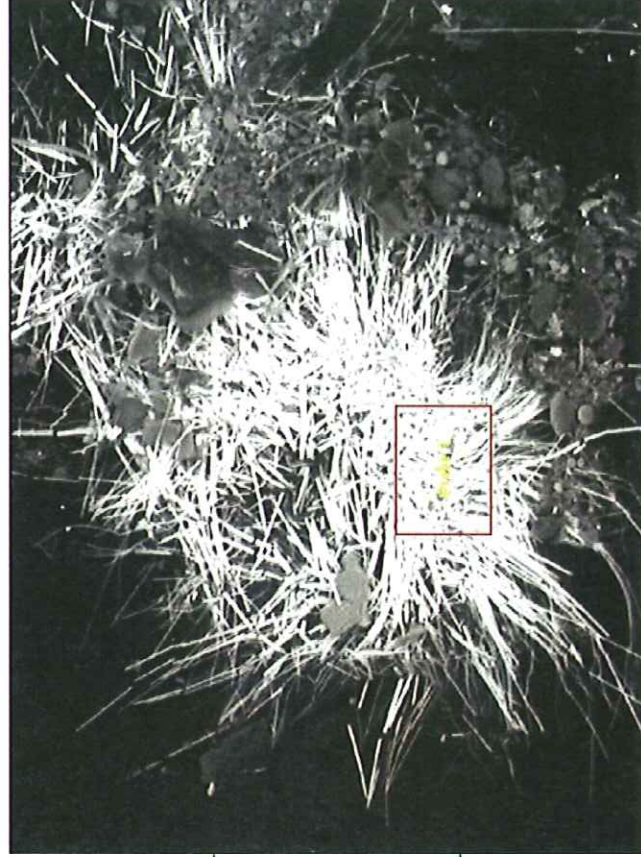
Quantitative Results for S/N 39989 Cartridge - Lead  
Analysis: Bulk Method: Standardless  
Acquired 28-Jul-2009, 20:0 KeV @ 10 eV/channel

Element	Weight %	Atomic %
C	33.67	72.02
S	29.16	23.37
Pb	37.17	4.61
Total	100.00
