# National Transportation Safety Board

## Railroad Accident Brief

### South Florida Regional Transportation Authority Highway-Rail Grade Crossing Collision

#### West Palm Beach, Florida

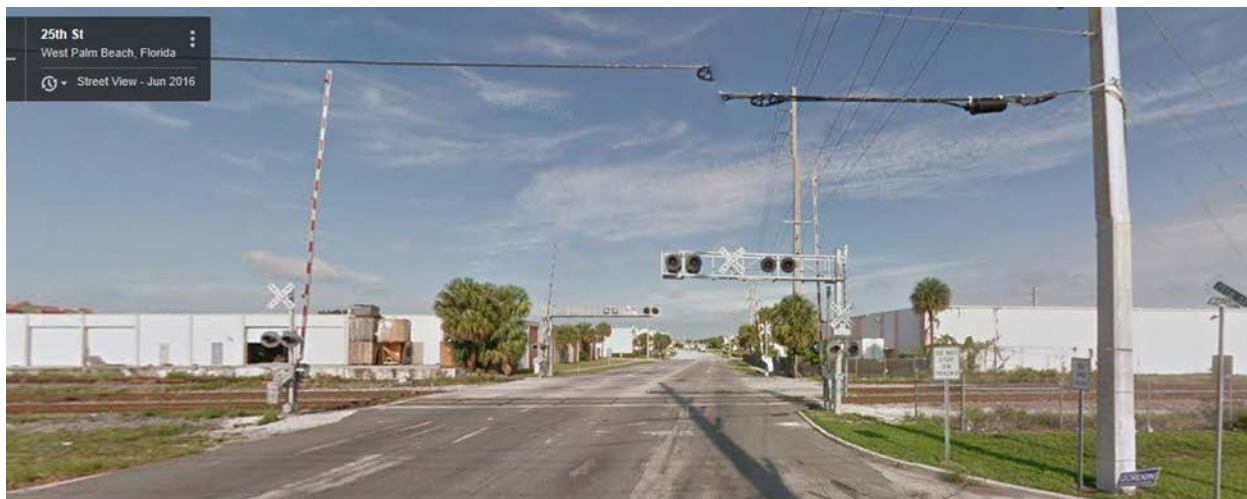
**Figure 3.** 25th Street crossing. (Photo courtesy of Google Maps.)

The 25th Street crossing in West Palm Beach, Florida is on the northern end of the 72-mile SFRTA rail corridor. (See figure 3.) Three tracks (two main and one industry) traverse the grade crossing in a north-south direction.

At the accident crossing, 25th Street is a four-lane undivided highway oriented in an east-west direction with a speed limit of 30 mph. The crossing is marked with stop lines (on the pavement) and warning signs. The crossing warning system is equipped with four quadrant gates, lights, bells and two cantilever structures for over-lane lighting. There are
