# National Transportation Safety Board

## Railroad Accident Brief

### Dallas, Garland & Northeastern Railroad Employee Fatality

August 13, 2018

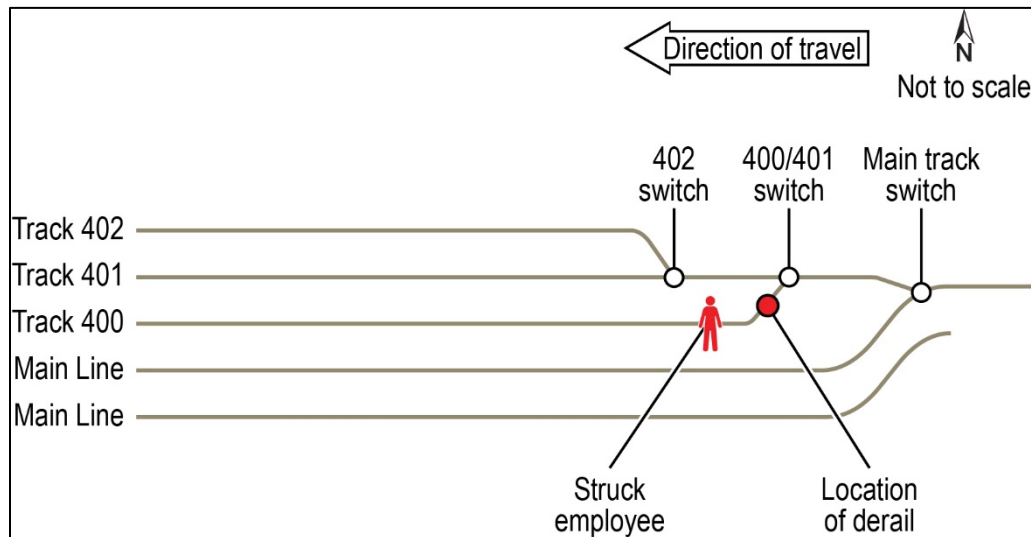
After a job briefing, the trainmaster transported the crew to Cadiz Yard. Cadiz Yard runs east to west and includes DGNO tracks 400 through 402; the tracks are adjacent to the UP double main tracks. (See figure 1.)

Figure 1. Cadiz Yard with main line and DGNO tracks.
