Rupture of a DOT-105 Rail Tank Car and Subsequent
Chlorine Release at Axiall Corporation
New Martinsville, West Virginia
August 27, 2016

NTSB/HZM-19/01
PB2019-100294

Hazardous Materials Accident Report

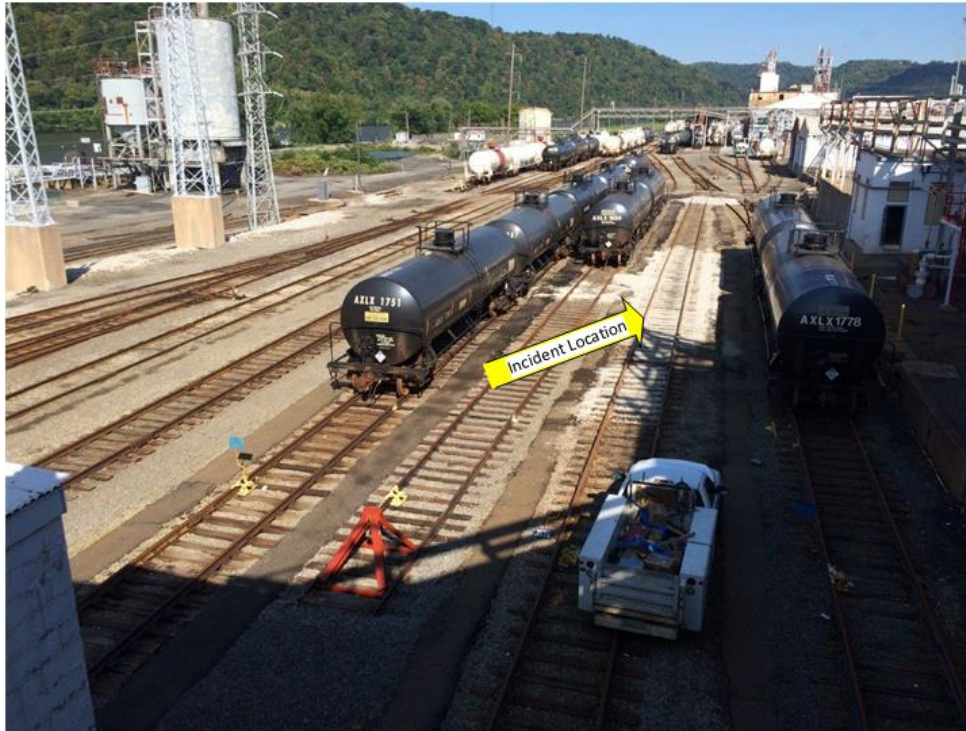
As the gas cloud grew, one chlorine-loading employee notified the guard station to initiate a chlorine release alarm. Both chlorine-loading employees shut down other railcar-loading equipment and evacuated the area. All nonessential employees and contractors immediately evacuated to the guard station or the dispensary for exposure treatment. Figure 2 shows where the chlorine release occurred north of the Axiall railcar loading shed on track 10.

Figure 2. Chlorine release incident location, September 1, 2016.

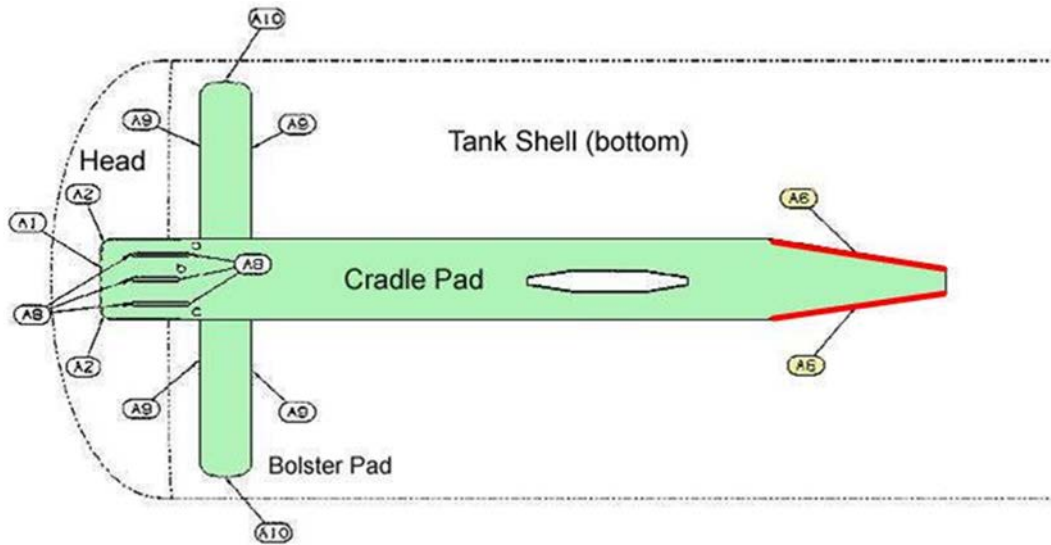
The ACF-200 stub sill underframe of the tank car was originally manufactured by ACF Industries, Incorporated. Figure 5 shows the ACF-200 underframe layout with cradle pad and bolster components and weld identification numbers from the AAR Data Collection template. At the inboard end of the cradle pad, A6 designates fillet welds.¹⁵ Figure 6 provides a three-dimensional view of the tank car and underframe showing the cradle pad and inboard fillet weld and terminations and attached underframe components.

Figure 5. ACF-200 underframe general layout and weld identification numbers.

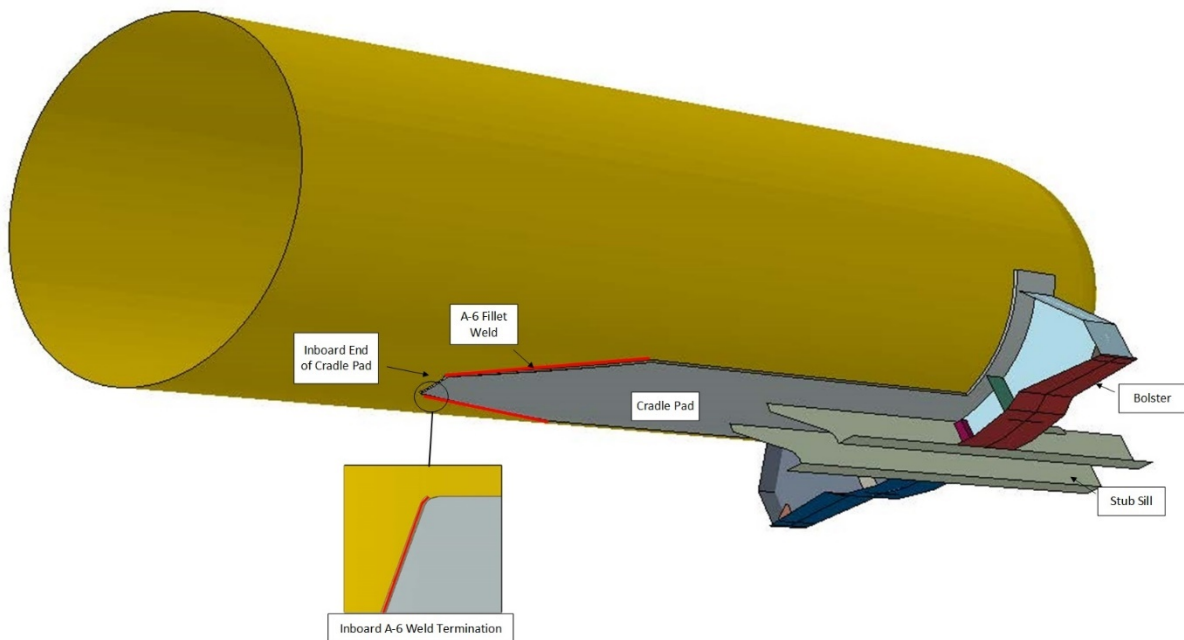
While both general service and pressure tank cars have employed the ACF-200 stub sill underframe design, about 2,186 DOT-105 pressure tank cars were equipped with this underframe.¹⁶ The design used cradle pads welded to the tank to transfer running loads from the stub sills through the tank.¹⁷ The ACF-200 underframe layout position of the cradle pad and bolster pad is shown in figure 5. The pads are highlighted in green and fillet welds designated A6 at the inboard end of the cradle pad are highlighted in red.

Figure 6. Three-dimensional image of the tank car and underframe.
