Derailment and Hazardous Materials Release of  
Union Pacific Railroad Unit Ethanol Train  
Graettinger, Iowa  
March 10, 2017

**Accident Report**

NTSB/RAR-18/02  
PB2019-100084

**National  
Transportation  
Safety Board**

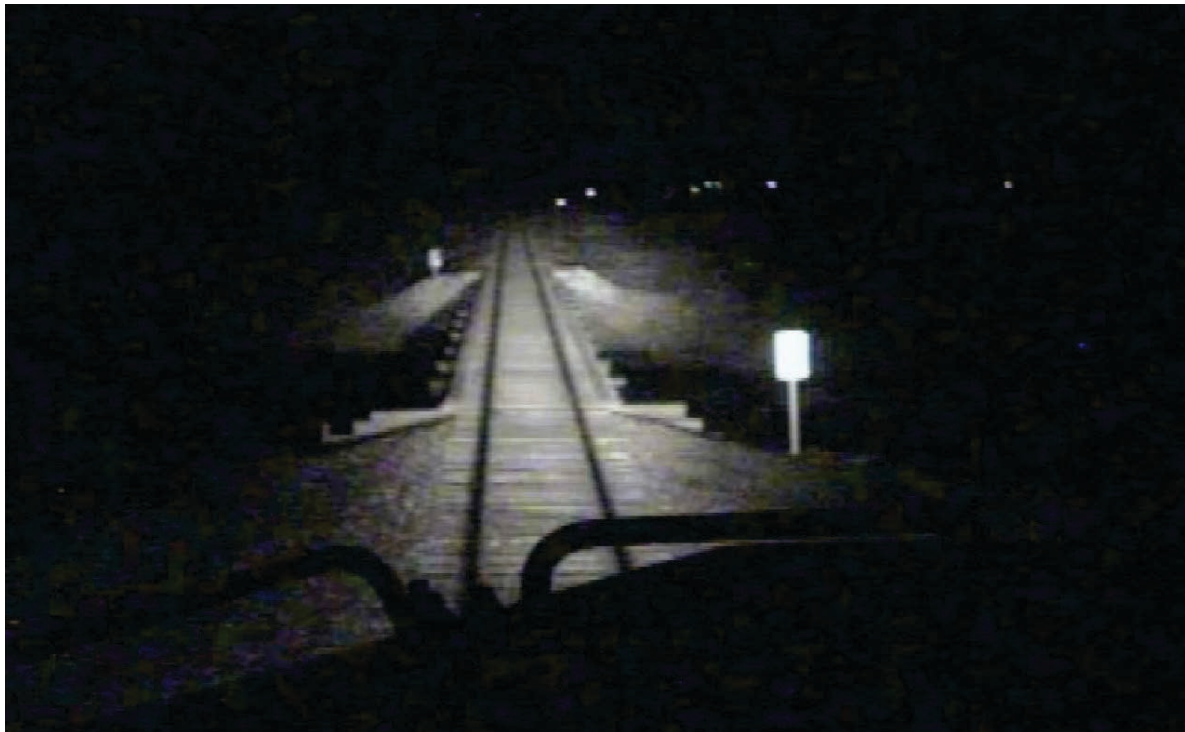
**Figure 9.** Still image of the track on approach to the Jack Creek Bridge.

The lead locomotive in this accident was equipped with a forward-facing video camera and an on-board image recording system. NTSB investigators reviewed the video and did not observe any discontinuities in the rail on the approach to the Jack Creek Bridge. (See figure 9.)
