In accordance with the Board's rules, the Air Line Pilots Association (ALPA) submits the attached comments concerning the accident involving Trans World Airlines Flight 800, which occurred on July 17, 1996, off Long Island, New York.

**SUBMISSION OF THE
AIR LINE PILOTS ASSOCIATION
TO THE
NATIONAL TRANSPORTATION SAFETY BOARD
REGARDING THE ACCIDENT INVOLVING
TRANS WORLD AIRLINES FLIGHT 800
OFF LONG ISLAND, NEW YORK
ON JULY 17, 1996**

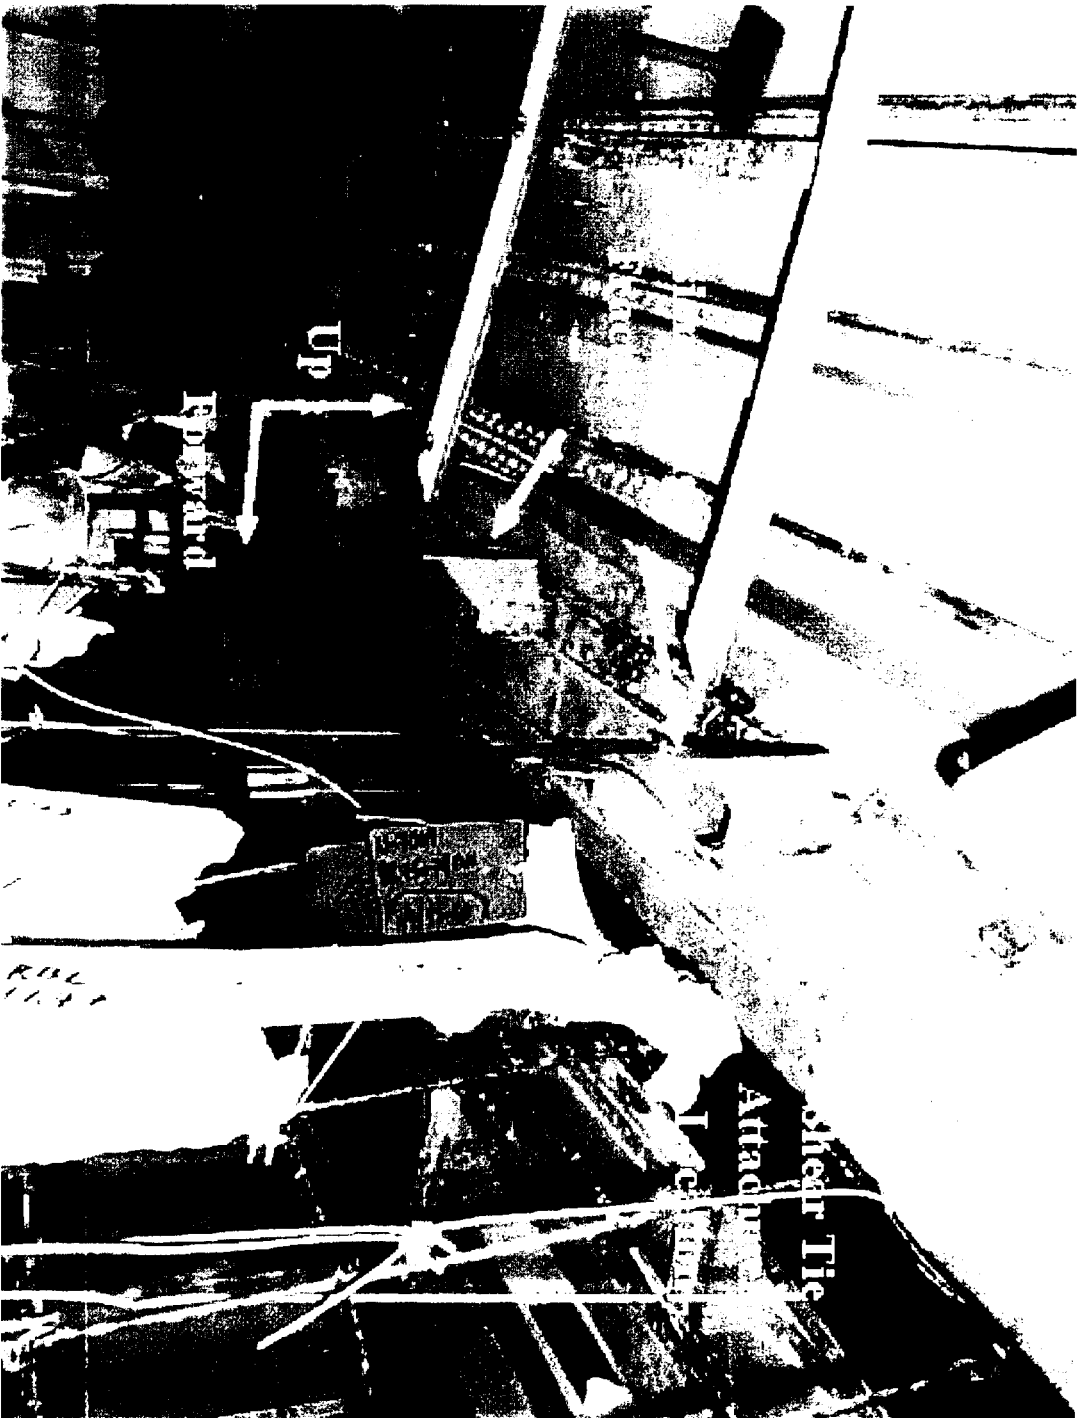
Figure 3

The exceptions to this are the stiffeners associated with tension fittings. Those SWB 3 stiffeners which resided under floor beams were equipped with single bolt tension fittings instead of shear ties. These stiffeners fractured several inches below the tension fittings in a fairly uniform manner (Figure 3). The fractures are consistent with in-plane tension loading and out-of-plane shear loading. The out-of-plane forces were applied to the aft side of the beam.

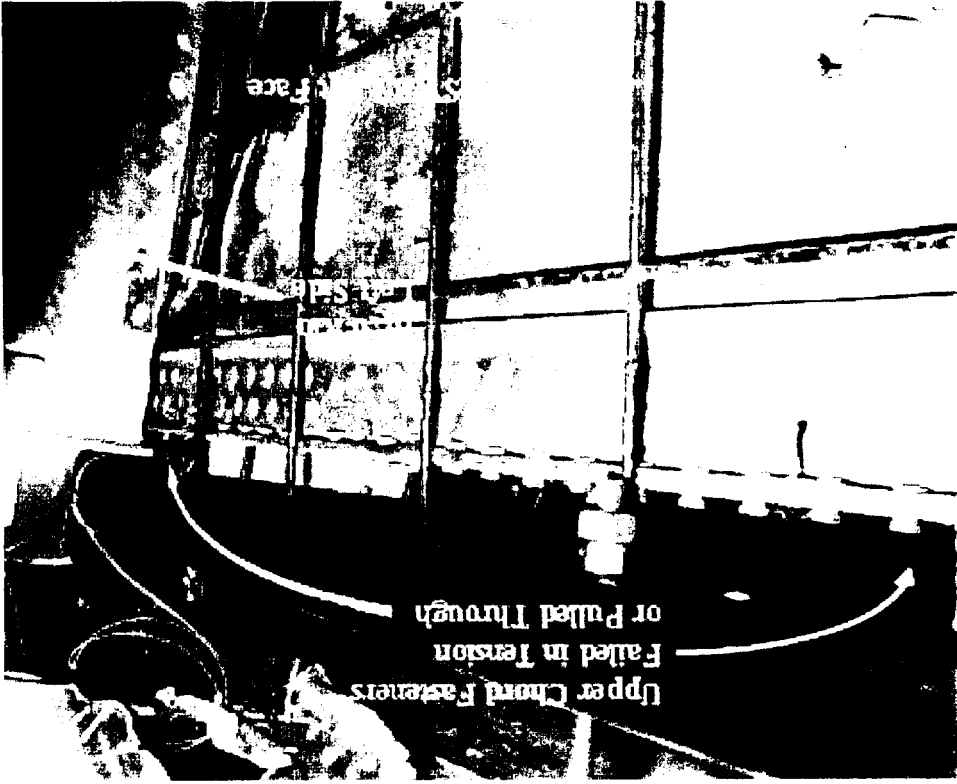
▼ Figure 6

The vertical faces of the tension fittings associated with spanwise beam 3 and 1 exhibited vertical bolt hole elongations or vertical deformations of the bolt remnant (Figure 6). These elongations are consistent with the tension fitting moving upward relative to the beam web. This evidence is also consistent with an increase in the dimension between upper and lower skins.

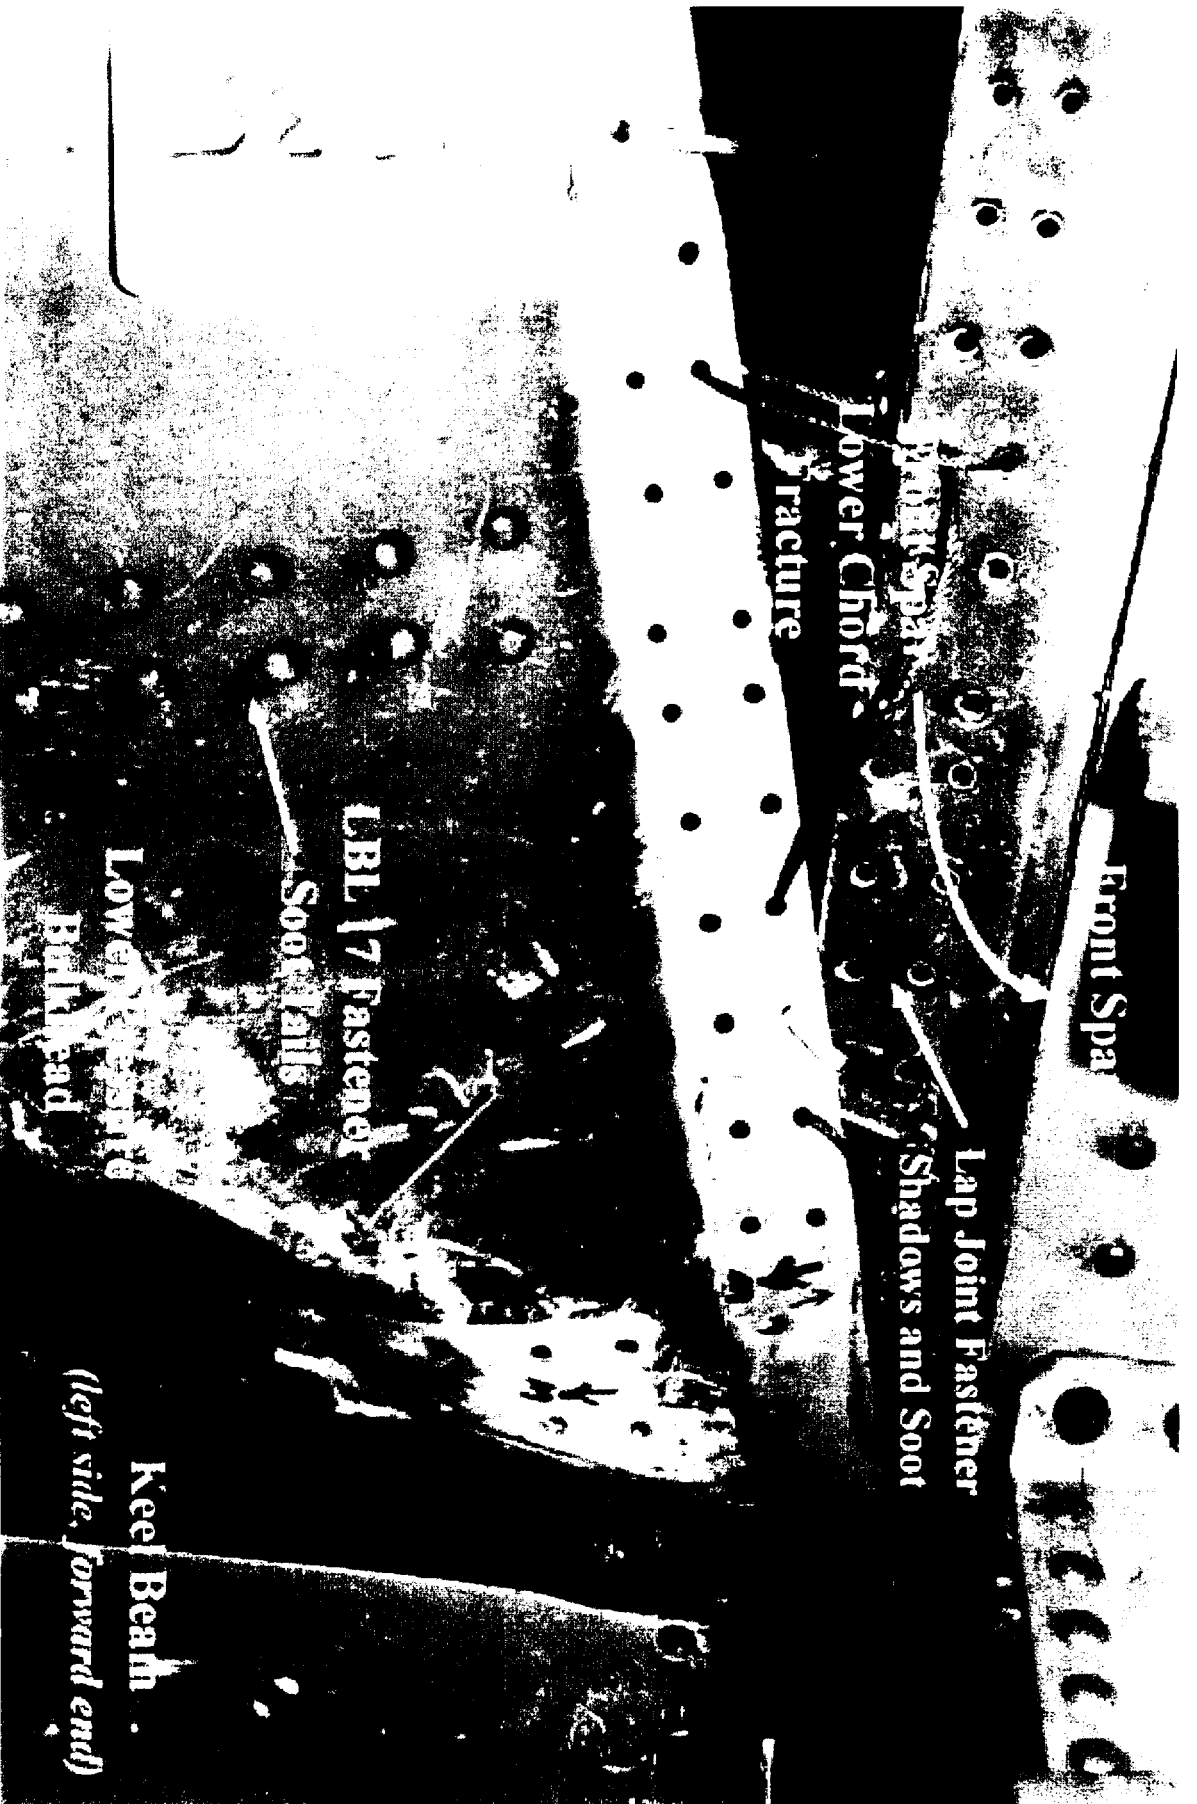
Figure 10

This region of sooting, shown in Figure 10, involves the lap joint flange which runs laterally across the aircraft and which joins the front spar with the lower pressure bulkhead (the "smiley face"). The entire lap joint resides below the lower skin of the center fuel tank. From approximately BL 0 left to approximately LBL 25 (LF55D, LF55C), the sooting on the lap joint is particularly heavy (Fig 11). The fasteners exhibit tails indicating downward flow, including the fasteners which attach the LBL 17 stiffener to the bulkhead web. Farther outboard, some

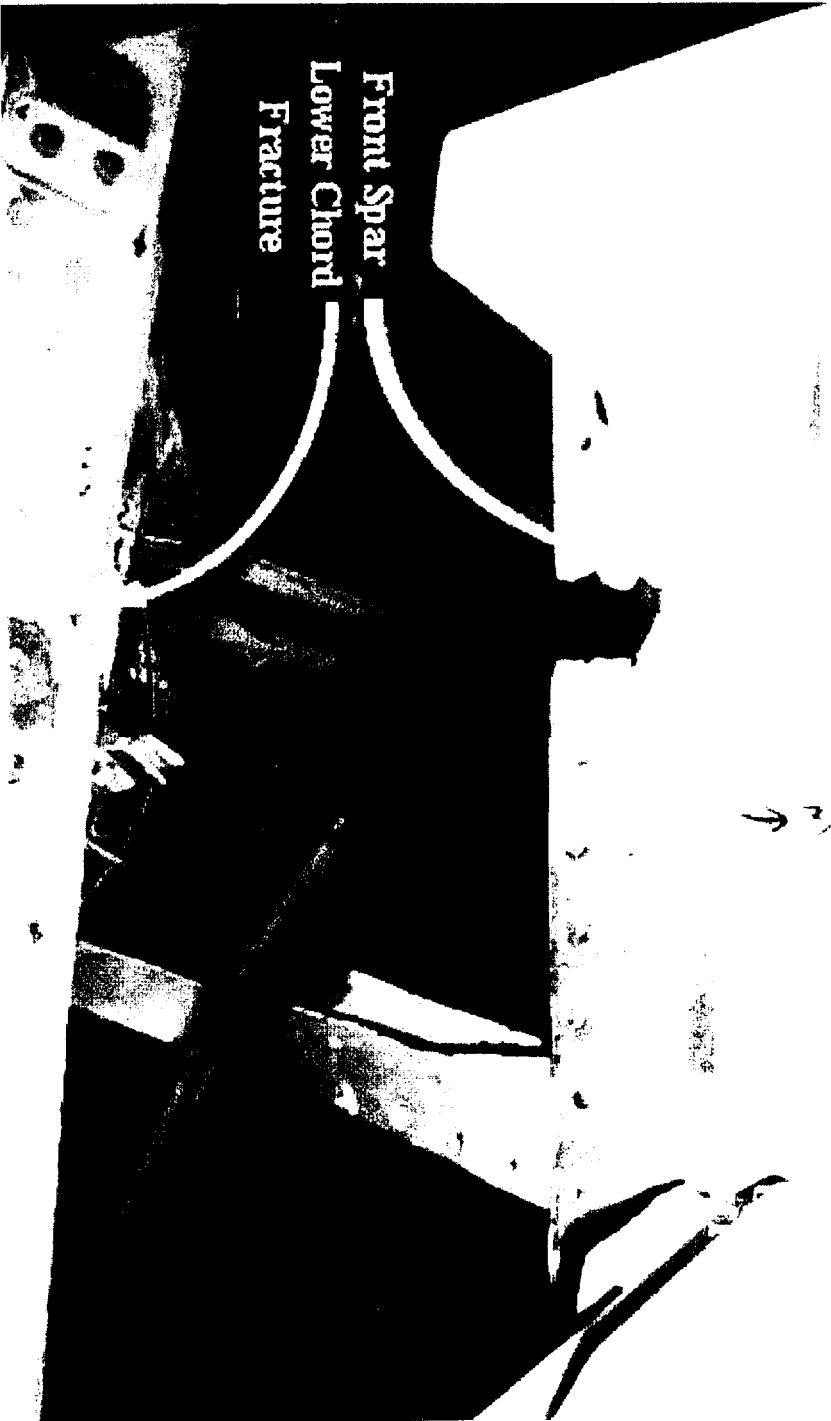
Figure 12

evidence of flow toward the left side-of-body is visible (Fig 12). There is very heavy soot built above the location of the LBL 9 angle chord which joins the left side of the keel beam to the bulkhead (Fig 13). The area directly beneath this location, which would be covered by the angle chord in the assembled state, exhibits a much lighter migration of soot to approximately the bolt hole plane.
