## NATIONAL TRANSPORTATION SAFETY BOARD

### Group Chairman's Factual Report

# AIR TRAFFIC CONTROL

OPS15IA011AB

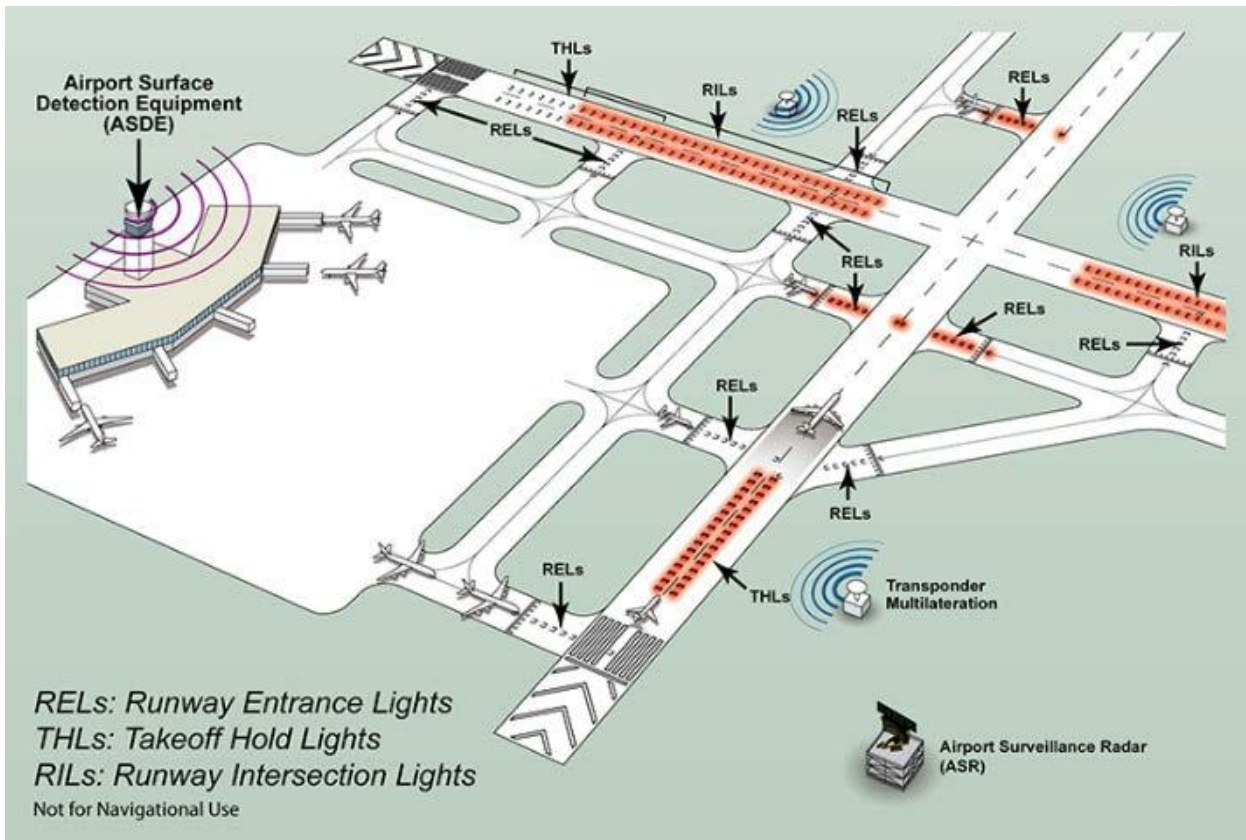
Figure 5 – Runway Status Lights (RWSL)

RELs are arrays of evenly spaced red lights aligned with the taxiway centerline which stop at the hold line at the runway edge, with one additional light at the runway centerline in line with the last two lights before the runway edge. The RELs illuminate when the runway is unsafe for entry or crossing.

THLs are composed of in-pavement lighting in a double, longitudinal row of lights aligned on either side of the runway centerline. The lights are focused toward the arrival end of the runway at the “line up and wait” point, and they extend for 1,500 feet in front of the holding aircraft. Illuminated THLs indicate to an aircraft in position for takeoff or rolling that it is unsafe to takeoff because the runway is occupied or about to be occupied by an aircraft or vehicle. See figure 5.

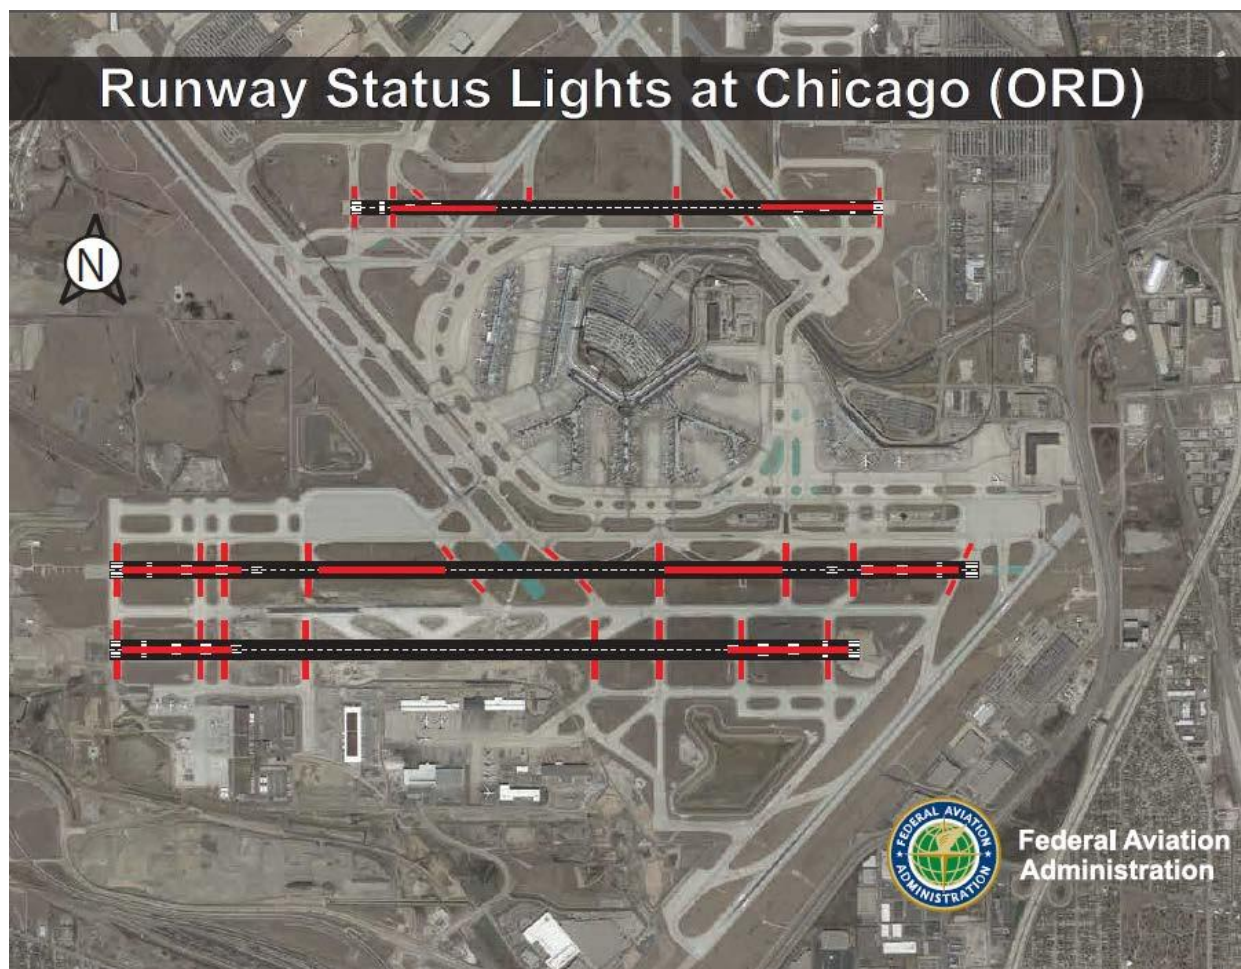
Figure 6 - ORD RWSL final configuration diagram

According to emails<sup>2</sup> dated March 9, 2015, and June 19, 2015, from the Managing Deputy Commissioner, Chicago Department of Aviation (CDA), Airport Airfield Operations/Vehicle Services Sections, the ORD RWSL infrastructure was installed in 2010 as part of a project involving runway 10C-28C and associated taxiways. The circuiting for the RWSL system was subsequently installed as a change order to this project. The installation of the regulators for the system and ancillary system upgrades/installations were performed by the FAA RWSL program office. Past equipment issues and concerns, e.g. malfunctioning light fixtures, arctic kits and snow ring concerns, appear to have been resolved.

Recent Megger testing<sup>3</sup> performed at the end of 2014 appeared to indicate that the resistance of the circuits installed in 2010 did not meet specification. The CDA planned to perform some additional testing to determine the extent of the issue. This plan also included the ordering of additional cabling to replace any circuits or portions thereof that did not meet specification.

- RWSL cans/conduit being installed as part of overlay project from July through November 2016
- RWSL shelter site is being coordinated with the designer, FAA and CDA
- Designer is developing scope of work for RWSL shelter/infrastructure upgrades and will coordinate scope of work and funding with the FAA program office

ORD RWSL commissioning is tentatively scheduled for the spring of 2016. See figure 6.
